Tahmoor Colliery Longwalls 25 to 26

PUBLIC, COMMERCIAL AND RESIDENTIAL STRUCTURES

SURFACE SAFETY AND SERVICEABILITY MANAGEMENT PLAN

REVISION D

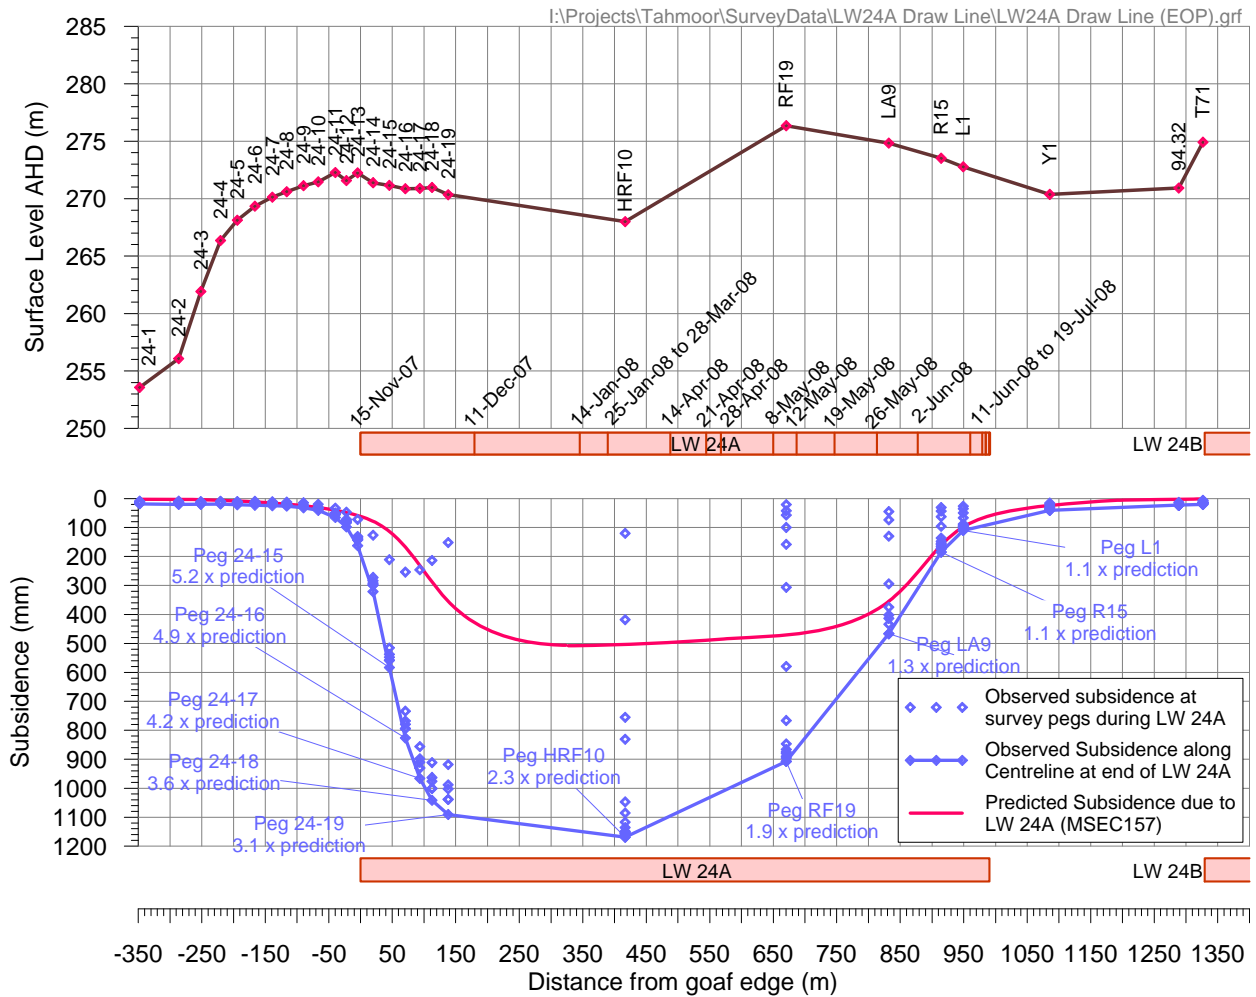
Fig. 2.1 Observed Subsidence along Centreline of Longwall 24A

While there has been a reasonable correlation between observed and predicted subsidence above Longwalls 22 to 24B, increased subsidence has been observed above Longwall 24A. Observed subsidence was greatest above the southern half of Longwall 24A, and gradually reducing in magnitude towards the northern half of the longwall, which was directly beneath the urban area of Tahmoor. These observations are shown graphically in Fig. 2.1, which shows observed subsidence at survey pegs located along the centreline of Longwall 24A.

It can be seen from Fig. 2.1 that while observed subsidence was substantially greater than predicted above the commencing end of the longwalls, observed subsidence compared reasonably well with predictions towards the finishing end of Longwall 24A. It is noted that the extent of the urban area of Tahmoor above Longwall 25 is located between Ralfe Street (Peg RF19) and Remembrance Drive (Peg R15).

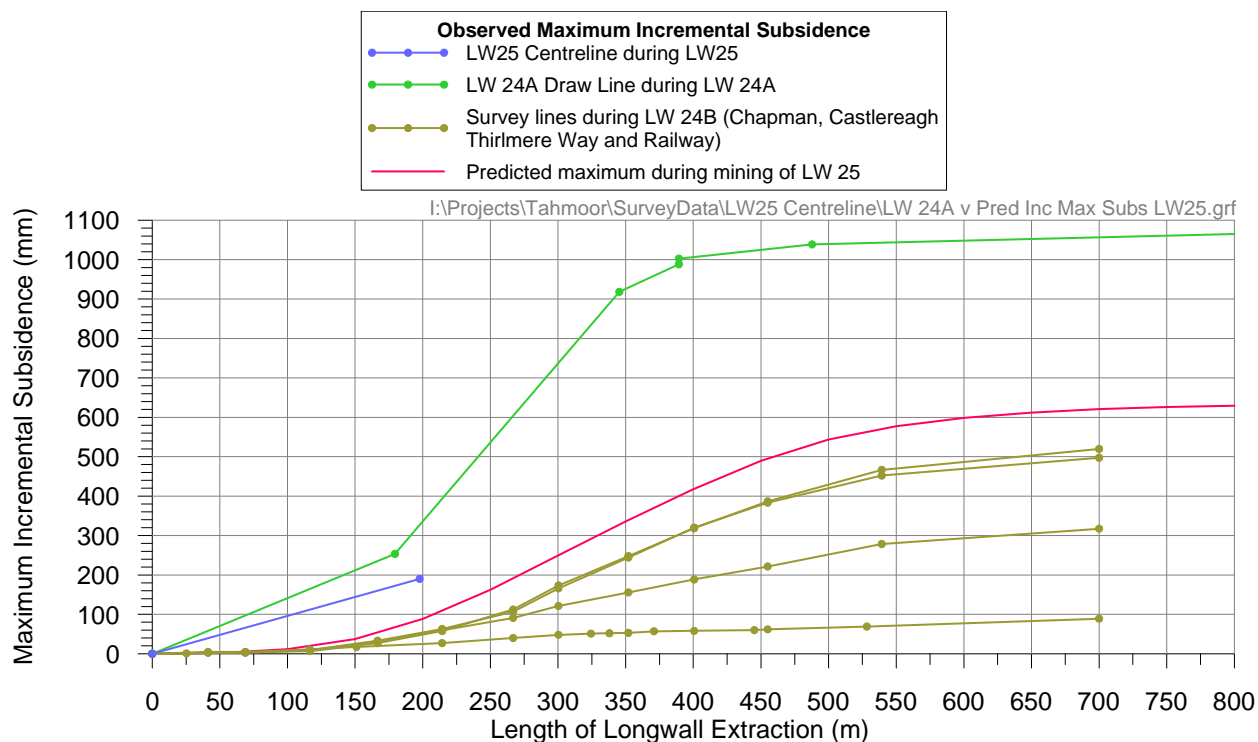
Fig. 2.2 Observed Maximum Incremental Subsidence during the mining of LWs 24B, 24A and 25

Recent subsidence monitoring after 200 metres of extraction has confirmed that increased subsidence is developing above the commencing end of Longwall 25. This is best illustrated by Fig. 2.2, which compares maximum observed subsidence during the mining of Longwalls 24B, 24A and 25, as well as maximum predicted subsidence during the mining of Longwall 25.

It can be seen from Fig. 2.2 that the observed subsidence behaviour during the mining of Longwall 25 is similar to but slightly less than the behaviour observed during the mining of Longwall 24A. This is substantially more subsidence compared to observations during the mining of Longwall 24B, which closely matches the subsidence predictions.
