Tahmoor Colliery Longwalls 27 to 30

ENVIRONMENTAL MANAGEMENT PLAN

REVISION D

February 2013

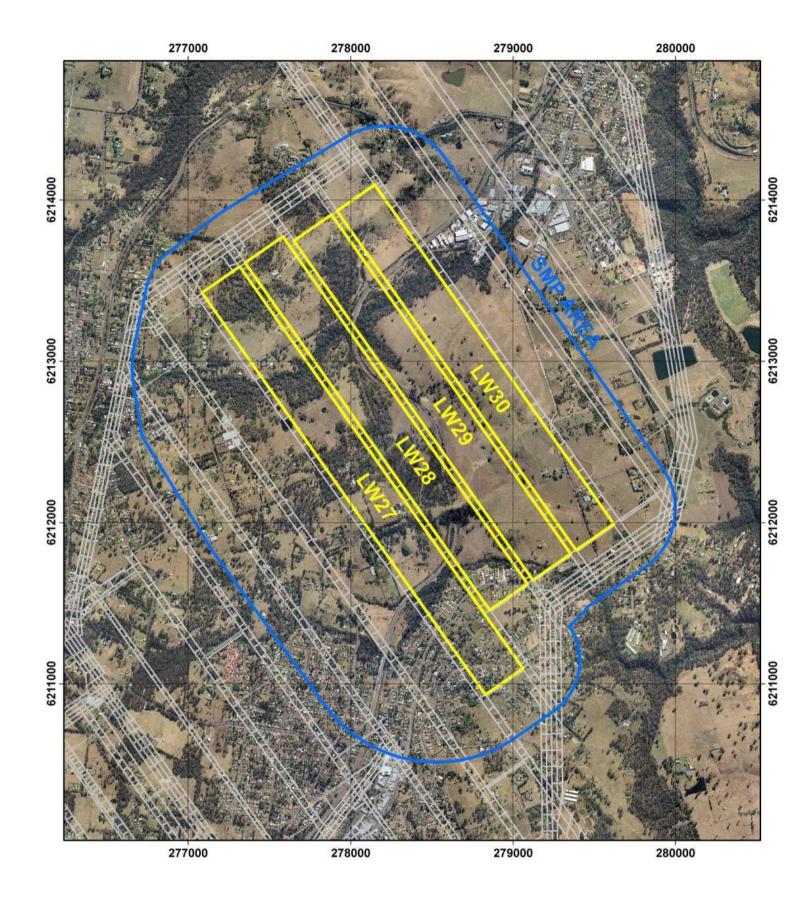
Figure 1.1 Aerial Photograph and Mine Plan

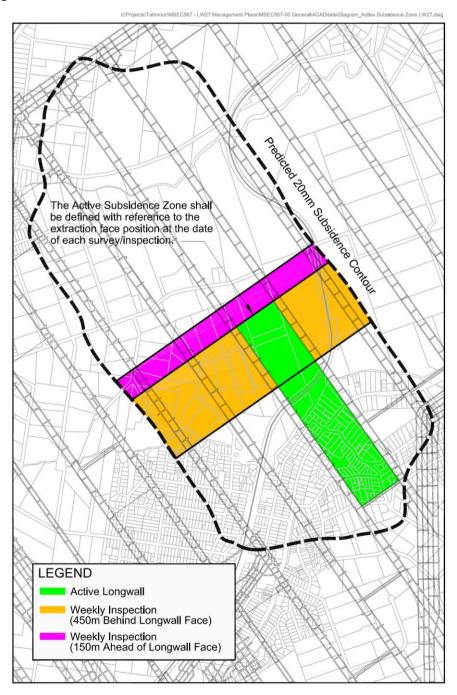
As a longwall progresses, subsidence begins to develop at a point in front of the longwall face and continues to develop after the longwall passes. The majority of subsidence movement typically occurs within an area 150 metres in front of the longwall face to an area 450 metres behind the longwall face.

This is termed the "active subsidence zone" for the purposes of this EMP. The active subsidence zone for each longwall is defined by the area bounded by the predicted 20 mm subsidence contour for the active longwall and a distance of 150 metres in front and 450 metres behind the active longwall face, as shown by Figure 1.2.

Figure 1.2 Diagrammatic Representation of Active Subsidence Zone

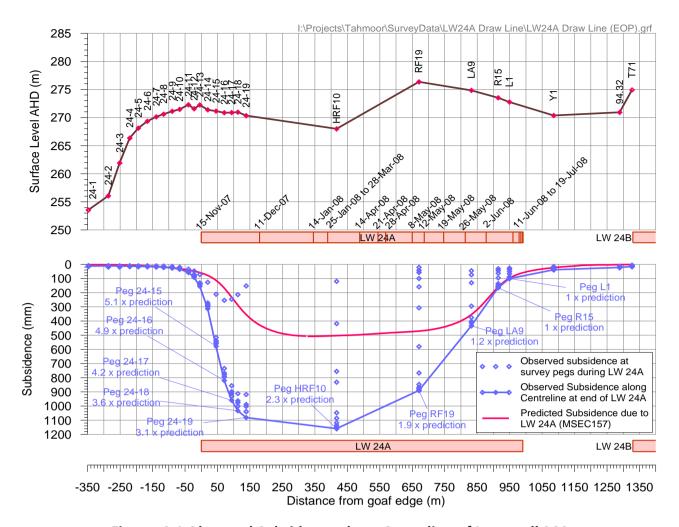
Observed subsidence was greatest above the southern half of Longwall 24A, that gradually reduced in magnitude towards the northern half of the longwall, and was directly beneath the urban area of Tahmoor. These observations are shown graphically in Figure. 2.1, which shows observed subsidence at survey pegs located along the centreline of Longwall 24A.

Figure. 2.1 Observed Subsidence along Centreline of Longwall 24A

It can be seen from Figure. 2.1 that observed subsidence was more than twice the predicted maximum value, reaching to a maximum of 1169 mm at Peg HRF10.

It is possible that actual maximum subsidence developed somewhere between Pegs HRF10 and RF19, though this was not measured. Observed subsidence was similar to prediction near Peg R15 on Remembrance Drive. Survey pegs RF19 and LA9 are located within a transition zone where subsidence gradually reduced from areas of maximum increased subsidence to areas of normal subsidence.

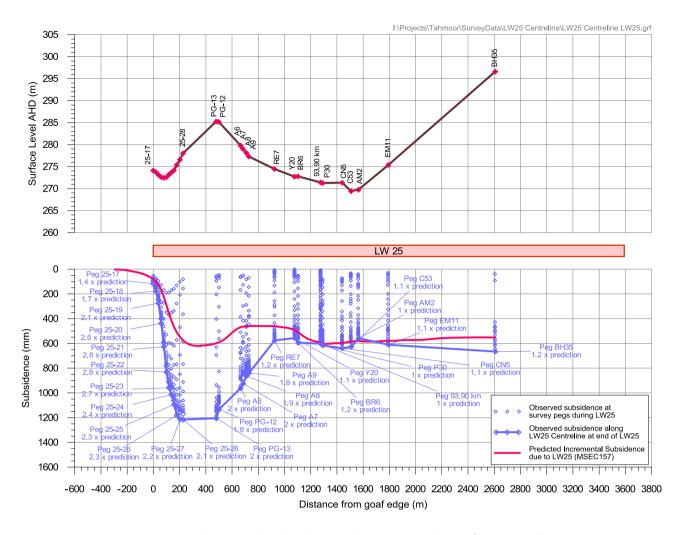
Increased subsidence was observed during the first stages of mining Longwall 25. These observations are shown graphically in Figure. 2.2, which shows observed subsidence at survey pegs located along the centreline of Longwall 25.

Figure. 2.2 Observed Subsidence along Centreline of Longwall 25

It can be seen from Figure. 2.2 that observed subsidence was approximately twice the predicted maximum value, with maximum subsidence of 1216 mm at Peg 25-28.

Observed subsidence is similar to but slightly more than predicted at Peg RE7 and is similar to prediction at Peg Y20 and at all pegs located further along the panel. Survey pegs A6, A7, A8 and A9 are located within a transition zone where subsidence has gradually reduced from areas of maximum increased subsidence to areas of normal subsidence.

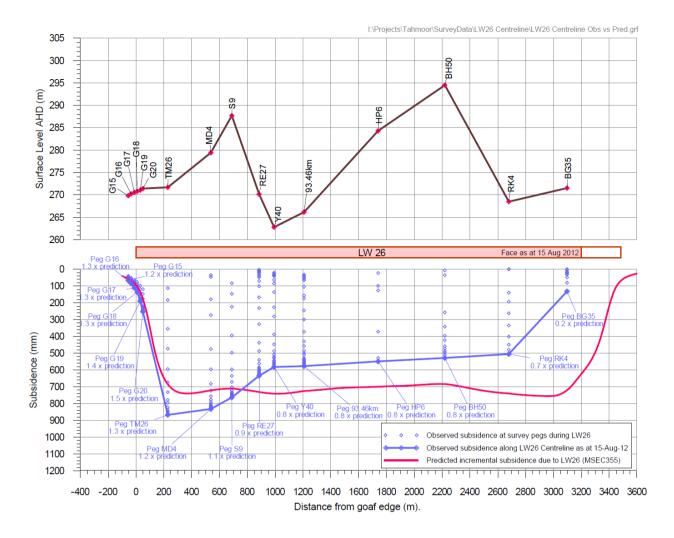
Increased subsidence was observed during the first stages of mining Longwall 26, but at a reduced magnitude compared to the subsidence observed above Longwalls 24A and 25. These observations are shown graphically in Figure 2.3, which shows observed subsidence at survey pegs located along the centreline of Longwall 26. The graph shows the latest survey results for each monitoring line as at August 2012. It is likely that further small increases in subsidence will be observed at these pegs when they are surveyed at the completion of Longwall 26.

Figure 2.3 Observed Subsidence along Centreline of Longwall 26 as at August 2012

It can be seen from Figure 2.3 that observed subsidence was approximately 1.3 times the predicted maximum value, with maximum subsidence of 867 mm at Peg TM26.

Observed subsidence reduced along the panel until Peg Y40 on York Street, where it was less than prediction. Survey pegs S9, and RE27 are located within a transition zone where subsidence has gradually reduced from areas of maximum increased subsidence between Pegs TM26 and MD4 to areas of normal subsidence at Peg Y40 and beyond.

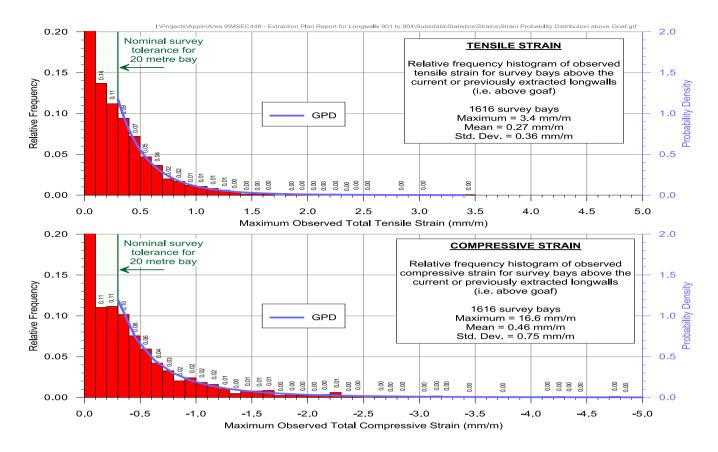
The relative frequency distribution of maximum observed tensile strains and compressive strains for survey bays located directly above goaf is provided in Figure 2.4.

Figure 2.4 Distributions of Measured Maximum Tensile and Compressive Strains at Any Time for Pegs Located Above Goaf in the Southern Coalfield

While not shown in Figure 2.4, it is noted that the maximum observed compressive strain of 16.6 mm/m, which occurred along the T-Line above Appin Longwall 408, was the result of movements along a low angle thrust fault within the Cataract Tunnel. All remaining compressive strains in this dataset (which exclude valley related movements) were less than 5 mm/m.

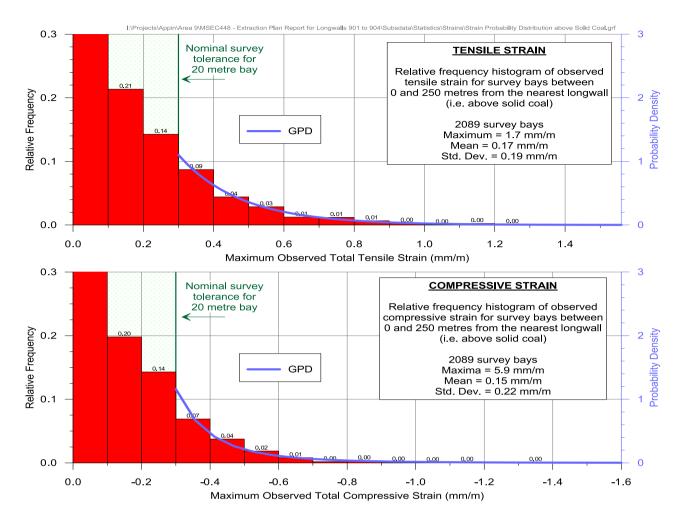
The relative frequency distribution of maximum observed tensile strains and compressive strains above solid coal is provided in Figure 2.5.

Figure 2.5 Distributions of Measured Maximum Tensile and Compressive Strains at Any Time for Pegs Located Above Solid Coal in the Southern Coalfield

While not shown in Figure 2.5, it is noted that the maximum observed compressive strain of 5.9 mm/m, which occurred along the T-Line above Appin Longwall 408, was the result of movements along a low angle thrust fault within the Cataract Tunnel as Longwall 408 approached the monitoring line. A maximum observed compressive strain of 3.1 mm/m was observed across the fault at the completion of Longwall 407. All remaining compressive strains in this dataset (which exclude valley related movements) were less than 5 mm/m.

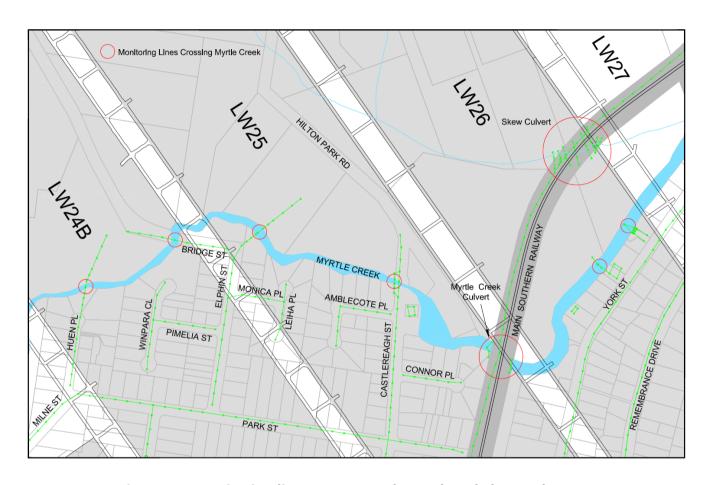
A map of monitoring lines across Myrtle Creek and a small unnamed tributary creek that crosses the Main Southern Railway (at a location called the Skew Culvert) is shown in Figure 2.6.

Figure 2.6 Monitoring lines across Myrtle Creek and Skew Culvert

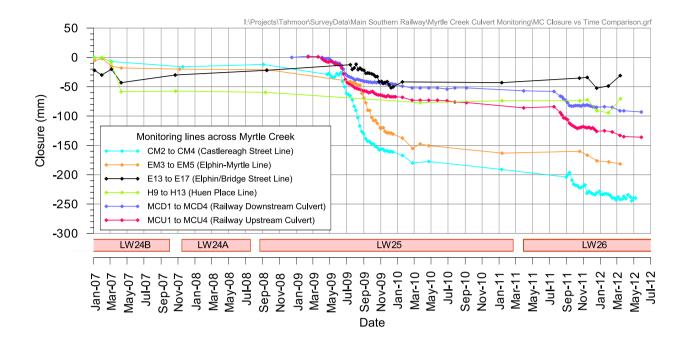
A summary graph showing the development of valley closure across the Myrtle Creek at each monitoring line is shown in Figure 2.7.

Figure 2.7 Development of closure across Myrtle Creek during the mining of Longwalls 24B to 26

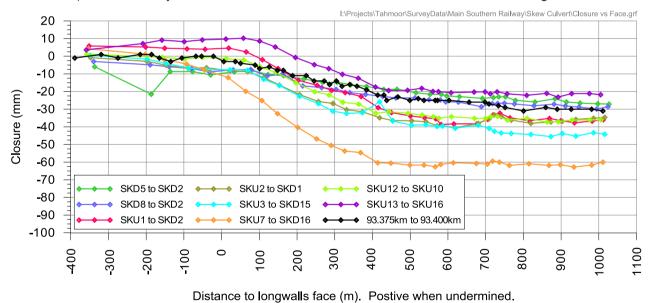
The development of valley closure across the creek at the Skew Culvert is shown in Figure 2.8.

Figure 2.8 Development of closure across Skew Culvert during the mining of Longwall 26 as at 27 March 2012

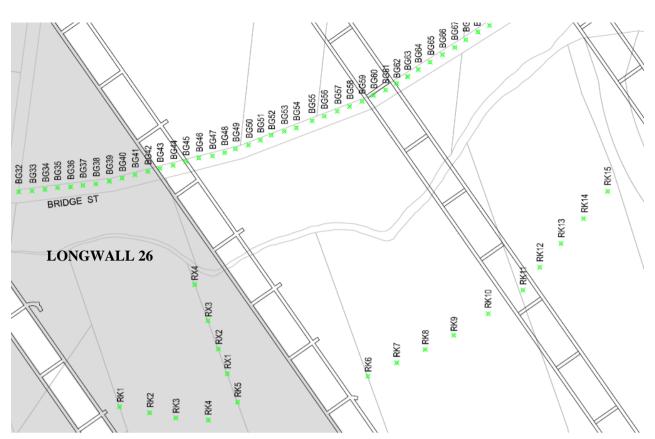
In light of the access constraints, ground surveys are being undertaken in relative 3D from Bridge Street to a new monitoring line that is located in cleared pasture land along the top of the valley. This will provide measurements of total valley closure. Some survey pegs have been installed along a fence line on the southern side to a point where surveyors can sight a survey peg on Bridge Street. Despite the best efforts of the survey team, the accuracy of the survey is challenged by the lack of cross lines across Redbank Creek. Baseline monitoring indicates that the valley closure measurements will be accurate to approximately 20 to 30 mm.

Figure 2.9 Location of survey marks across Redbank Creek

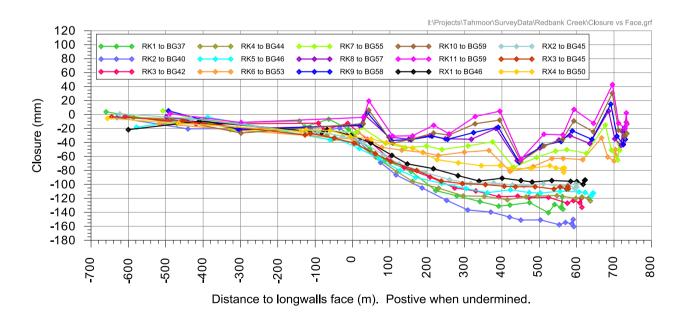
The development of valley closure across Redbank Creek during the mining of Longwall 26 is shown in Figure 2.10. The results indicate that valley closure has developed across Redbank Creek, particularly where the longwall face has passed directly beneath the creek.

Figure 2.10 Observed development of closure across Redbank Creek

Maximum predicted valley closure due to extraction of Longwall 26 was 120 mm. As shown in Figure 2.10, observed valley closure was slightly greater than predicted closure at this stage of mining but much less than the predicted total closure of 500 mm due to the mining of Longwalls 22 to 30.

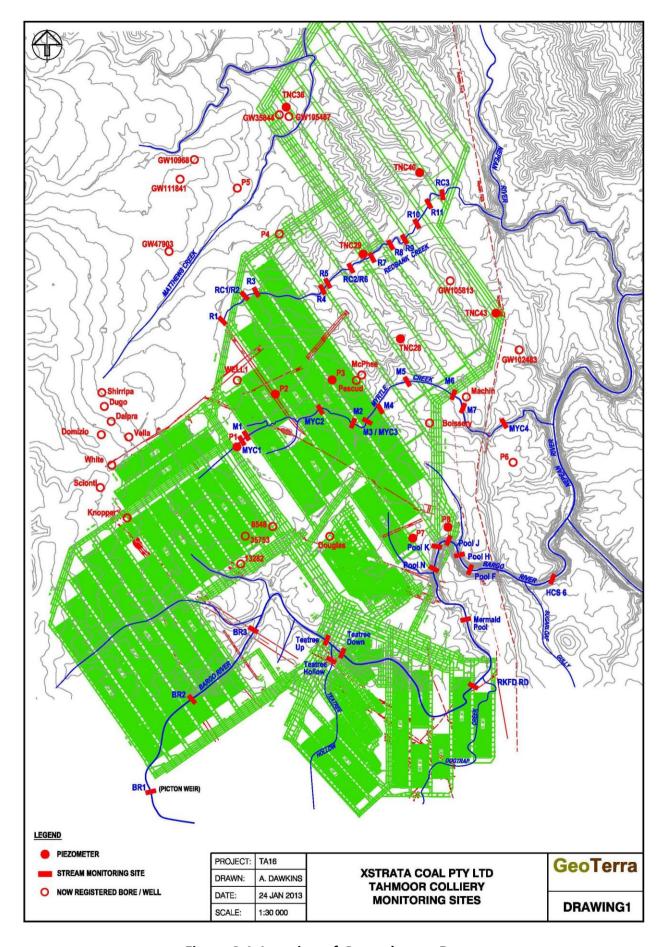
Piezometers used for monitoring surface and groundwater within the SMP Area and the locations of these are shown in Figure 3.1. In addition, a number of exploration bores were installed by Tahmoor Colliery in the vicinity of the SMP Area that may also be affected by far-field movements, or change in water quality or supply. These bores are generally sealed from seam to surface after drilling is completed. Their locations are shown in Figure 3.1.

Where access is granted by the landowner, all relevant private bores and piezometers located within a 3km limit of mining in Longwall 27, then subsequently 28, 29 and 30 will be monitored, with locations of the groundwater monitoring suite shown in Figure 3.1.

Figure 3.1 Location of Groundwater Bores

A disused well is located near Structure W50a, which is located above the pillar between Longwalls 25 and 26 and its location is also shown in Figure 3.1.

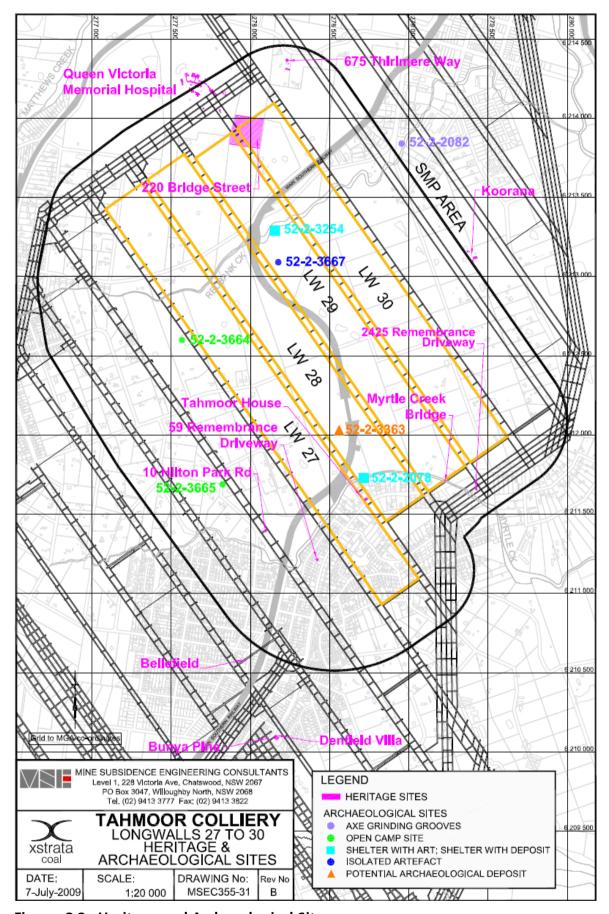
Figure. 3.2 Heritage and Archaeological Sites

There are 6 Aboriginal archaeological sites within the Subsidence Management Plan (SMP) Area. The sites consist of shelters with artefacts/deposit (n=2); Potential Archaeological Deposit (n=1) and open sites with artefacts (n=3). A summary of these sites are provided in Table 3.2 below. Also Refer Figure 3.2.

Biosis (2009) identified nine heritage items in the SMP Area. Based on the subsidence predictions and recommendations provided by MSEC, five of the nine identified historical heritage items are at very low risk of impact from the proposed mining. Refer Figure 3.2.

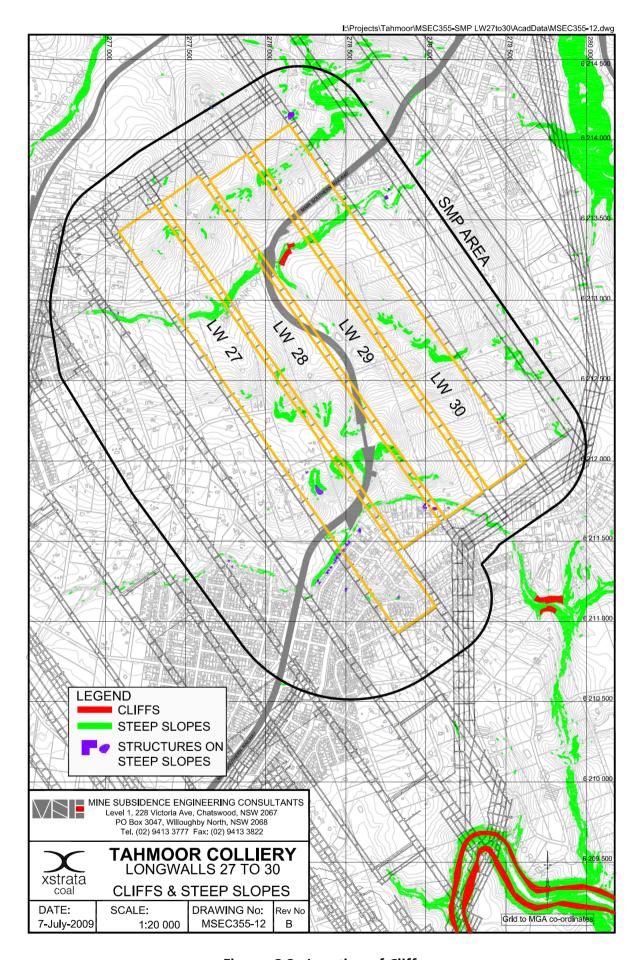
The locations of cliffs directly above Longwalls 27 to 30 are shown in Figure. 3.3.

Figure. 3.3 Location of Cliffs

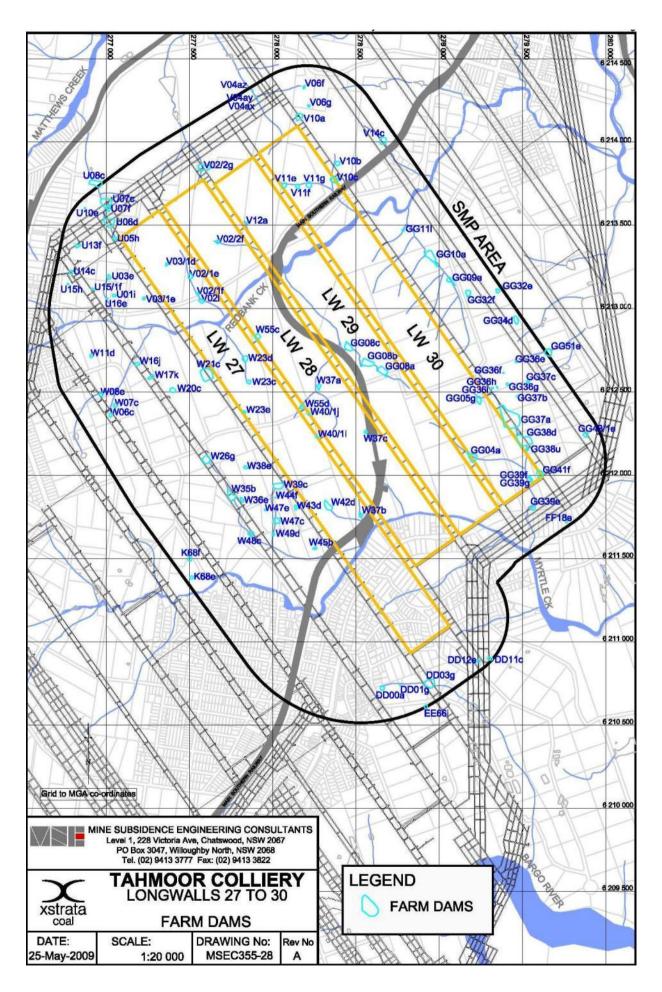
Dams to be monitored only include those that directly overly an actively subsided longwall or associated chain pillars. Dams outside of the active longwall and associated chain pillar do not require monitoring at locations shown in Figure. 3.3.

- Longwall 27 W23c,d,e, 24d, 37b, 40/1i,i, 42d, 55c,d, V02i, V02/1e, f and V031d
- Longwall 28 W37a,c, 40/1i,j, 55c and V02/2f
- Longwall 29 GG04, 08a,b,c
- Longwall 30 GG04a, 05g, and V11a, c, e, f, g

Figure. 4.1 Location of Dams

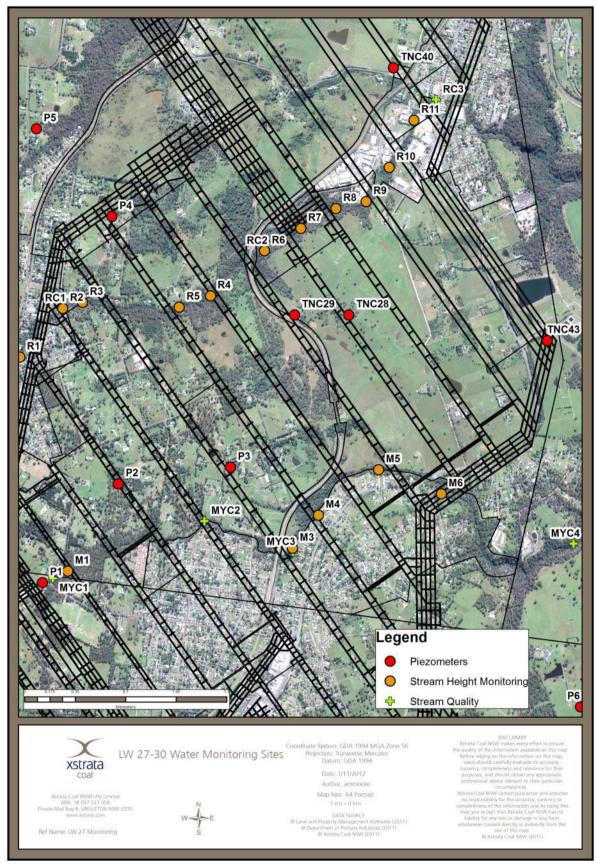
Figure 4.3 Tahmoor Colliery Stream and Bore Monitoring Sites

Water level monitoring is undertaken monthly at identified pools in Myrtle and Redbank Creeks (figure 4.3). 11 stream depth monitoring sites using pressure transducers and loggers were instigated by Hydrometric Consulting Systems (HCS) in Redbank Creek during March 2010 and 7 in Myrtle Creek during June 2010.

Water quality monitoring is undertaken in both Myrtle and Redbank Creeks (fig 4.3). Water quality monitoring in Myrtle Creek started in December 2004 and began in Redbank Creek in April 2005.

Water quality monitoring is not determined by longwall position. Water quality data is collected monthly at Myrtle and Redbank Creek monitoring sites (fig 4.3), is ongoing and is reported in Tahmoor Colliery EoP Reports.
