XSTRATA COAL:  
**Tahmoor Colliery - Longwall 27**

Management Plan for Potential Impacts to Public, Commercial and Residential Structures

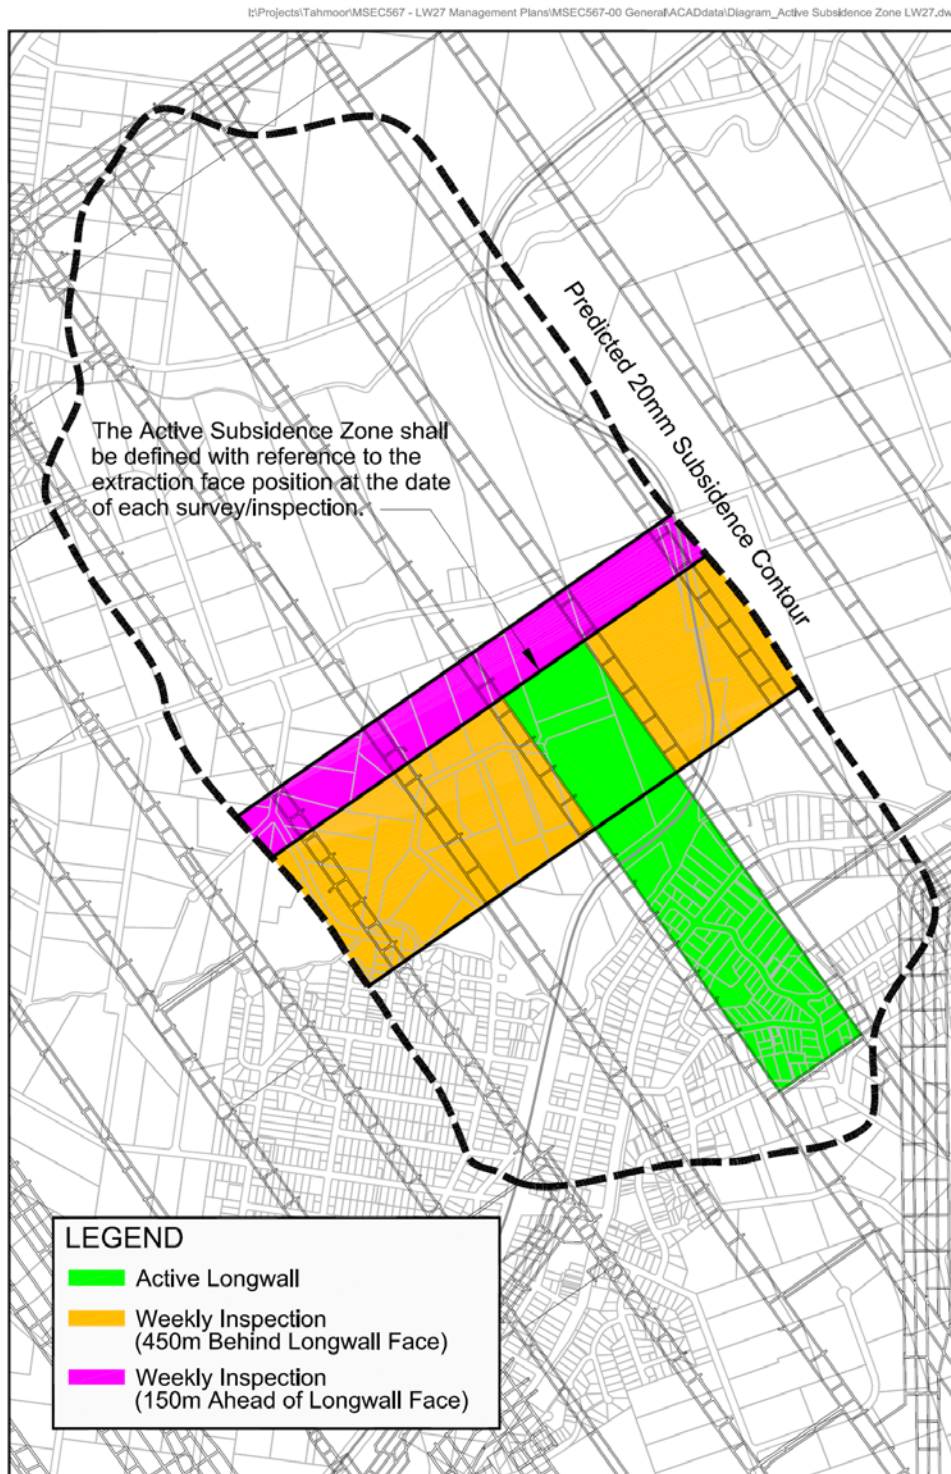
This is termed the “active subsidence zone” for the purposes of this Management Plan, where surface monitoring is generally conducted. The active subsidence zone for each longwall is defined by the area bounded by the predicted 20 mm subsidence contour for the active longwall and a distance of 150 metres in front and 450 metres behind the active longwall face, as shown by Fig. 1.1.

Fig. 1.1 Diagrammatic Representation of Active Subsidence Zone

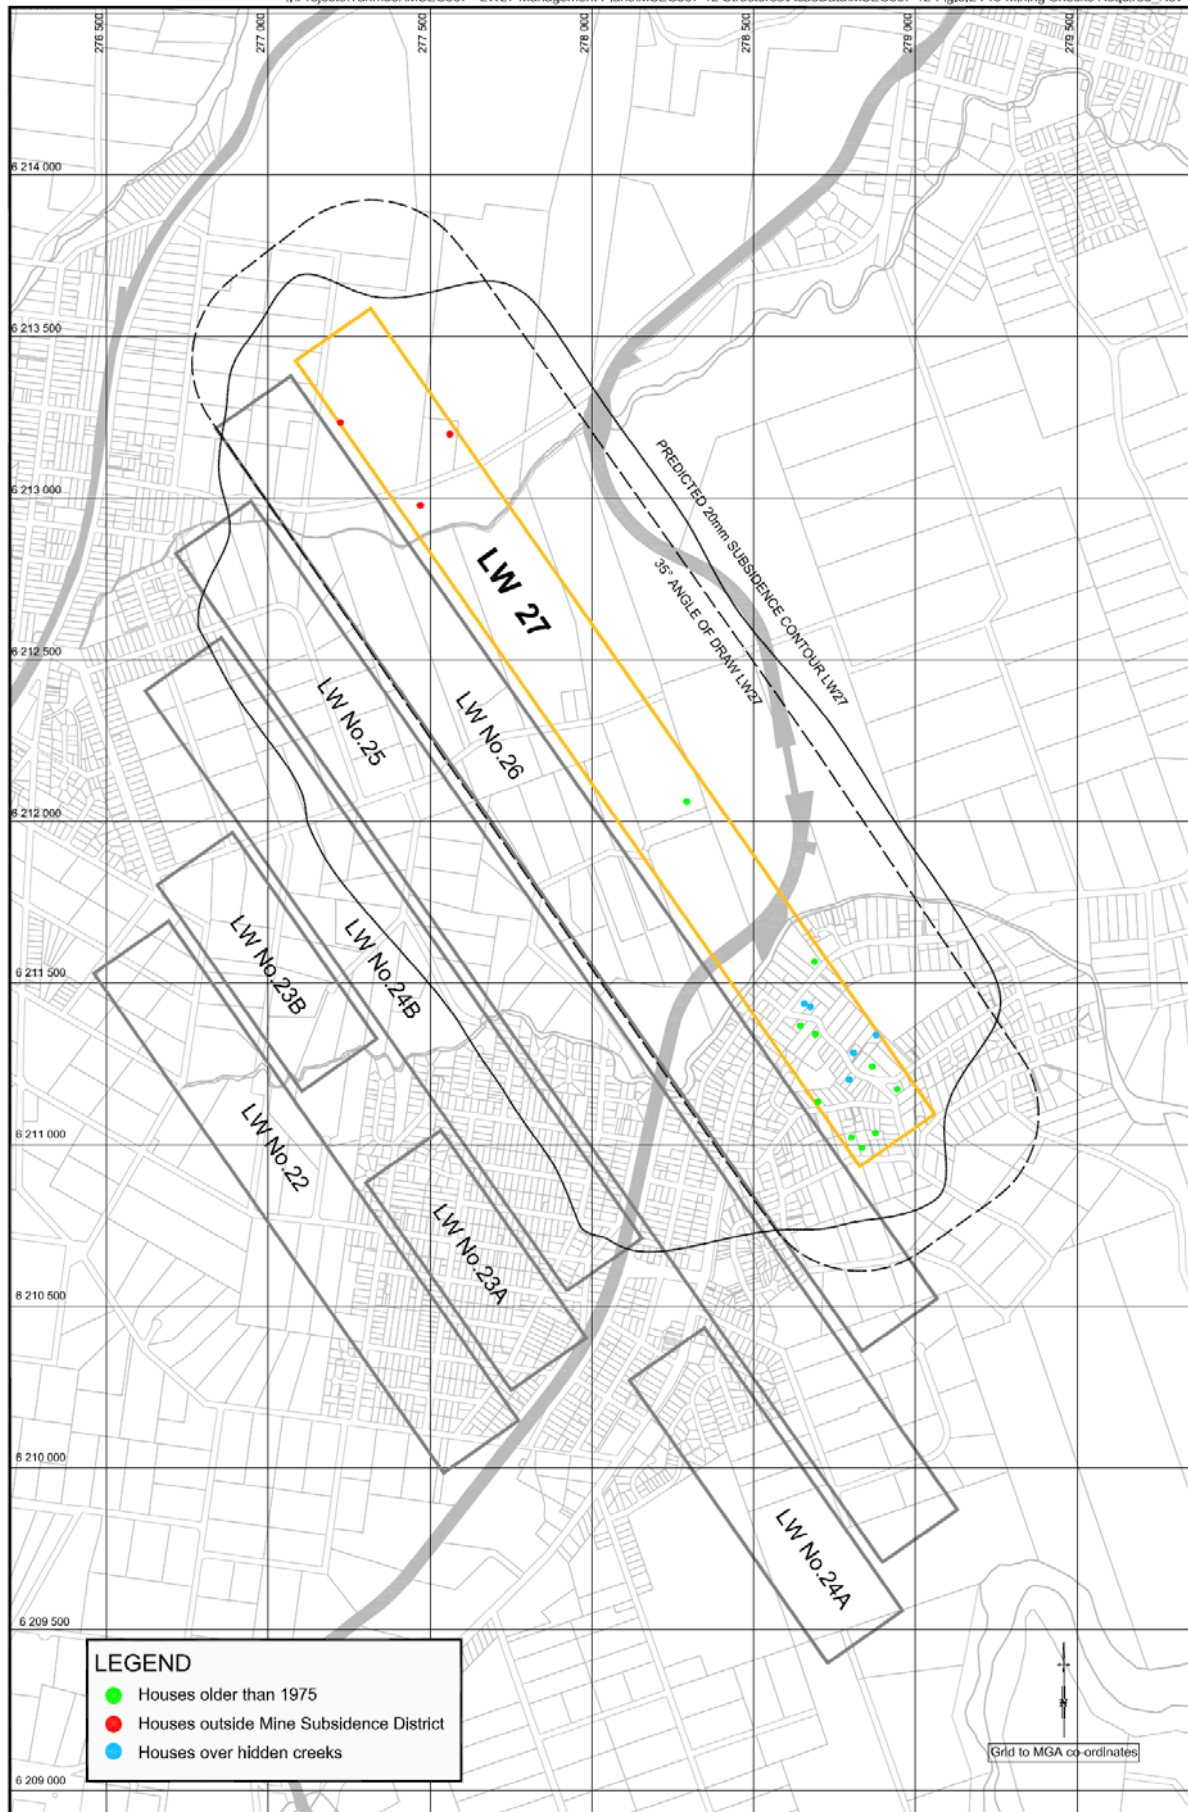
**Fig. 5.2 Location of all Structures selected for Pre-Mining Checks**

Pre-mining building checks will be conducted at structures shown in Fig. 5.2, where access is available and which have not already been directly mined beneath by previous longwalls. The structures include the following:

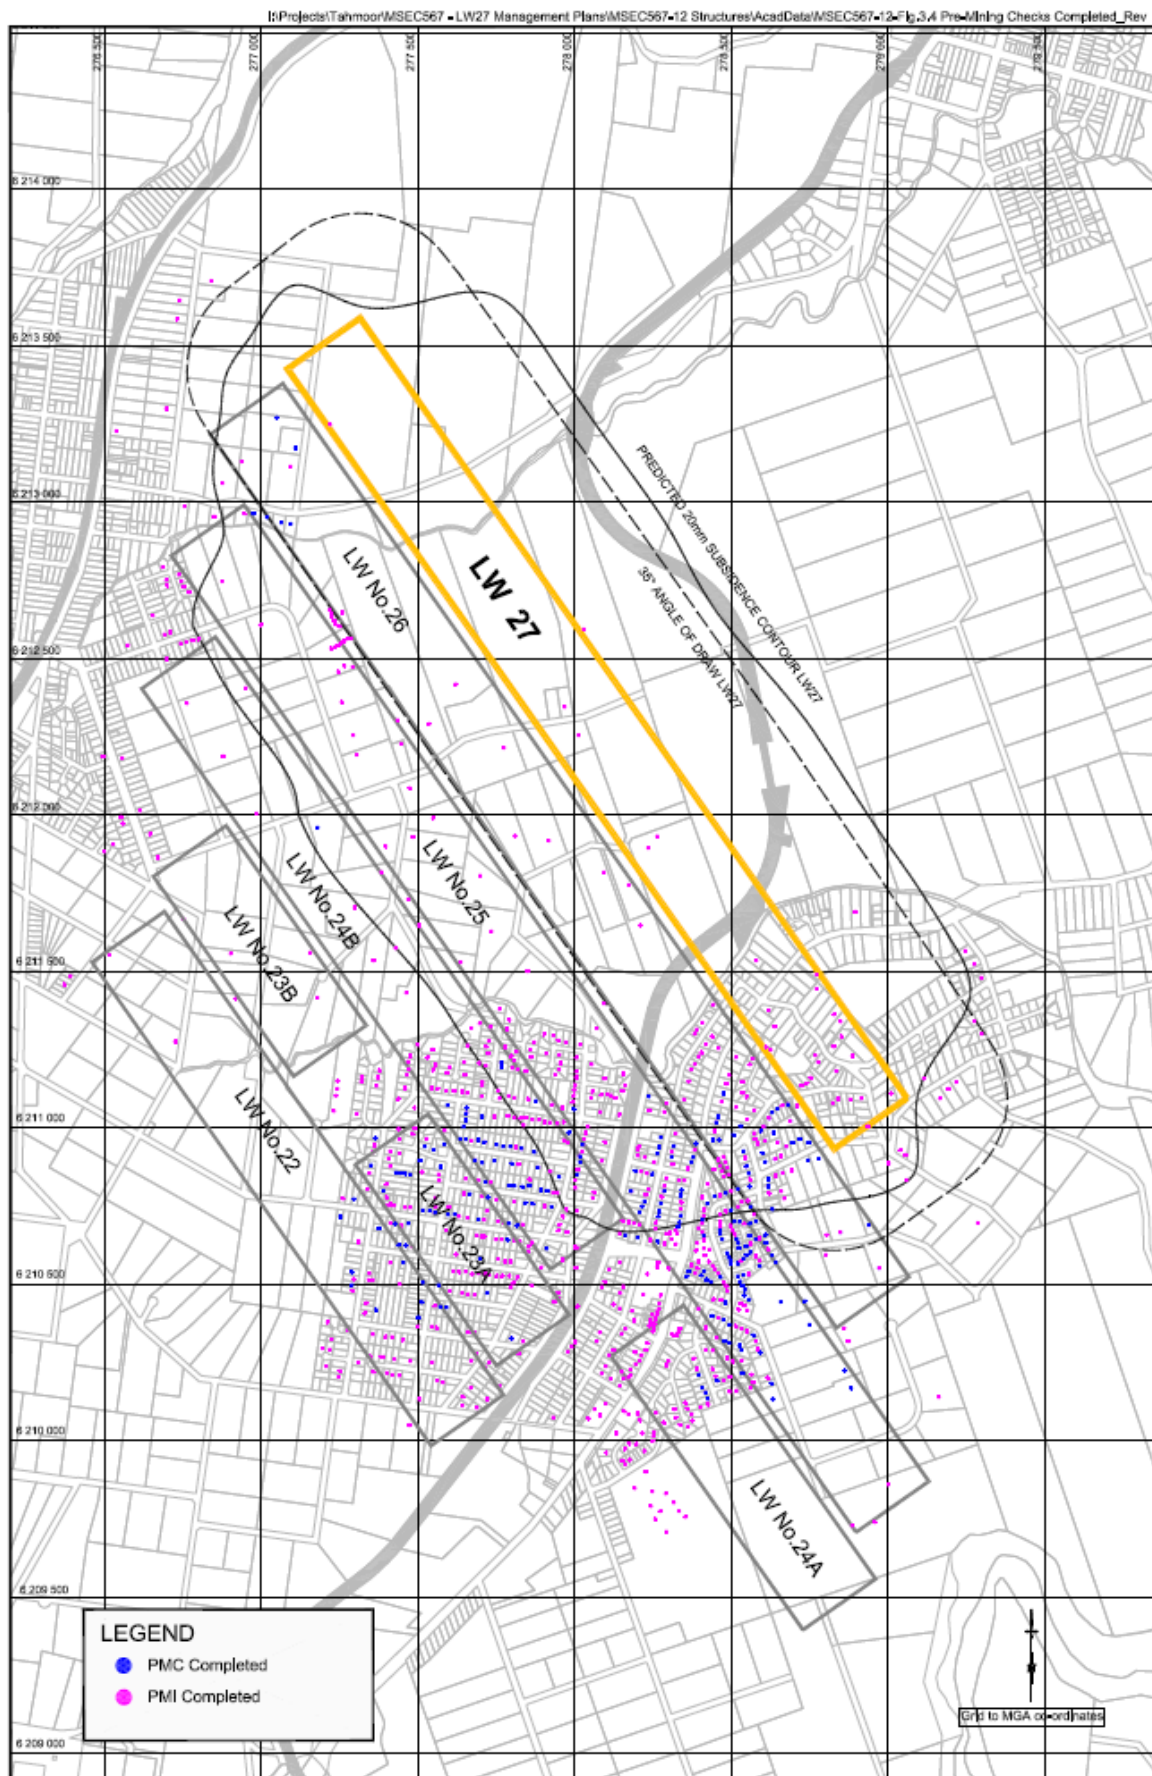
**Fig. 5.3 Properties for which Pre-Mining Inspections or Pre-Mining Checks have been completed**

Many pre-mining inspections have been completed, as shown in Fig. 5.3. The remainder will be undertaken prior to active subsidence of each property during the mining of Longwall 27, subject to landowner approval.

This type of inspection checks for potential stability issues on the property. The inspection is conducted by a licensed builder with experience in mine subsidence or a structural engineer. Many pre-mining checks have been completed, as shown in Fig. 5.3. The remainder will be undertaken prior to active subsidence of each property during the mining of Longwall 27, subject to landowner approval.

The Mine Subsidence Board (MSB) has undertaken a number of pre-mining inspections above Longwalls 22 to 27. These are shown in Fig. 5.3. Further inspections may be conducted by the MSB in the future if requested by a landowner. Tahmoor Colliery will undertake pre-mining inspections on behalf of the MSB if requested by the landowner, or if access is only available after business hours or on weekends.
