TAHMOOR
UNDERGROUND

Tahmoor Colliery - Longwalls 28 to 30

Management Plan for Potential Impacts to Built Heritage

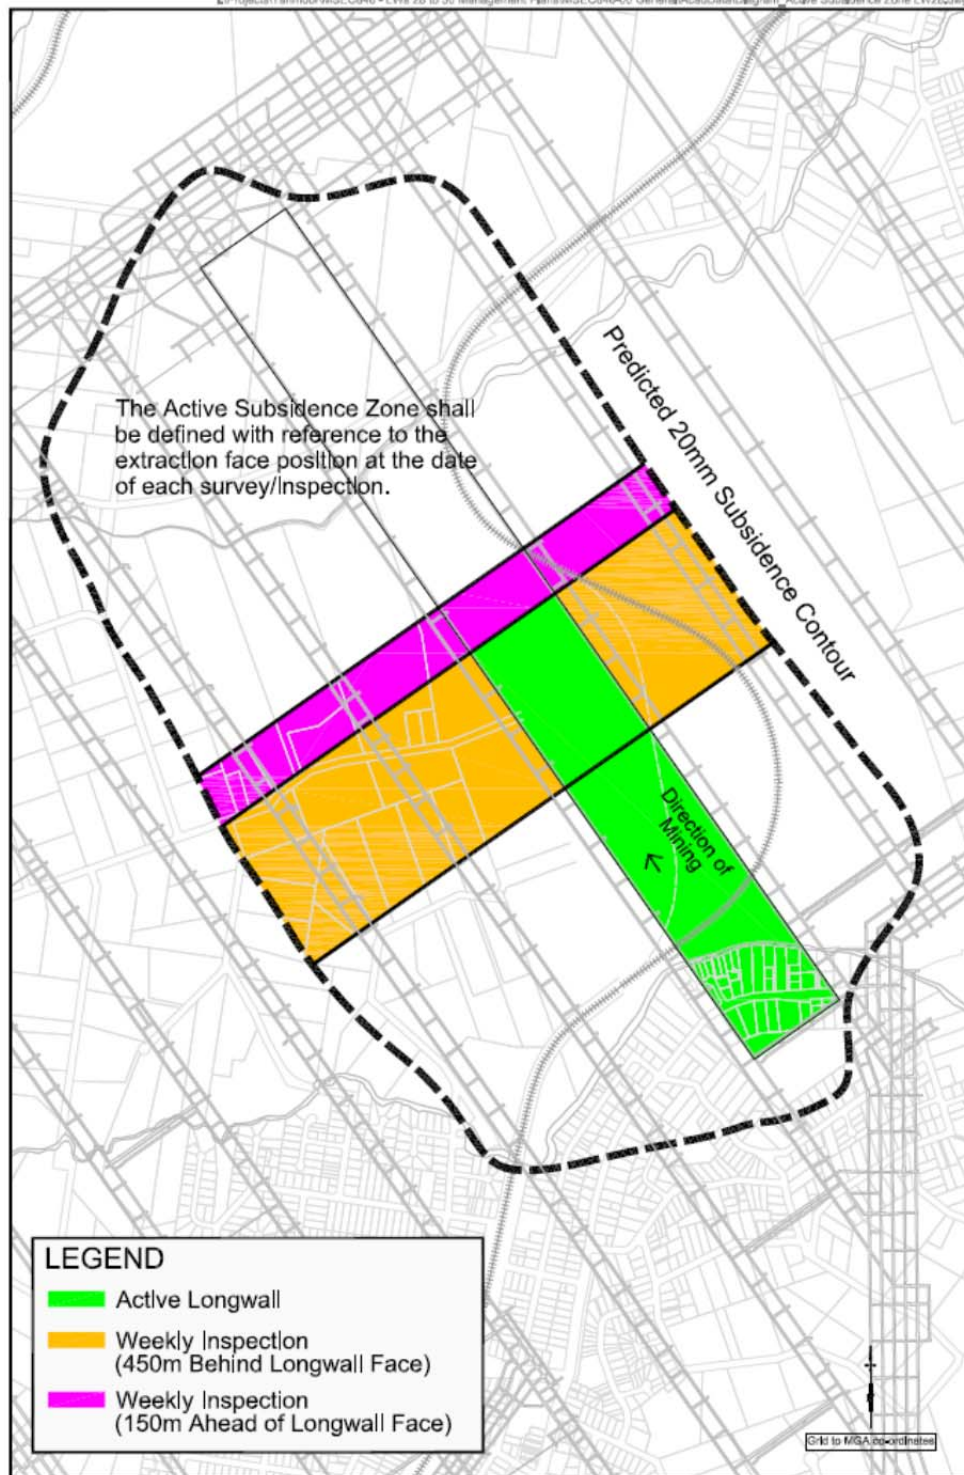
Fig. 1.1 Diagrammatic Representation of Active Subsidence Zone

This is termed the “active subsidence zone” for the purposes of this Management Plan, where surface monitoring is generally conducted. The active subsidence zone for each longwall is defined by the area bounded by the predicted 20 mm subsidence contour for the active longwall and a distance of 150 metres in front and 450 metres behind the active longwall face, as shown by Fig. 1.1.

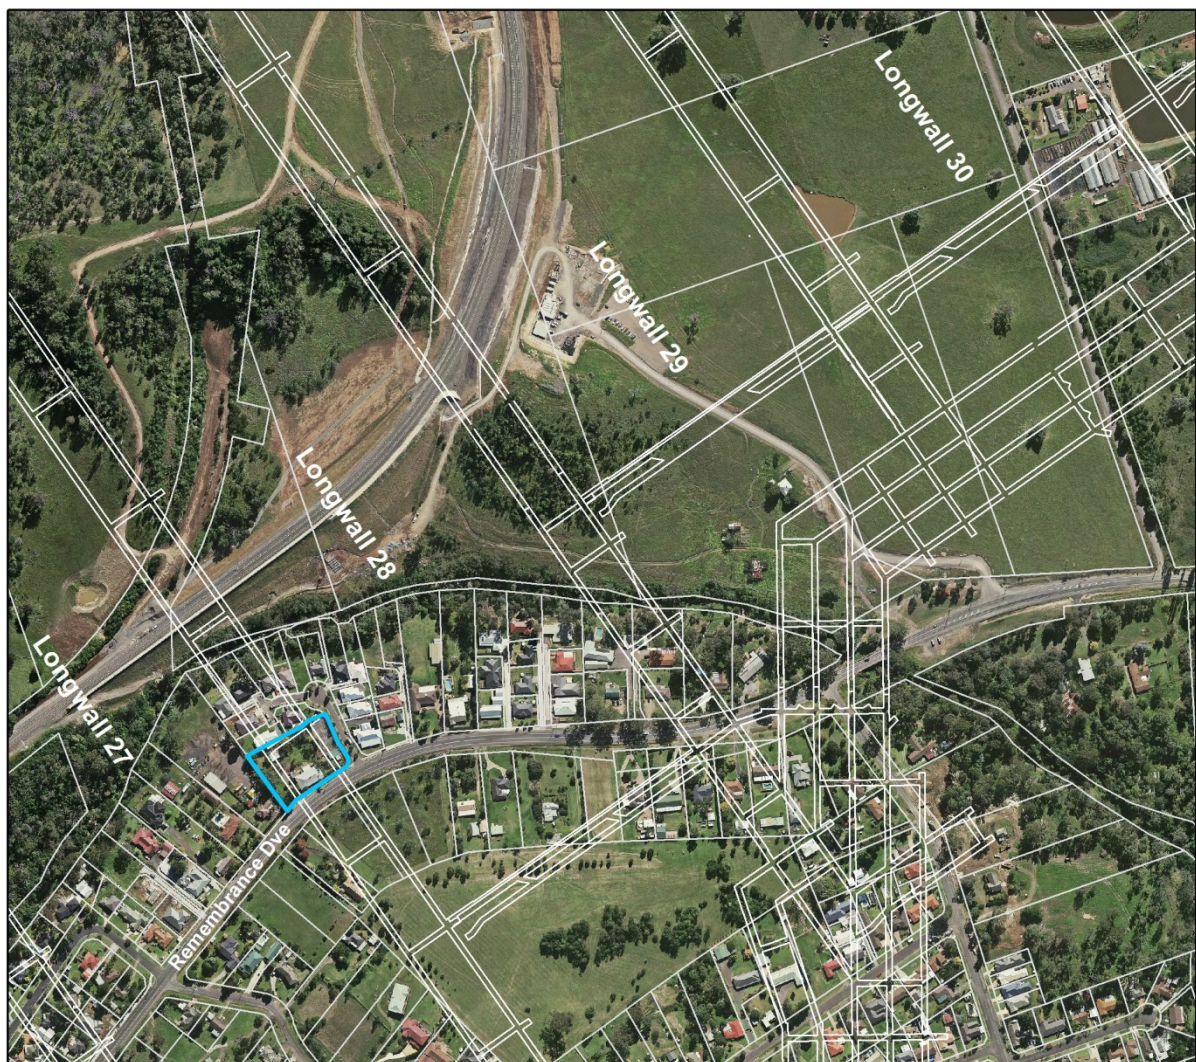
Fig. 2.1 Location of Tahmoor House in relation to Longwalls 28, 29 and 30

Tahmoor House (MSEC Structure Ref. CC92a) is located directly above the chain pillar between Longwalls 27 and 28, as shown in Fig. 2.1. The items of heritage significance consist of a house and remnants of former outbuildings.

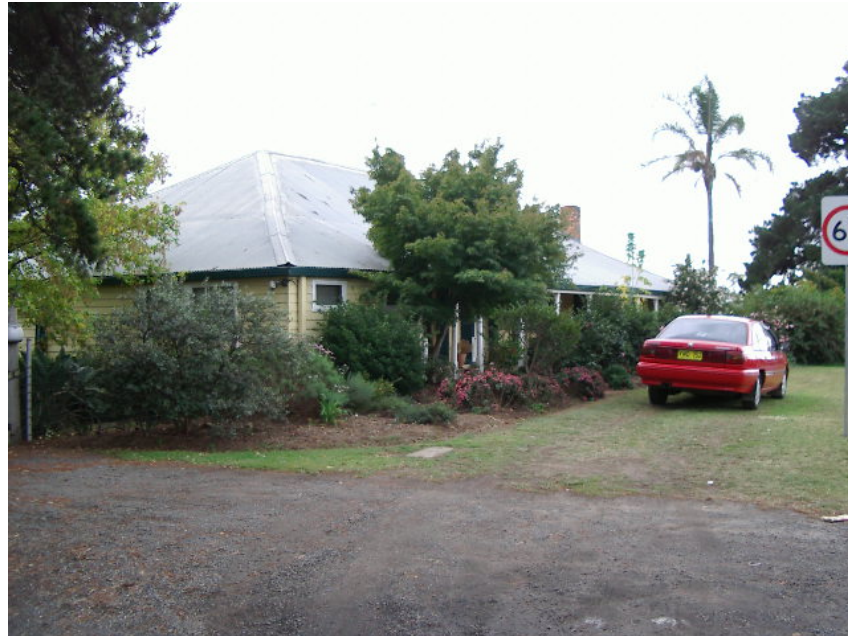
Fig. 2.2 Front of Tahmoor House

Tahmoor House is a single-storey weatherboard house constructed on sandstone foundations with a part basement. It has a maximum plan dimension of approximately 24 metres. The pitched timber framed roof is covered by corrugated iron. There is evidence of some past termite damage in the roof and JMA (2012) recommends that the owner replace a small number of rafters. There are four brick chimneys within the house. While the main building fabric is constructed with weatherboard panels, the lower levels of the house are constructed with sandstone and sandstock brick. While the sandstock brick appears to have been more recently built, the bricks themselves may have heritage value. Some of the masonry walls have been exposed following the construction of a lower floor and new brick piers have been inserted through walls, replacing the original sandstone. The internal walls are generally lined with plasterboard or more recently constructed sandstock brick.

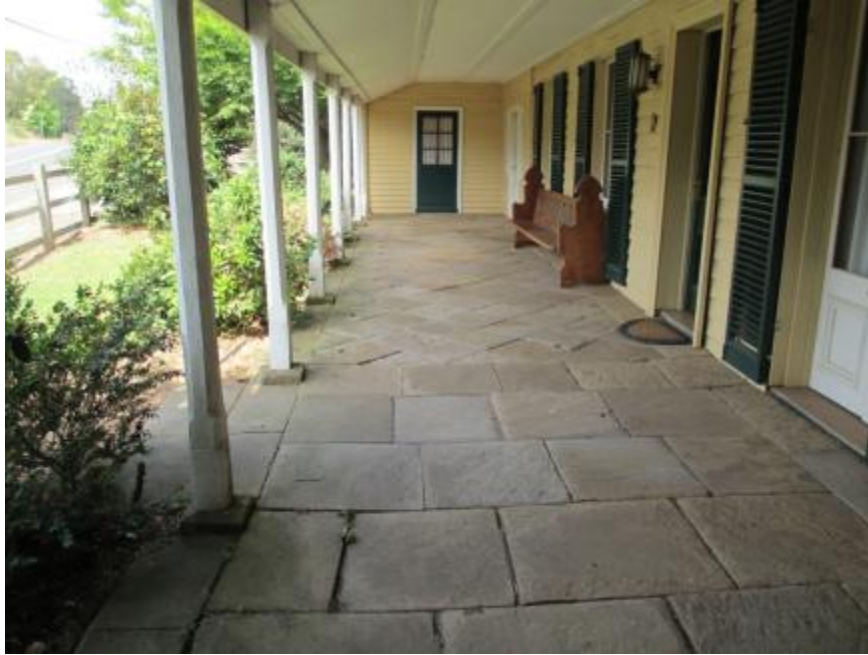
Fig. 2.5 Sandstone flagging on front verandah

As per its original floor plan (see Figure 11), the house features two front entrances, one of which appears to be original (Plate 4). The original pitch of the roof has been slightly modified and the original verandah posts replaced and original railings removed. Of note, the flagstones on the verandah are original and feature two patterns - the diagonal design for the private section of the former Inn and the square patten for the public section (see Plate 3).

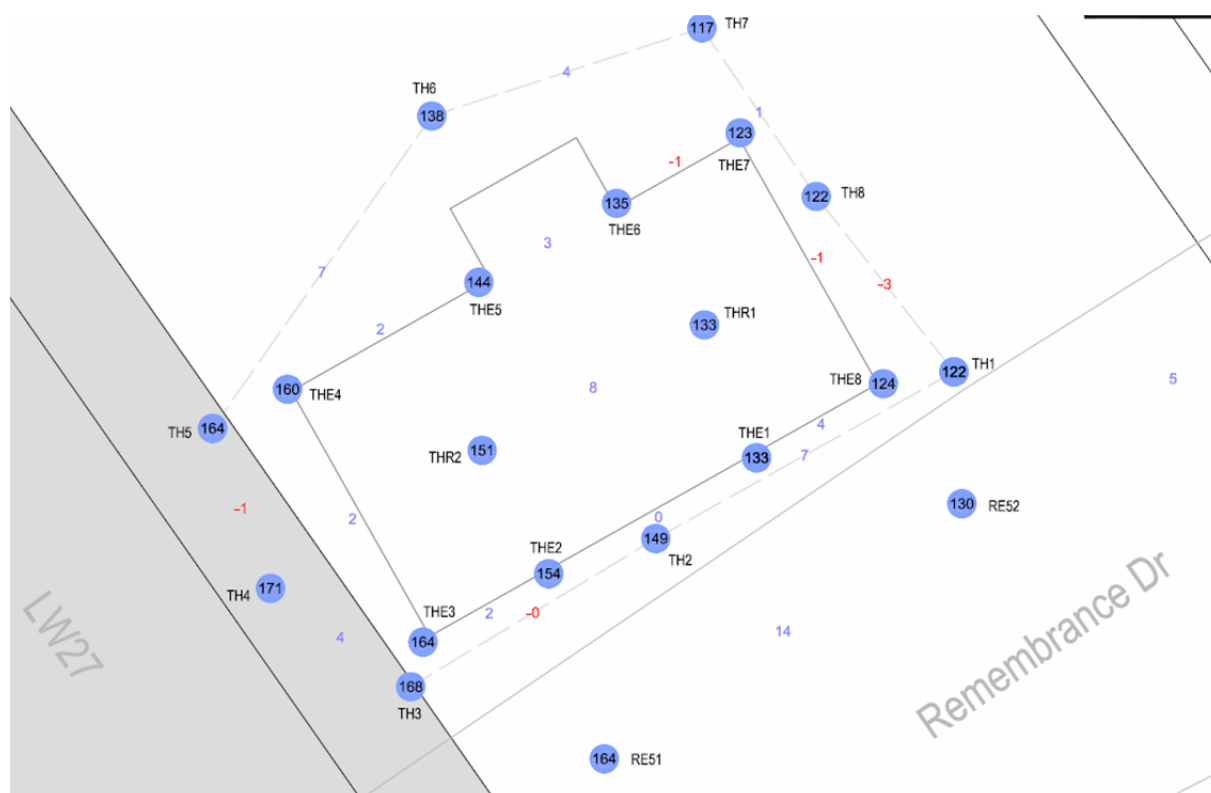
Fig. 2.7 Observed subsidence at Tahmoor House during the mining of Longwall 27

Prior to the influence of Longwall 27, survey pegs were installed in the ground around Tahmoor House and on the roof and fascia boards. A plot of subsidence at each survey peg is shown in Fig. 2.7. It can be seen that a maximum of 171 mm of subsidence has been observed around the perimeter of Tahmoor House since the commencement of Longwall 27. This compares well with and is slightly less than the prediction of 200 mm for the House due to the mining of Longwall 27.

It can be seen from Fig. 2.7 that the house has tilted along its long axis, with slightly more subsidence (approximately 40 mm) observed at the western side of the house compared to the eastern side. This is within expectations as the western side of the house is closest to the longwall face.

Ground strain is a measure of change in horizontal distance between adjacent survey pegs, divided by their original length. Observed changes in horizontal distance around the house are shown in Fig. 2.7. It can be seen that measured changes in horizontal distances are generally within survey tolerance but generally tensile in nature. The measured changes in horizontal distance represent maximum tensile strains of approximately 0.5 mm/m. This is also within expectations.

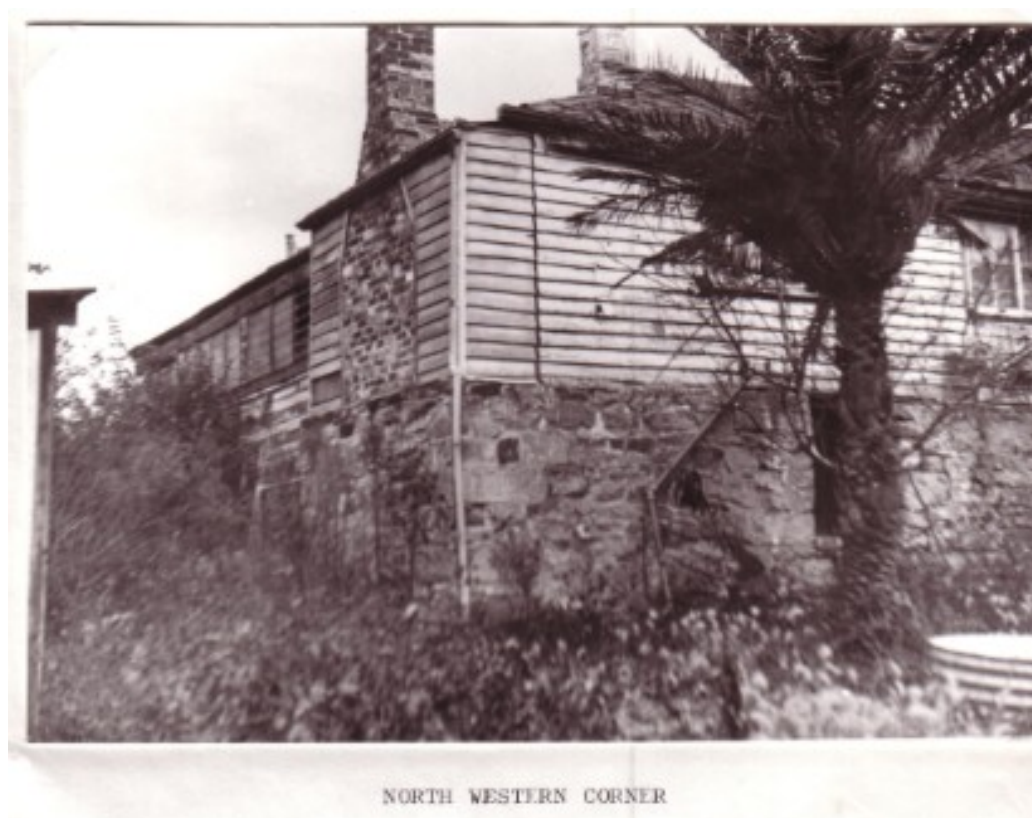
Figure 15: The northwest corner with the sunroom and kitchen, showing the condition of Tahmoor House at the beginning of restoration work in 1972 (Anon. n.d)

George and Maree Rhodes purchased the property on the 17th June 1972 (LTO Vol.3274 Fol.109) by which stage the house was in a poor state requiring refurbishment (Fairfax n.d 'Historic Buildings). The house was infested with rats and possums and the sunroom and kitchen were badly damaged through white ant activity. The gardens were overgrown and intruded into the living areas of the house (Figure 15).

The sunroom floorboards, ceiling and windows were removed. The ceiling and windows in the kitchen were also replaced, though the floorboards were retained. Some ceiling joists needed to be replaced. A small extension was added either side of the fireplace to accommodate cupboards in the kitchen. The Rhodes spent six years repairing and refurbishing the house (Anon n.d).

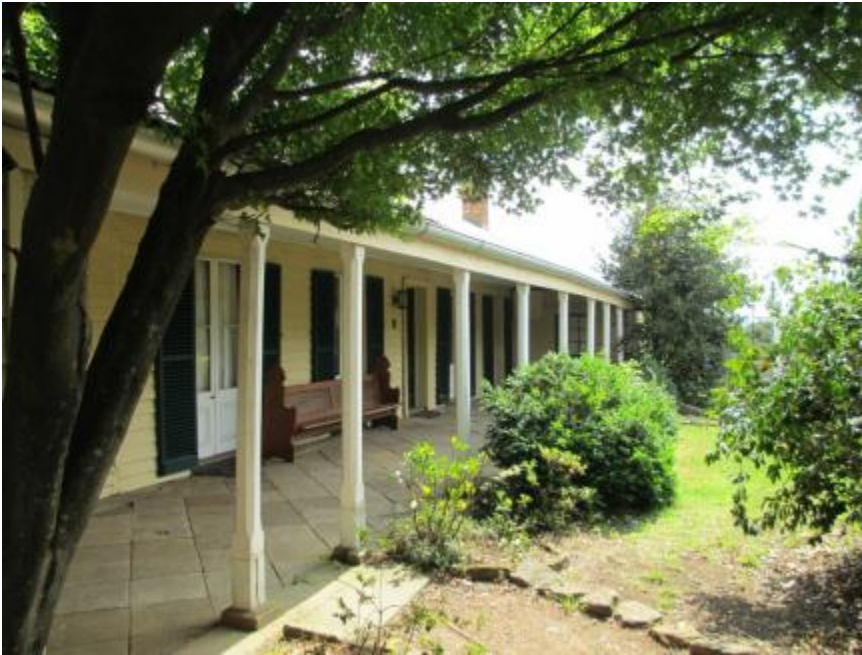
Plate 1: Front view of Tahmoor House (Source: Niche 2012)

Tahmoor House is a single storey weatherboard residence constructed on sandstone foundations in c1821 (Plates 1 & 2). It features a corrugated steel clad hipped roof that continues over the front verandah, which is flagged with sandstone and has been in-filled at its southern end (Plate 3).

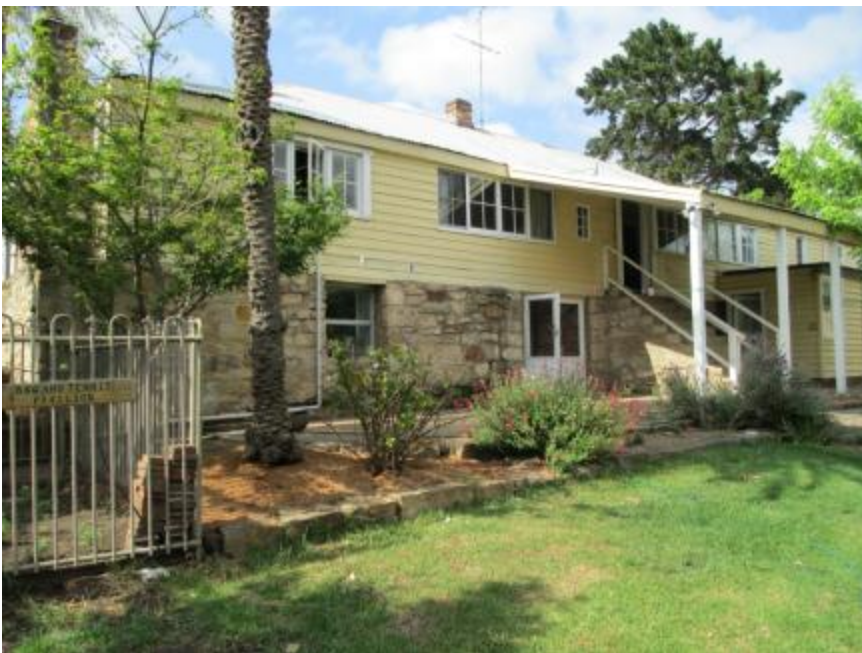
Plate 2: Rear view of Tahmoor House (Source: Niche 2012)

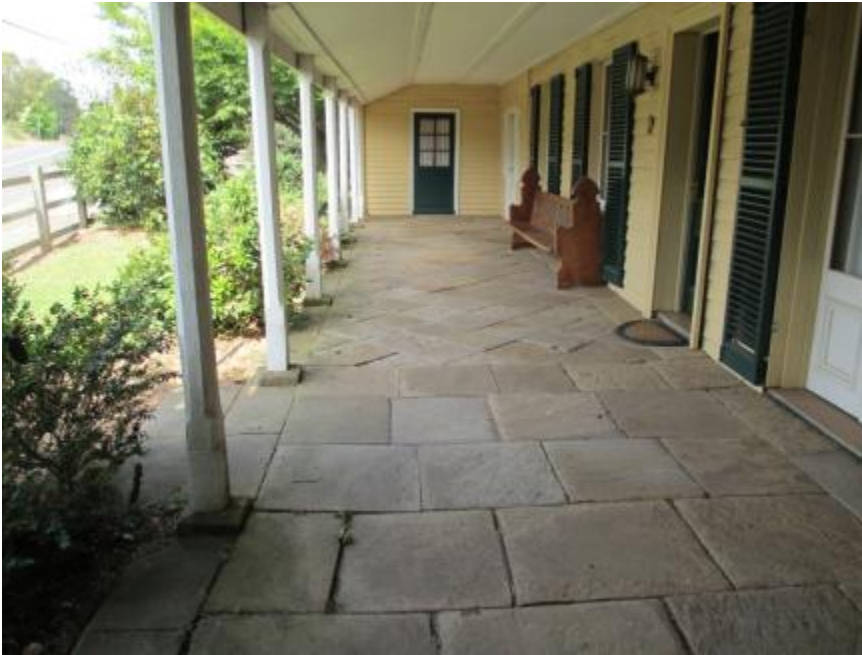
Plate 3: Sandstone flagging on front verandah (Source: Niche 2012)

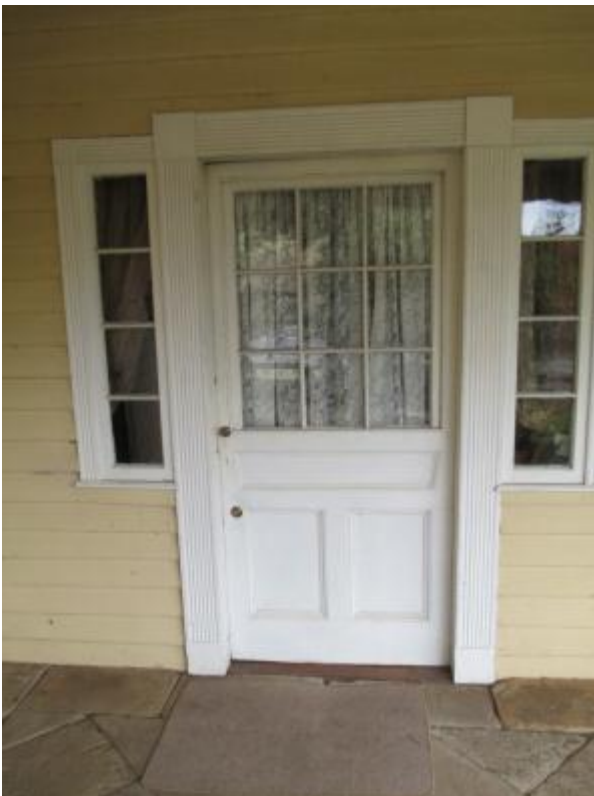
Plate 4: Original (west) entrance (Source: Niche 2012)

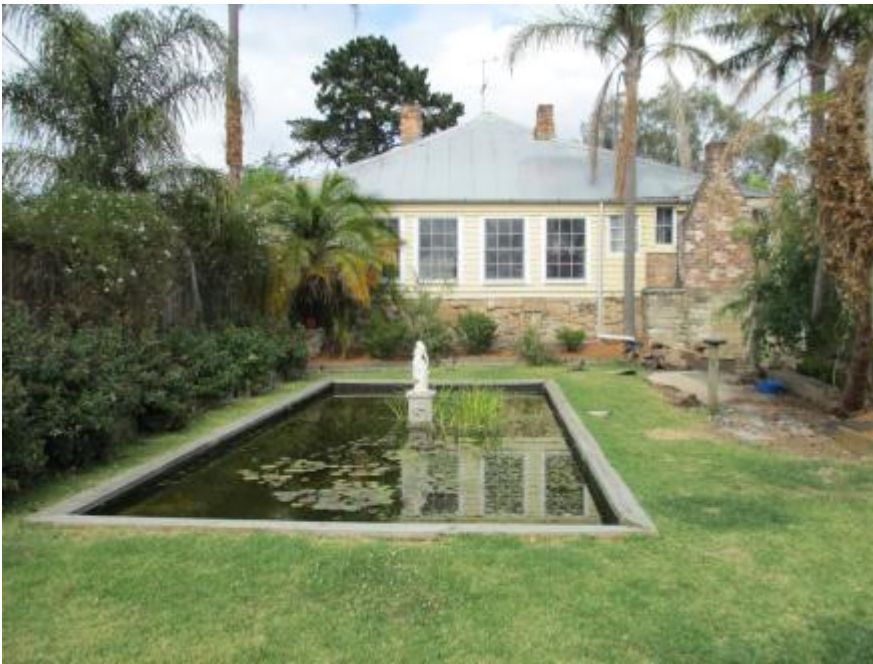
Plate 5: Formal pond (converted swimming pool) (Source: Niche 2012)

On the eastern side of the house a formal pond is present (Plate 5). This water feature was created in July 2010 by modifying a former swimming pool added to the property in the 1970s. Behind and adjacent to the formal pond, a grassed area, bbq area and tiered garden beds were also added c2010 (Plate 6). The bbq area features recycled bricks that vary in age and condition (Plate 7).

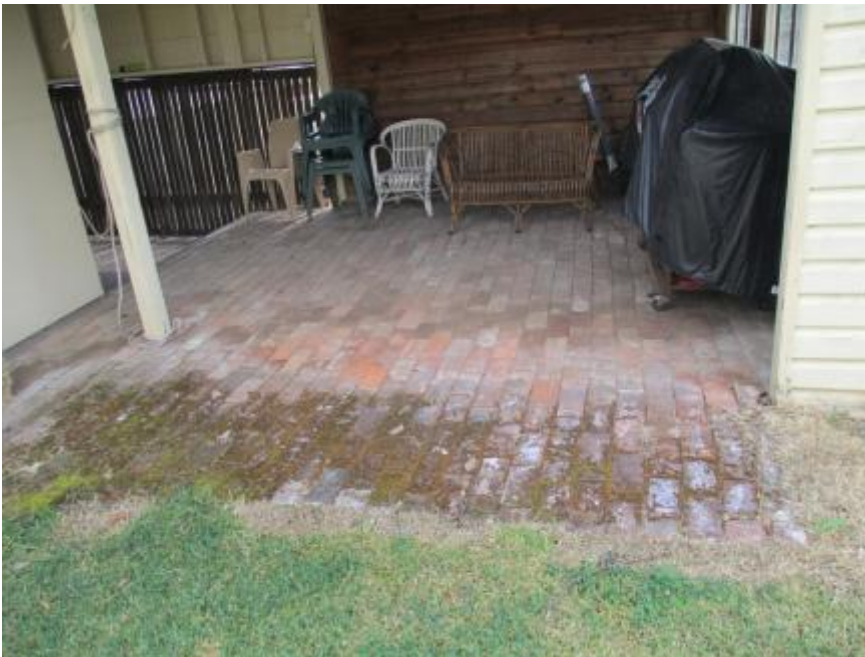
Plate 7: Brick paving in bbq area, using recycled bricks (Source: Niche 2012)

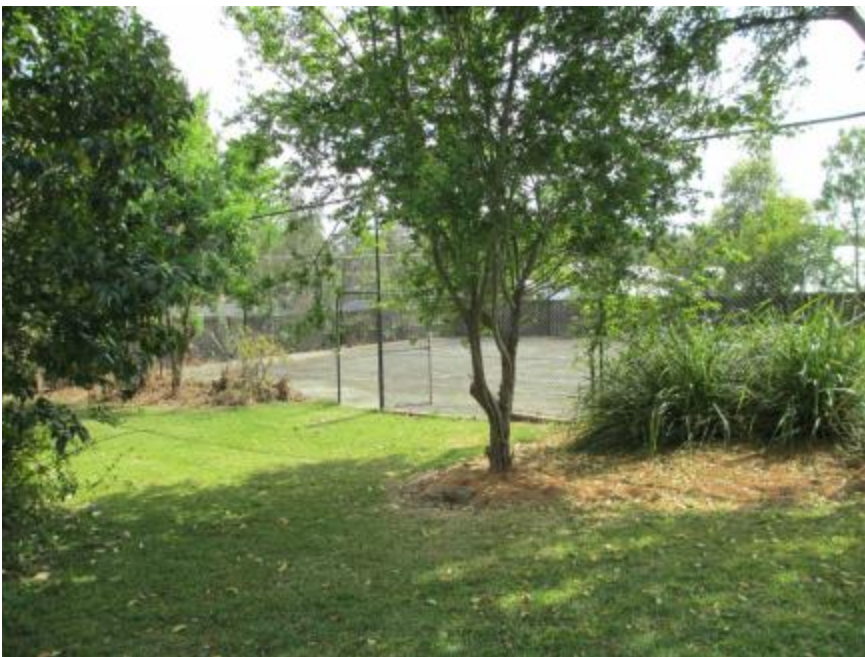
Plate 8: Sunken tennis court (Source: Niche 2012)

Along the eastern boundary of the property a tennis court, pavilion and associated retaining wall were added in the 1980s (Plates 8 & 9). The tennis court is below ground level and its construction would have involved considerable excavation and levelling works. Timber decking has been added more recently. Large worked sandstone blocks have been used to edge the garden beds in this area (Plate 10). Given their size and workmanship they appear to have been recycled from the large stone water tank shown in early photographs. A chicken coop is located directly adjacent to the tennis courts.

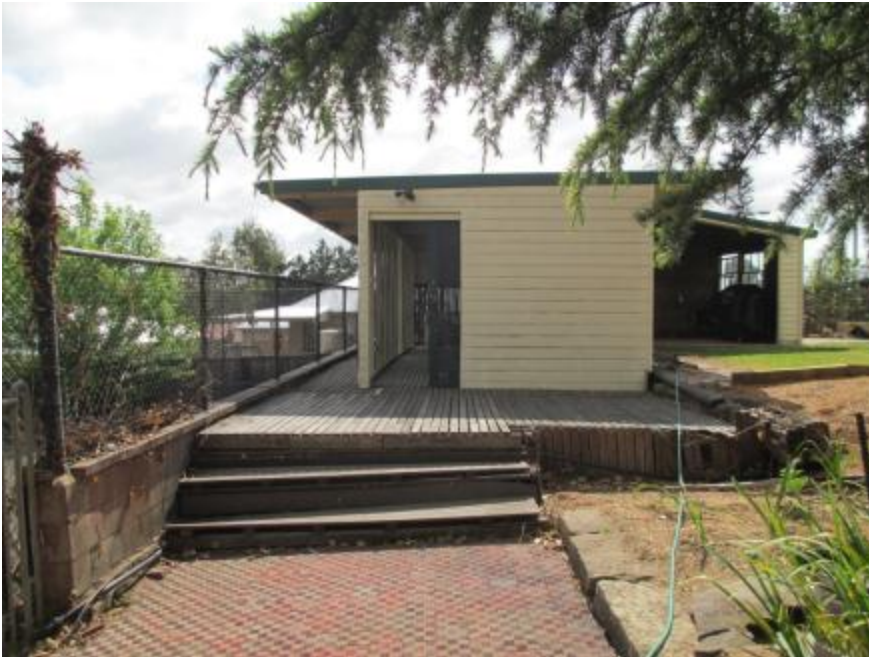
Plate 9: Tennis Court Pavilion and timber decking (Source: Niche 2012)

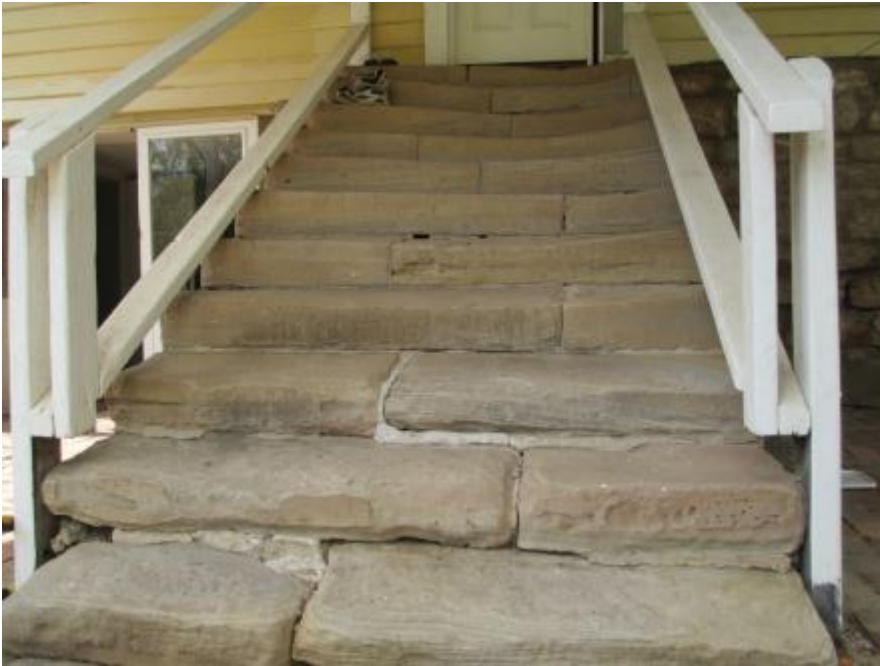
Plate 11: Sandstone staircase at rear of house (Niche: 2012)

The rear of the house features very impressive original sandstone stairs leading from the rear verandah to the rear yard (Plate 11) and a covered car port (Plate 12). The stairs are considerably worn resulting from their extended use since construction of the house in c1821. The rear courtyard features sandstone and concrete paving (Plate 13). A noticeable depression in this paving indicates the original location of the former stone tank. A gravel driveway on the western side of the property leads to the car port and a large timber barn, which occupies the north-west corner of the property (Plate 14).

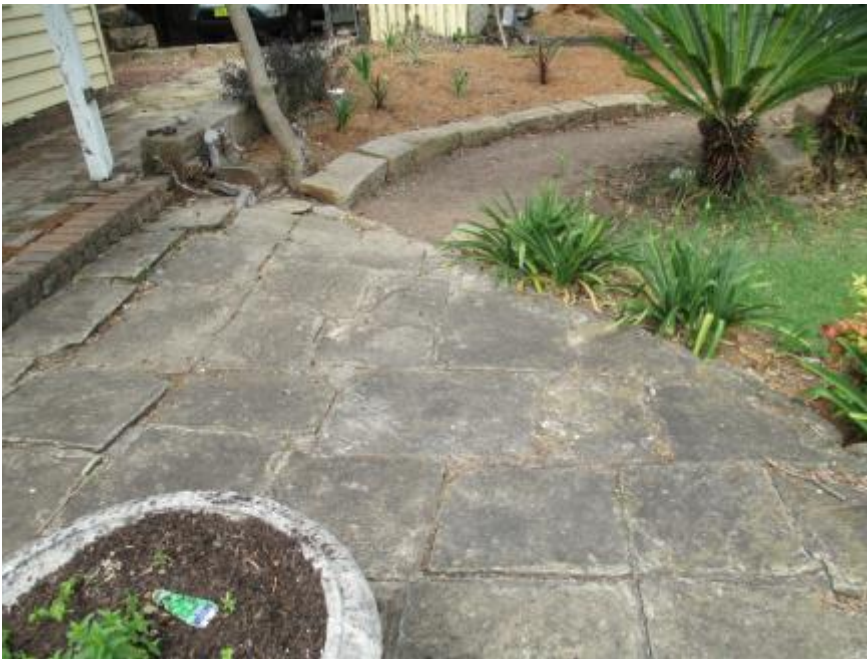
Plate 13: Concrete and sandstone paving and location of former stone well (Source: Niche 2012)

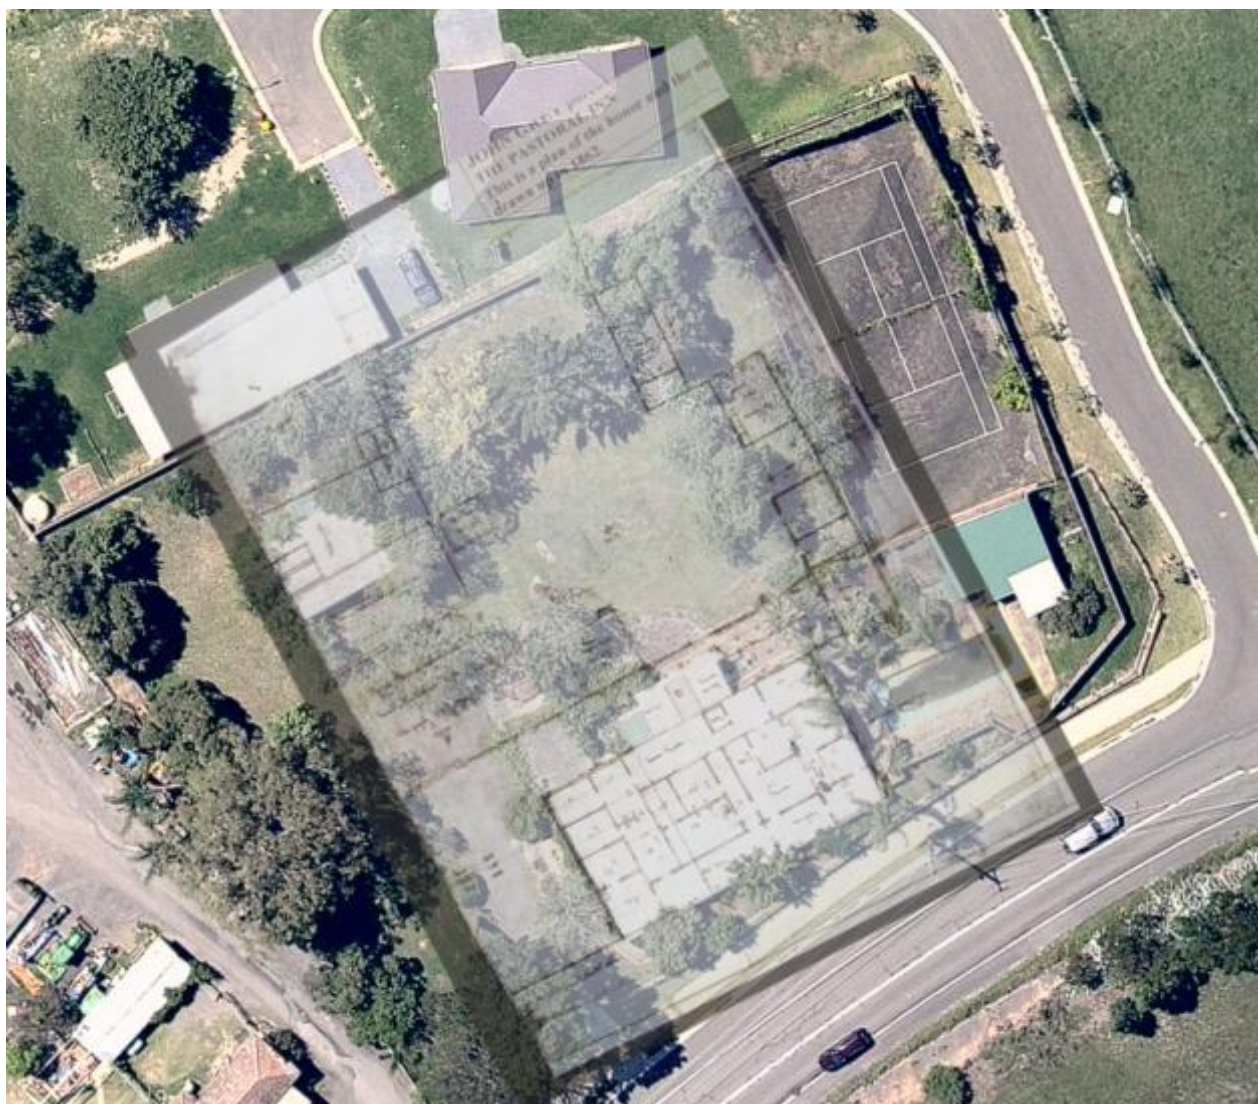
Figure 16: Overlay of the 1862 Survey and a current aerial photograph (Source: Niche 2012)

An overlay of the 1862 plan and a current aerial photograph indicates that the rear yard of property has high archaeological potential for historical relics (See Figure 15). As shown in this plan, the rear yard may contain remnants of the following former buildings / structures below current surfaces:

- ☐ A large stone tank; and
- ☐ A large stone barn, coach-house, fowl-houses, stock and milking yards and stables;

Apart from excavation for the tennis court and formal pond, there has been minimal disturbance to the rear yard of the property. It is therefore likely that structural features, such as the footings of the large stone tank and the large stone barn have survived below the current ground, although some of the sandstone has been re-used for garden beds. Significant archaeological deposits, particularly deep deposits associated with wells and privies, are also likely to have survived with some localised disturbance.
