XSTRATA COAL:  
**Tahmoor Colliery - Longwall 27**

Management Plan for Potential Impacts to Sydney Water Potable Water Infrastructure

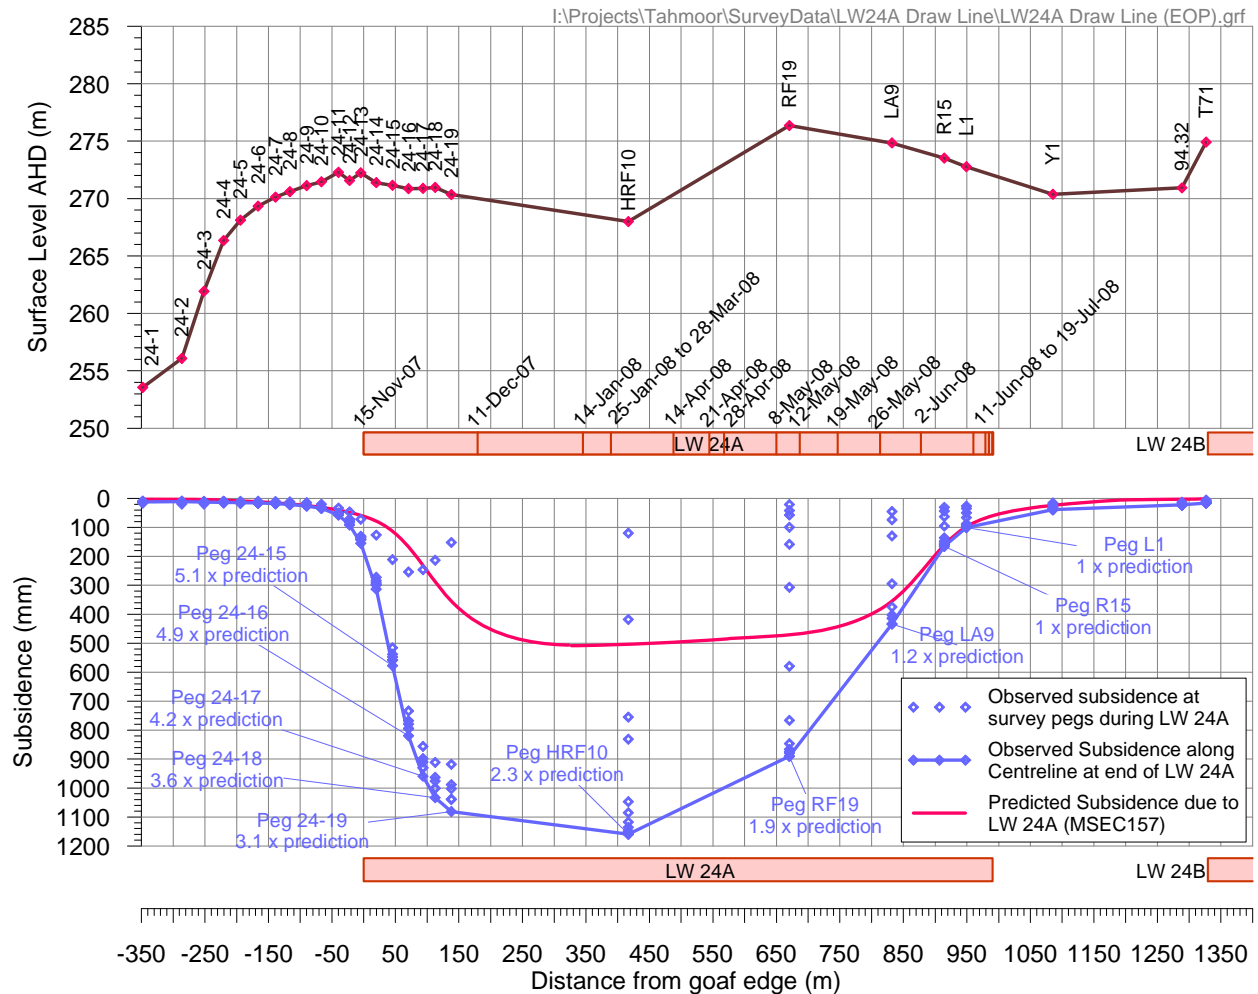
Observed subsidence was greatest above the southern half of Longwall 24A, and gradually reducing in magnitude towards the northern half of the longwall, which was directly beneath the urban area of Tahmoor. These observations are shown graphically in Fig. 1.1, which shows observed subsidence at survey pegs located along the centreline of Longwall 24A.

**Fig. 1.1 Observed Subsidence along Centreline of Longwall 24A**

It can be seen from Fig. 1.1 that observed subsidence was more than twice the predicted maximum value, reaching to a maximum of 1169 mm at Peg HRF10. It is possible that actual maximum subsidence developed somewhere between Pegs HRF10 and RF19, though this was not measured. Observed subsidence was similar to prediction near Peg R15 on Remembrance Drive. Survey pegs RF19 and LA9 are located within a transition zone where subsidence gradually reduced from areas of maximum increased subsidence to areas of normal subsidence.

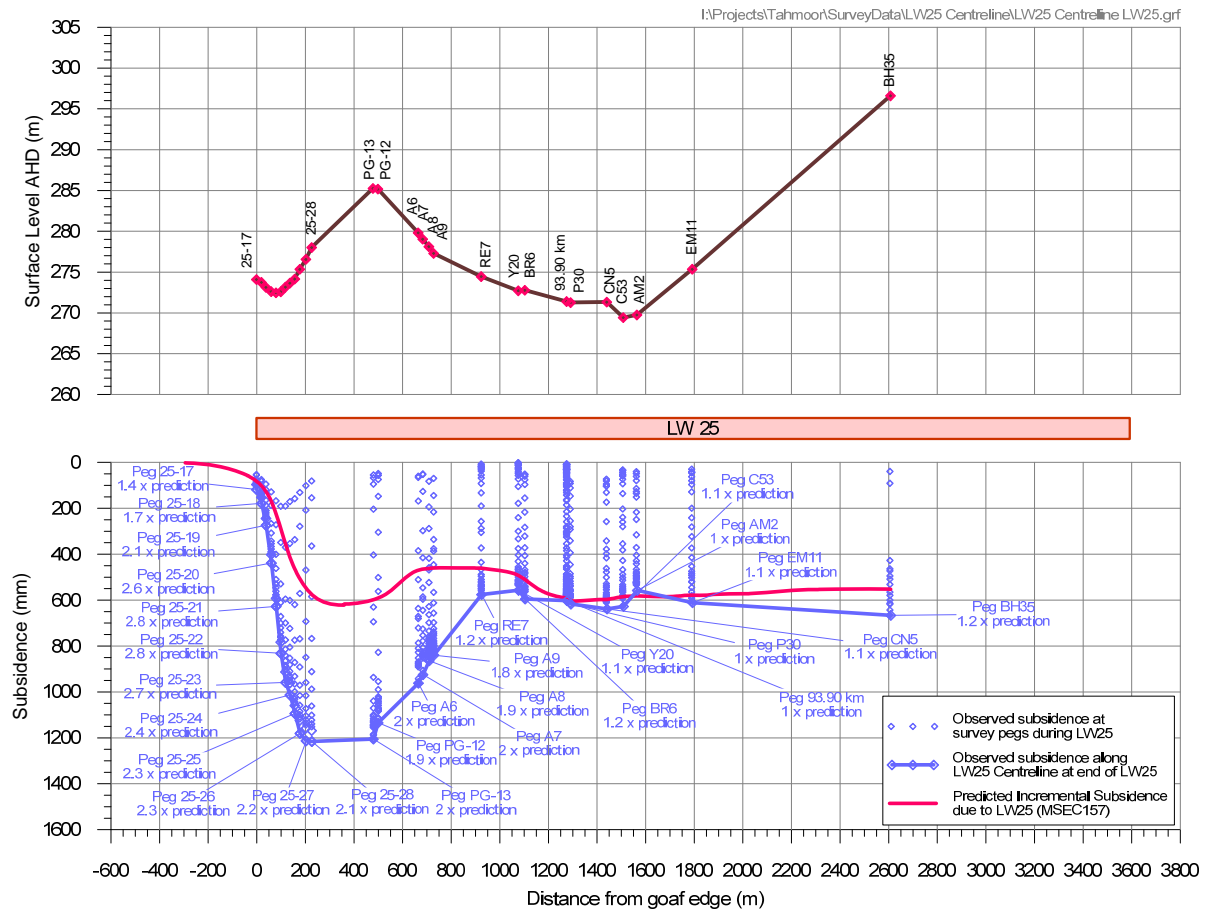
Increased subsidence was observed during the first stages of mining Longwall 25. These observations are shown graphically in Fig. 1.2, which shows observed subsidence at survey pegs located along the centreline of Longwall 25.

**Fig. 1.2 Observed Subsidence along Centreline of Longwall 25**

It can be seen from Fig. 1.2 that observed subsidence was approximately twice the predicted maximum value, with maximum subsidence of 1216 mm at Peg 25-28.

Observed subsidence is similar to but slightly more than predicted at Peg RE7 and is similar to prediction at Peg Y20 and at all pegs located further along the panel. Survey pegs A6, A7, A8 and A9 are located within a transition zone where subsidence has gradually reduced from areas of maximum increased subsidence to areas of normal subsidence.

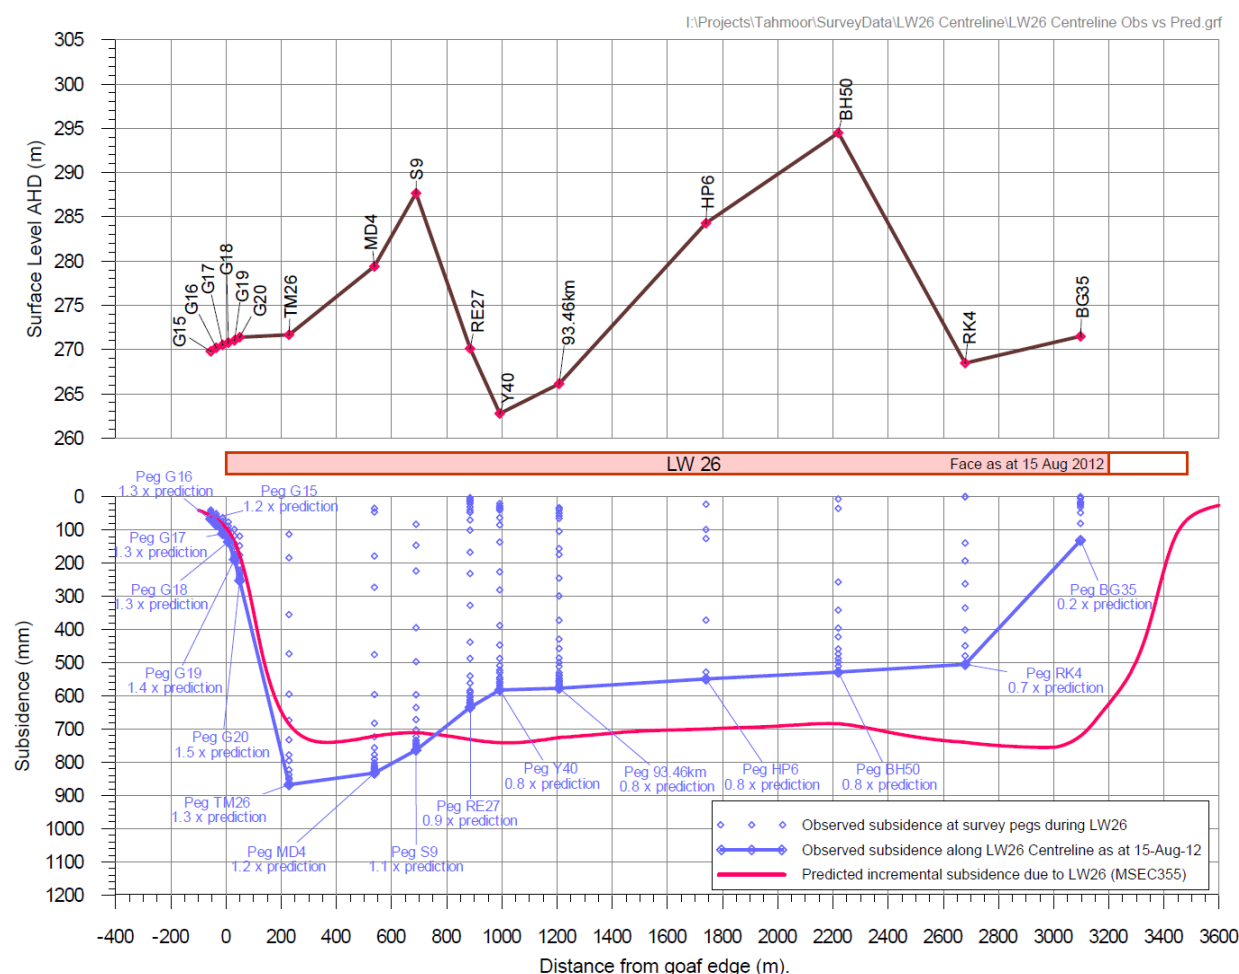
Increased subsidence was observed during the first stages of mining Longwall 26, but at a reduced magnitude compared to the subsidence observed above Longwalls 24A and 25. These observations are shown graphically in Fig. 1.3, which shows observed subsidence at survey pegs located along the centreline of Longwall 26. The graph shows the latest survey results for each monitoring line as at August 2012. It is likely that further small increases in subsidence will be observed at these pegs when they are surveyed at the completion of Longwall 26.

**Fig. 1.3 Observed Subsidence along Centreline of Longwall 26 as at August 2012**

It can be seen from Fig. 1.3 that observed subsidence was approximately 1.3 times the predicted maximum value, with maximum subsidence of 867 mm at Peg TM26.

Observed subsidence reduced along the panel until Peg Y40 on York Street, where it was less than prediction. Survey pegs S9, and RE27 are located within a transition zone where subsidence has gradually reduced from areas of maximum increased subsidence between Pegs TM26 and MD4 to areas of normal subsidence at Peg Y40 and beyond.

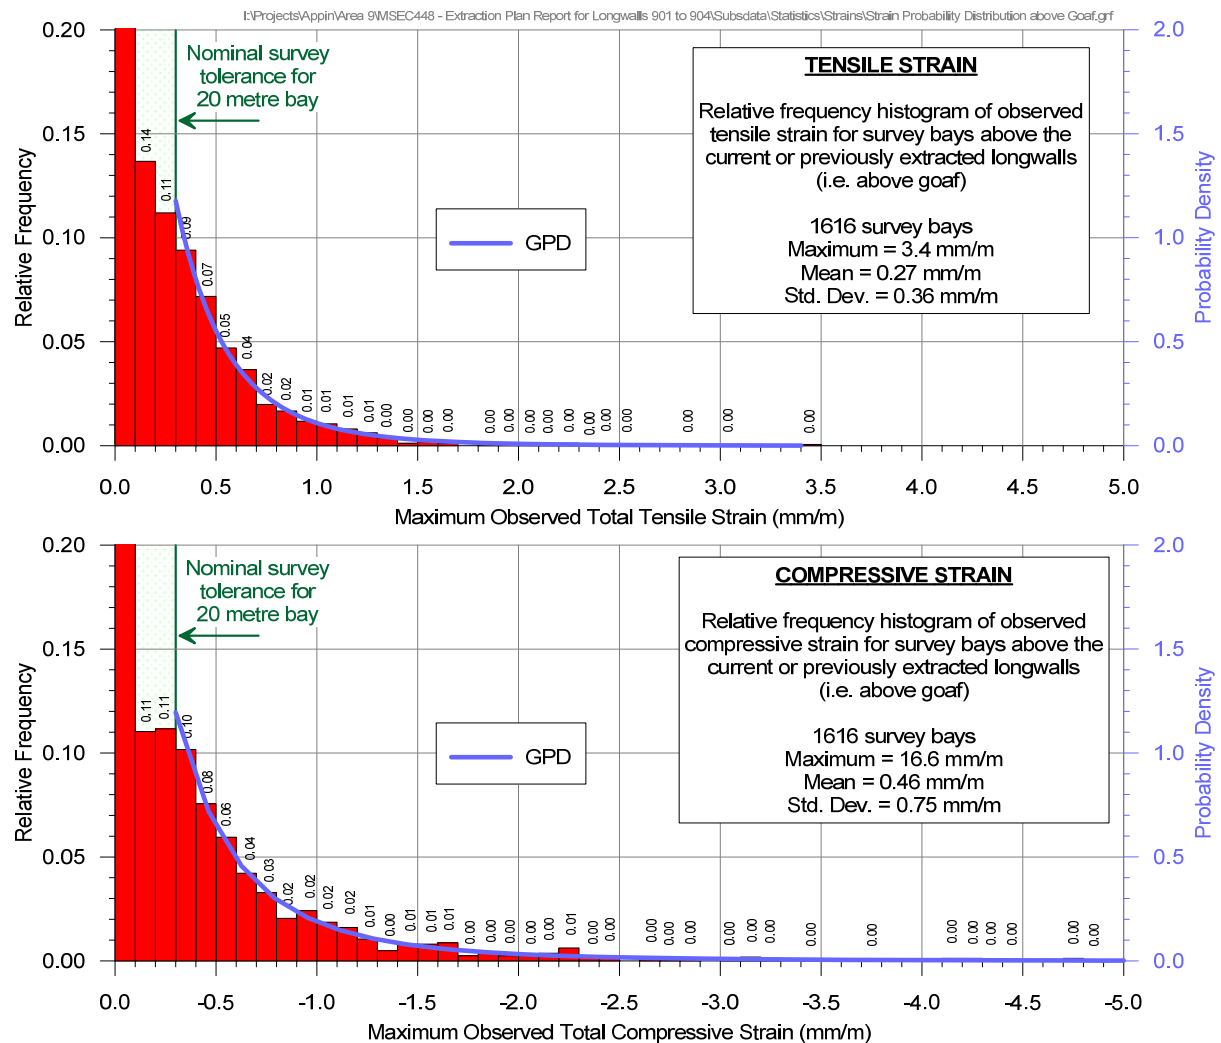
The relative frequency distribution of maximum observed tensile strains and compressive strains for survey bays located directly above goaf is provided in Fig. 1.4.

**Fig. 1.4 Distributions of Measured Maximum Tensile and Compressive Strains at Any Time for Pegs Located Above Goaf in the Southern Coalfield**

While not shown in Fig. 1.4, it is noted that the maximum observed compressive strain of 16.6 mm/m, which occurred along the T-Line above Appin Longwall 408, was the result of movements along a low angle thrust fault within the Cataract Tunnel. All remaining compressive strains in this dataset (which exclude valley related movements) were less than 5 mm/m.

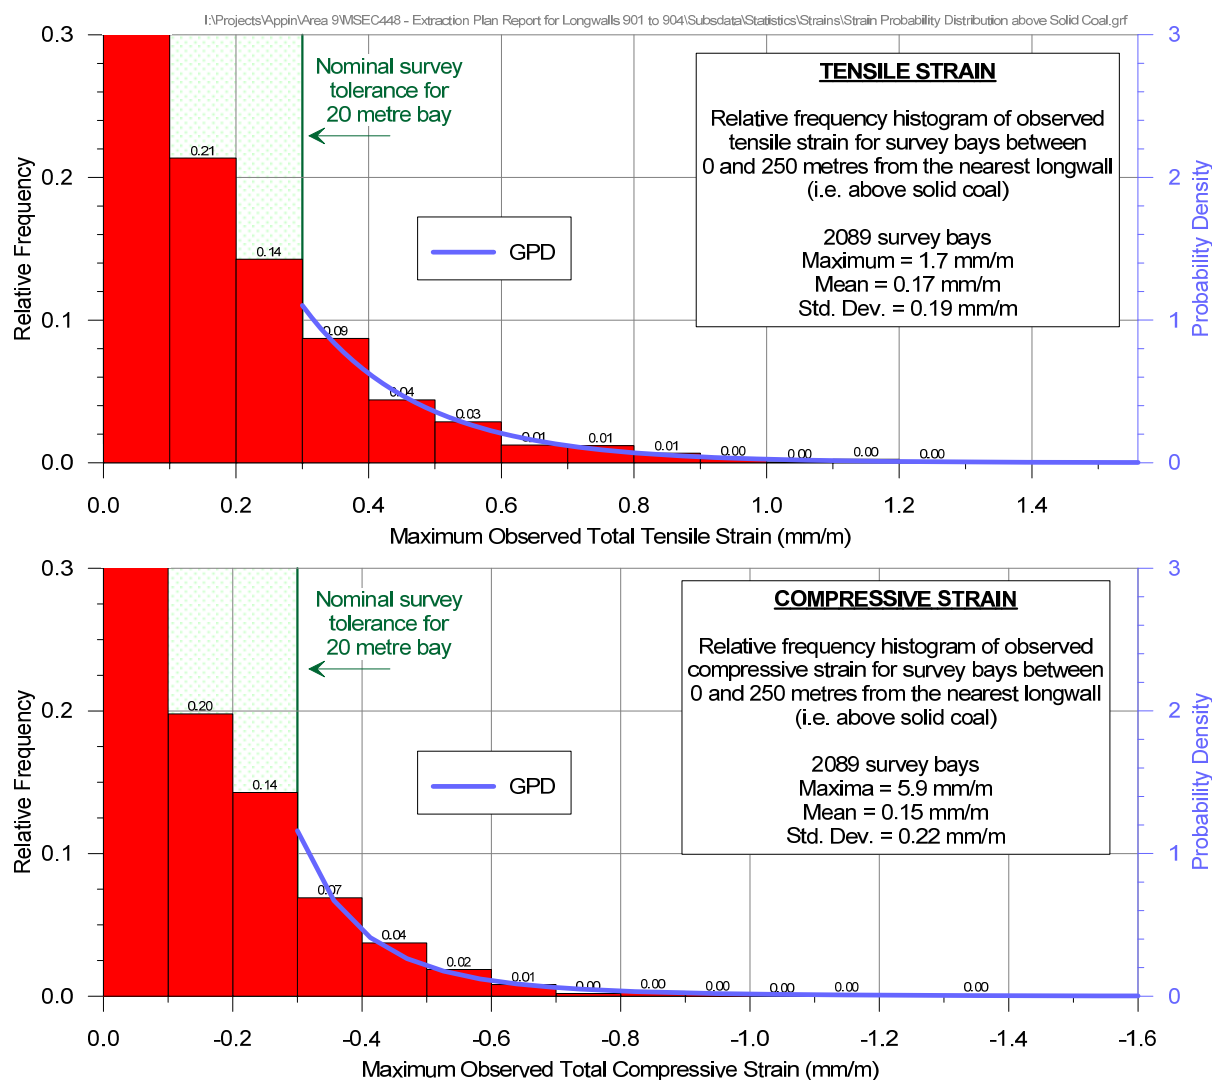
The relative frequency distribution of maximum observed tensile strains and compressive strains above solid coal is provided in Fig. 1.5.

**Fig. 1.5 Distributions of Measured Maximum Tensile and Compressive Strains at Any Time for Pegs Located Above Solid Coal in the Southern Coalfield**

While not shown in Fig. 1.5, it is noted that the maximum observed compressive strain of 5.9 mm/m, which occurred along the T-Line above Appin Longwall 408, was the result of movements along a low angle thrust fault within the Cataract Tunnel as Longwall 408 approached the monitoring line. A maximum observed compressive strain of 3.1 mm/m was observed across the fault at the completion of Longwall 407. All remaining compressive strains in this dataset (which exclude valley related movements) were less than 5 mm/m.

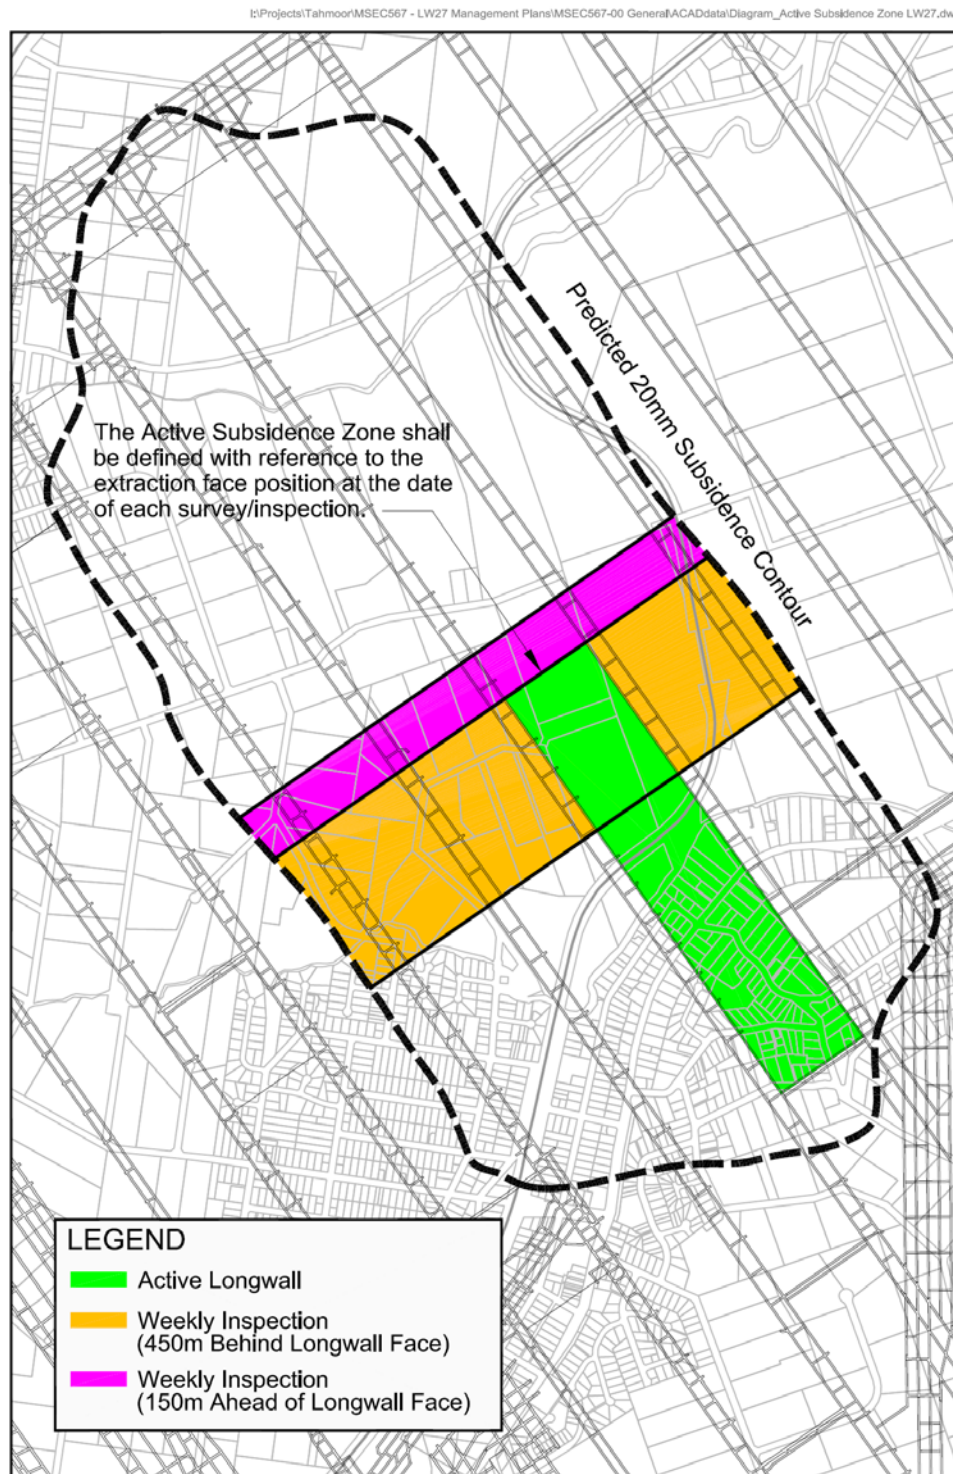
This is termed the “active subsidence zone” for the purposes of this Management Plan, where surface monitoring is generally conducted. The active subsidence zone for each longwall is defined by the area bounded by the predicted 20 mm subsidence contour for the active longwall and a distance of 150 metres in front and 450 metres behind the active longwall face, as shown by Fig. 1.6.

**Fig. 1.6 Diagrammatic Representation of Active Subsidence Zone**

As a longwall progresses, subsidence begins to develop at a point in front of the longwall face and continues to develop after the longwall passes. The majority of subsidence movement typically occurs within an area 150 metres in front of the longwall face to an area 450 metres behind the longwall face.

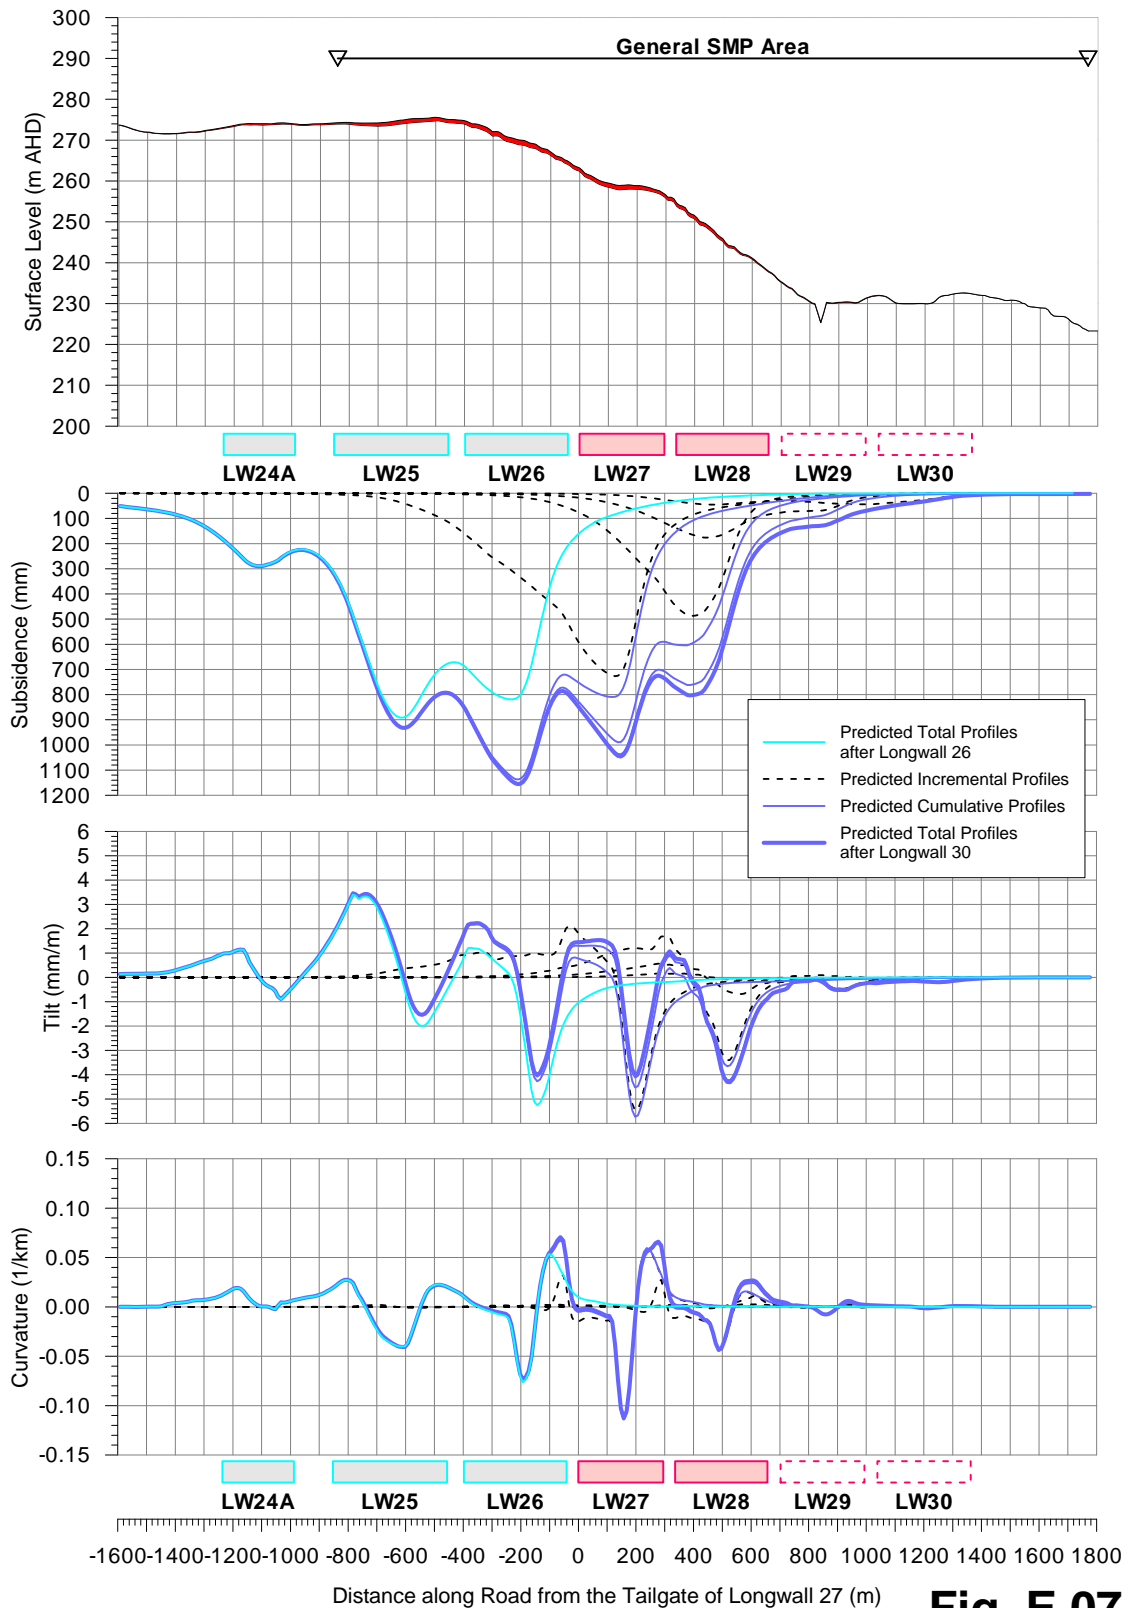
**Fig. E.07**

## Predicted Profiles of Systematic Subsidence, Tilt and Curvature along Remembrance Drive Resulting from the Extraction of Longwalls 22 to 30

**Fig. 3.1 Predicted Subsidence Parameters along Remembrance Drive (Extract from MSEC355)**

The largest water mains that will experience the full range of subsidence movements during the mining of Longwall 27 are the 300 mm DICL pipes that run along Remembrance Drive from Emmett Street towards Picton. The pipeline changes down in size to an older 200 mm diameter CICL pipe approximately 70 metres north of the intersection of Remembrance Drive and Myrtle Creek Avenue. This section of pipe is located directly above the previously mined Longwall 26. No impacts were observed during the mining of Longwalls 24A to Longwall 26. Predictions of subsidence, tilt and strain along Remembrance Drive are provided in Fig. 3.1 and are summarised in Table 3.1.
