## **Tahmoor Coking Coal Operations - Longwall 32**

Management Plan for Potential Impacts to Sydney Water Potable Water Infrastructure

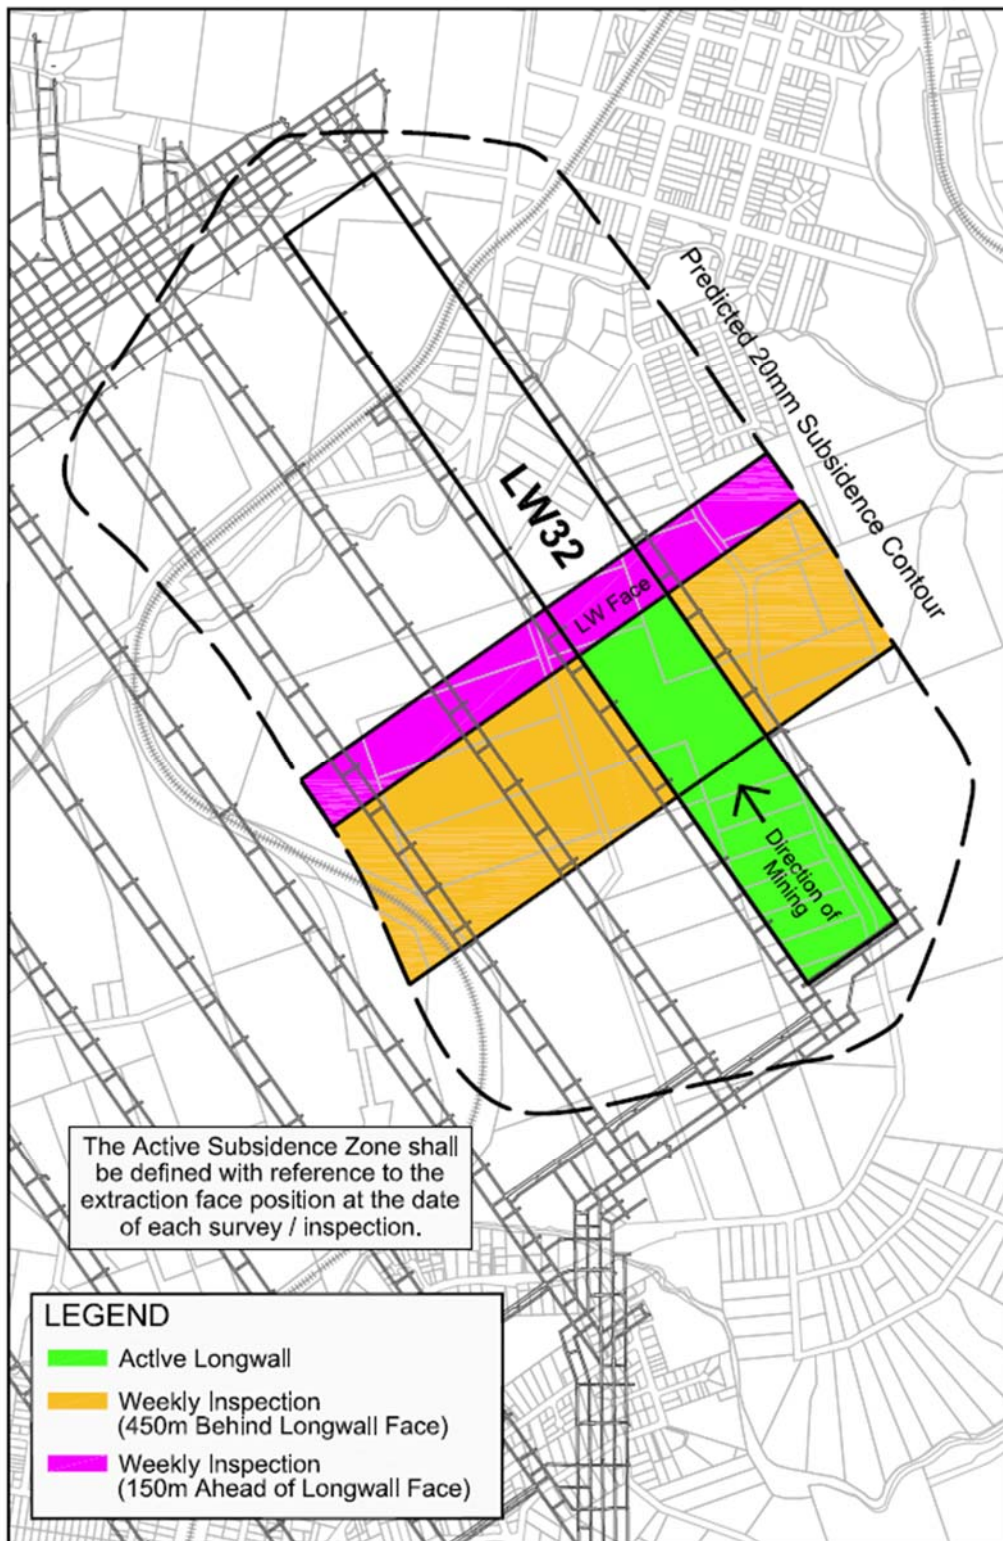
As a longwall progresses, subsidence begins to develop at a point in front of the longwall face and continues to develop after the longwall passes. The majority of subsidence movement typically occurs within an area 150 metres in front of the longwall face to an area 450 metres behind the longwall face.

This is termed the “active subsidence zone” for the purposes of this Management Plan, where surface monitoring is generally conducted. The active subsidence zone for each longwall is defined by the area bounded by the predicted 20 mm subsidence contour for the active longwall and a distance of 150 metres in front and 450 metres behind the active longwall face, as shown by Fig. 1.1.

**Fig. 1.1 Diagrammatic Representation of Active Subsidence Zone**
