## Tahmoor Coking Coal Operations - Longwall 32

Management Plan for Potential Impacts to Endeavour Energy Infrastructure

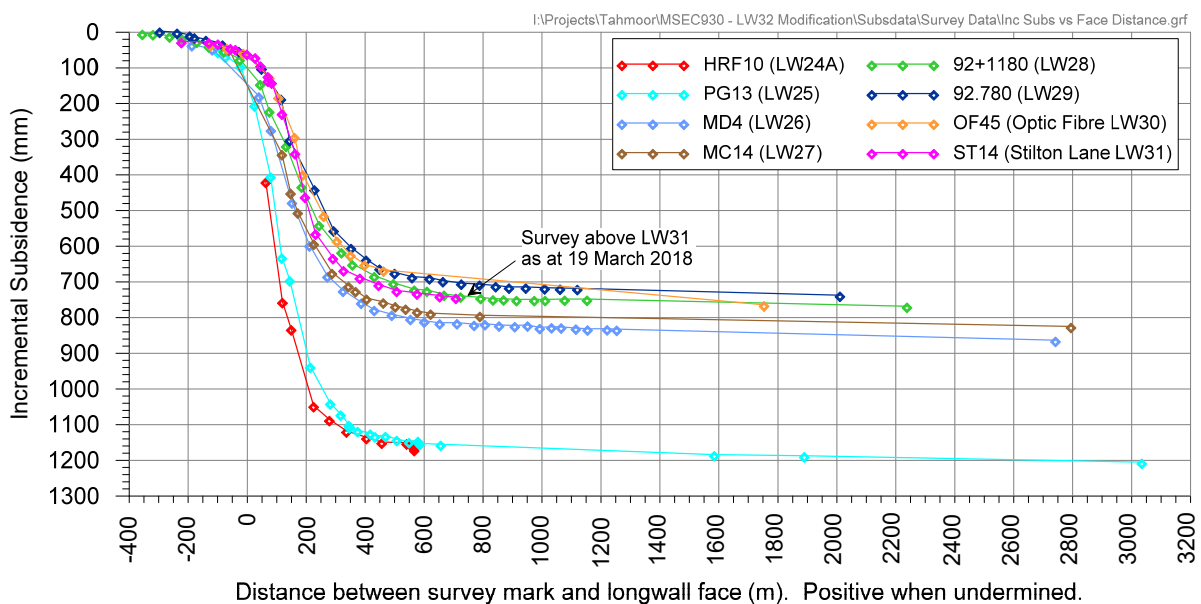
Survey Peg ST14 on Stilton Lane is located above the centreline of Longwall 31. As shown in Fig. 3.1, subsidence developed at an equivalent magnitude to pegs located above previously extracted Longwalls 28 to 30.

**Fig. 3.1 Observed development of subsidence of survey pegs above the centrelines of Longwalls 24A to 31**

Ground surveys will continue to be undertaken above Longwall 32. The survey results will be checked against predictions to confirm whether subsidence continues to develop in a normal manner during the mining of Longwall 32.

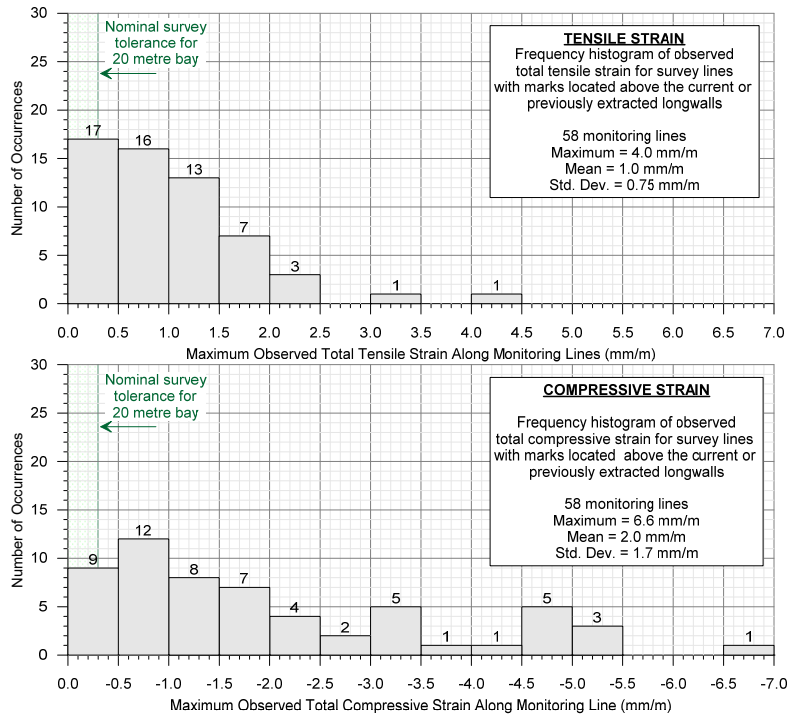
The histogram of maximum observed total tensile and compressive strains measured anywhere along the monitoring lines, at any time during or after the extraction of Longwalls 22 to 28 at Tahmoor Coking Coal Operations, is provided in Fig. 3.4.

**Fig. 3.4 Distributions of measured maximum tensile and compressive strains anywhere along the monitoring lines**

It can be seen from Fig. 3.4, that 33 of the 58 monitoring lines (i.e. 57 %) had recorded maximum total tensile strains of 1.0 mm/m, or less, and that 53 monitoring lines (i.e. 91 %) had recorded maximum total tensile strains of 2.0 mm/m, or less. It can also be seen from this figure, that 36 of the 58 monitoring lines (i.e. 62 %) had recorded maximum compressive strains of 2.0 mm/m, or less, and that 48 of the monitoring lines (i.e. 83 %) had recorded maximum compressive strains of 4.0 mm/m, or less.

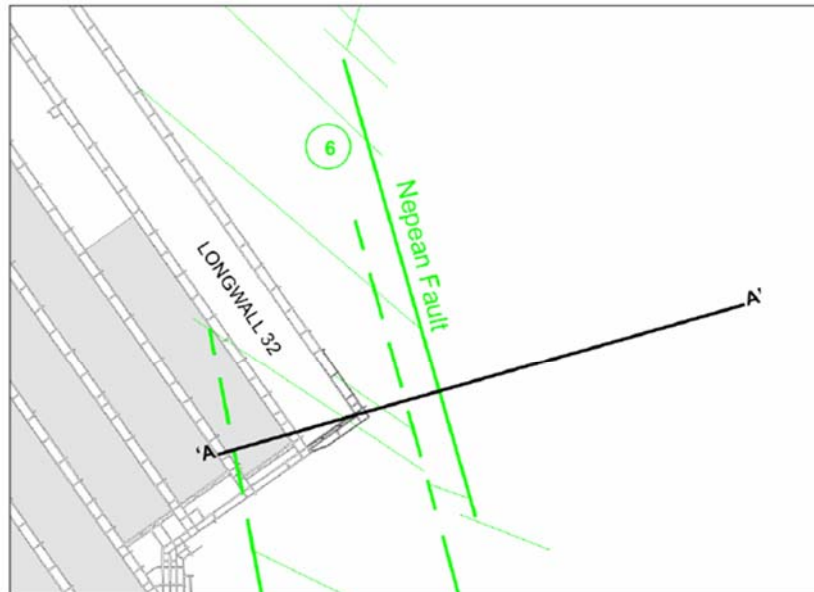
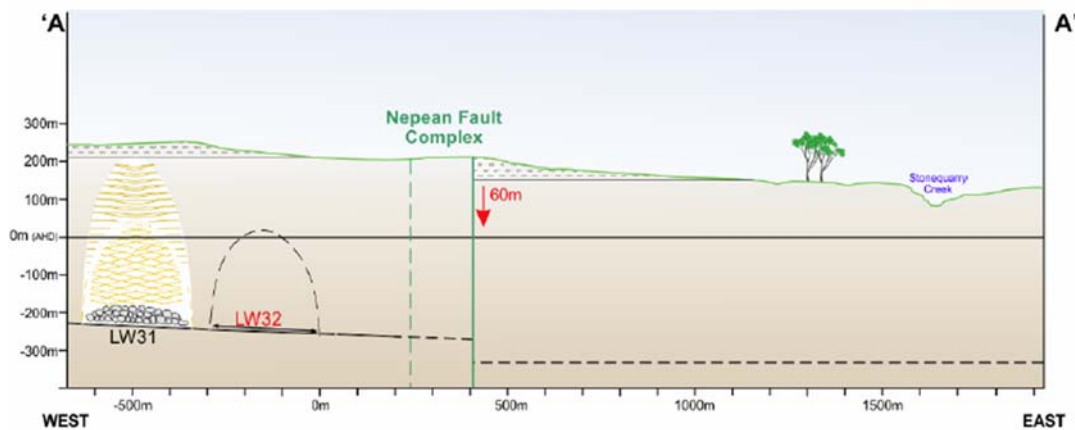
SCT (2018a) further advise that the fault is sub-vertical from surface to seam, based on site investigations and geological information gathered by Tahmoor Coking Coal Operations since 2014. The cross-section provided by SCT (2018a) has been reproduced in Fig. 3.5.

**Fig. 3.5 Cross-section of Nepean Fault near Longwall 32 by SCT (2018a)**

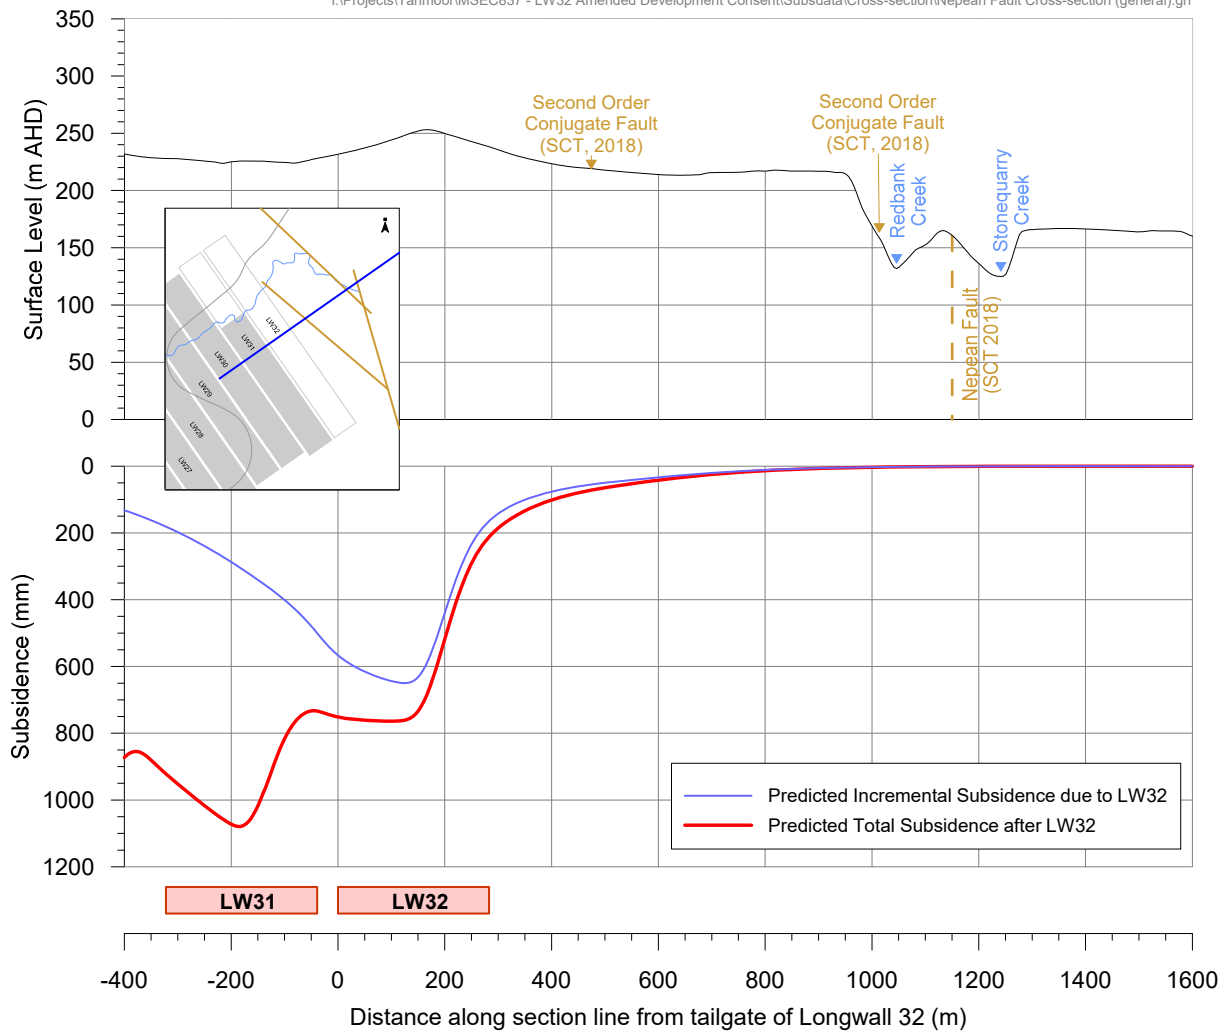
A cross-section has been produced in Fig. 3.6 to show the location of the Nepean Fault and Longwall 32. Predicted subsidence profiles due to the extraction of Longwalls 31 and 32 are also shown in Fig. 3.6. It can be seen from Fig. 3.6 that the first order Nepean Fault structure is located away from Longwall 32.

**Fig. 3.6 Cross-section showing the mapped geological structures by SCT (2018a), and predicted subsidence profiles**

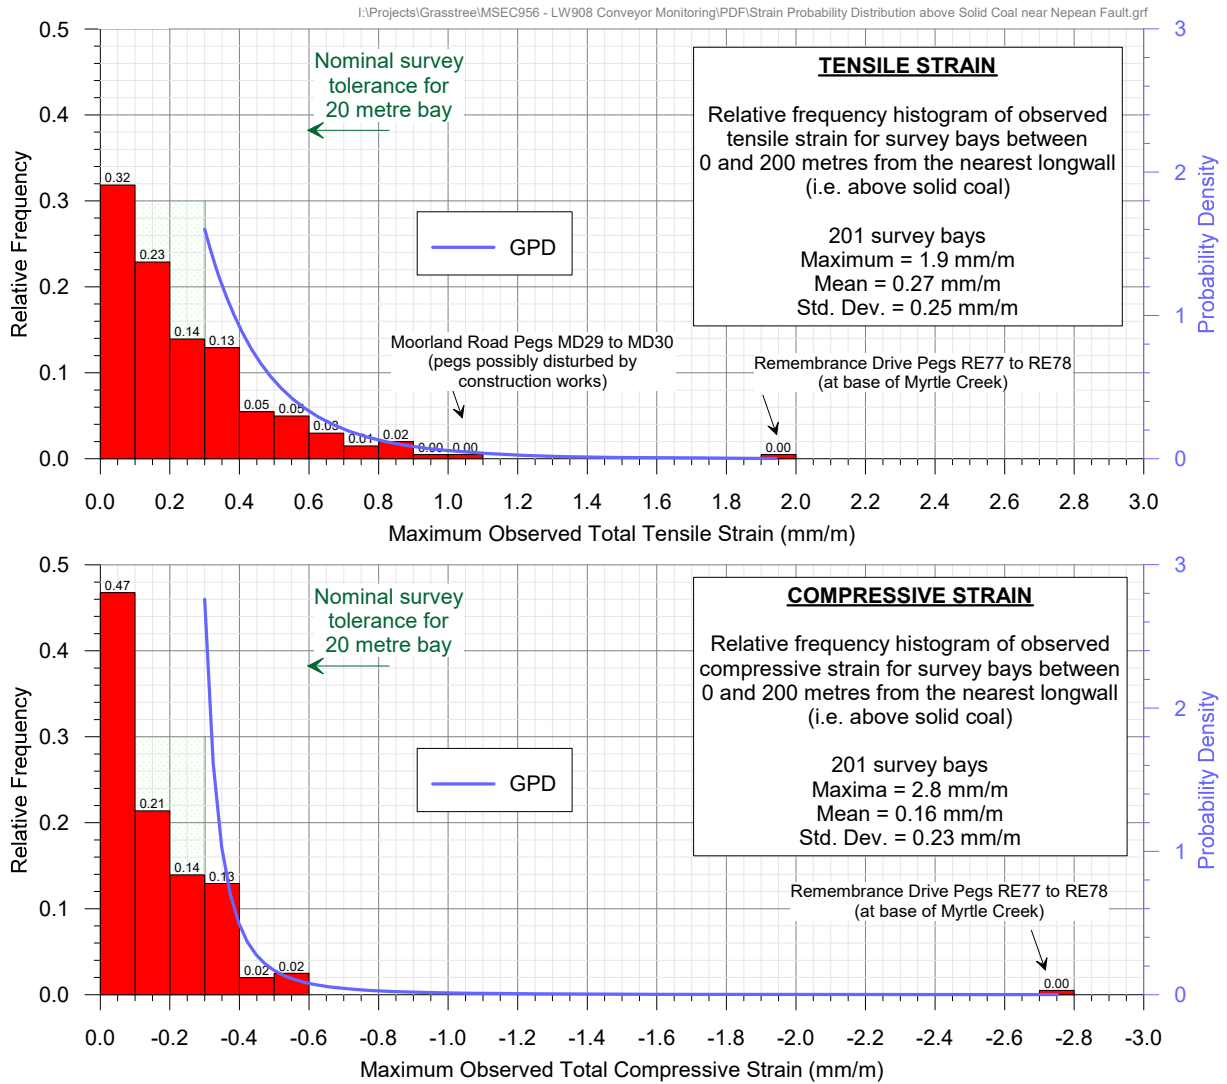
A histogram of the maximum observed tensile and compressive strains measured along the selected survey lines for survey bays located over solid coal between previously extracted longwalls at Tahmoor and the Nepean Fault is provided in Fig. 3.8.

It can be seen from Fig. 3.8 that observed ground strains have been, on average, within survey tolerance. A pair of outlying data points are labelled in Fig. 3.8.

**Fig. 3.8 Distributions of the Measured Maximum Tensile and Compressive Strains for Bays Located over Solid Coal between previously extracted longwalls at Tahmoor Coking Coal Operations and the Nepean Fault**

Pegs RE77 and RE78 are located within the base of Myrtle Creek, which is the main watercourse in the area. Whilst Myrtle Creek has experienced a small amount of valley closure at this location due to the mining of Longwalls 29 and 30, it can be seen from Fig. 3.9 that measured strains across the base of the Creek have varied greatly over time. The main reason for the variations is that the pegs are spaced only 3 metres apart, meaning that survey tolerance has a much greater influence on the measured result. Most survey bays in the Southern Coalfield are spaced apart by nominally 20 metres. The second reason is that variations have occurred after periods of heavy rainfall, where the pegs have been affected by swelling of the natural soils.

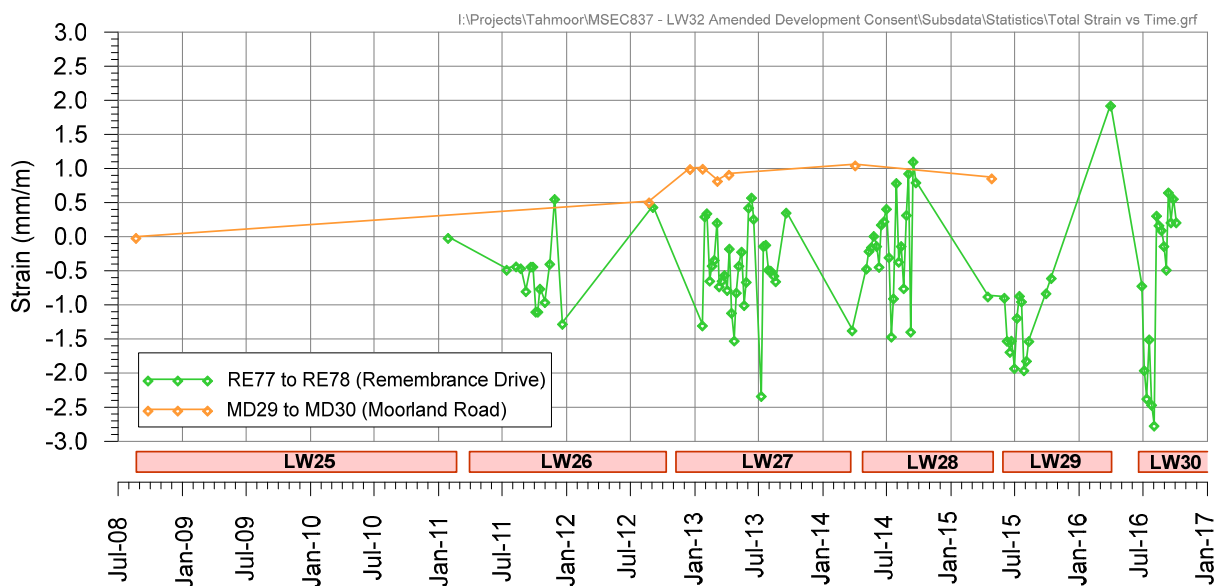
**Fig. 3.9 Observed ground strains at selected sites during the mining of Longwalls 25 to 30**

Pegs MD29 to MD30 appear to have been disturbed by construction works. The changes occurred after the completion of Longwall 26. The pegs, however, are located approximately 35 metres from the commencing end of Longwall 27, as shown in Fig. 3.9, but they experienced no changes during the mining of this longwall.

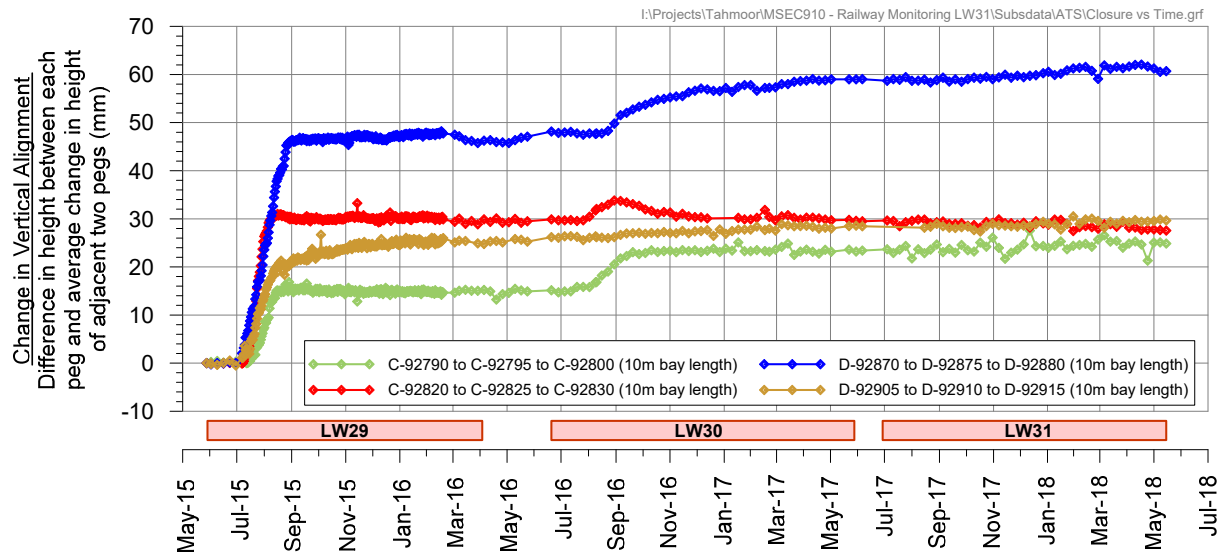
The results of observed changes in vertical alignment of the pegs along the railway cutting are shown in Fig. 3.12. It can be seen that the most significant changes occurred during the mining of Longwall 29. The changes, however, developed gradually over time, allowing the railway track to be adjusted such that trains could continue to travel through the site.

**Fig. 3.12 Changes in vertical alignment across a geological fault within a railway cutting during the mining of Longwalls 29 to 31 at Tahmoor Coking Coal Operations**

A recent example occurred at a low angle fault that intersected the Main Southern Railway in a railway cutting at Tahmoor, which was located directly above Longwall 29. The site was monitored extensively during the mining of Longwalls 28 to 31. This included three monitoring lines along the railway cutting, and survey prisms along the railway track.

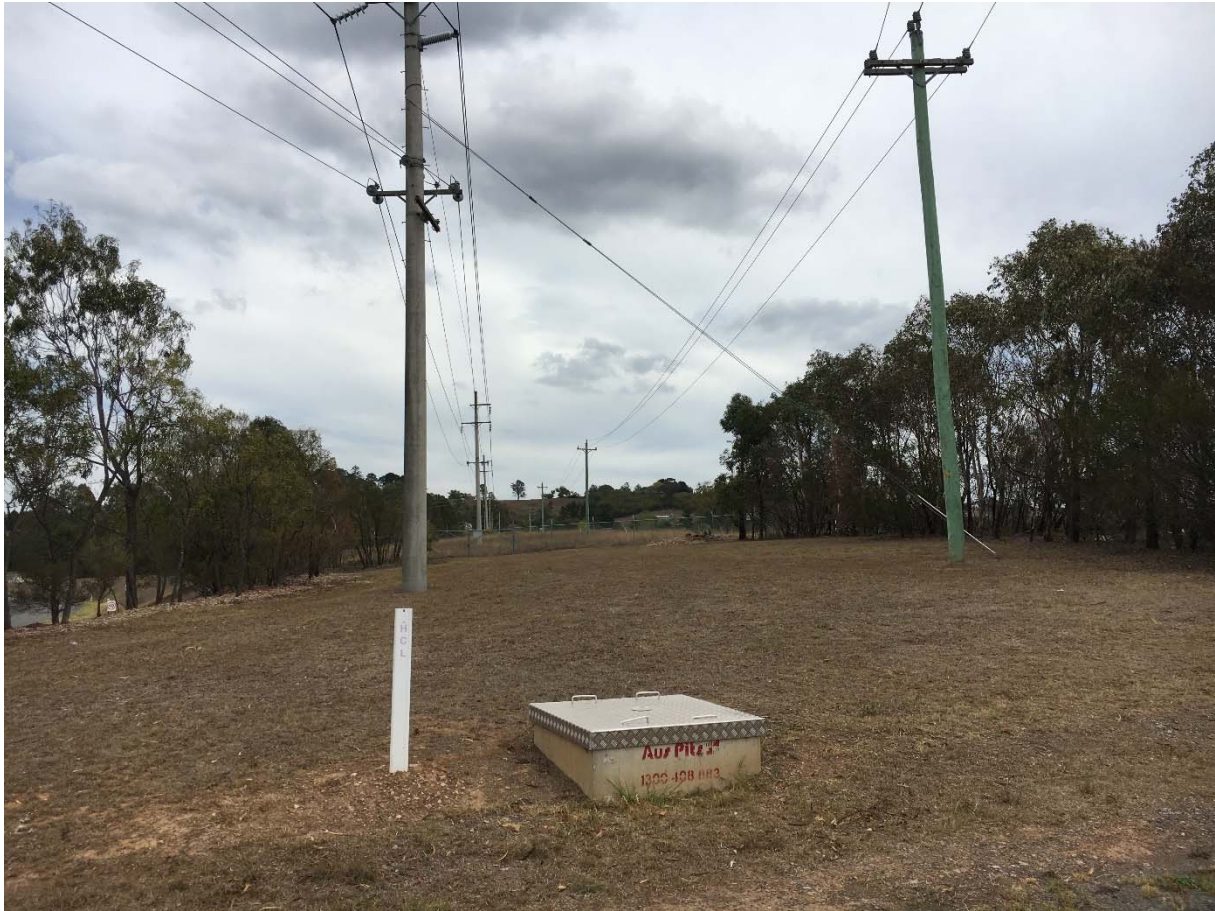
The 66kV powerline is a single pole line that runs along Remembrance Drive before turning east across property owned by Sydney Water's Picton Water Recycling Plant. The powerline crosses the mapped first order Nepean Fault. A photograph of the 66kV powerline and the adjacent 11kV powerline is shown in Fig. 3.14.

**Fig. 3.14 66kV Powerline (left) and 11kV Powerline (right) within Sydney Water's Picton Water Recycling Plant**

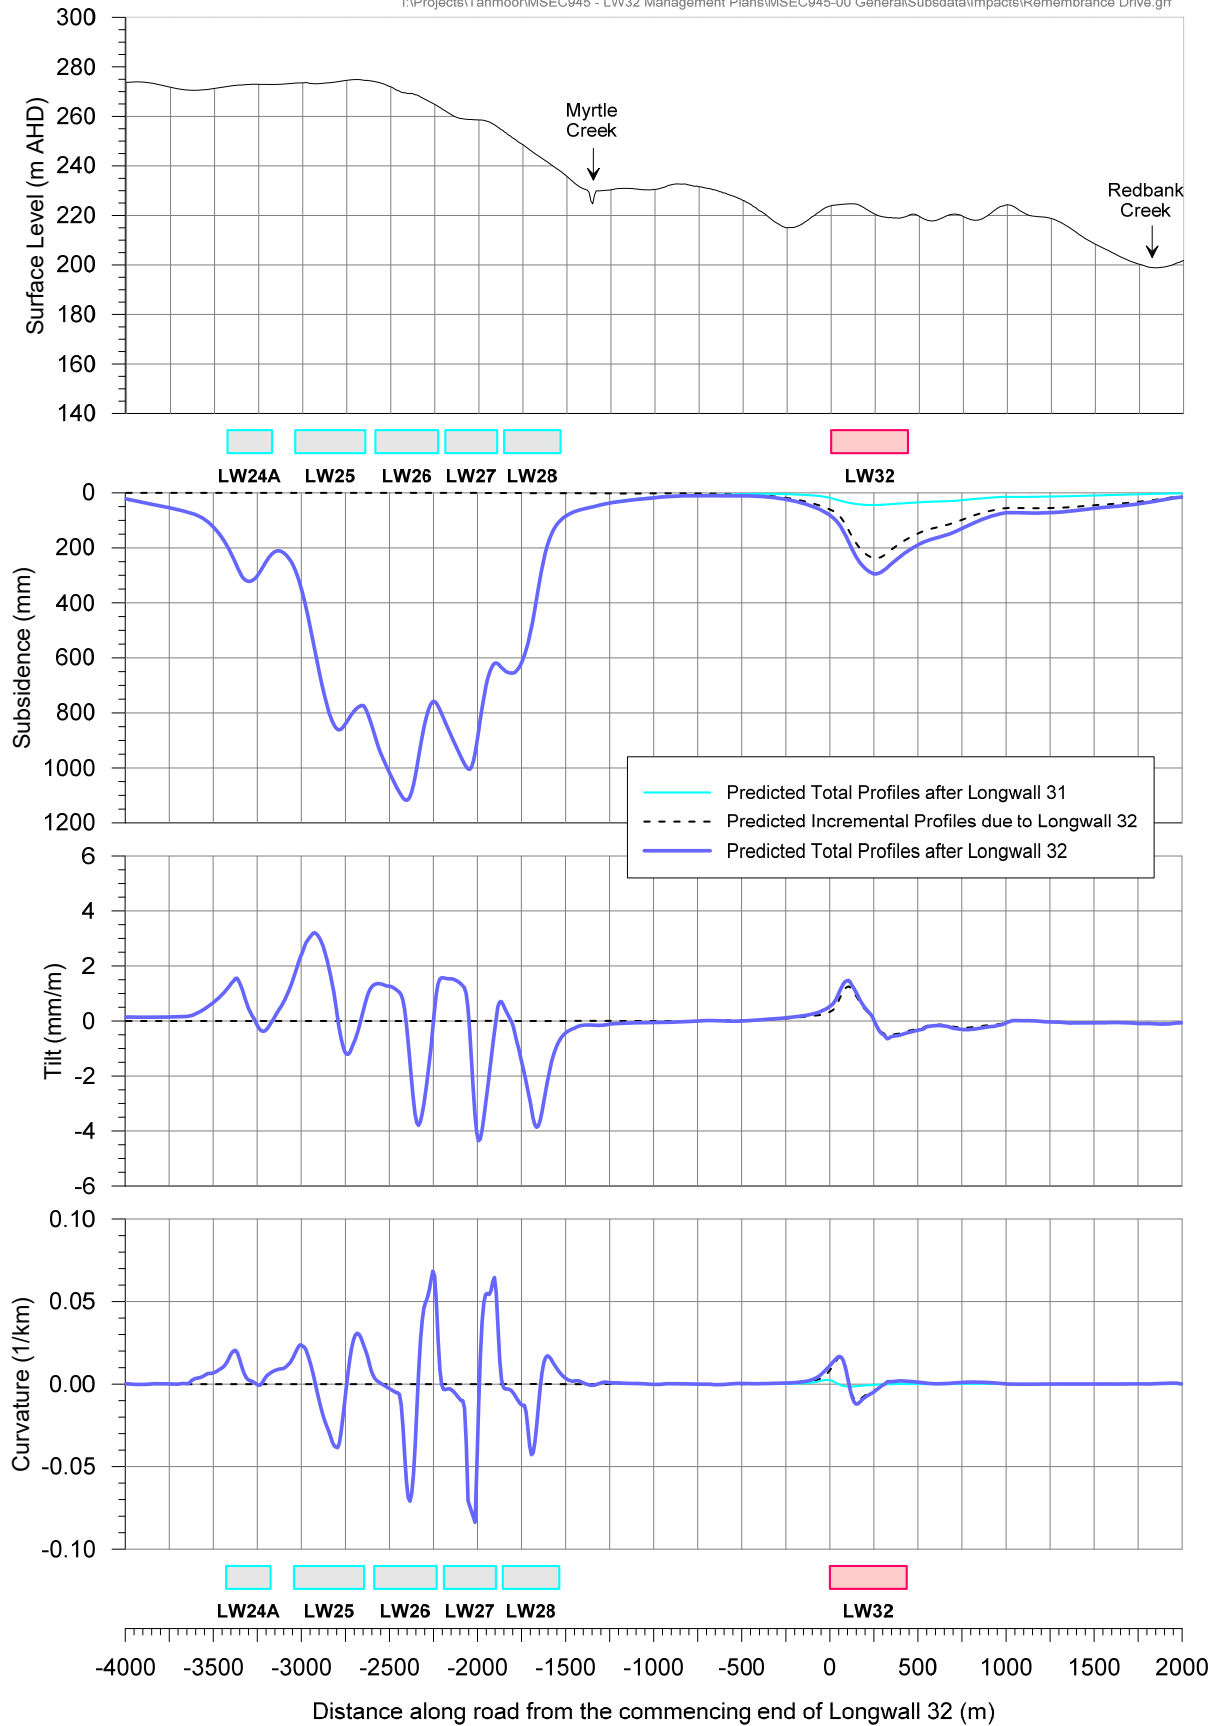
**Fig. 3.15 Predicted profiles of total subsidence, tilt and curvature for the powerline along Remembrance Drive due to the mining of Longwalls 22 to 32**

The predicted profiles of conventional subsidence, tilt and curvature for the 66kV powerline along Remembrance Drive is shown in Fig. 3.15. The predicted profiles of conventional subsidence, tilt and curvature for the 11kV powerline along Bridge Street is shown in Fig. 3.16. The predicted total profiles after the completion of Longwall 32 are shown in cyan. The predicted incremental profiles due to the extraction

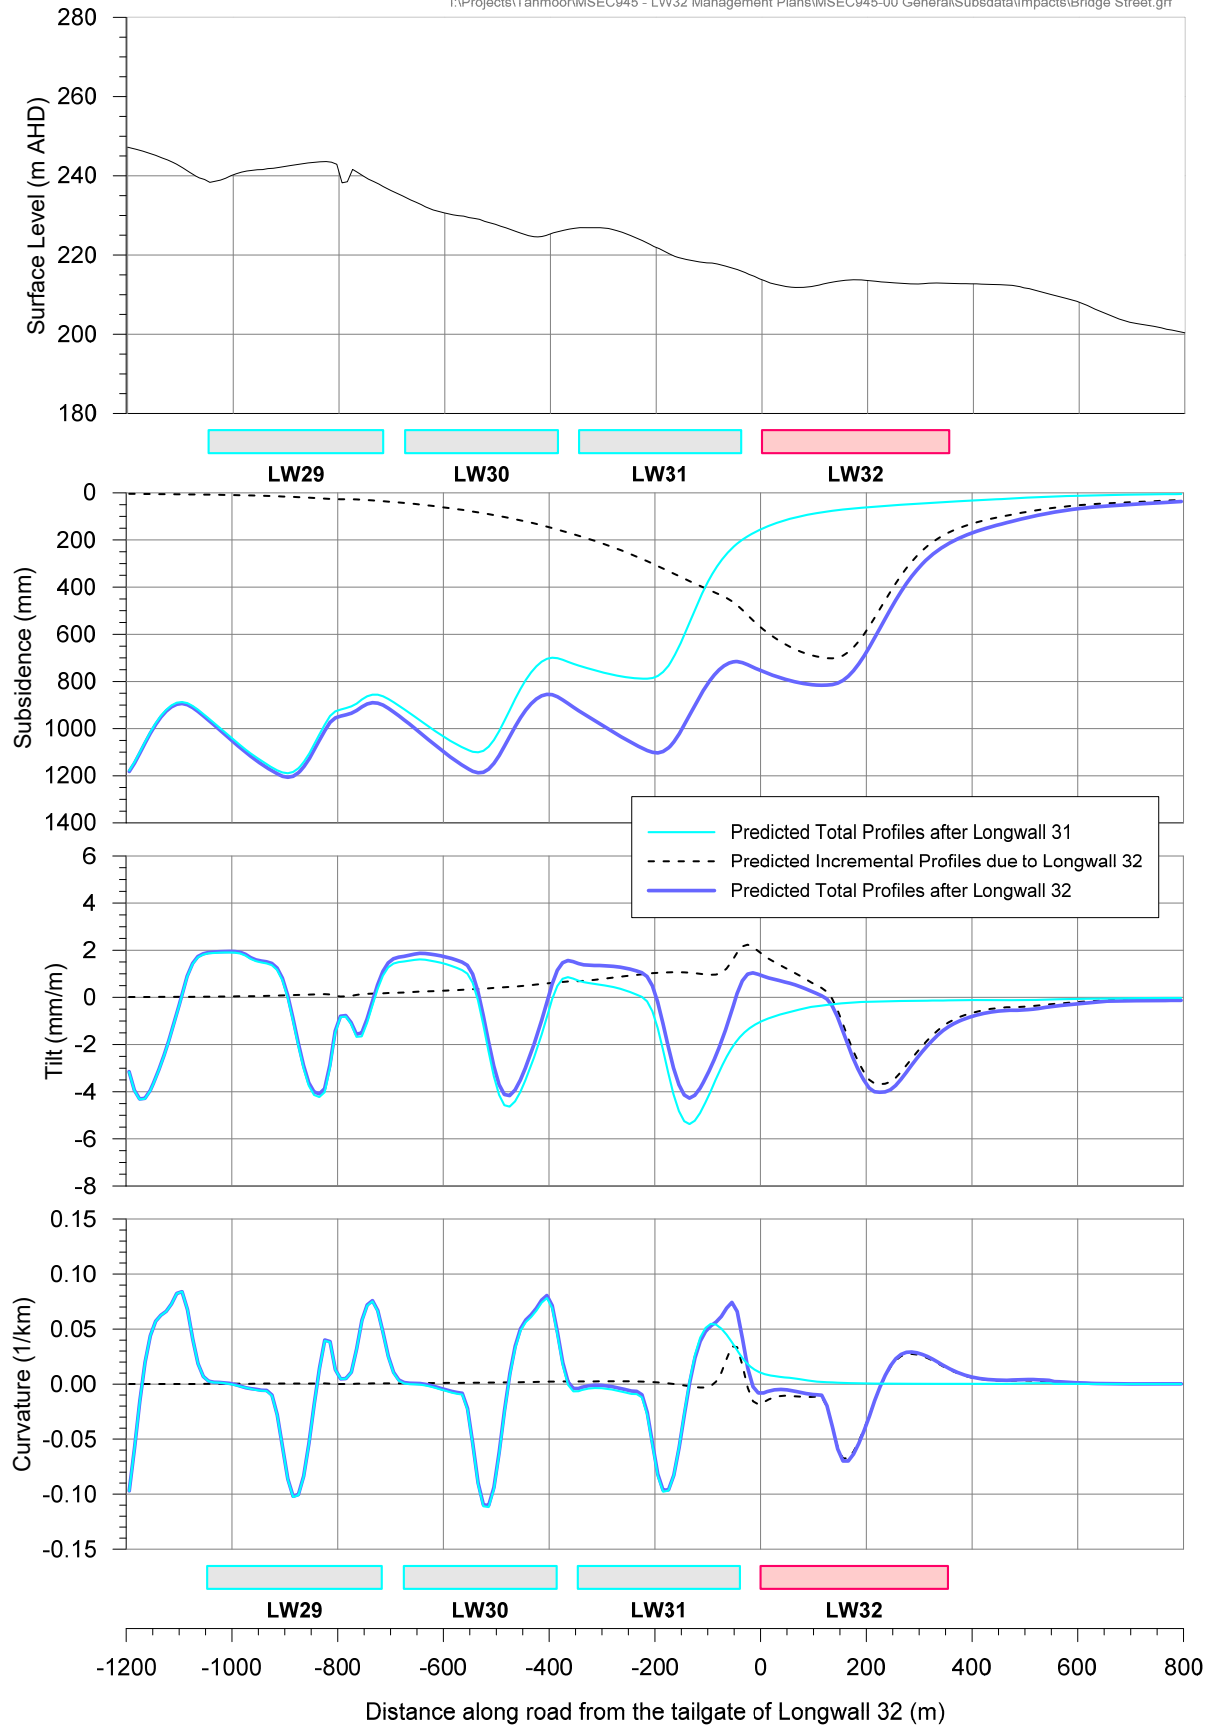
**Fig. 3.16** Predicted profiles of total subsidence, tilt and curvature for the powerline along Bridge Street due to the mining of Longwalls 22 to 32

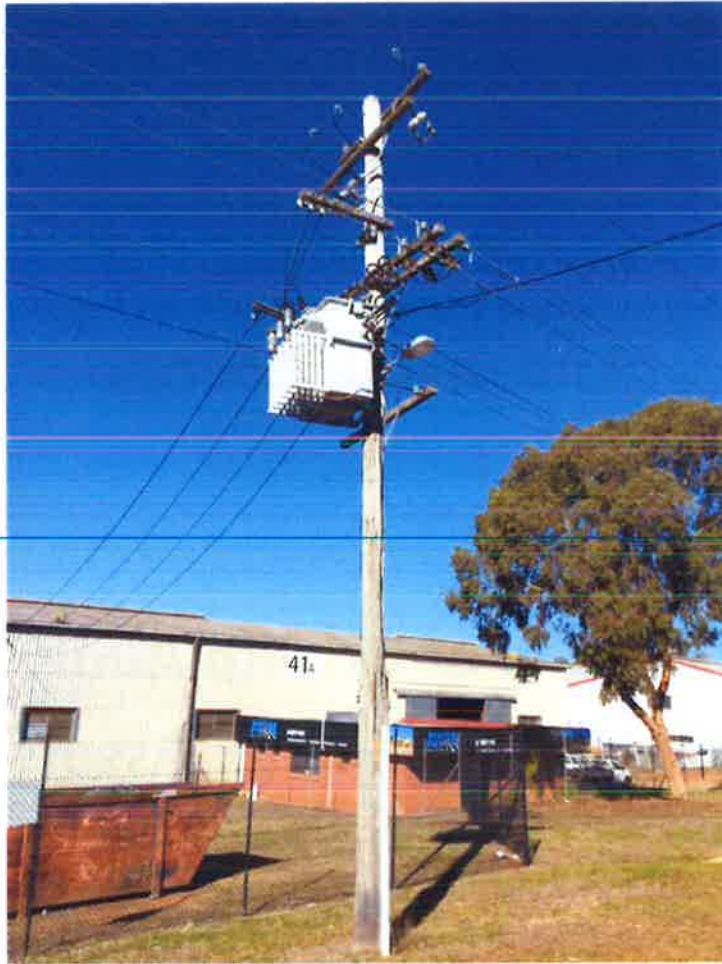
<b>Pole No</b>	<b>Asset</b>	<b>Location</b>	<b>Photo number</b>
PL725341	Pole Substation 11581	Bridge St Picton	1

Site inspection has indicated no evidence to suggest any compromise of the integrity of the inspected distribution lines in the effected mining zone. The lines were found to be in a good state of repair and in serviceable order.

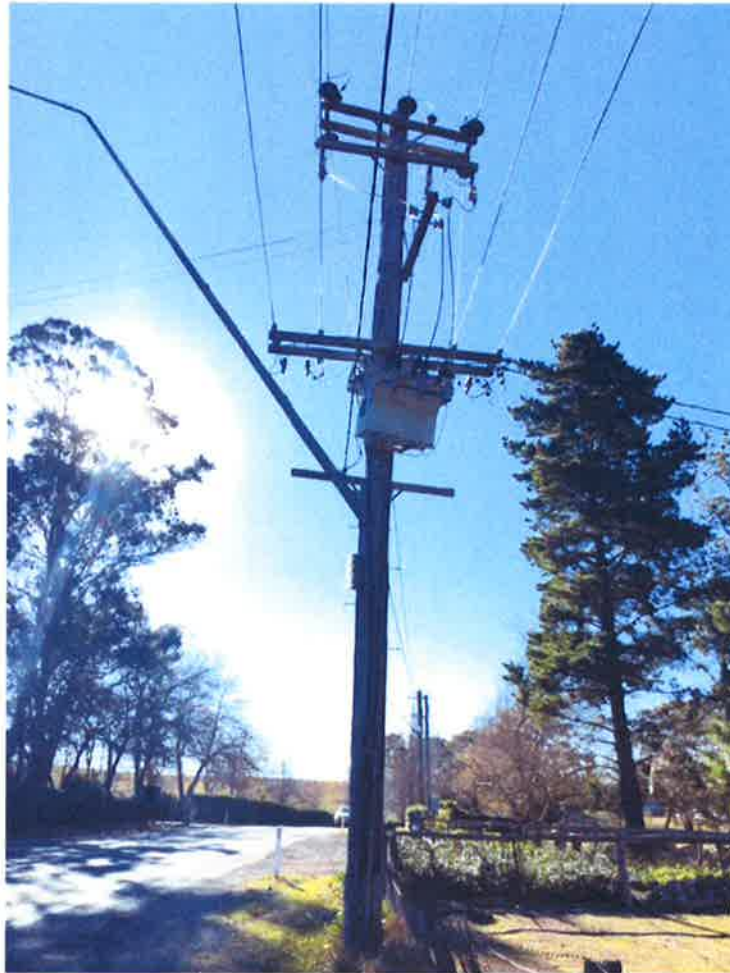
<b>Pole No</b>	<b>Asset</b>	<b>Location</b>	<b>Photo number</b>
PL628607	Pole Substation 10965	Remembrance DWY Picton	2

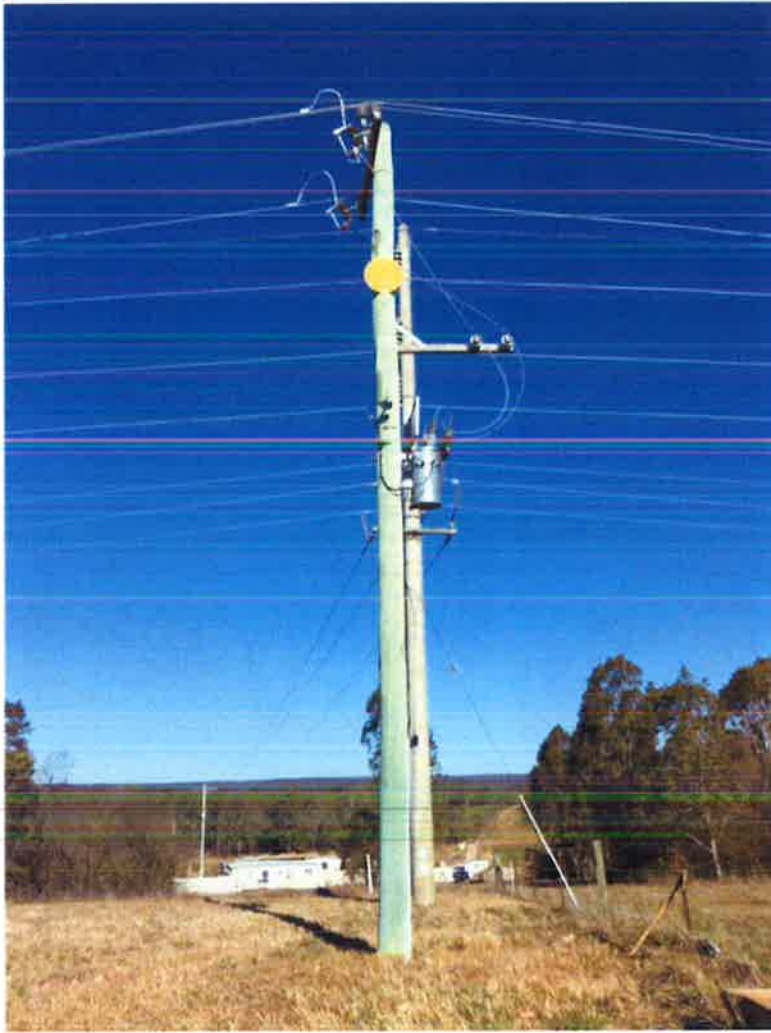
<b>Pole No</b>	<b>Asset</b>	<b>Location</b>	<b>Photo number</b>
PL214850	Pole Substation 29188	Remembrance DWY Picton	3

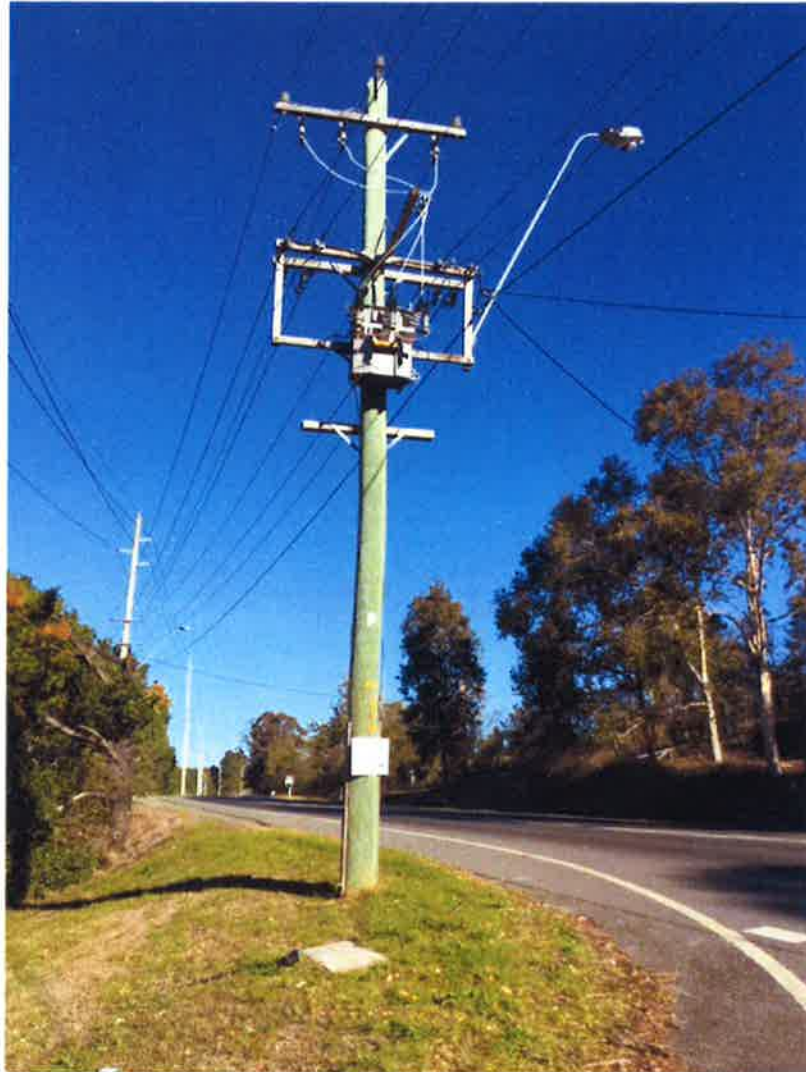
<b>Pole No</b>	<b>Asset</b>	<b>Location</b>	<b>Photo number</b>
PL737270	Pole Substation 20102	Remembrance DWY Picton	4

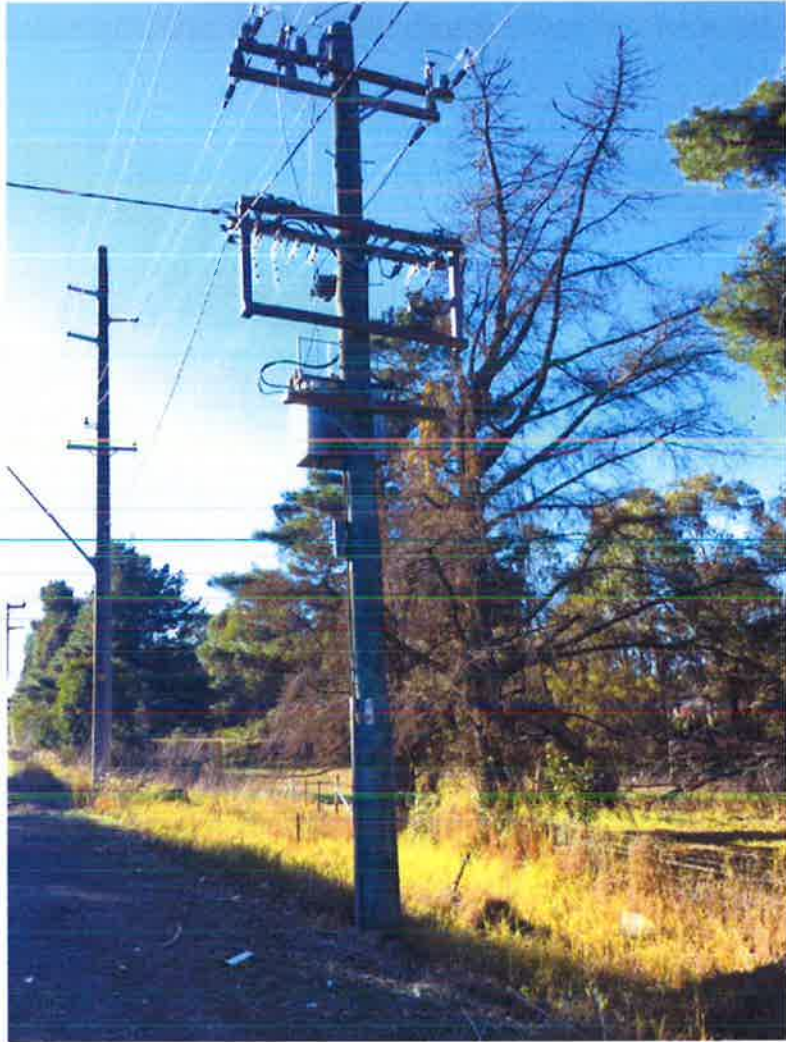
<b>Pole No</b>	<b>Asset</b>	<b>Location</b>	<b>Photo number</b>
PL289373	Pole Substation 22844	Remembrance DWY Picton	5
