SIMEC Mining:  
**Tahmoor Coking Coal Operations – Longwall 32**

Management Plan for Potential Impacts to Building Structures

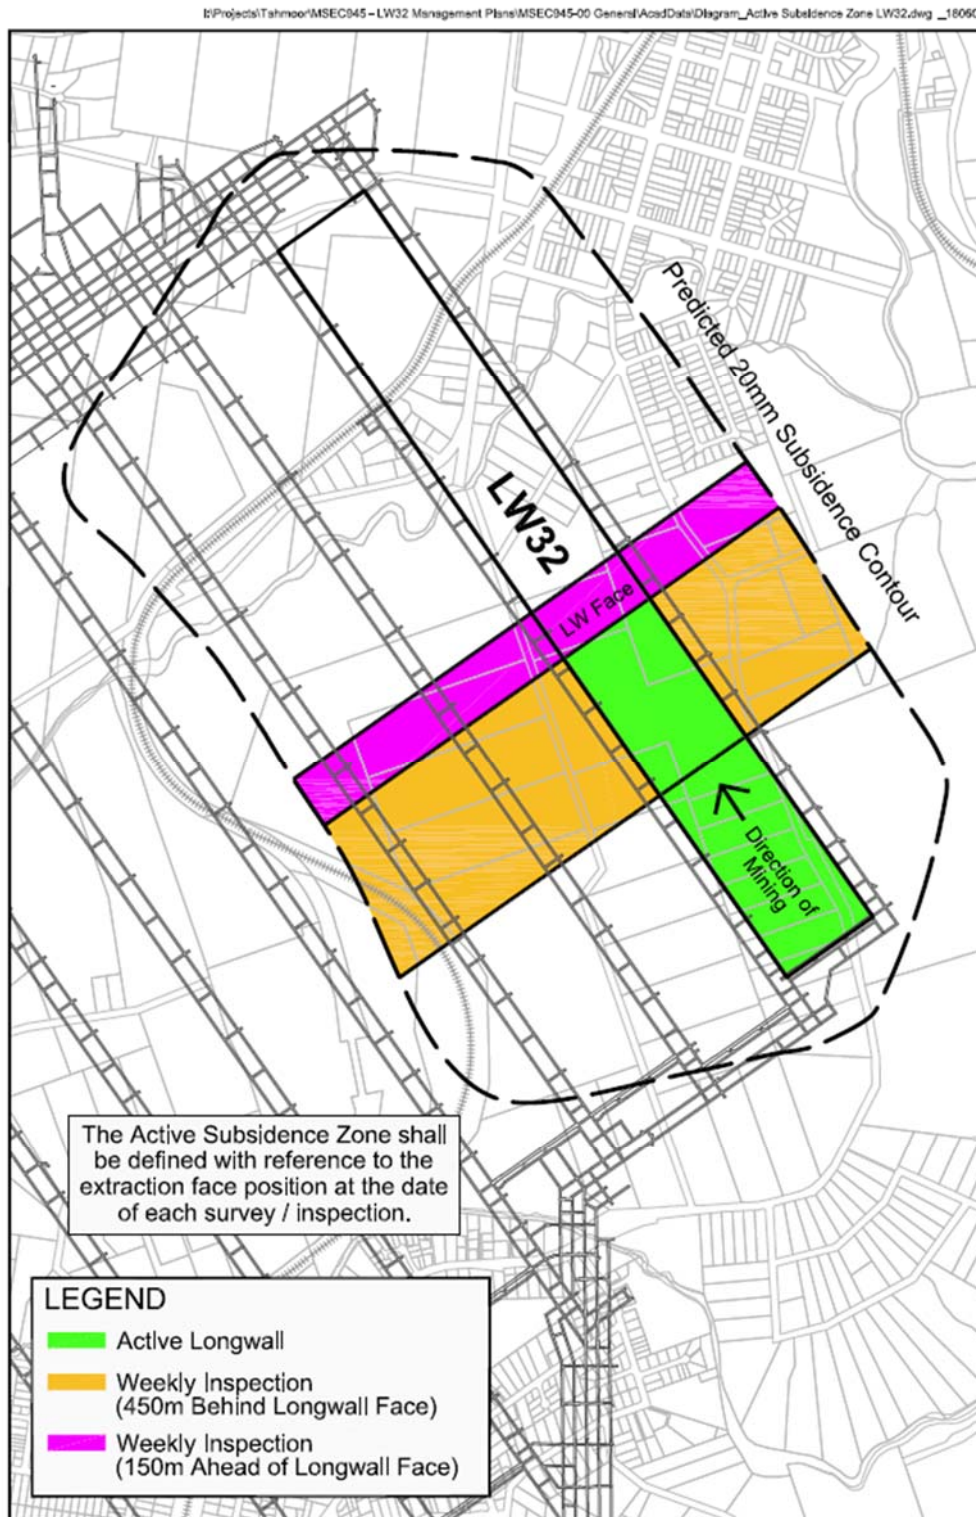
This is termed the “active subsidence zone” for the purposes of this Management Plan, where surface monitoring is generally conducted. The active subsidence zone for each longwall is defined by the area bounded by the predicted 20 mm subsidence contour for the active longwall and a distance of 150 m in front and 450 m behind the active longwall face, as shown by Fig. 1.2.

**Fig. 1.2** Diagrammatic representation of the active subsidence zone

As a longwall progresses, subsidence begins to develop at a point in front of the longwall face and continues to develop after the longwall passes. The majority of subsidence movement typically occurs within an area 150 m in front of the longwall face to an area 450 m behind the longwall face.
