**Tahmoor Colliery
Longwalls 25 to 26**

TAHMOOR TOWN CENTRE

**SURFACE SAFETY AND
SERVICEABILITY MANAGEMENT
PLAN**

REVISION E

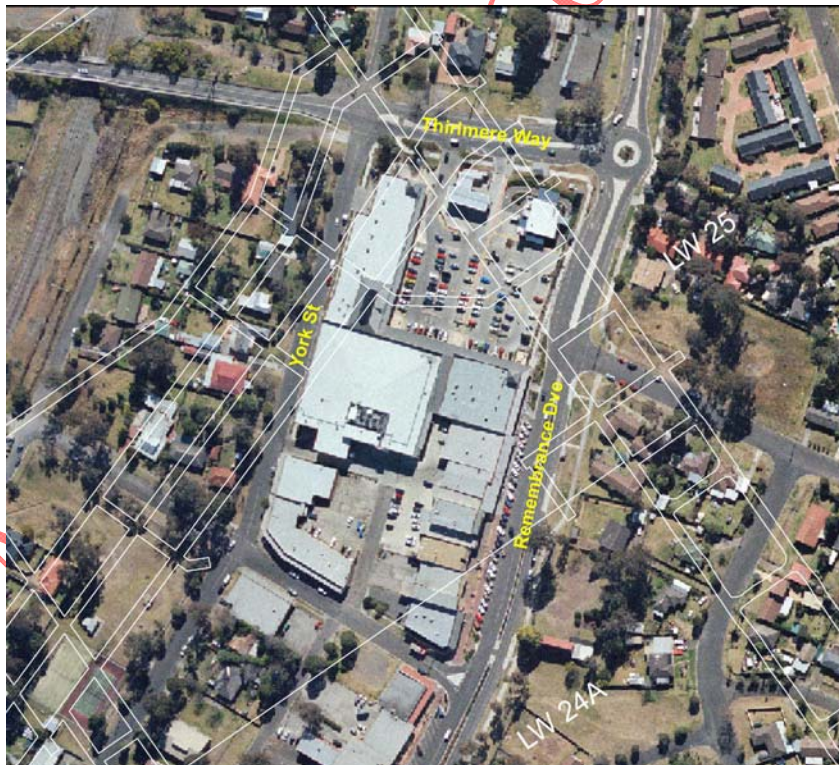
Fig. 1.1 Aerial photograph of Tahmoor Town Centre overlaid with Mine Plan

Tahmoor Town Centre is located between Longwalls 24A and 24B and to the side of Longwall 25, as shown in Fig. 1.1 and Dwg No. MSEC286-070101. Longwall mining will not mine directly beneath it.

The closest distance between Tahmoor Town Centre and the edge of the extracted Longwall 24A was 60 metres. The closest distance between Tahmoor Town Centre and the edge of Longwall 25 is 25 metres.

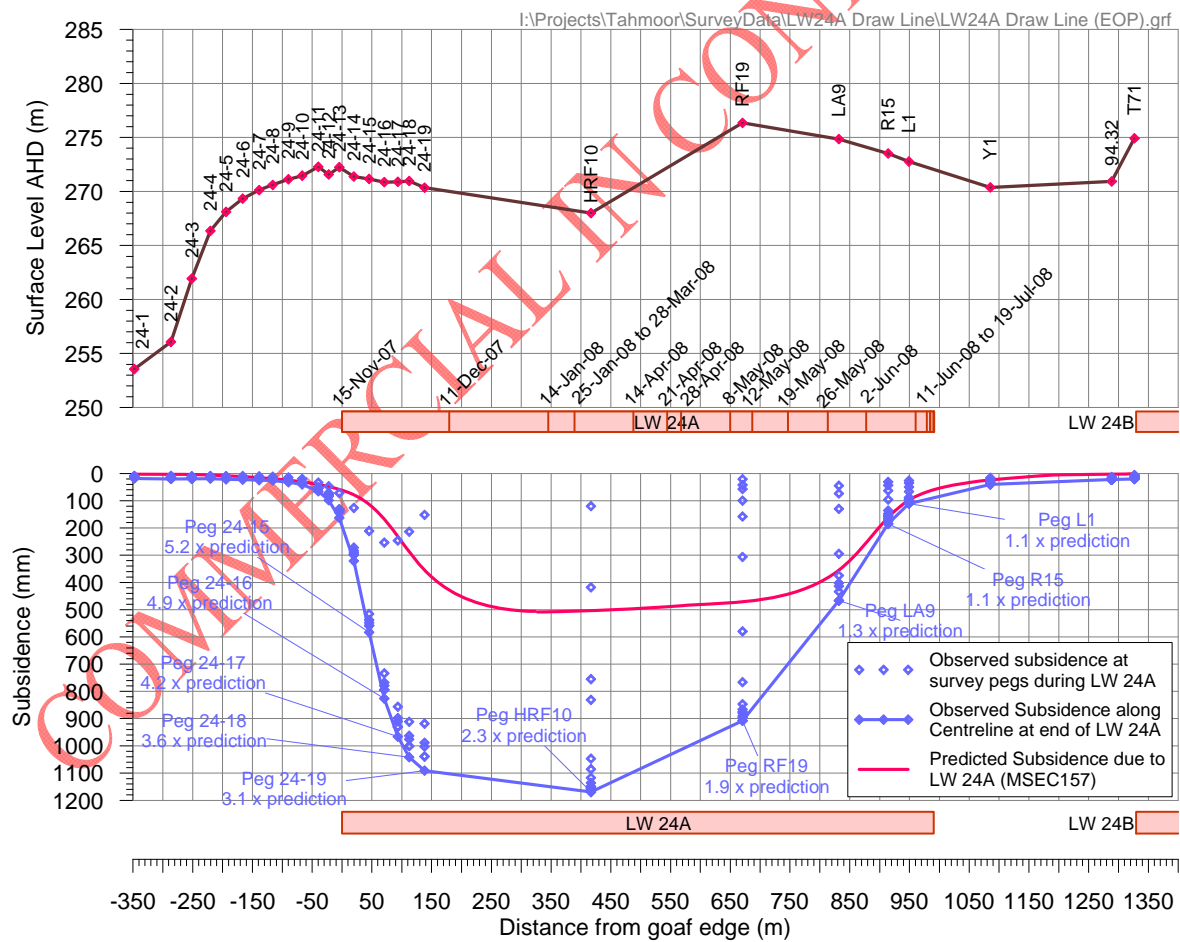
Fig. 3.1 Observed Subsidence along Centreline of Longwall 24A

While there has been a reasonable correlation between observed and predicted subsidence above Longwalls 22 to 24B, increased subsidence has been observed above Longwall 24A. Observed subsidence was greatest above the southern half of Longwall 24A, and gradually reducing in magnitude towards the northern half of the longwall, which was directly beneath the urban area of Tahmoor. These observations are shown graphically in Fig. 3.1, which shows observed subsidence at survey pegs located along the centreline of Longwall 24A.

It can be seen from Fig. 3.1 that while observed subsidence was substantially greater than predicted above the commencing end of the longwalls, observed subsidence compared reasonably well with predictions towards the finishing end of Longwall 24A. It is noted that the Tahmoor Town Centre is located further north along Remembrance Drive (Peg R15).

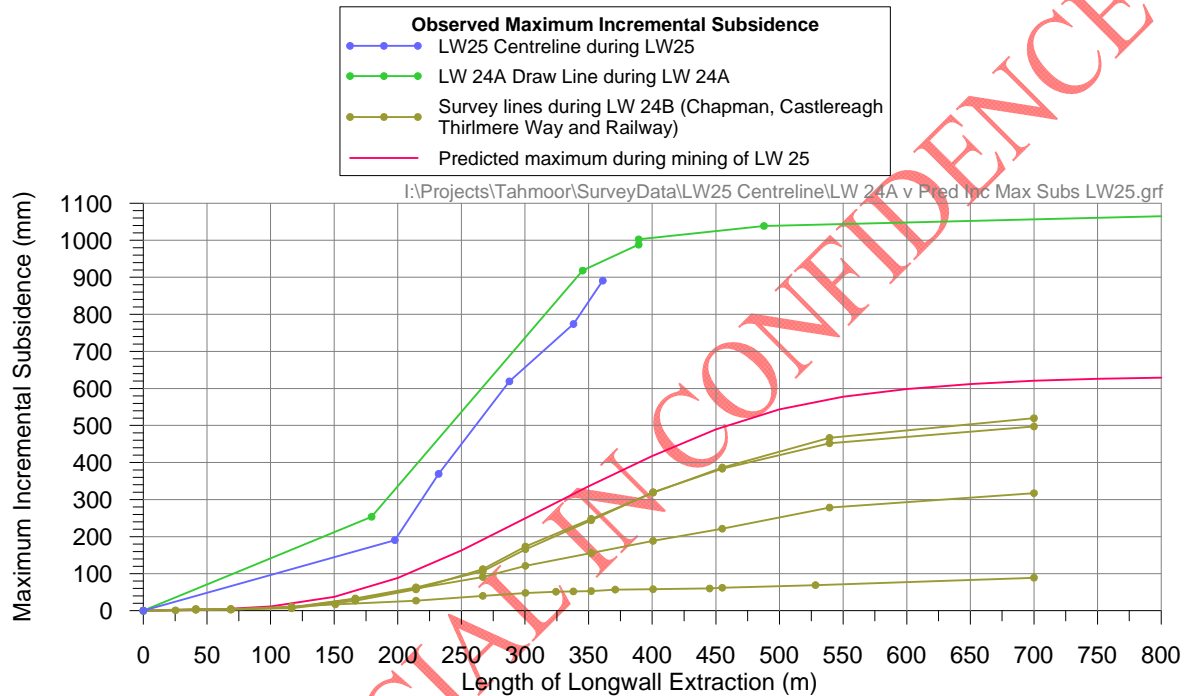
Fig. 3.2 Observed Maximum Incremental Subsidence during the mining of LWs 24B, 24A and 25

Recent subsidence monitoring after 372 metres of extraction has confirmed that increased subsidence is developing above the commencing end of Longwall 25. This is best illustrated by Fig. 3.2, which compares maximum observed subsidence during the mining of Longwalls 24B, 24A and 25, as well as maximum predicted subsidence during the mining of Longwall 25.

It can be seen from Fig. 3.2 that the observed subsidence behaviour during the mining of Longwall 25 is similar to but slightly less than the behaviour observed during the mining of Longwall 24A. This is substantially more subsidence compared to observations during the mining of Longwall 24B, which closely matches the subsidence predictions.
