LW26 Wollondilly Shire Council Roads, Bridges and Culverts SSSMP Review

Minutes from Meeting

Date: 22 December 2010

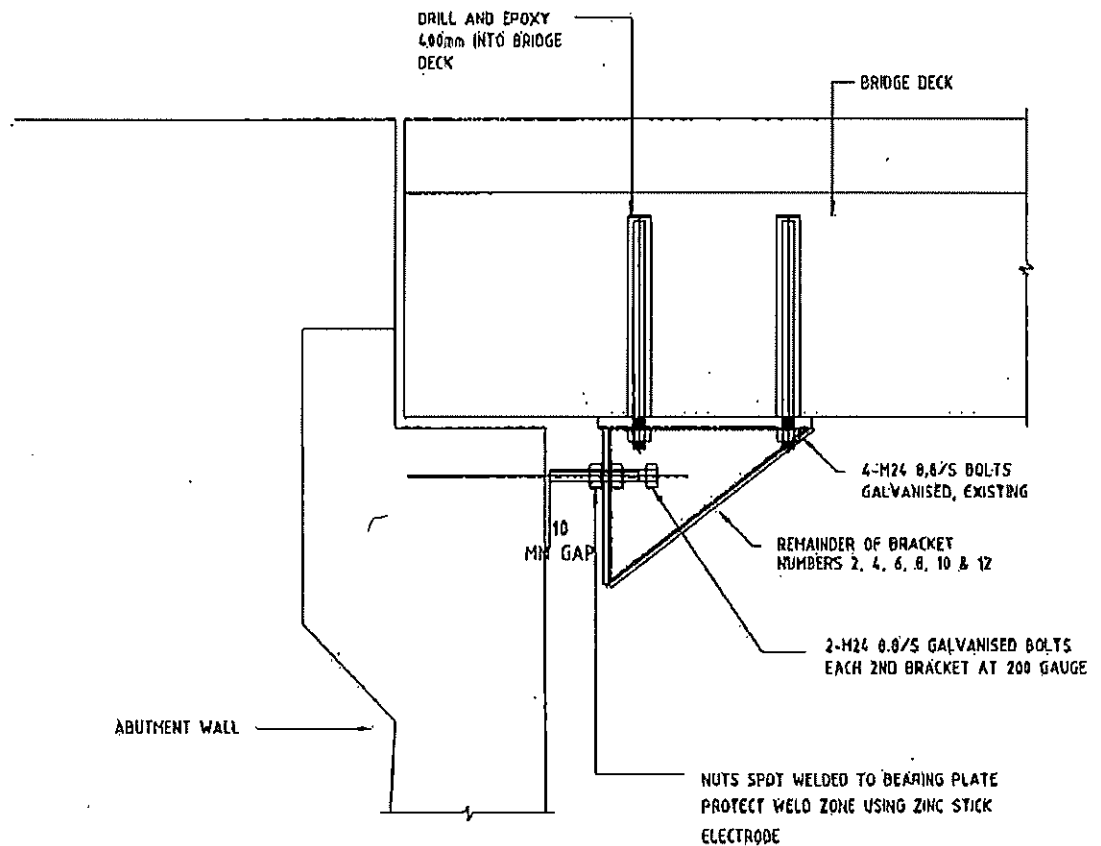
Figure A – Bracket Adjustment Detail (courtesy John Matheson & Associates)

Monitoring of the bridge during the mining Longwall 25 has indicated that the dowels have sheared. Adjustments were therefore made to the brackets so there is currently a small air gap between the abutment walls and the bracket supports so that there is no pressure on the brackets, abutments or bridge deck. The brackets have been left in place to provide some support to the abutments and they can be easily re-adjusted during mining. A sketch showing the adjustment of the brackets is shown below.

However, at that time, there was concern that the dowels between the top of the abutments and underside of the deck may shear and damage the concrete abutments. Steel brackets were installed to provide additional support to the abutment walls, ensuring that the dowels shear without breaking the concrete that surround them. It was possible, however, that the brackets, after achieving their design purpose of preventing abutment cracking at time of dowel shear, may reach the limit of their bearings and have begun to apply lateral loads onto the abutment walls. It is for this reason that daily inspections were required.

2.8 The scaffold beneath the deck at both abutments will be re-erected prior to the longwall approaching Castlereagh Street Bridge to provide access for detailed visual inspections and to allow the gap between the abutment walls and the brackets to be measured.
