**Tahmoor Colliery**

**MANAGEMENT PLAN**

**PEPES DUCKS INFRASTRUCTURE**

**LONGWALL 26**

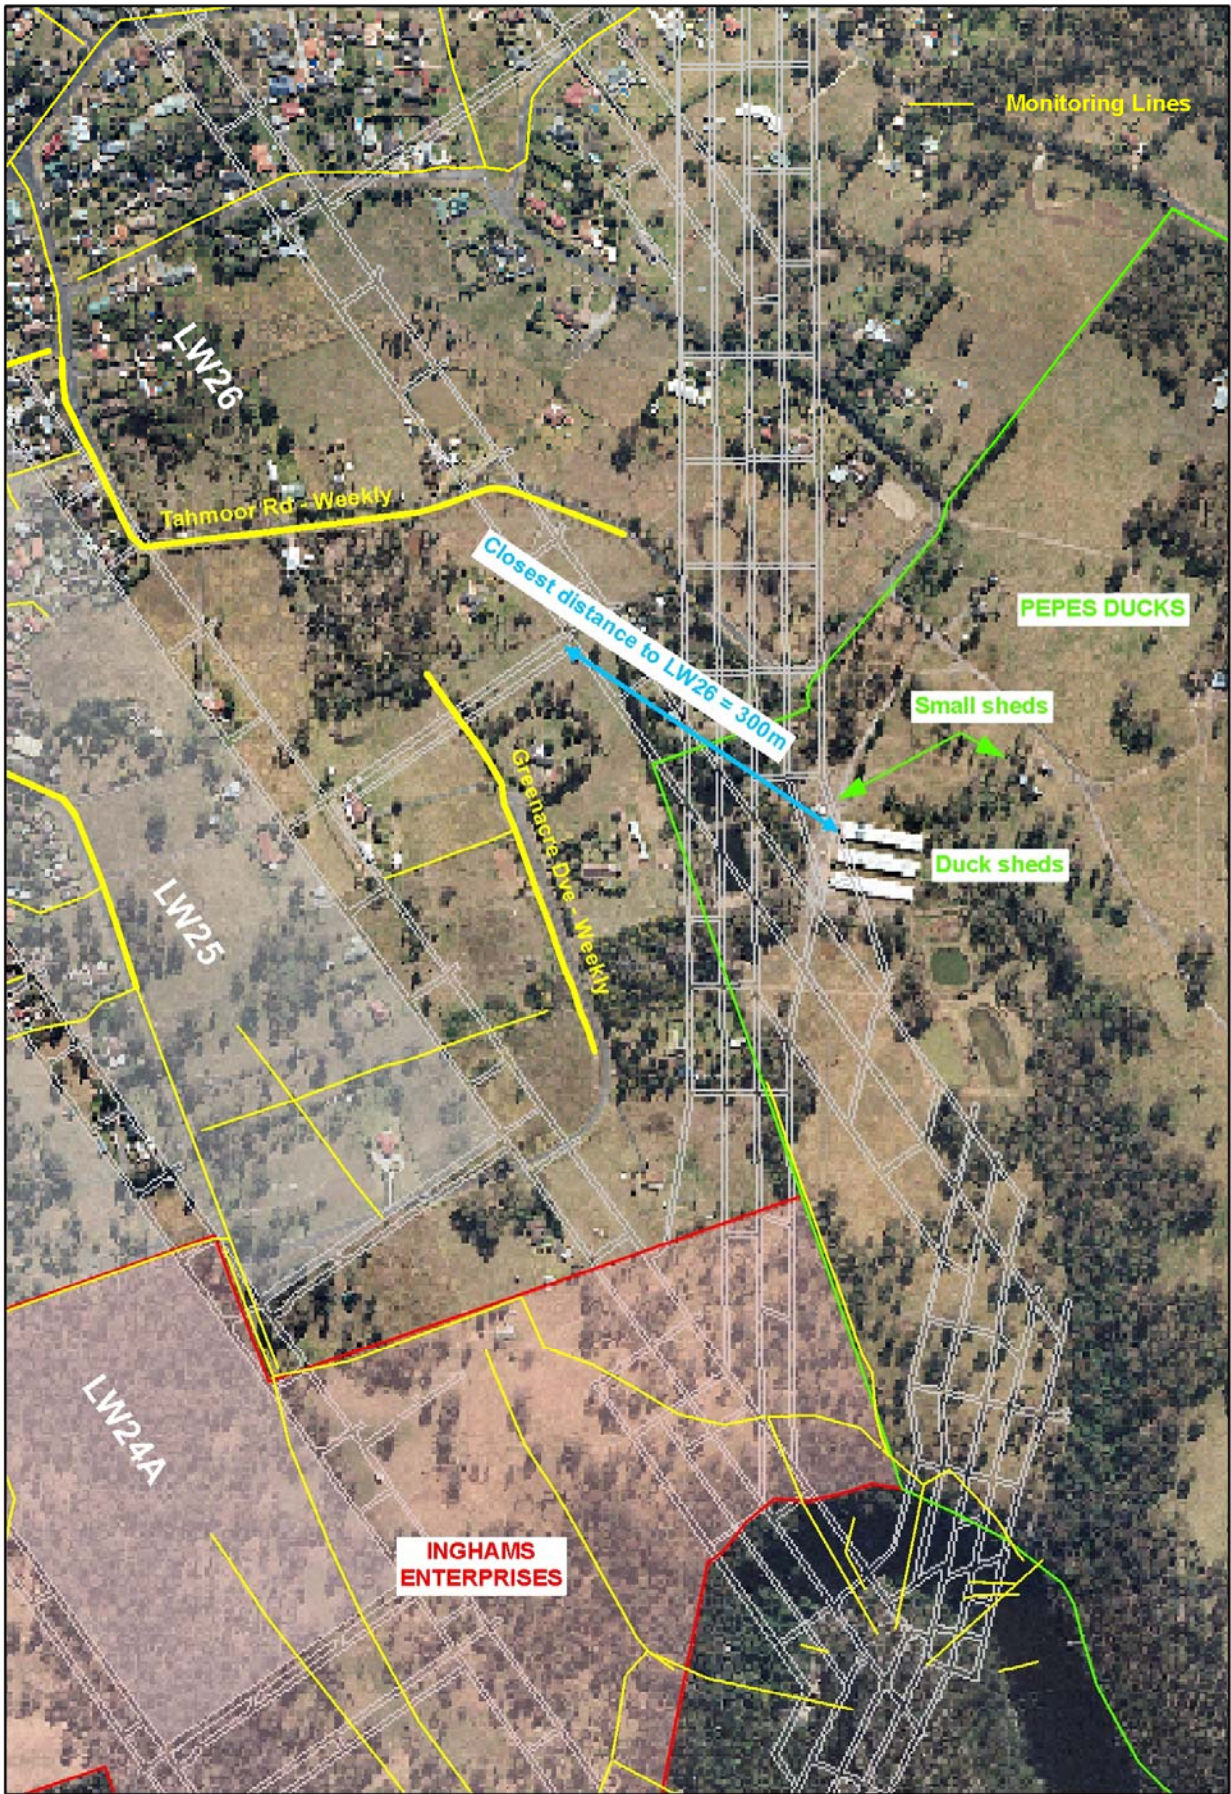
**Fig. 1.1 Location of Pepes Ducks relative to Longwall 26**

A map showing the location of Pepes Ducks property relative to Longwall 26 is shown in Fig. 1.1. It can be seen that the closest distance between the duck sheds and Longwall 26 is 300 metres.

In relation to the area around Greenacre Drive, Tahmoor Road and Myrtle Creek Avenue, no reports of ground vibration were received from residents during the commencement of mining of Longwall 25, which mined directly beneath a number of residential properties and was located approximately 380 metres to the west of the duck sheds (please refer Fig. 1.1).

- Tahmoor Colliery will be conducting, at its cost, weekly ground surveys along Greenacre Drive and Tahmoor Road, as shown in Fig. 1.1. These surveys measure subsidence movements due to the extraction of Longwall 26. They will commence after 200 metres of longwall extraction when significant subsidence is expected to start developing directly above the longwall and will cease when the longwall face moves away from this area and monitoring shows small changes between surveys.

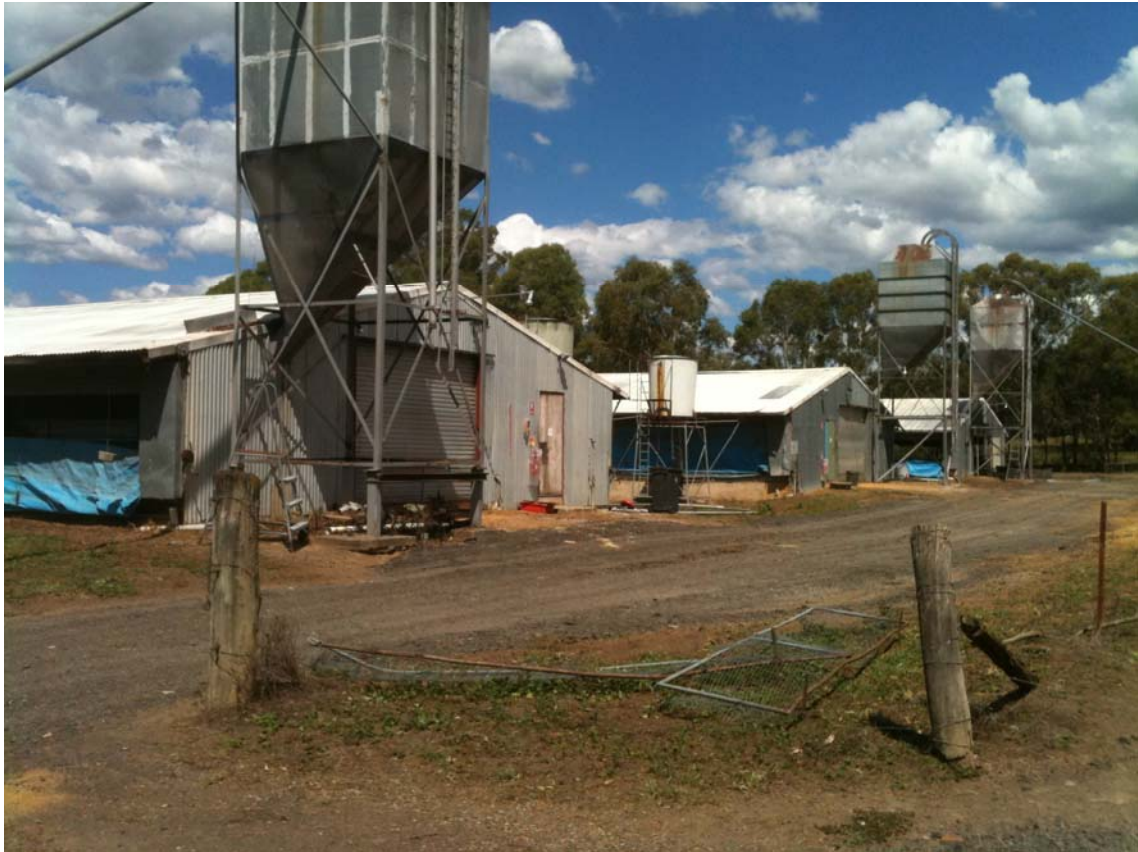
**Fig. 1.2 Duck sheds viewed from north**

Photographs of the duck sheds are shown in Fig. 1.2, Fig. 1.3 and Fig. 1.4. The sheds consist of light-weight frames buildings with metal sheeting. While the sheds are enclosed and secured, the openings are covered with mesh and plastic sheeting.

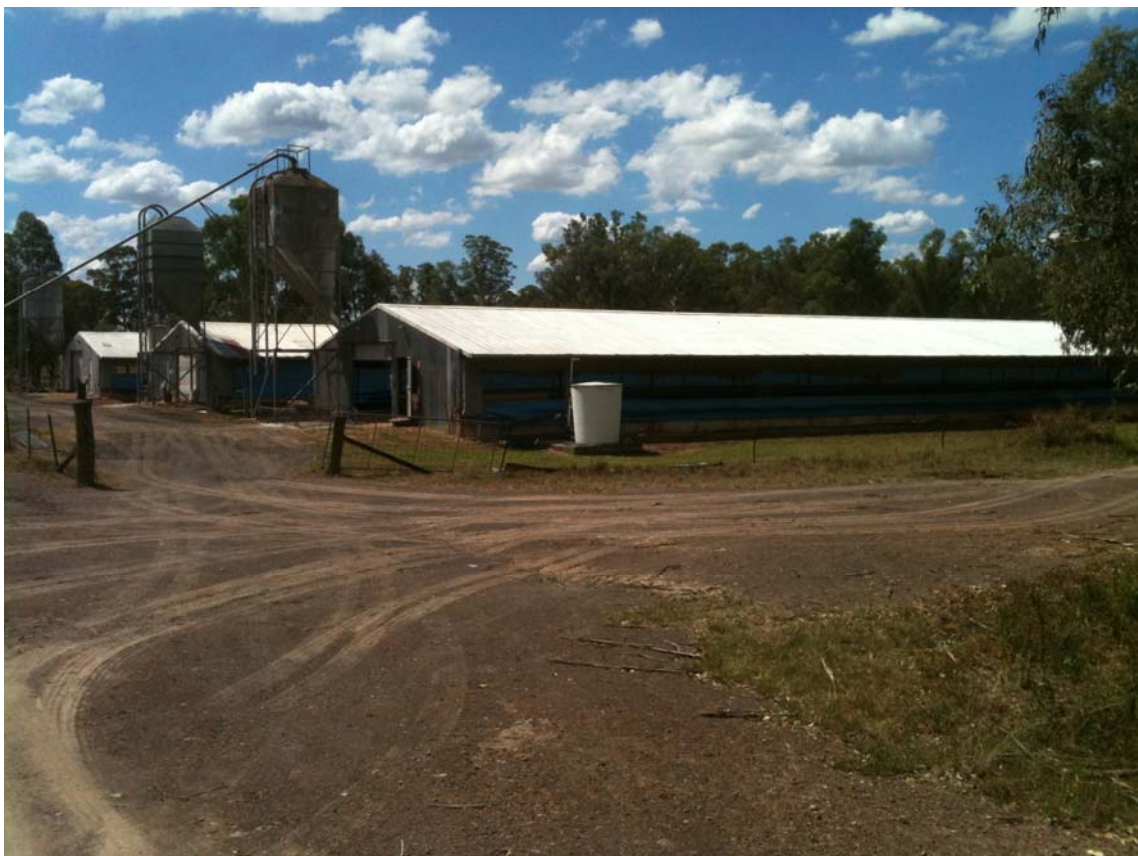
**Fig. 1.3 Duck sheds viewed from south**

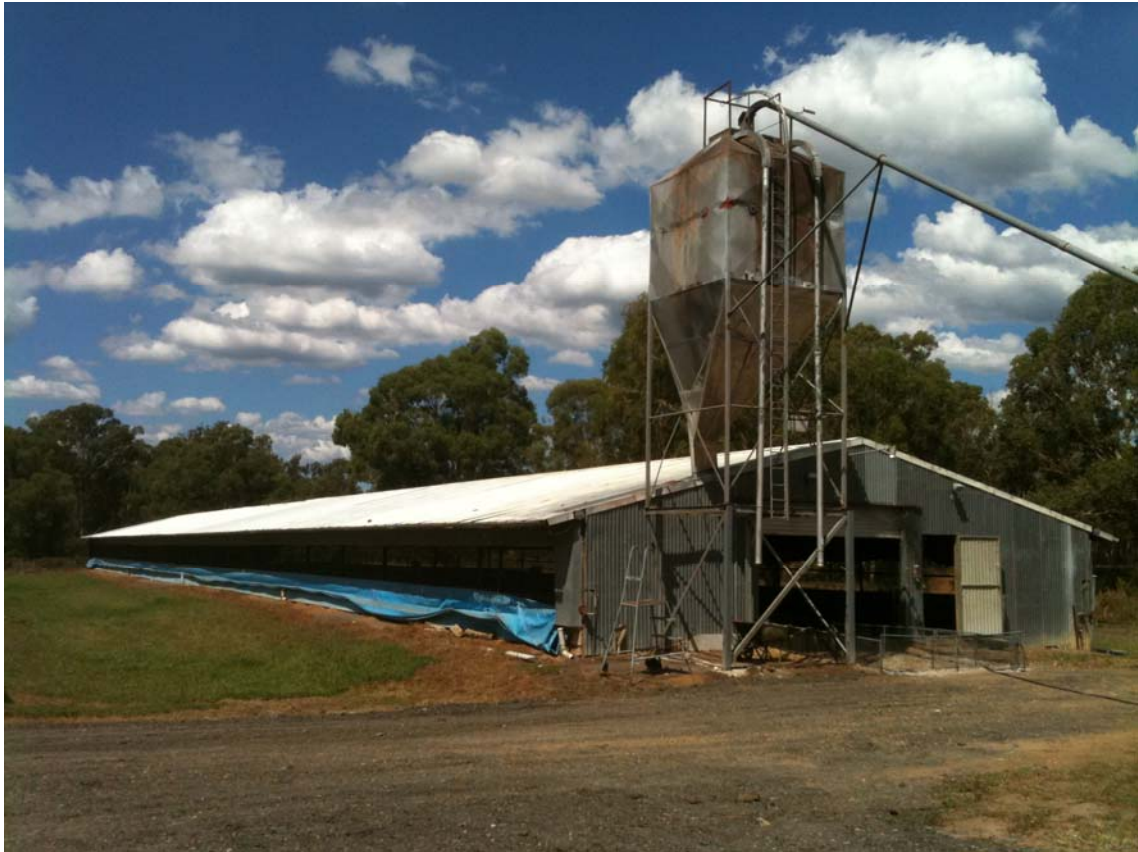
**Fig. 1.4 Closer view of duck shed**

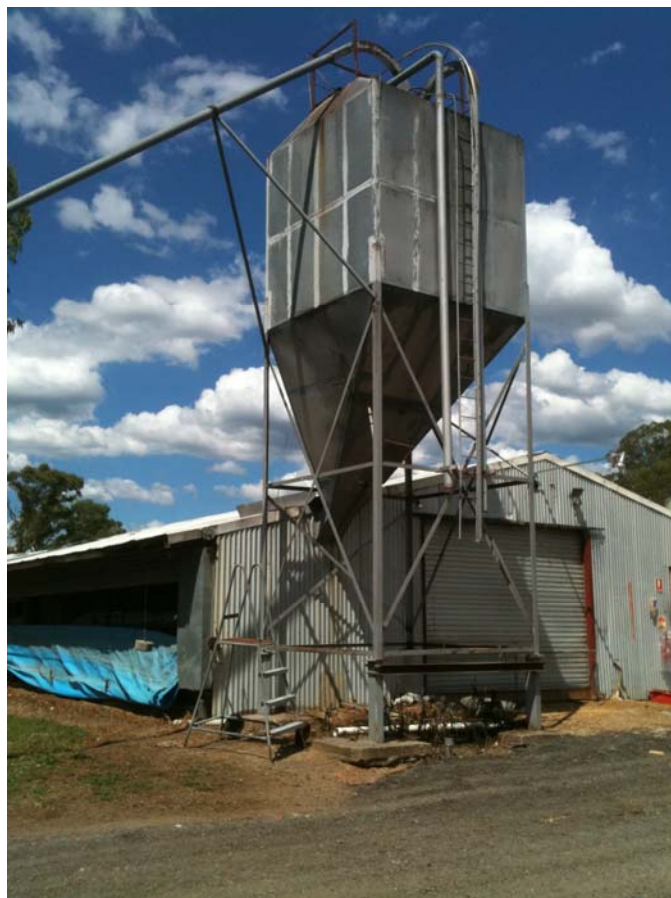
**Fig. 1.5 Feed hopper**

Feed is supplied to the ducks via steel hoppers, as shown in Fig. 1.5. The hoppers are supported by four concrete pad footings.

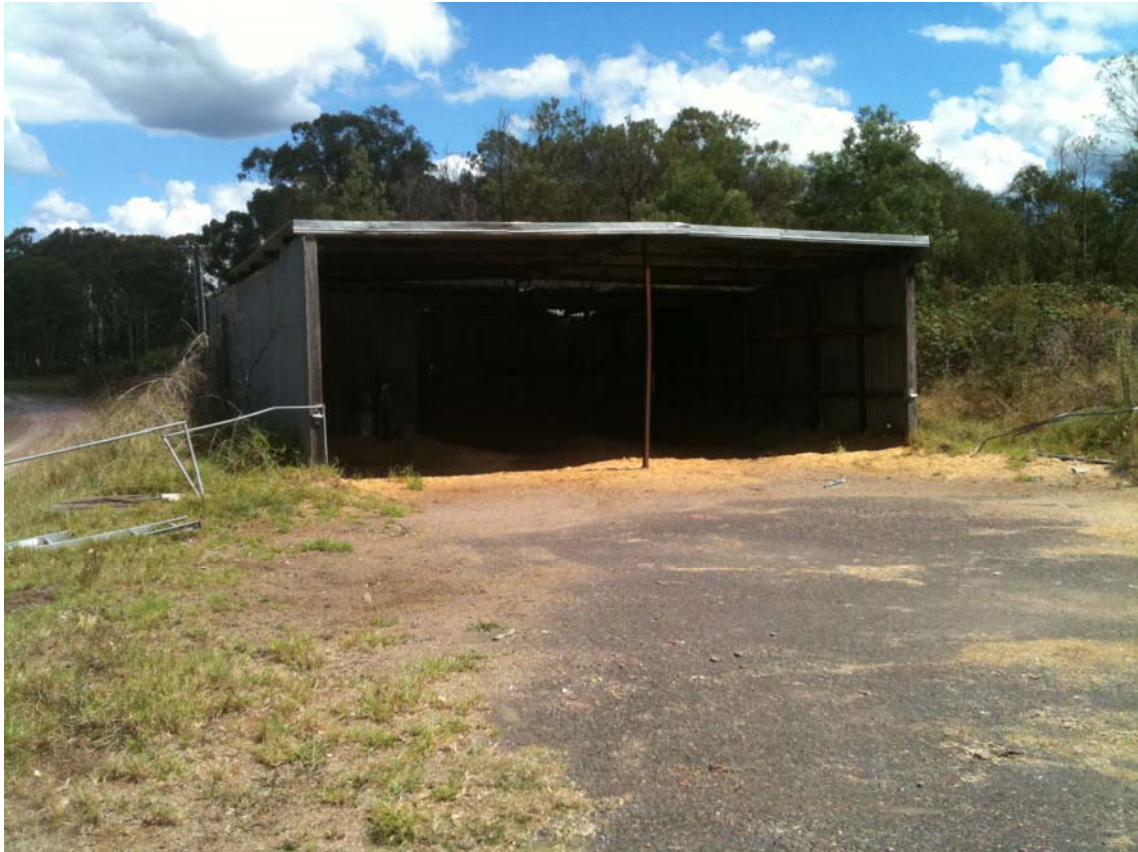
**Fig. 1.6 Small shed north of 3 duck sheds**

A number of small sheds and other buildings are located to the north and east of the duck sheds. These buildings are of light-weight construction and are shown in Fig. 1.6.

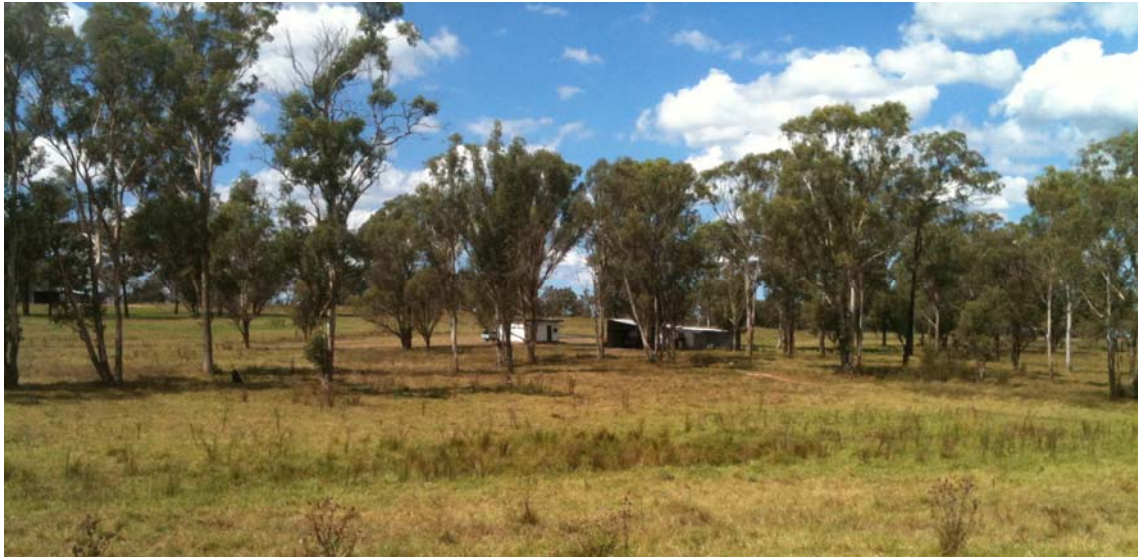
**Fig. 1.8 Sheds and building east of duck sheds**
