# Tahmoor Coal Pty Ltd 2020 ANNUAL REVIEW, AEMR AND REHABILITATION REPORT

**March 2021**

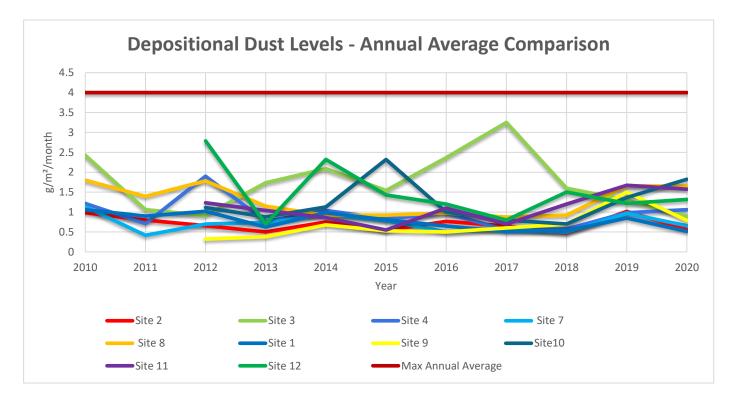
Figure 2 Depositional Dust Monitoring Annual Average Comparison

**Figure 2** indicates that there are no trends of concern occurring within depositional dust sites 1-12. In general, levels continue to fluctuate between an average of  $0.5 - 2.0 \text{ g/m}^2/\text{month}$ . Due to no significant changes to the scale and location of the mining operation, it is anticipated levels will continue within this range throughout 2021.

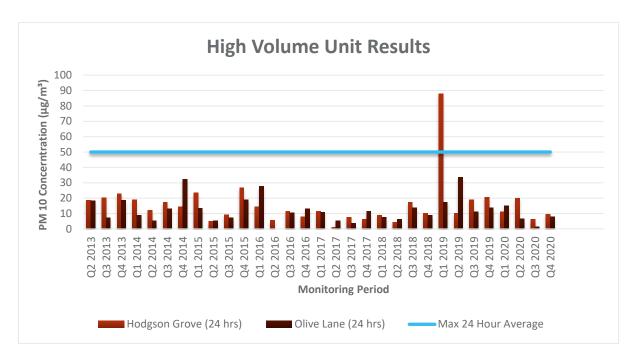
Figure 3 High Volume Air Quality Monitoring Results

In **Figure 3**, the historical high recorded in Q1 2019 was attributed to a localised dust event at Hodgson Grove (87.9  $\mu$ g/m³) that is not thought to be related to mining operations. During 2020, Hi vol results have remained low and well below our 24 hour Maximum Average Level of 50  $\mu$ g/m³.

**Figure 3** and **Figure 4** outline the results of the particulate matter (PM10) monitoring at Charlies Point Road, Olive Lane and Hodgson Grove in Tahmoor. PM10 particles have a diameter of 10 micrometers or smaller and are found in dust and smoke as a common air pollutant. Monitoring sites have been established since August 2013.

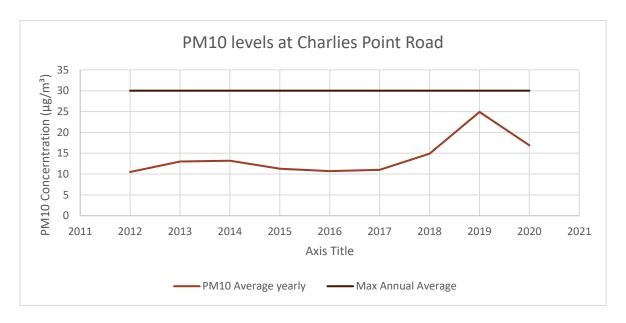
Figure 4 PM10 Annual Average

In **Figure 4**, bushfires and hazard reduction burns impacted on the air quality significantly during November and December 2019 causing a steep increase in the TEOM annual average but have considerably declined during 2020 forcasting to return to baseline levels during 2021. During 2020, PM10 results at Charlies Point Road have remained below our Maximum Annual average of  $30 \,\mu\text{g/m}^3$ .

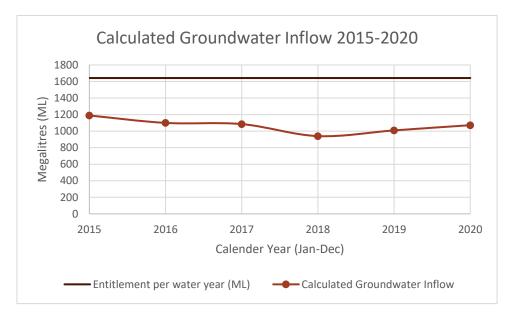
Figure 12 Calculated Groundwater Inflow Annual Volume (Calender Year)

Please note Tahmoor Coal have remained within groundwater extraction limits as per the water licence WAL36442 for 2020 (as shown in **Figure 12** above) and the water year FY20.

In addition, extra information has been provided above with the addition of 'Total Water to Underground' (Water sent from Tahmoor Coal's Recycle Water Treatment Plant and Sydney Water to underground workings), 'Calculated Groundwater inflow' ('Calculated inflow' euqals 'Total from' less 'Total to' the mine workings) and 'Total water loss from Underground' (includes vented moisture and water entrained in ROM material extracted).

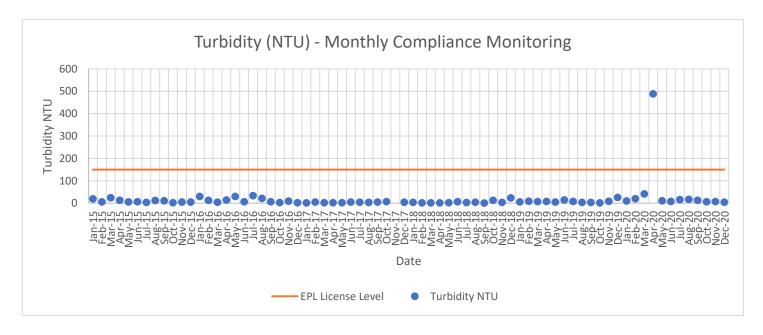
Figure 16 Monthly Compliance Monitoring of Turbidity at LDP1 from 2015-2020.

<sup>\*</sup>Exceedance in April 2020 atributed to Turbid Water discharge incident

The EPL 1389 states maximum discharge limits for alalytes discharged via LDP1, these results are provided in Table 18-4 for the reporting period. The water quality trend for LDP1 is outlined in Figures 13 to Figure 19 and shows relatively consistent results from monthly data in the last 5 years of monitoring.

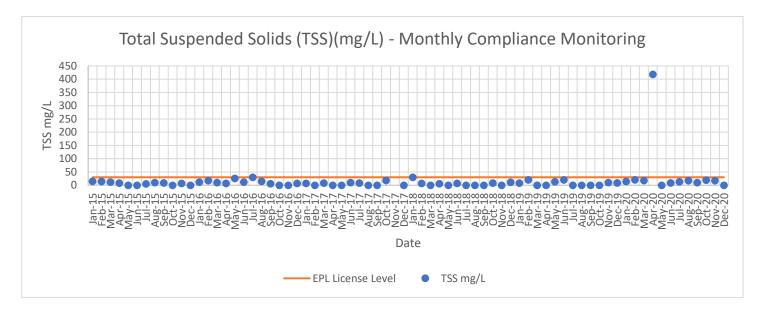
Figure 17 Monthly Compliance Monitoring of Total Suspended Solids at LDP1 from 2015-2020.

<sup>\*</sup>Exceedance in April 2020 atributed to Turbid Water discharge incident

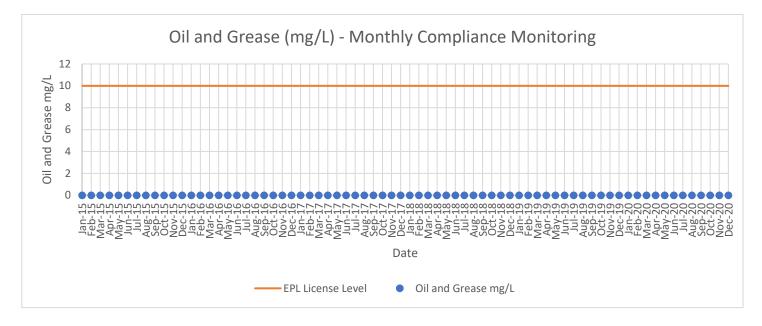
Figure 19 Monthly Compliance Monitoring of Oil and Grease at LDP1 from 2015-2020.

Note results have been consistently <5 mg/L every month.

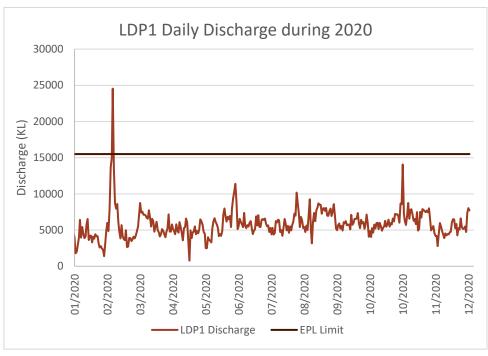
Figure 20 Daily Discharge (kL) via LDP1

<sup>\*</sup>The spike in February 2020 is attributed to a rainfall high event.

On average Tahmoor Mine discharged 5,819 kL/day with a total of 2,129,625 kL or approximately 2,130 ML discharged during the reporting period. This is shown in Table 18-5, Figure 20 and Figure 21. The peak in Table 20 in February 2020 was as a result of heavy rainfall. This is in accordance as per EPL 1389 (more than 10 mm rainfall in 24 hrs, recorded from Tahmoor Coal's Pit Top weather station).

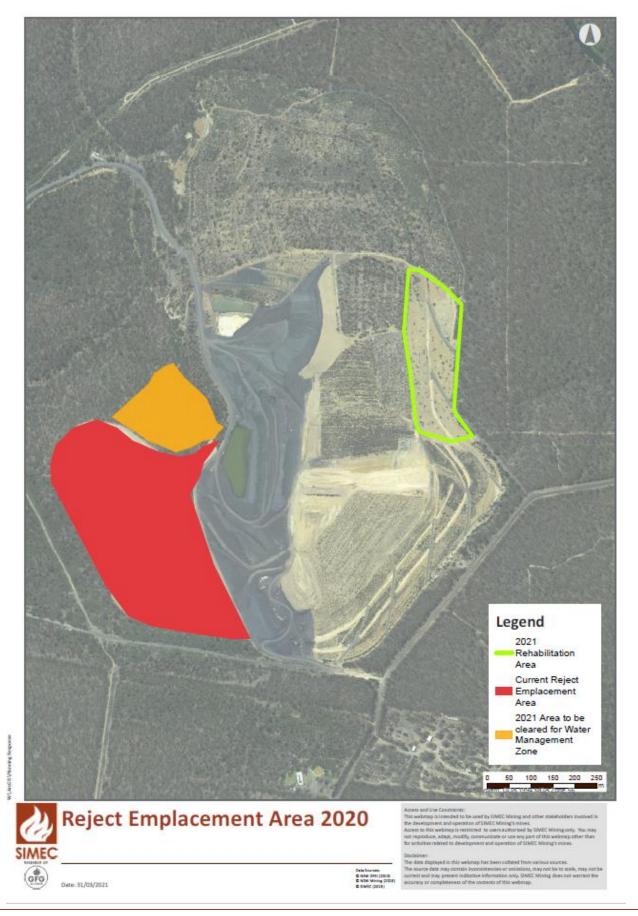
Figure 22 Reject Emplacement Area 2020 Progress and 2021 proposed works.

Figure 22 demonstrates future rehabilitation works planned for commencement during 2021 however no rehabilitation works were completed during 2020. Current Emplacement is taking

place within the red section shown in Figure 22 and clearance works are planned for 2021 within the orange section, for further details see **Appendix 11**.

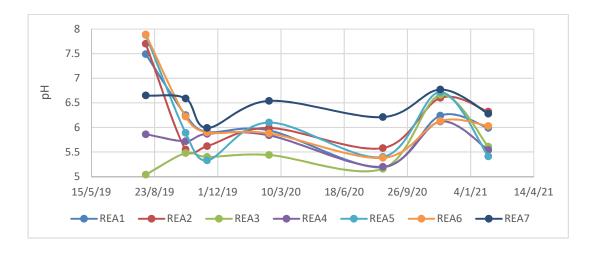
рН	REA1	REA2	REA3	REA4	REA5	REA6	REA7
9/8/19	7.49	7.7	5.04	5.86	7.88	7.89	6.65
11/10/19	6.25	5.55	5.48	5.72	5.89	6.22	6.59
14/11/19	5.91	5.62	5.4	5.87	5.33	5.9	5.99
20/2/20	5.94	5.99	5.44	5.84	6.1	5.88	6.54
18/8/20	5.19	5.58	5.16	5.2	5.4	5.38	6.21
17/11/20	6.24	6.6	6.66	6.12	6.72	6.13	6.77
1/2/21	5.99	6.32	5.61	5.54	5.41	6.03	6.28
Min	5.19	5.55	5.04	5.2	5.33	5.38	5.99
Max	7.49	7.7	6.66	6.12	7.88	7.89	6.77
Median	5.99	5.99	5.44	5.84	5.89	6.03	6.54

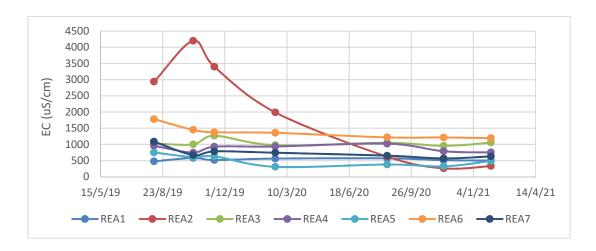
EC	REA1	REA2	REA3	REA4	REA5	REA6	REA7
9/8/19	477	2940	1030	958	750	1780	1084
11/10/19	583	4200	1000	747	608	1450	672
14/11/19	519	3400	1270	930	634	1377	787
20/2/20	563	1992	976	936	309	1358	744
18/8/20	570	623	1050	1024	380	1218	653
17/11/20	515	262	956	790	323	1215	568
1/2/21	502	333	1055	754	490	1193	632
Min	477	262	956	747	309	1193	568
Max	583	4200	1270	1024	750	1780	1084
Median	519	1992	1030	930	490	1358	672
