Mine Operations Plan

Tahmoor Colliery

MINE OPERATIONS PLAN

(MOP) - Amendment G

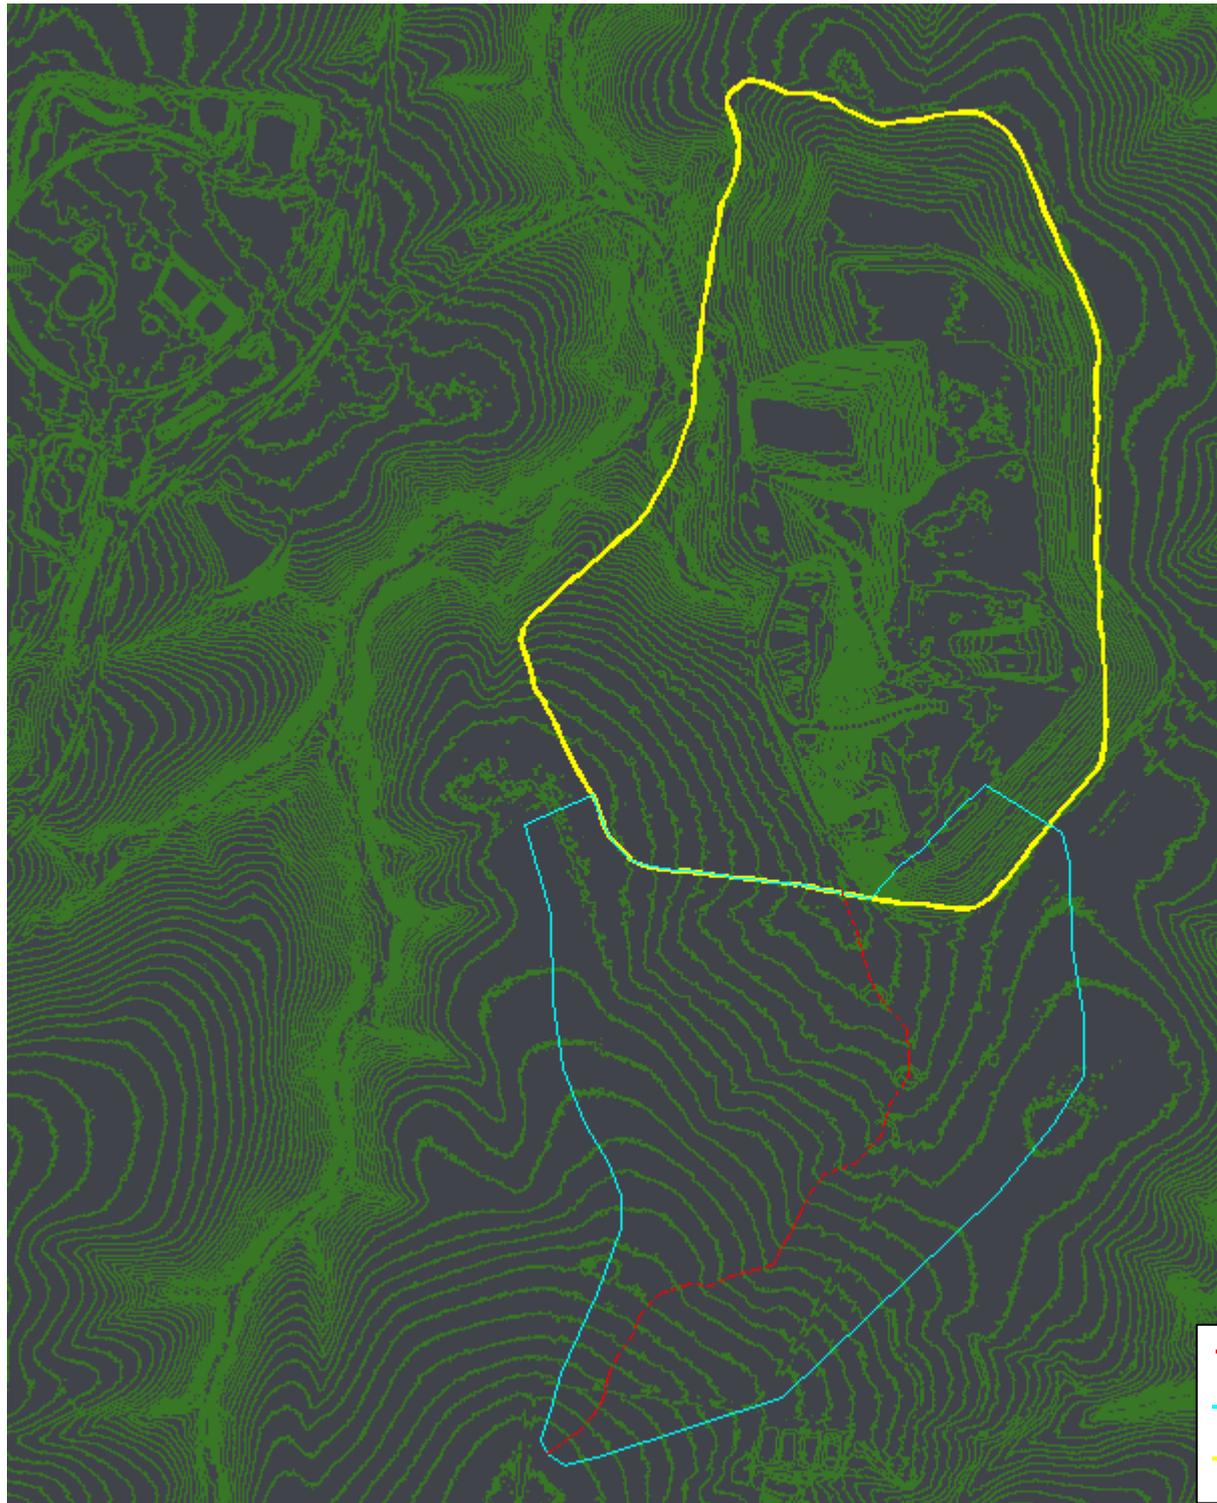
- Clean drainage:
 - Catchment: Area = 61.33ha of which is 100% grassed. See shape in figure below.
 - Overland concentrated flow time = 34mins (based on average flow velocity = 0.6m/s)
 - Flow path = 1215m with an average slope of 2.44%.
 - Horton roughness $n = 0.3$
 - $Q_{100} = 5.15\text{m}^3/\text{s}$
 - Critical storm duration = 6hrs

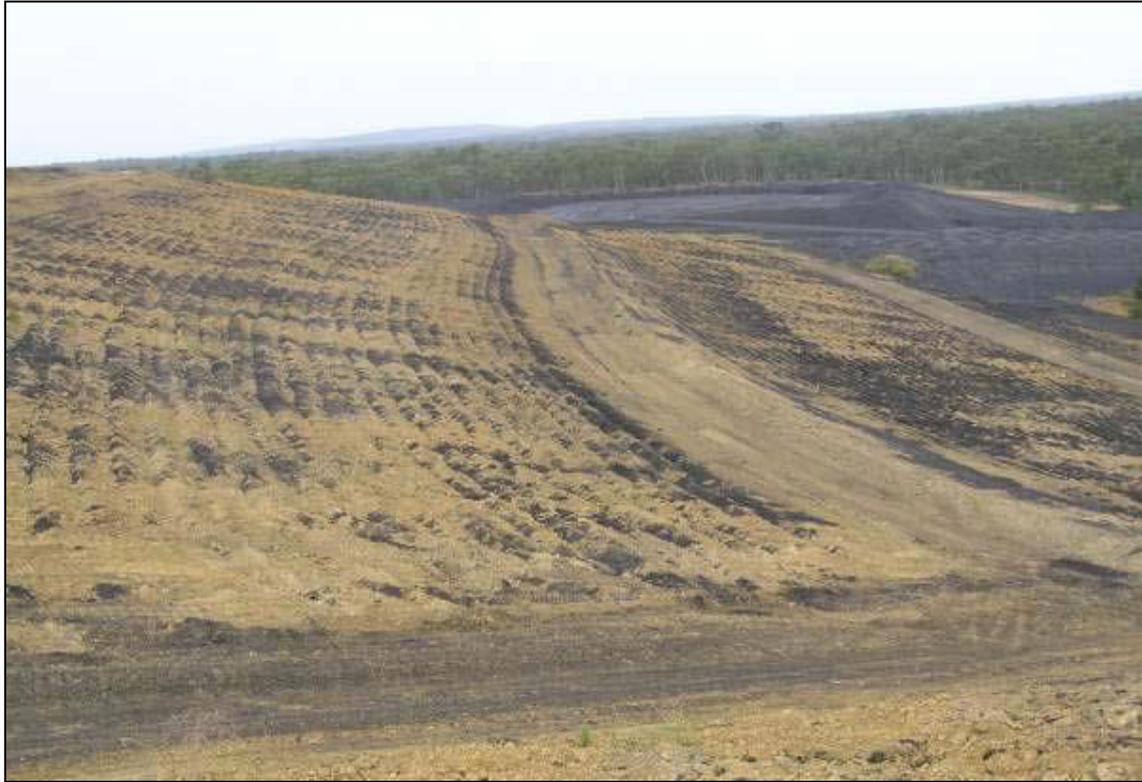
Figure 1 Examples of contour ripping and graded banks

Prior to topsoiling and seeding the REA rehabilitation site, the underlying material (reject or subsoil) is to be contour ripped down to the first graded bank to between 400 and 500mm depth. This method is shown in Figure 1 below and is undertaken in this sequence to avoid reject material being brought to the surface.

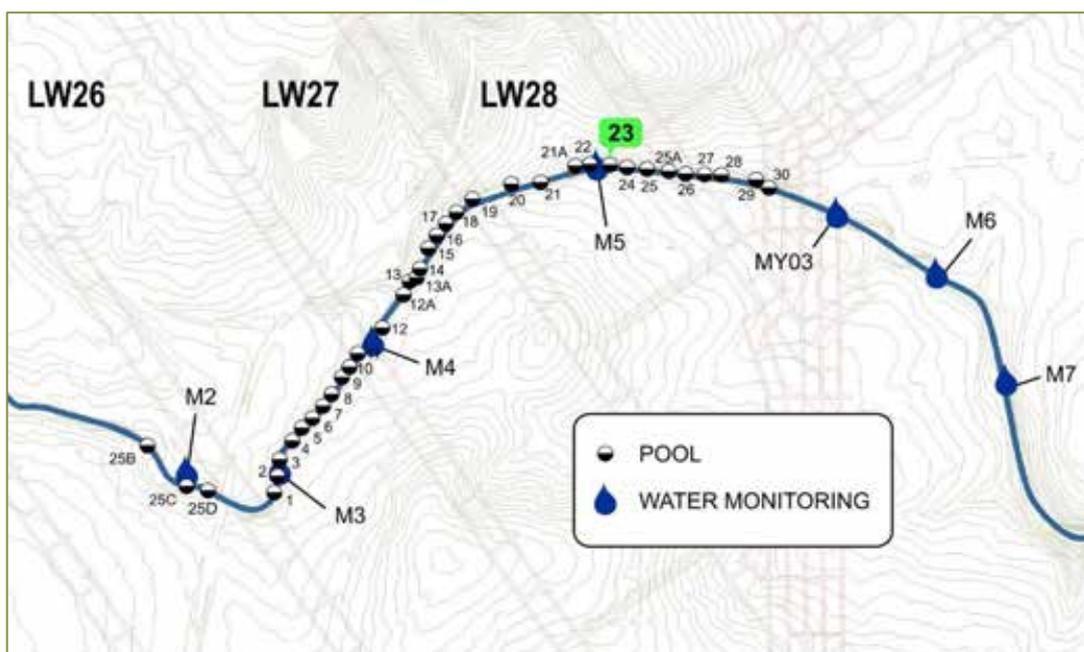
Figure 1 Initial site characterisation at sites along Myrtle Creek

The site characterisation in the Myrtle Creek CMAP Trial Project will include a hydrological assessment of key hydrological controls for the length of the impacted reach of Myrtle Creek, of which Site 23 is one. Initial site characterisation drilling will define the fracture network in detail at Site 23 and subject to site access constraints and further approvals, will define the fracture network at the other Myrtle Creek sites listed above.

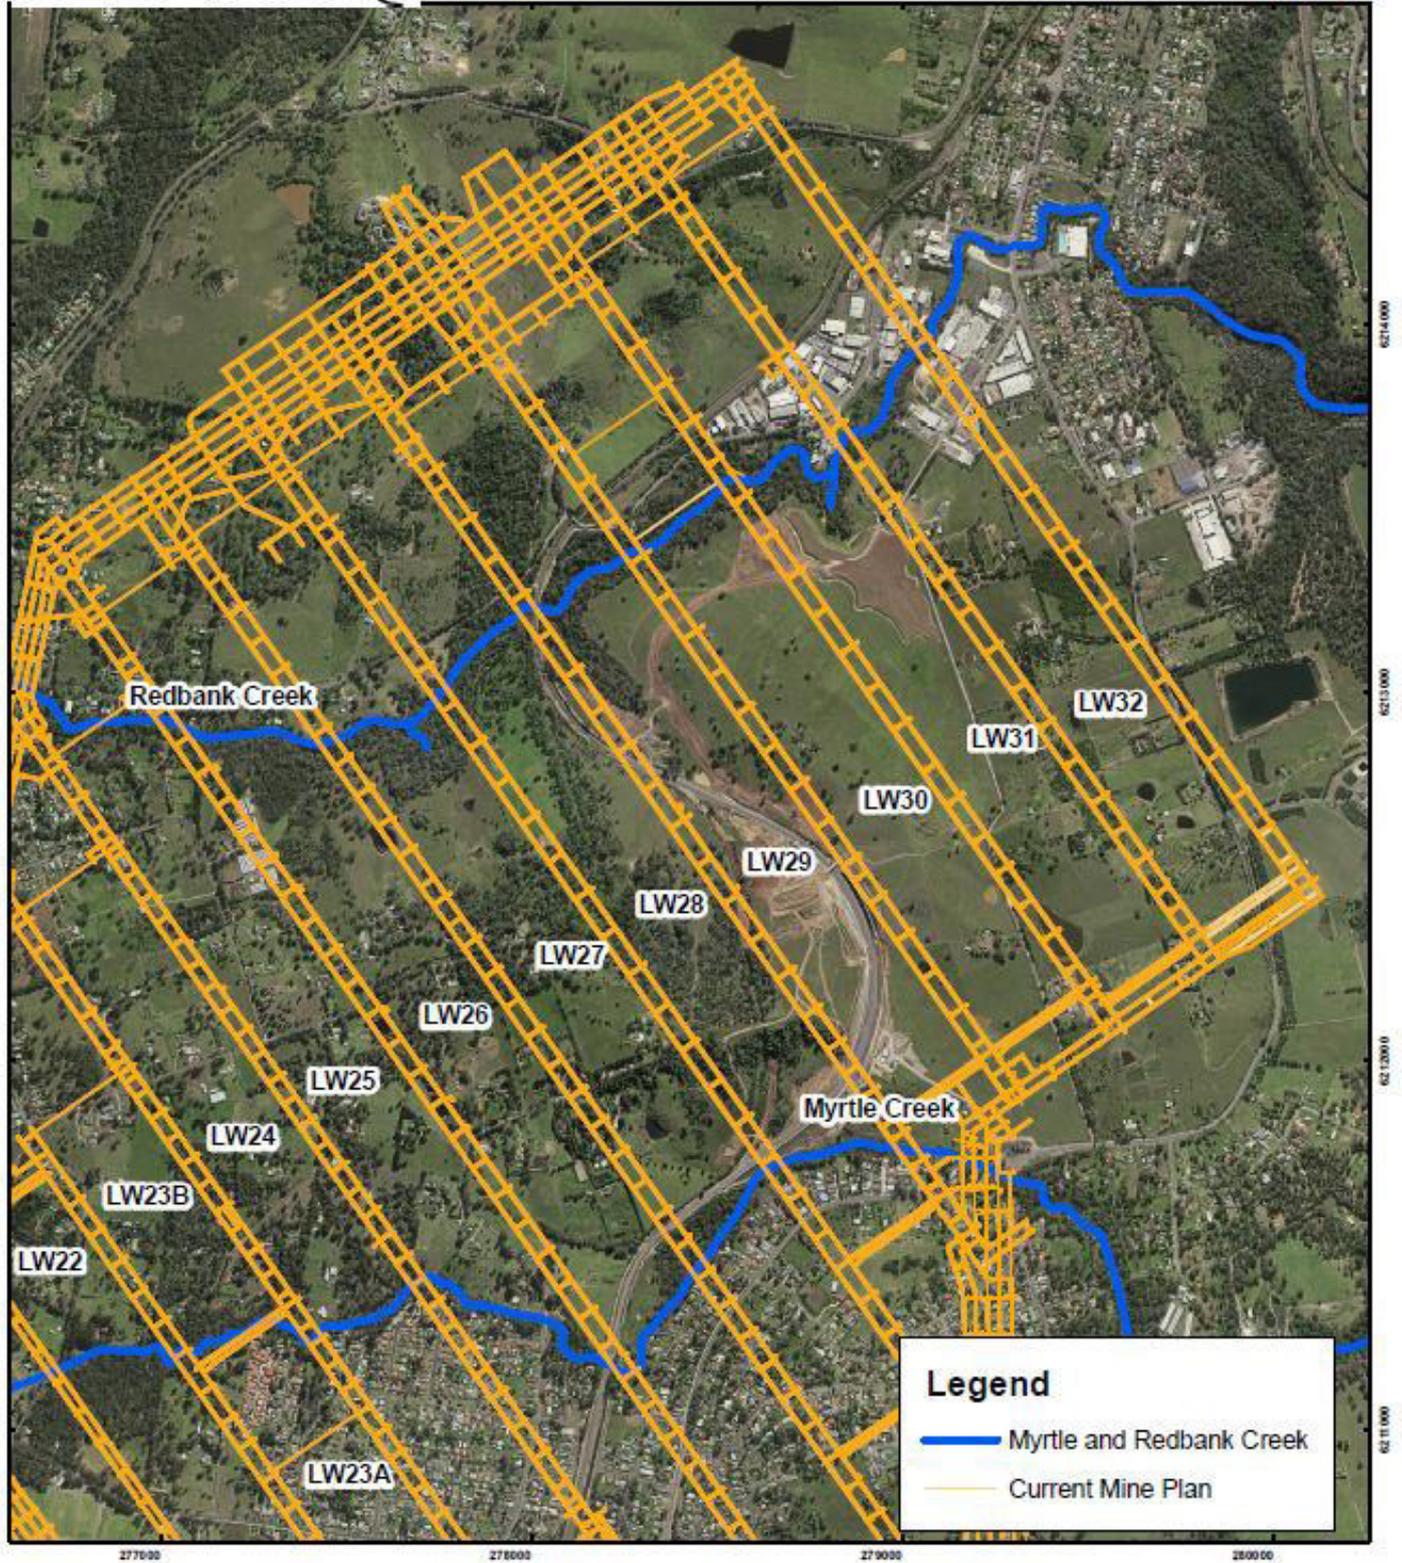
Figure 2 Myrtle and Redbank Creeks relative to Tahmoor Colliery mine plan

Myrtle Creek is a tributary of the Nepean River and its headwaters are located over Longwall 4, which is upstream of Longwall 22 as shown in **Figure 2**. It generally consists of small grass covered channels in its headwaters which become wider and more incised into the Hawkesbury Sandstone downstream of Longwalls 23 to 29.

Tahmoor Colliery's Longwalls 25 to 30 have directly extracted beneath Redbank Creek. The Creek is currently experiencing active subsidence movements from the continued extraction of Longwall 30 as shown in **Figure 2**. Longwall 31 and Longwall 32 will also extract directly beneath Redbank Creek. Mine subsidence movements will continue at Redbank Creek until extraction of Longwall 31 is completed. This is scheduled to occur in the middle to end of 2019.

Seam thickness varies from 1.8m at the finish end of Panel 24B / Panel 25 up to 2.15m in Longwall 29. Longwalls 22 to 29 are 283m wide rib to rib, with 34.5m to 40m wide chain pillars, cut-throughs at 100m centres and the Longwalls were from 771 - 3, 730m long as shown in **Figure 2**.

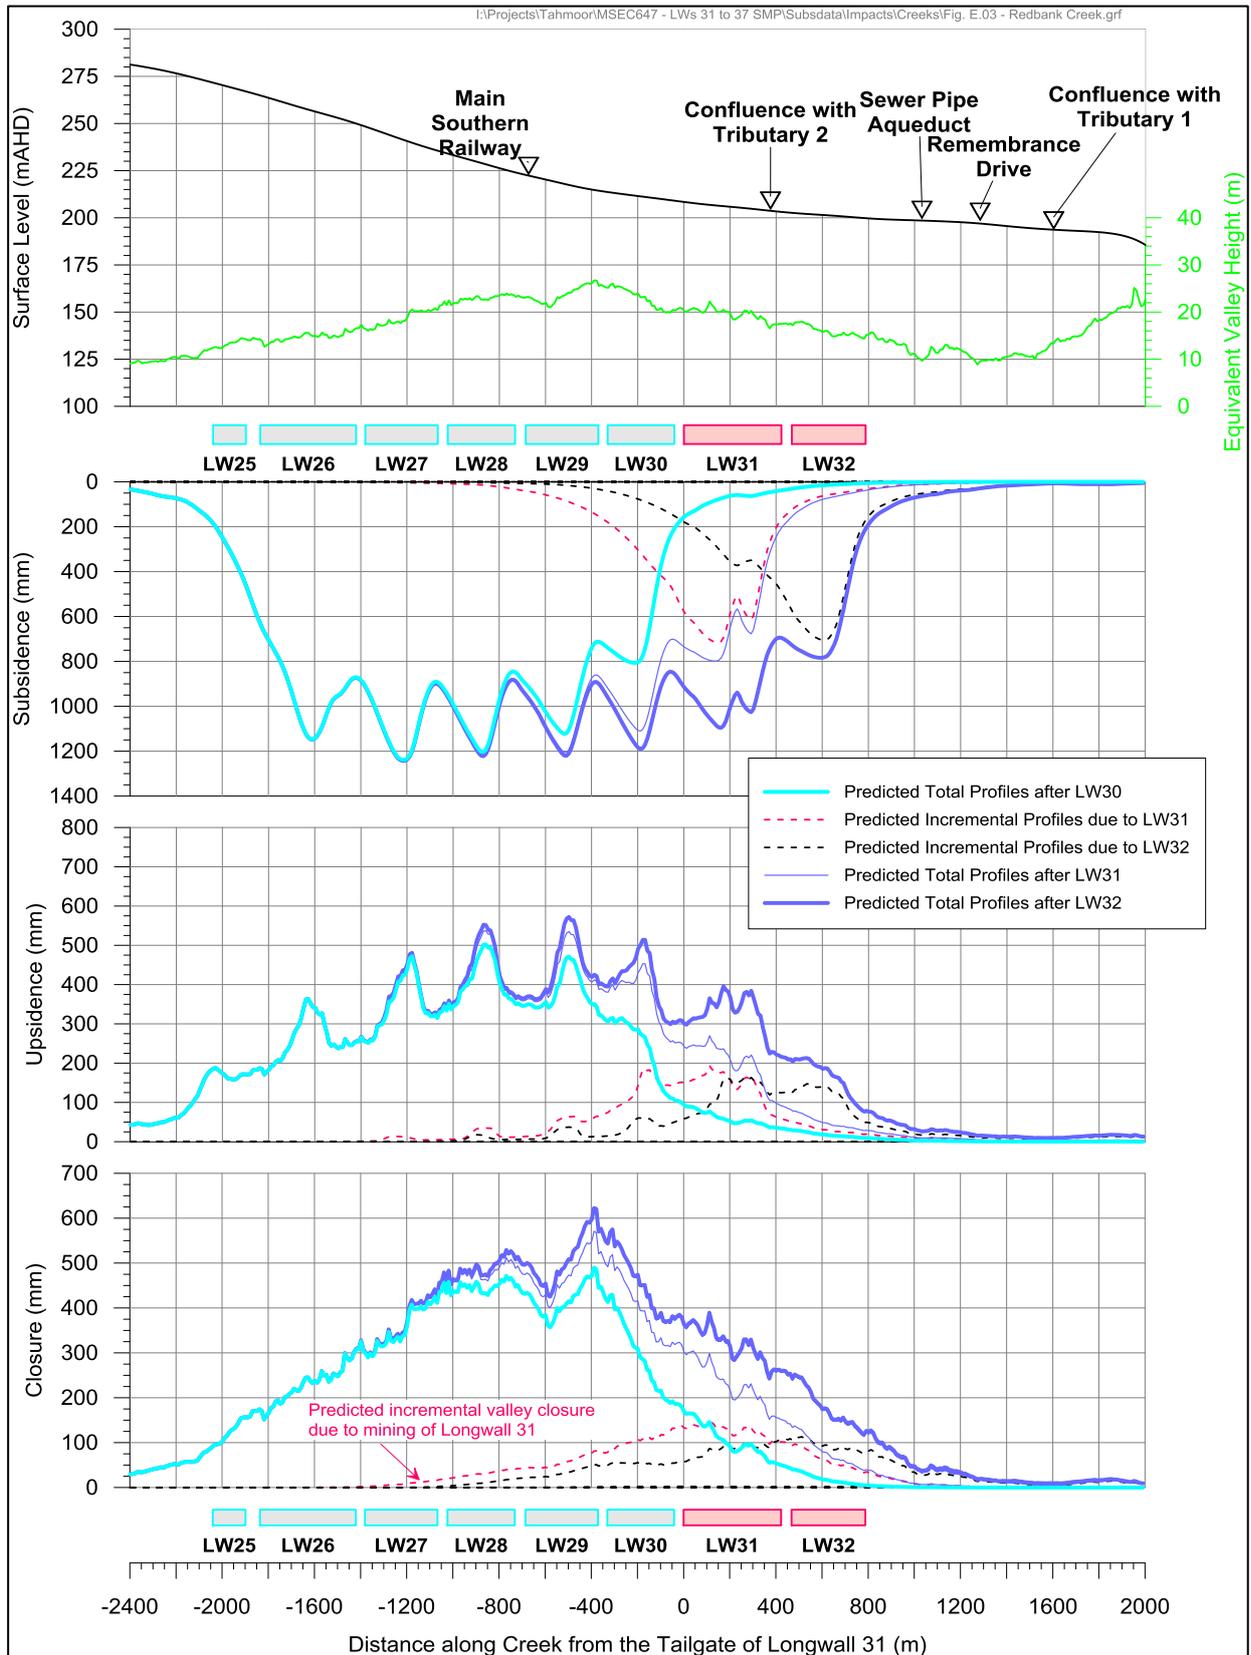
Figure 3 Predicted subsidence, upsidence and valley closure along Redbank Creek due to the mining of LW's 22 to 32

Predictions of subsidence, upsidence and valley closure along Redbank Creek due to the extraction of Longwall 31 and Longwall 32 were provided in Report No. MSEC647, which was prepared in support of Tahmoor Colliery's SMP Application for Longwalls 31 to 37. The predictions are shown in **Figure 3** below, with the predicted incremental subsidence, upsidence and closure due to the extraction of Longwall 31 highlighted in red.

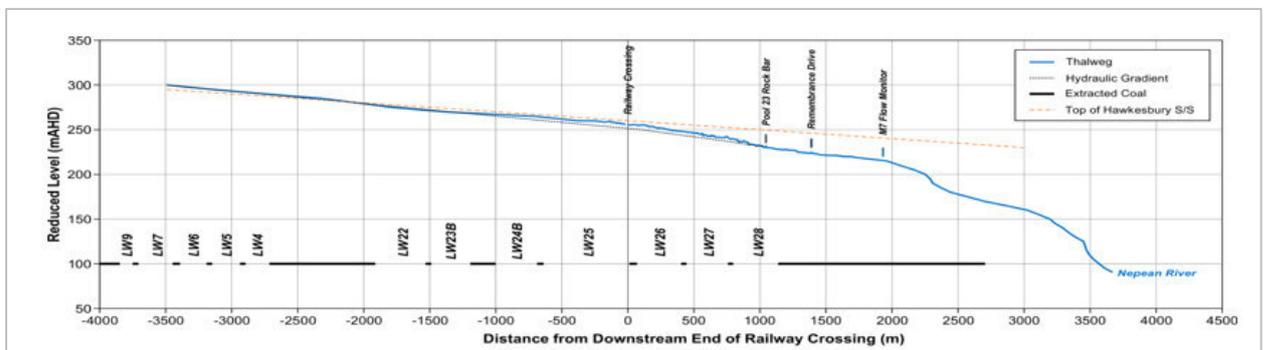
Figure 9 Myrtle Creek thalweg survey

The average stream gradient varies along the length of Myrtle Creek from about 13mm/m (1.3%) upstream of the railway crossing, to 21mm/m (2.1%) over the section of interest between the railway crossing and Remembrance Drive and about 60-75mm/m (6-7.5%) downstream of Remembrance Drive to the Nepean River.

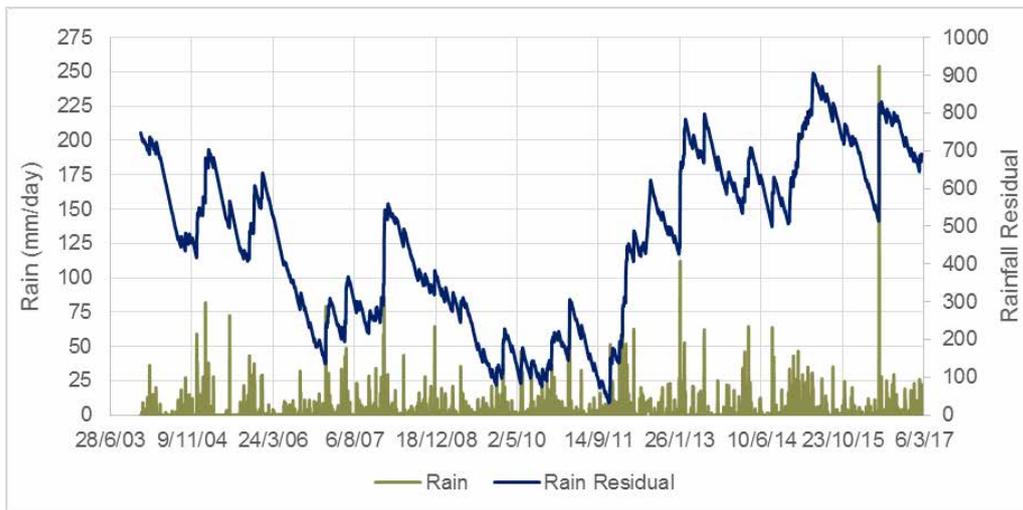
Figure 11 Rainfall residual plot

Rainfall has been monitored at Tahmoor Colliery pit top since January 2004, with the rainfall residual plot shown in **Figure 11** indicating an overall rainfall reduction up to November 2011, followed by a rising trend up to March 2013, then an essentially flat trend, although impacted by storm and extended dry periods, up to the present.

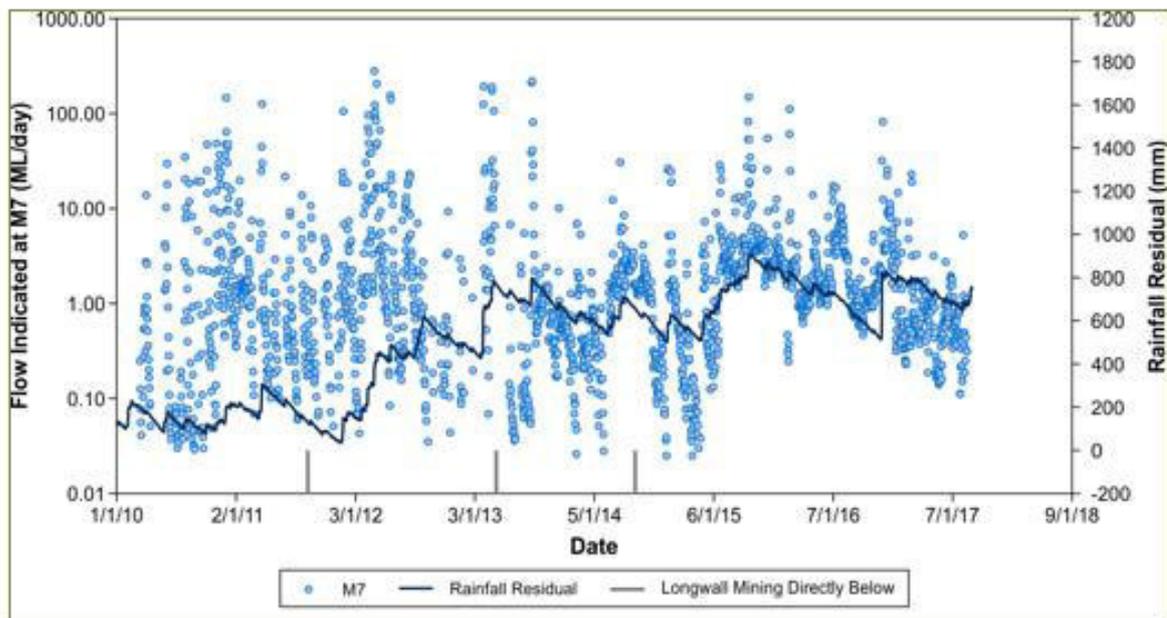
Figure 12 Myrtle Creek flow at M7 and rainfall residual

Figure 12 shows a summary of the flow indicated at the M7 monitoring station and the rainfall residual. The location of Longwalls that underlie Myrtle Creek are also shown.

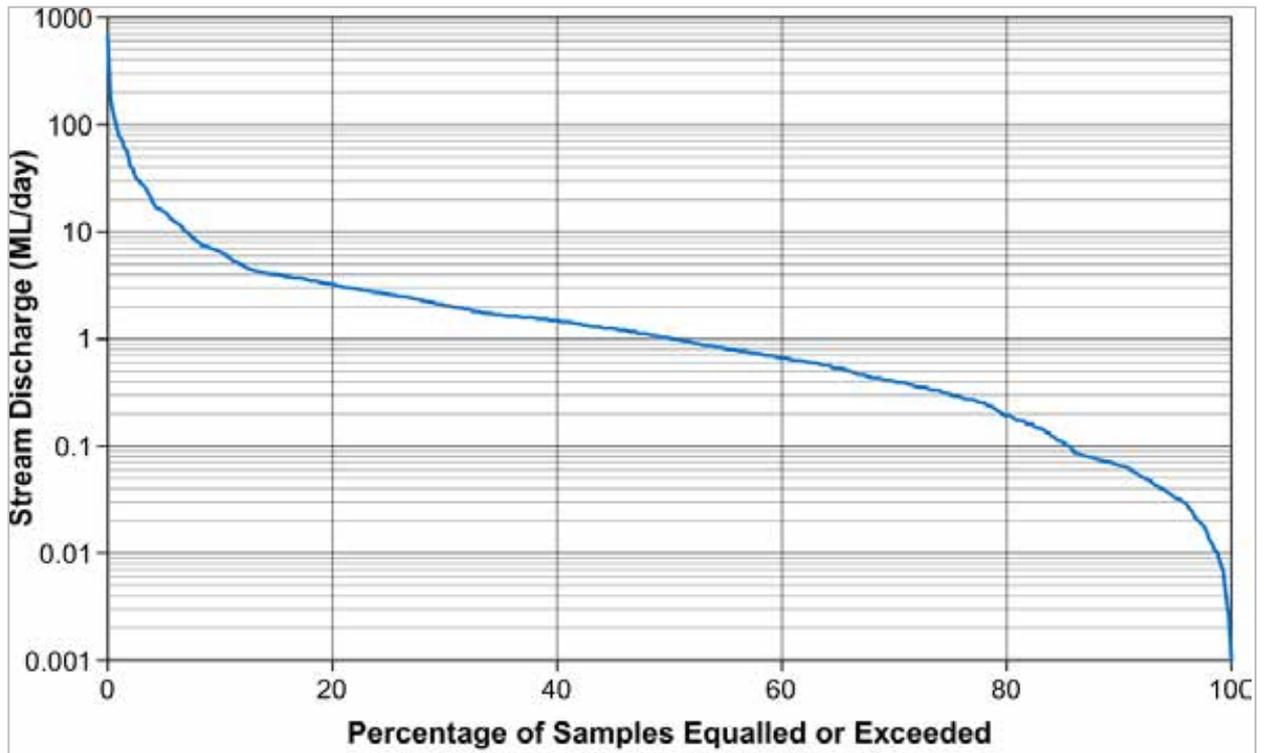
Figure 13 Myrtle Creek time weighted stream discharge duration curve

Figure 13 shows the time weighted stream discharge duration curve based on the M7 monitoring results. This curve demonstrates the period of time that flow in the creek is greater than indicated for any given flow rate. The dataset includes periods when the flow estimates may be on the low side due to damage to the flow monitoring system and periods when the station was not able to accurately monitor flood peaks.

The flow in Myrtle Creek at M7 is indicated as being 1ML/day at least 50% of the time and greater than 0.4ML/day at least 70% of the time. At the location of interest, these values are decreased by about 12-25% based on catchment area. Flow in the section of Myrtle Creek of interest is therefore

estimated to be 0.8ML/day or greater at least 50% of the time and 0.3ML/day or greater at last 70% of the time.

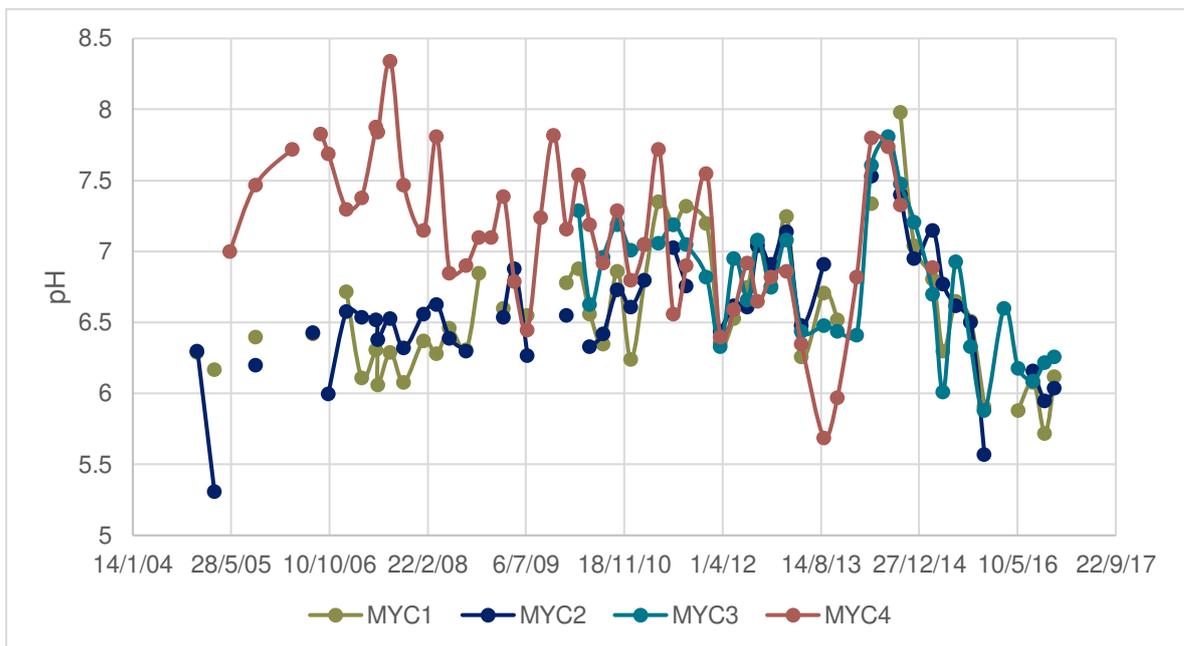
Figure 16 Myrtle Creek monitoring – pH

MYC1 is located upstream of MYC2, with MYC3 and MYC4 being located progressively downstream as shown in **Figure 6**. Myrtle Creek has an electrical conductivity (EC) range from 125 to 2630uS/cm, with pH between 5.31 and 8.34. Myrtle Creek becomes mildly more alkaline and slightly more saline with flow downstream as shown in **Figure 16**.

During the Longwall 28 mining period, the Myrtle Creek pH trended to being slightly more alkaline then became more acidic at all four (4) monitoring sites, whilst salinity peaked at around 2070uS/cm at MYC3 (approximately 285m downstream of Longwall 28) and at MYC4.

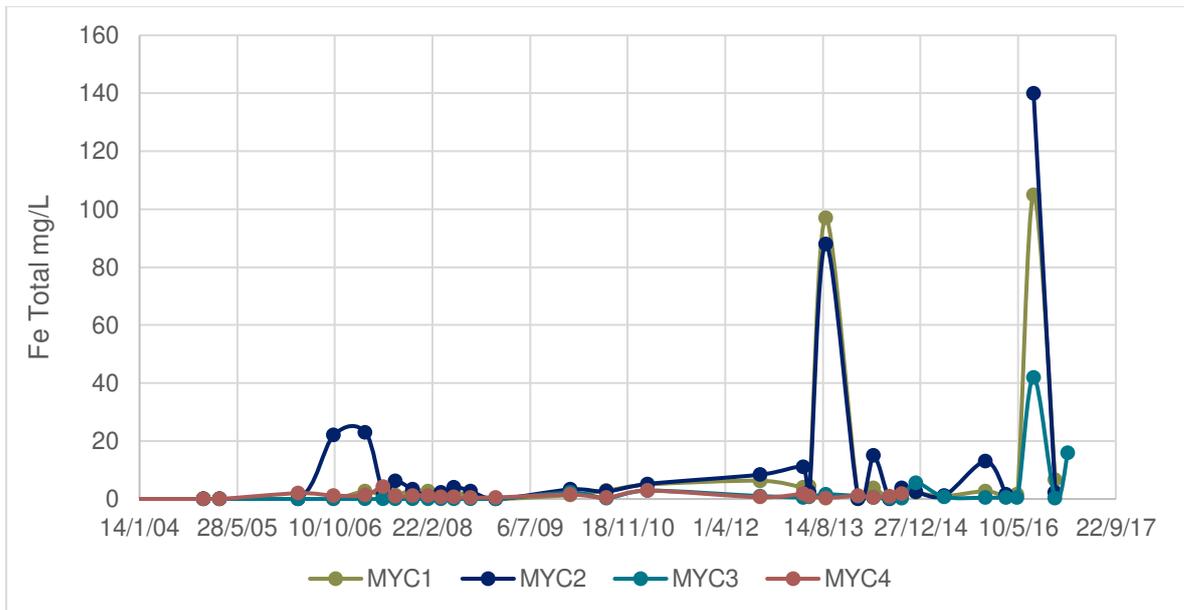
Figure 18 Myrtle Creek monitoring – iron

Iron (Fe) and manganese (Mn) levels are generally not elevated in Myrtle Creek, apart from isolated occasions at MYC1 and MYC2 during extraction of Longwall 27, with no long term trend or increase over subsided areas as shown in **Figure 18** and **Figure 19**.

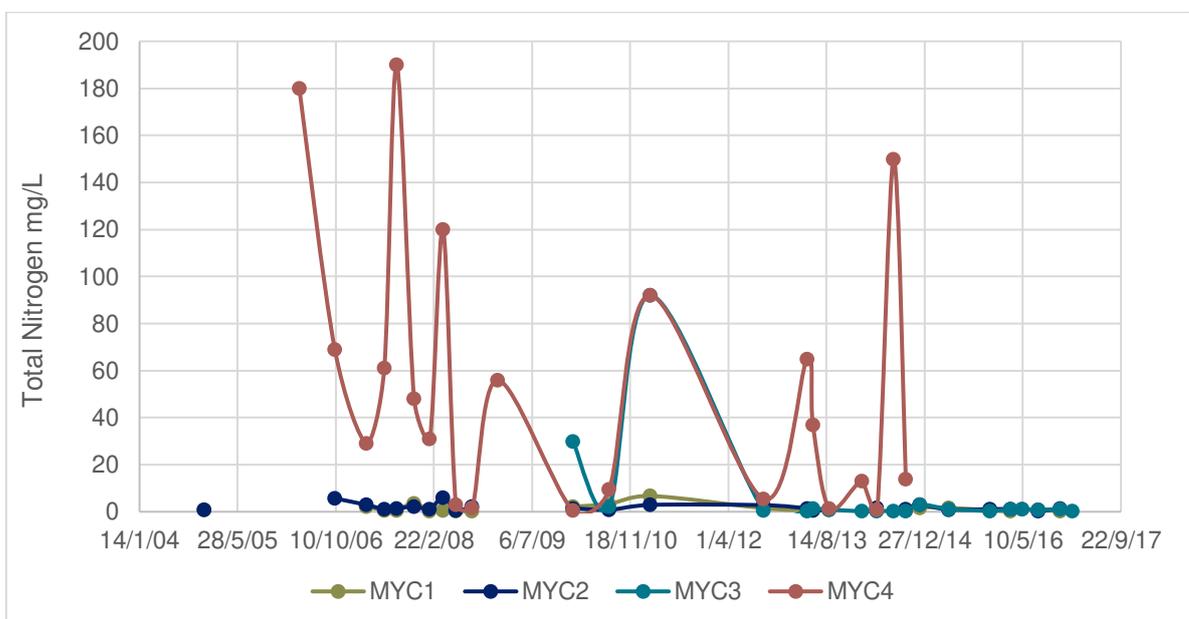
Figure 20 Myrtle Creek monitoring – nitrogen

Myrtle Creek can have total nitrogen up to 190mg/L and total phosphorous up to 30mg/L, which are above the ANZECC 2000 SE Australian Upland Stream criteria, generally at all water quality monitoring sites, but not at all times, as shown in **Figure 6**.

The above criteria nutrients are present due to urban and rural / residential runoff in the catchment from house gardens, market gardens, as well as properties with poultry and stock, along with leakage from sewers and are not related to mining influences.

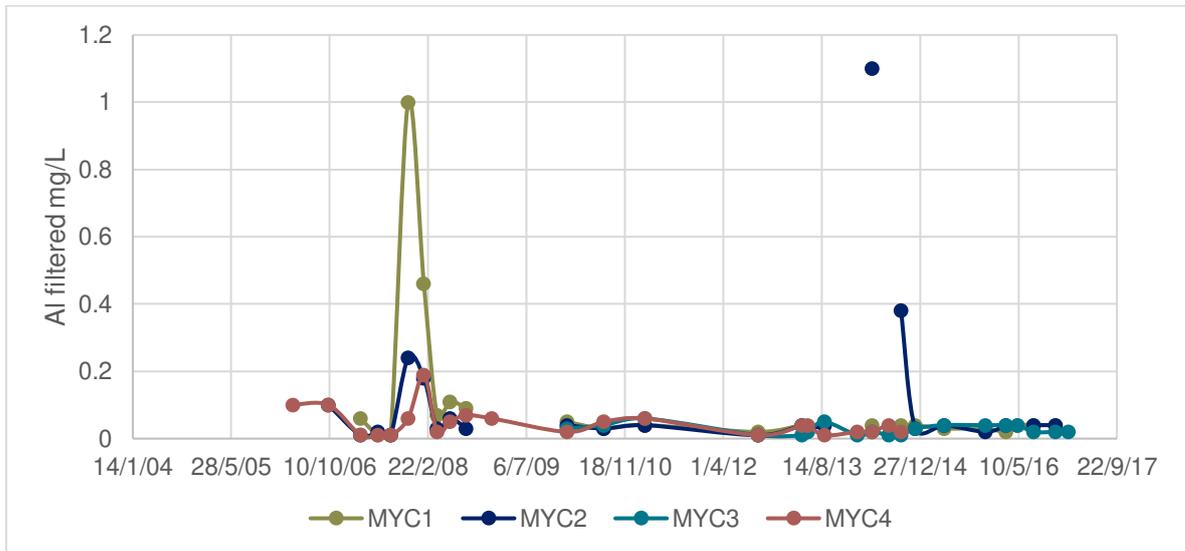
Figure 22 Myrtle Creek monitoring – aluminium

Myrtle Creek can also exceed the ANZECC 2000 trigger levels for filterable aluminium (<1.0mg/L), copper (<0.009mg/L) or zinc (0.027mg/L) at all sites, for variable times at each monitoring site. A notable increase in copper occurred at MYC2 (over the chain pillar between longwalls 24B and 25) and for zinc at MYC2 and MYC4 (approximately 1.5km downstream of Longwall 28) during the extraction period of Longwall 28 as shown in Figure 24.

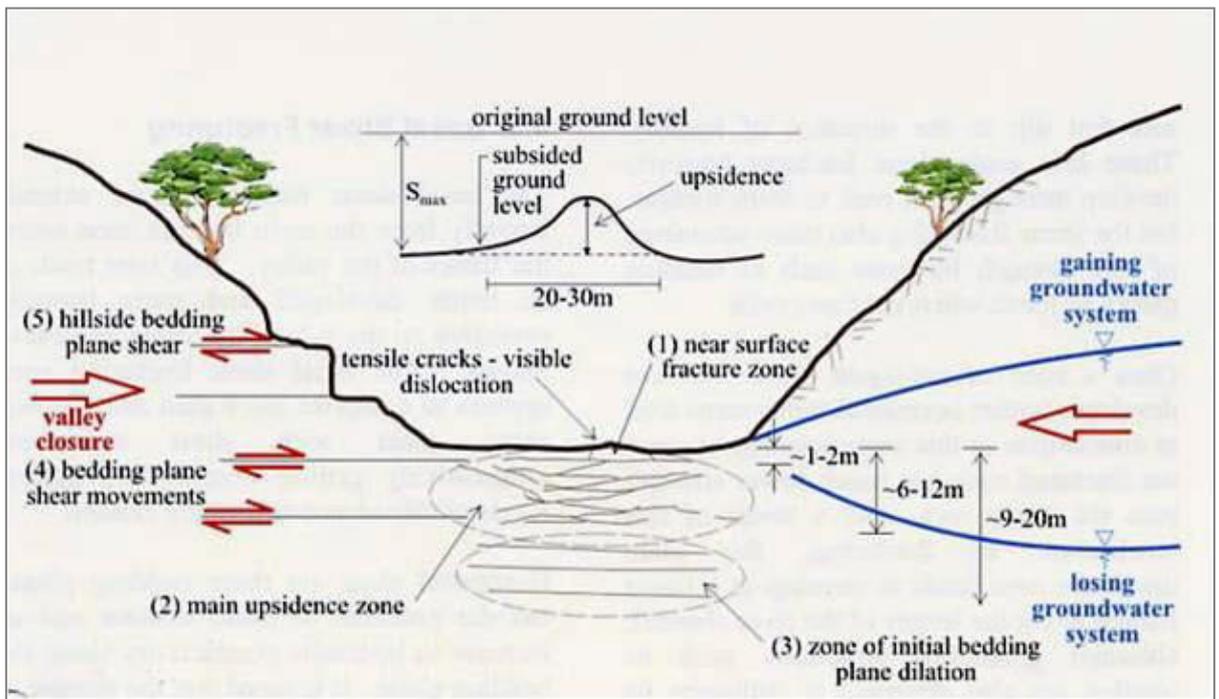
Figure 25 Idealised fracture network typical of that seen in the Waratah Rivulet

Figure 25 shows the distribution of the fracturing observed at a site in the Southern Coalfield of NSW impacted by valley closure of approximately 600mm (ACARP 2009). The fracture network was determined using a program of intensive drilling and borehole calliper logging.

A zone of intense fracturing is evident below the creek bed. This zone is typically evident to a depth of less than 6m, but has been observed to range up to about 12m below the surface at some sites. The intense fracturing is evident as open fractures of up to several hundred millimetres wide. These develop as low angle conjugate fractures to form wedges that lift the surface causing localised upward movement or upsidence directly above the zone of intense fracturing.

A basal shear plane extends outward from the base of the zone of intense fracturing on either side of the river channel. Shear on this basal plane enables horizontal movement of the valley sides' inward toward the creek to generate the zone of intense fracturing. Measurements at various sites indicate that basal shear planes are likely to follow bedding and may extend hundreds of metres either side of the valley. They may be formed as part of natural valley forming processes and are then remobilised by the dilation associated with mining subsidence.

Depending on the magnitude of valley closure, both the zone of intense fracturing and the basal shear plane have potential to be hydraulically conductive. At low flows, all the flow in the creek can flow through these fracture networks without appearing on the surface.

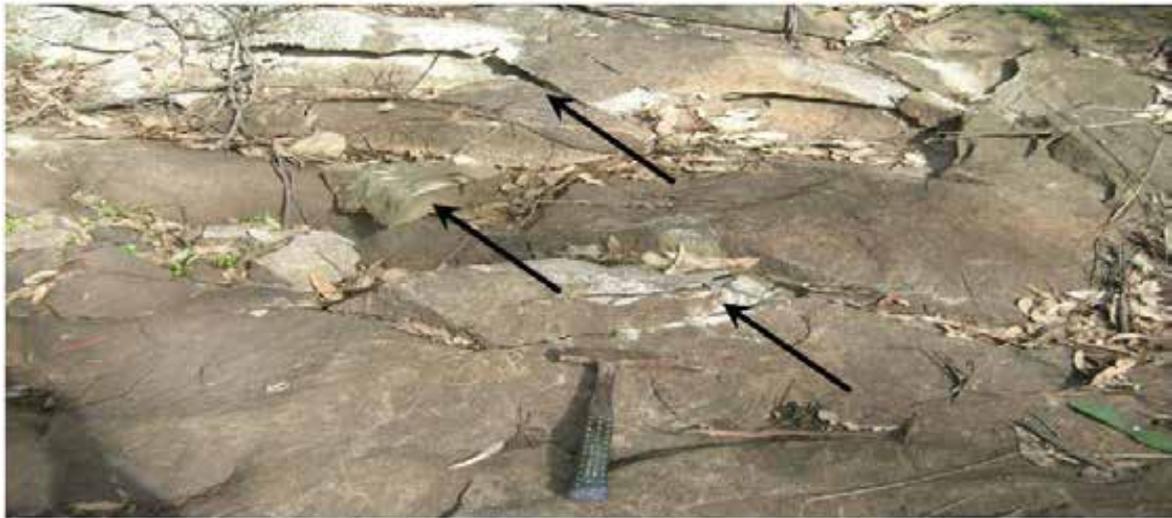
Figure 26 Myrtle Creek over LW22 – cracking

Figure 26 shows sandstone pool base cracking that developed over Longwall 22 after Longwall 23 undermined the creek.

The cracking was up to 10mm wide and limited to the base of the creek within a small rock bar over Longwall 22, whilst the soil cracking occurred at the southern end of Longwall 23B, close to the barrier pillar between Longwalls 23A and 23B.

The bedrock crack in the creek bed over Longwall 22 is within a small sandstone rock bar outcrop, with no observable adverse effect on stream flow, and therefore, no rehabilitation of the Longwall 22 cracking was proposed.

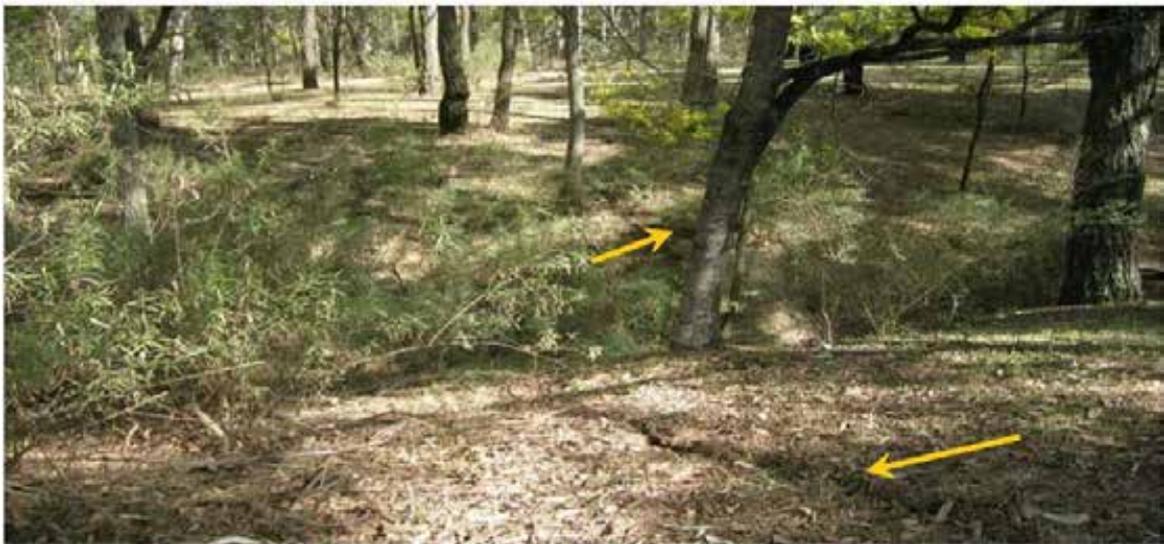
Figure 27 Myrtle Creek over LW23B – cracking

The soil crack over 23B was located close to the Longwall 23A and 23B barrier pillar. It was up to 65mm wide and extended into the soil to approximately 1.5m - 2.0m over an approximate length of 40m, however, it did not develop within the bed of Myrtle Creek, even though it was observed on both the upper banks and flank of the creek.

Even though soil cracking was noted in the creek over Longwall 23B, it did not instigate bed or bank instability and was not rehabilitated. No surface flow diversion, reduction in water quality or change to ponding or pool storage capacity was observed in the creek.

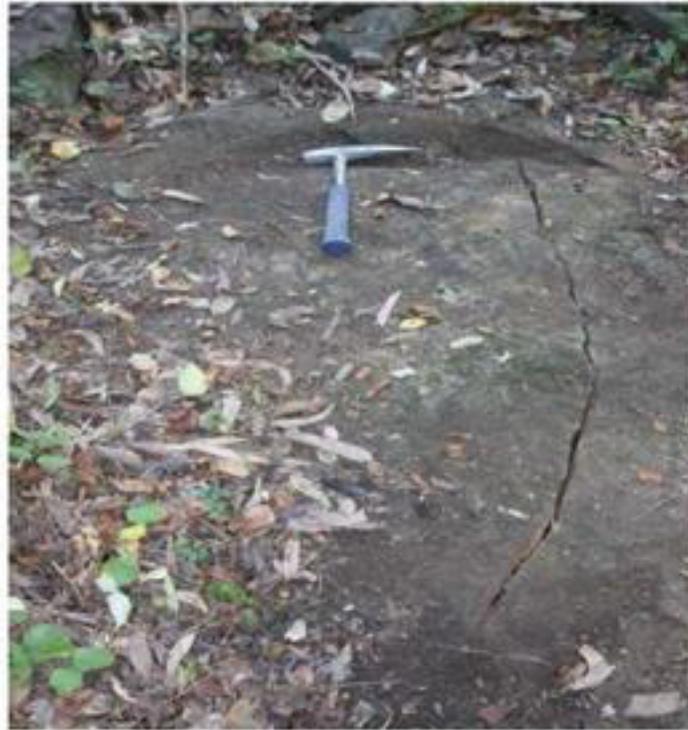
Figure 28 Myrtle Creek over LW25 – soil cracking

Three areas of isolated cracking of exposed sandstone in the base or sides of generally dry pools occurred after the completion of Longwall 25 as summarised in **Table 6** and shown in **Figure 28**, **Figure 29** and **Figure 30**.

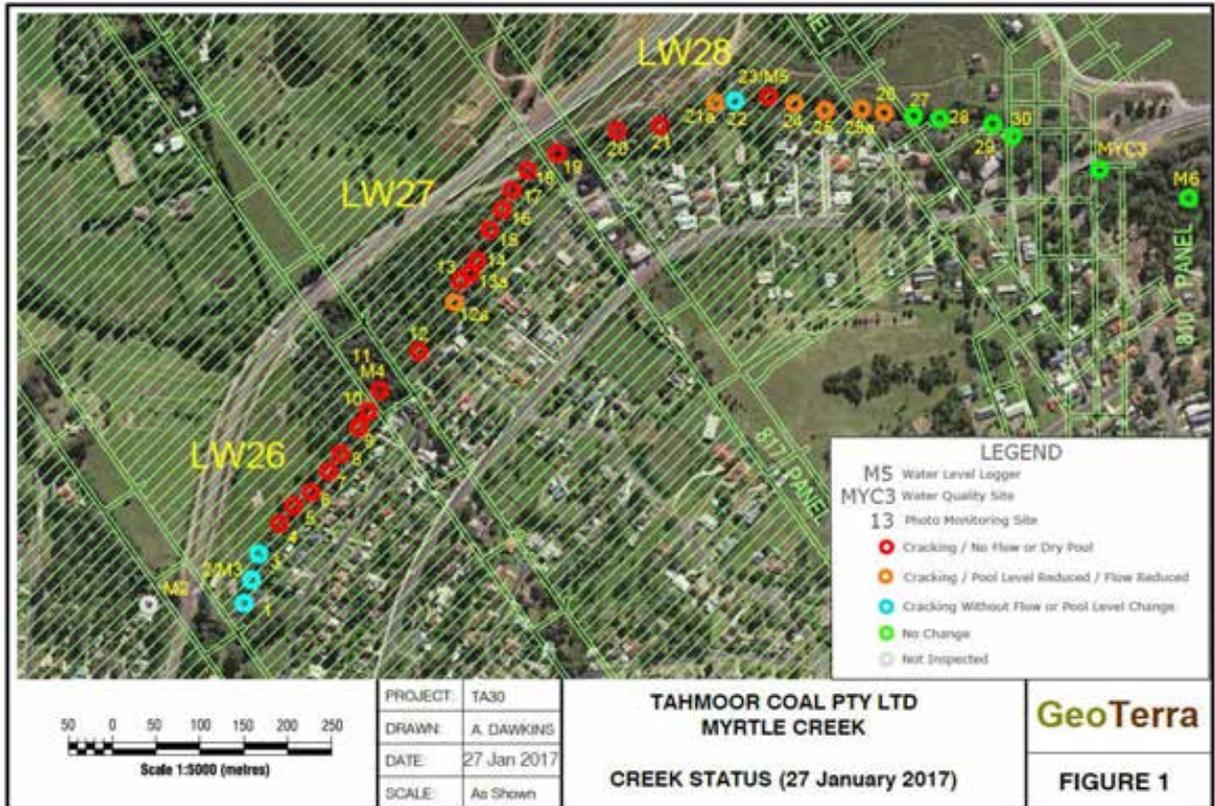
Figure 53 Myrtle Creek – bi-monthly Creek Status Report 27 January 2017

Figure 53 outlines Myrtle Creek bi-monthly Status for 27 January 2017, however the legend does not accurately represent Myrtle Creek as the inspection was completed after a storm event and the Creek was flowing from top to bottom.

Regular pool mapping was instigated within Myrtle Creek when Longwall 26 undermined the creek at identified rock bars, boulder fields, exposed Hawkesbury Sandstone rock shelves and their associated pools and has continued to the present day at sites shown in **Figure 53**.

- a) 5 to 9, over the central to maingate section of Longwall 26.
- b) Sites 9, 10 and 11 over the chain pillar between Longwall 26 and 27.
- c) Sites 12 to 19 over all of Longwall 27.
- d) Sites 20, 21 and 23, with less significant effects at Sites 21A to 28 over Longwall 28 as shown in **Figure 53**.

A summary of the observed subsidence effects during the period of Longwall 30 extraction is shown in the below **Figure 53**. Longwall 30 did not undermine the Myrtle Creek, although bi-monthly monitoring of monitoring and observation sites over Longwalls 26, 27 and 28 is currently being conducted during the period of longwall extraction.

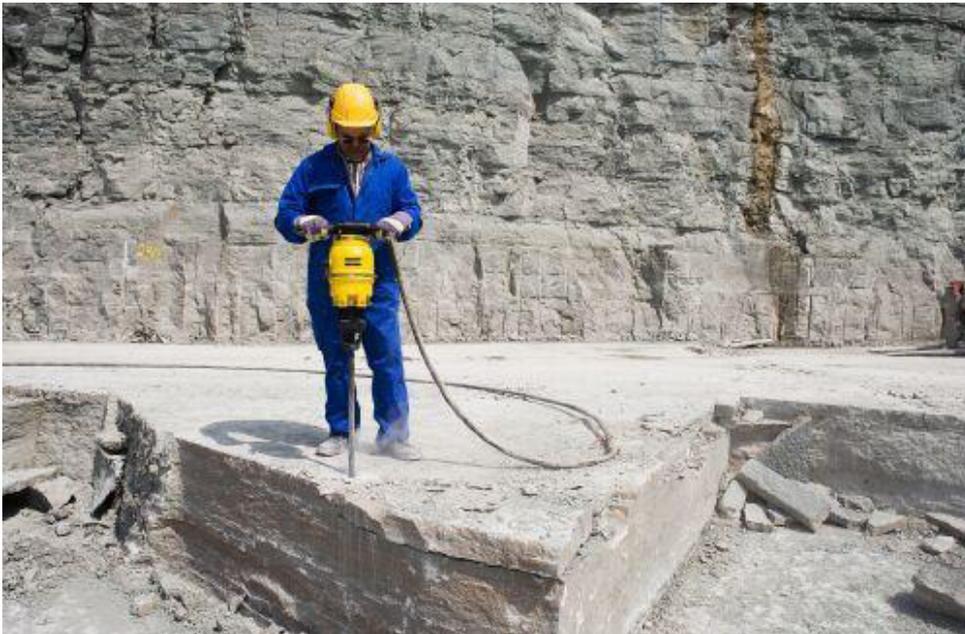
Figure 55 Pneumatic hand drill

- a) Mini track-mounted NMLC or open hole.
- b) Pneumatic hand drill - open hole.
- c) Percussion tube hand corer (soil).
- d) Geotechnical logging - rock mass characteristics.

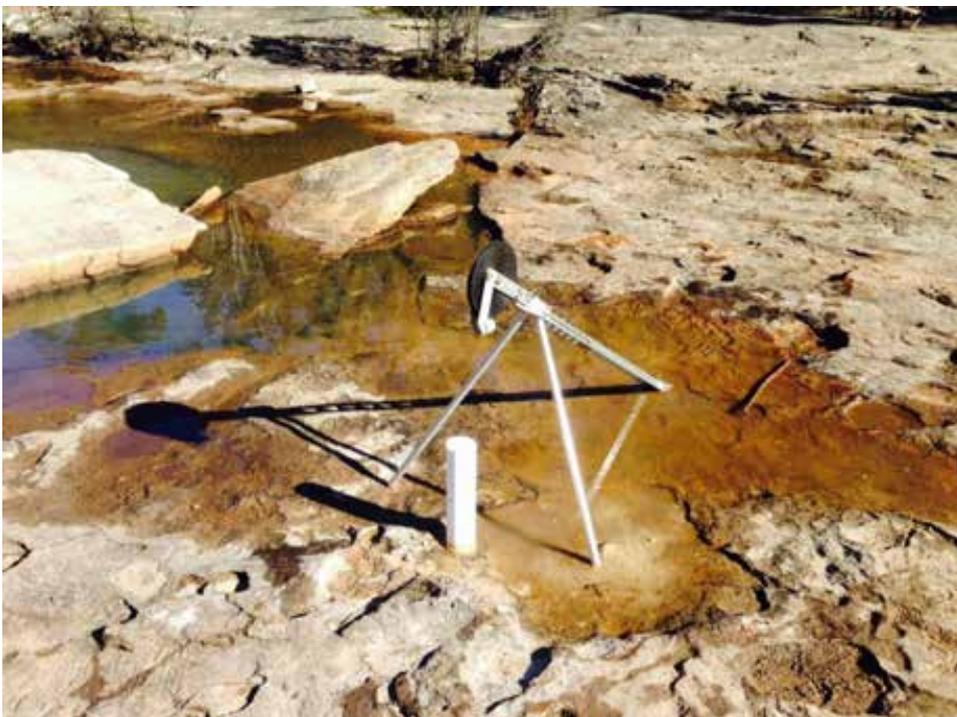
Figure 56 Three arm Caliper tool downhole

- a) Caliper Tool.
- b) ATV (Acoustic Televiewer).
- c) OTV (Optical Televiewer).
- d) Seismic Tomography and ERI (Electrical Resistivity Imaging).

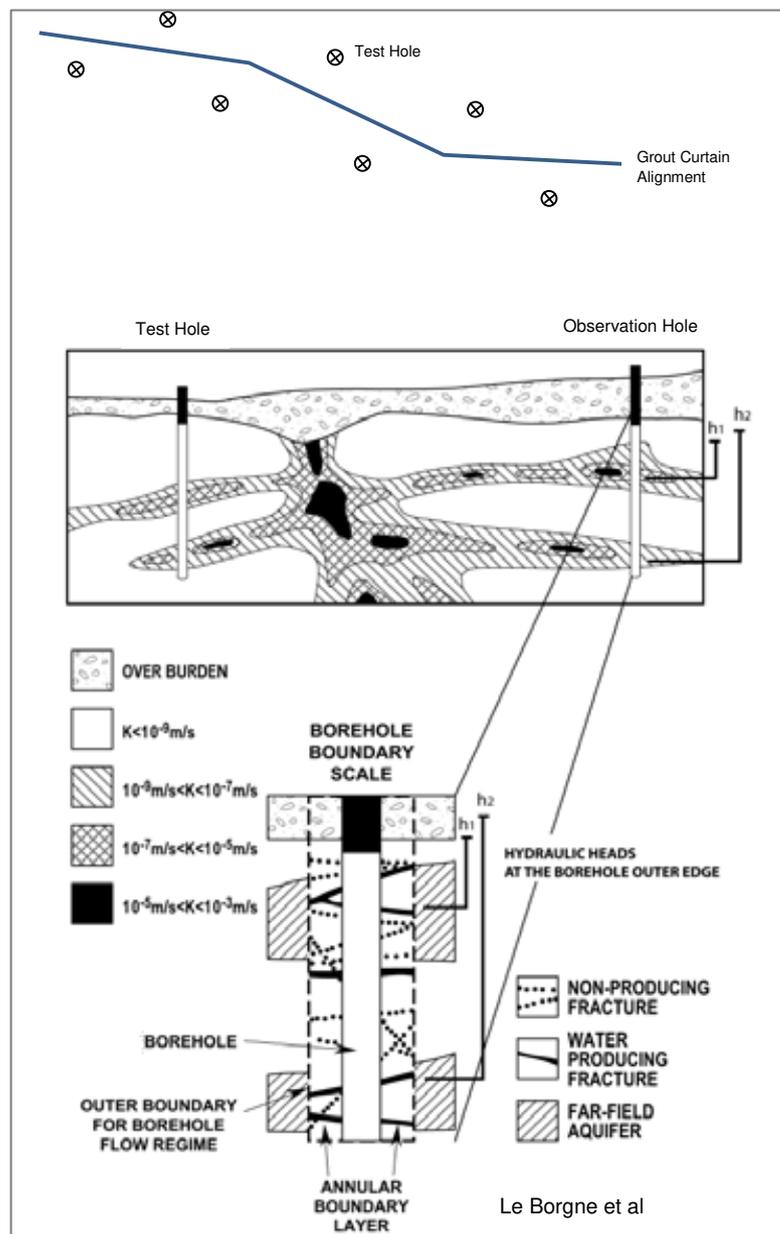
Figure 58 Schematic illustration of the site setup

Flow meter testing of ground characterisation holes and across holes estimate transmissivity of single fractures (instead of multiple fractures within a test interval as typical for water pressure testing) intersected by the holes and connectivity of the fractures between a set of holes. This technology is most suitable for testing of the achieved level of ground improvement when conducted pre and post grouting across holes located at either site of a treat section. A schematic illustration of the setup is shown in the figure below.
