Mine Operations Plan

Tahmoor Colliery

MINE OPERATIONS PLAN

(MOP) - Amendment G

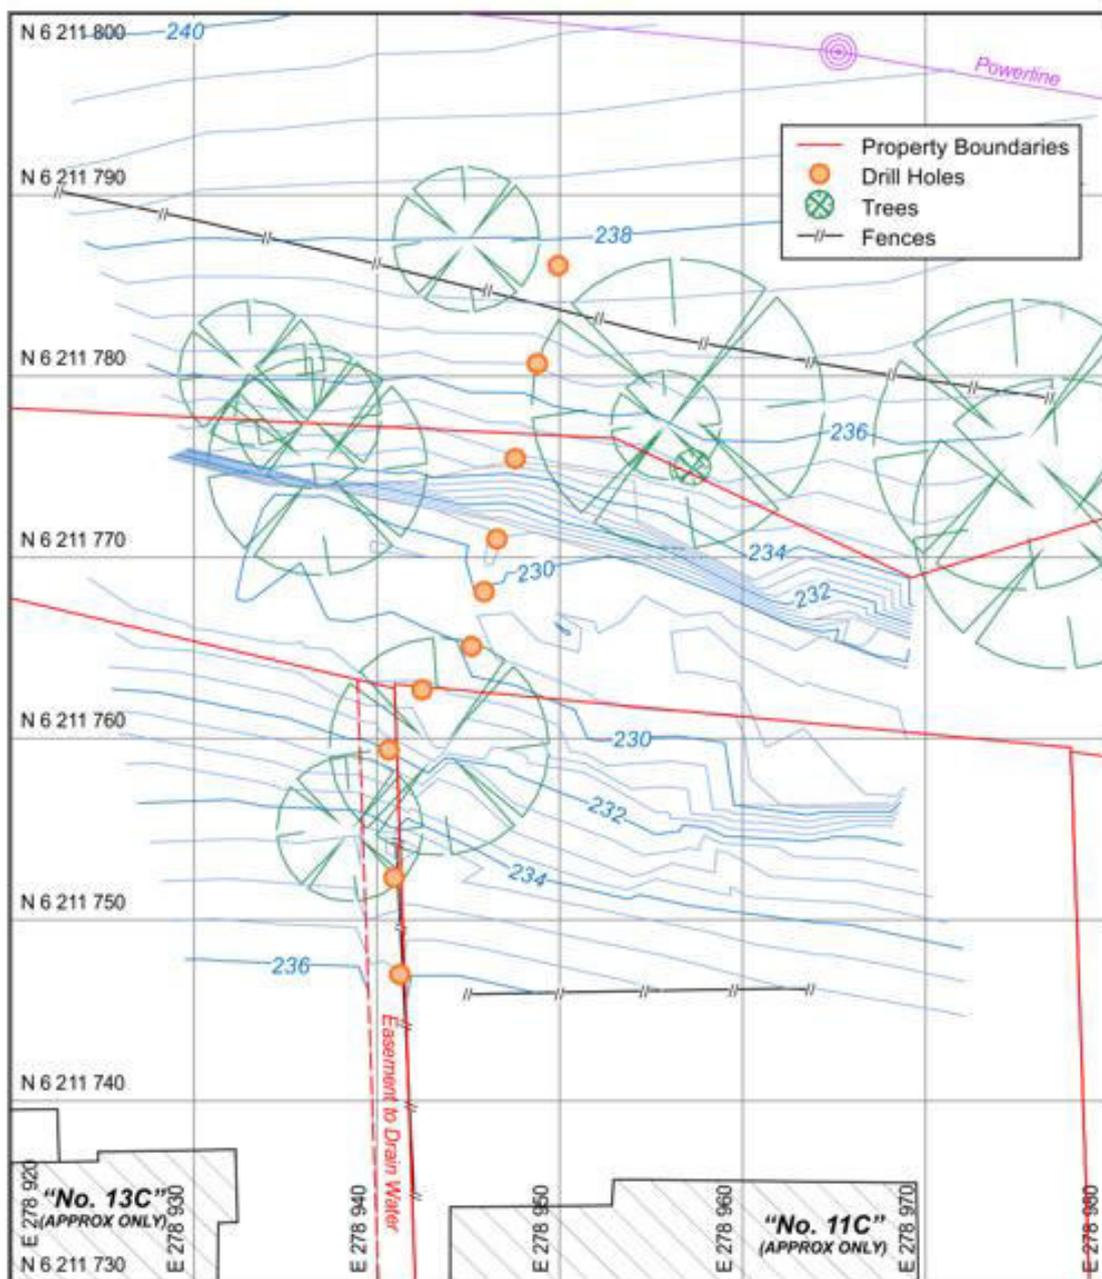
Figure 62 Myrtle Creek Site 23 – rock bar and proposed drill holes

The below **Figure 62** shows a plan of the Pool 23 rock bar and indicative drill holes in the Myrtle Creek CMAP Trial Project.

The first proposed site to be characterised is Site 23. This proposal may be modified if the hydrological assessment indicates that a more suitable trial site is evident. It is not possible to estimate the number of boreholes that will be required to characterise the fracture network. Approval for at least 30 boreholes will be sought. An indicative drill-hole pattern is shown in **Figure 62**.

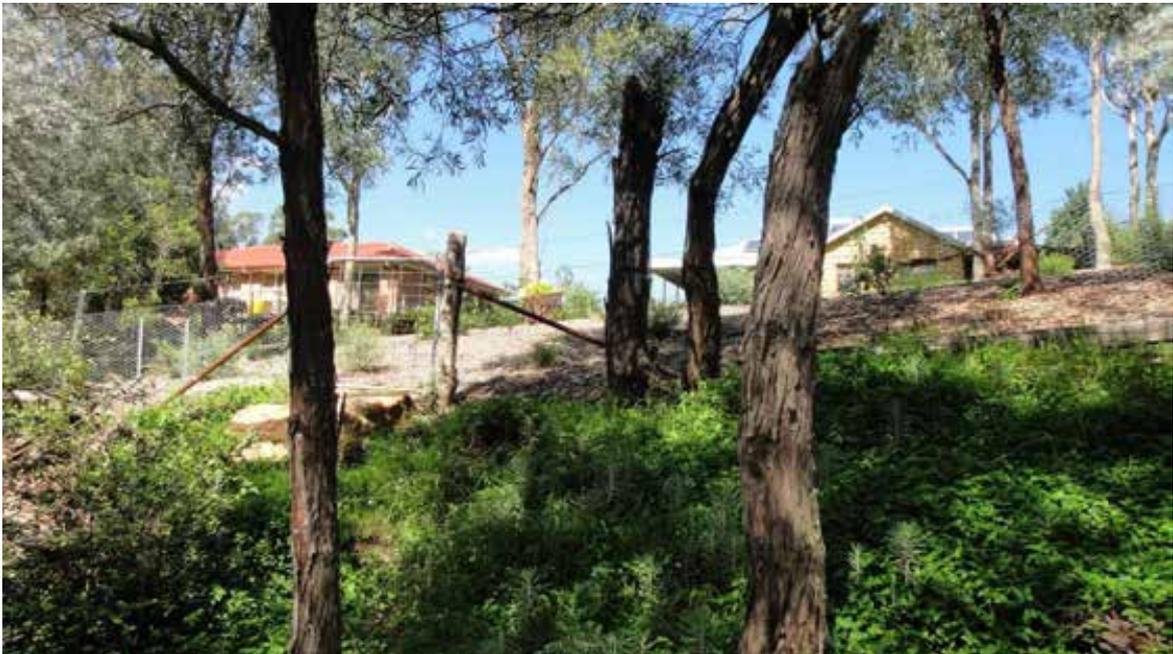
Figure 63 Myrtle Creek Site 23 – southern bank

The southern bank is covered by some rock debris that leads up to a grassy slope and the back of several residential properties as shown in below **Figure 63**. The boundary fence is approximately 5m from the end of the rock bar and the nearest houses are located 30m from the rock bar. The northern bank is also covered by some rock debris and small trees leading up to open grassland as shown in below **Figure 64**. Selected photographs of Site 23 are show on the following pages.

Site access for remediation works is possible from both sides of the creek, but will require access agreements with landowners. As **Figure 63** demonstrates, the residential dwellings and steep / vertical banks on the southern bank will provide limited opportunity for drill rig access.

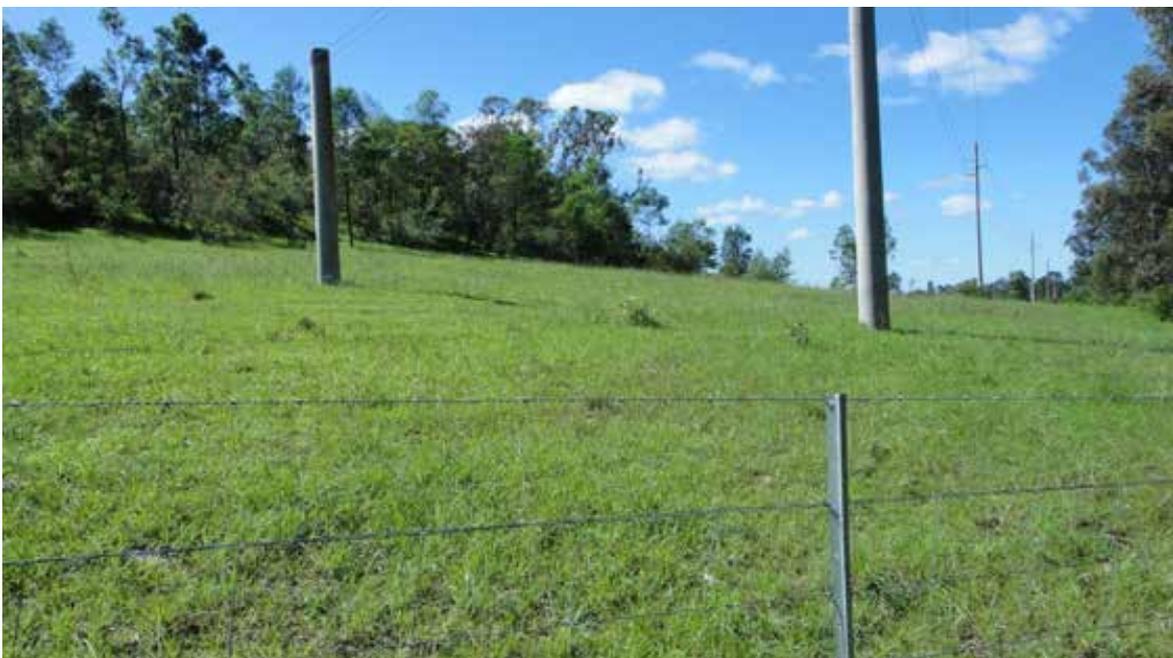
Figure 64 Myrtle Creek Site 23 – northern bank

The rock bar is located in an area where the banks are approximately up to 8m above the creek bed. The northern bank is vertical near the creek and approximately 5m high along with a 3m sloping riparian zone with a small corridor of bushland separating the creek from some open farmland which has good access.

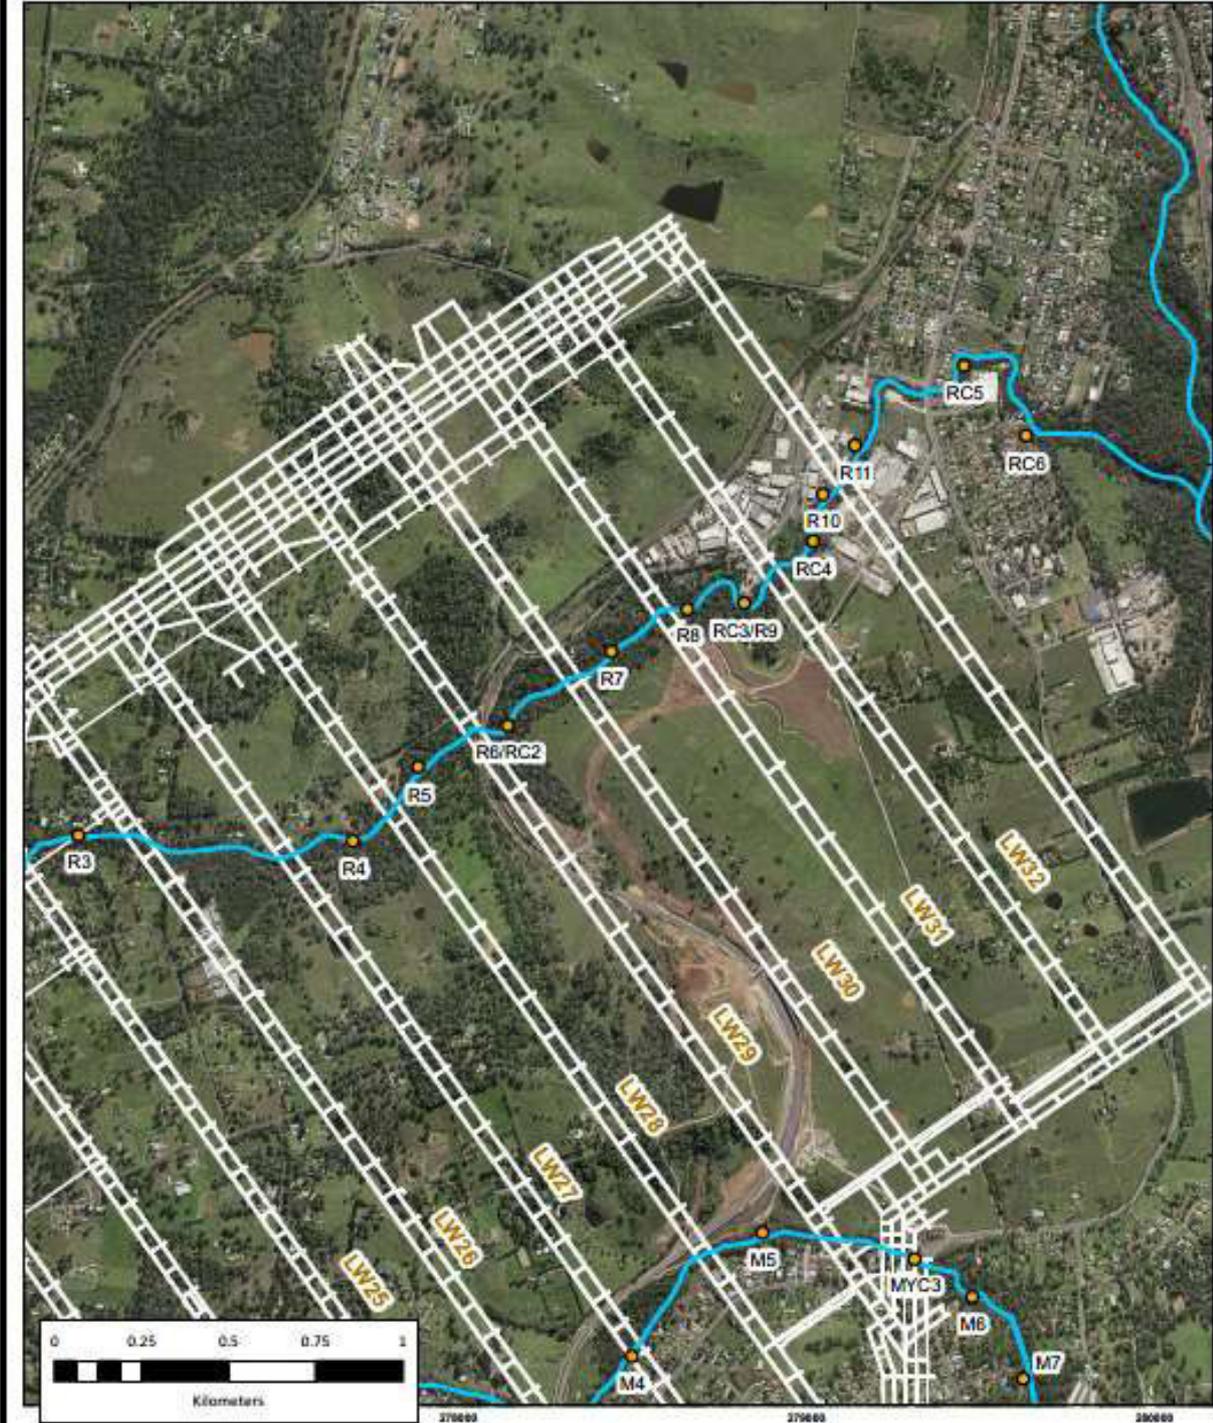
Figure 2: Redbank Creek Monitoring Gauge Stations

TCCO established gauging stations along Redbank Creek at 11 sites, as shown on **Figure 2**, and has undertaken a flow gauging program to develop flow ratings for each station. A baseline water quality monitoring program has also been undertaken at each gauging station, such that gauging station sites are paired with water quality monitoring sites.

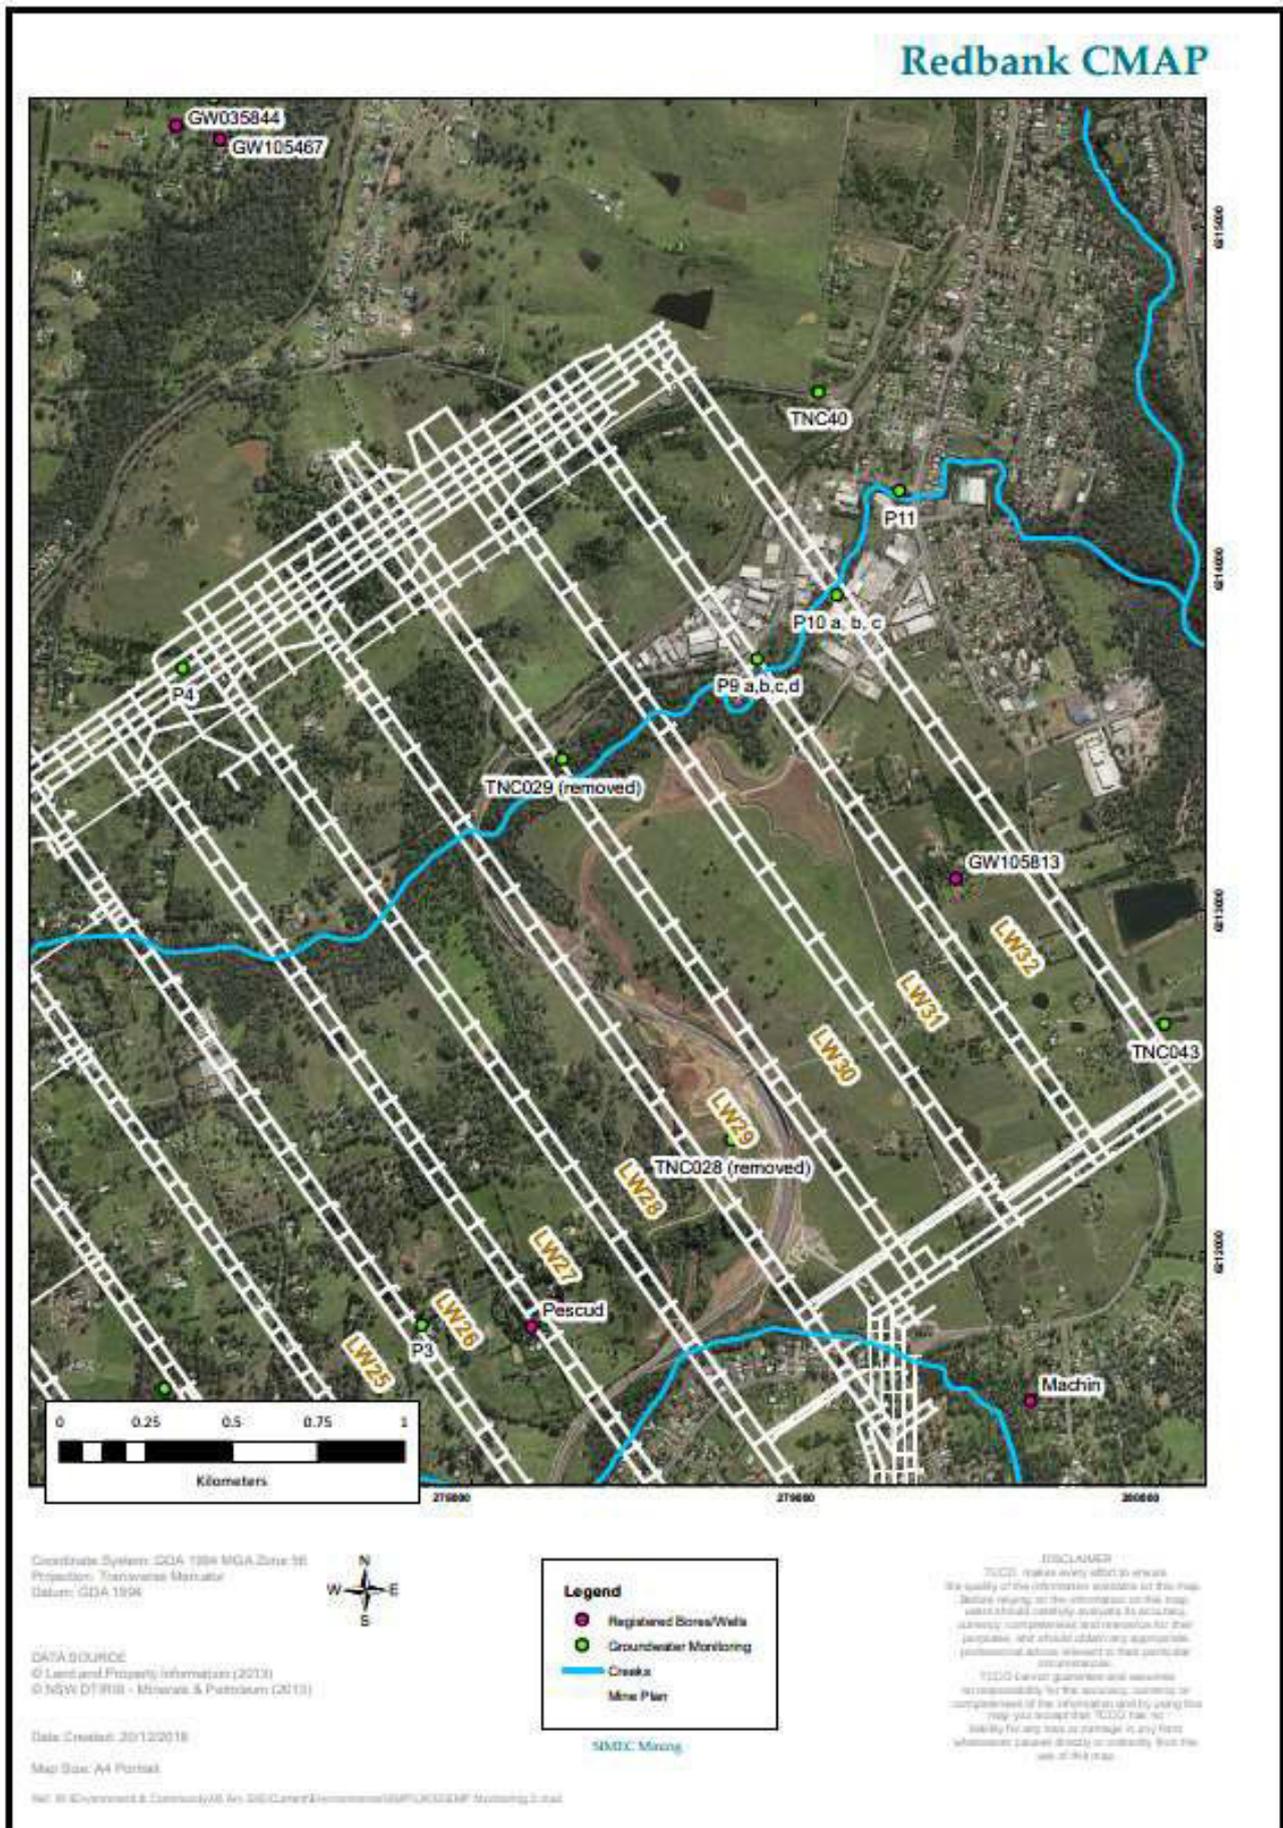
Figure 3: Redbank Creek Groundwater Monitoring Bores

TCCO has nine (9) piezometers (P1 to P9) where regular manual and data logger based standing water level monitoring has been conducted since June 2004 for some locations, as shown on **Figure 3**.

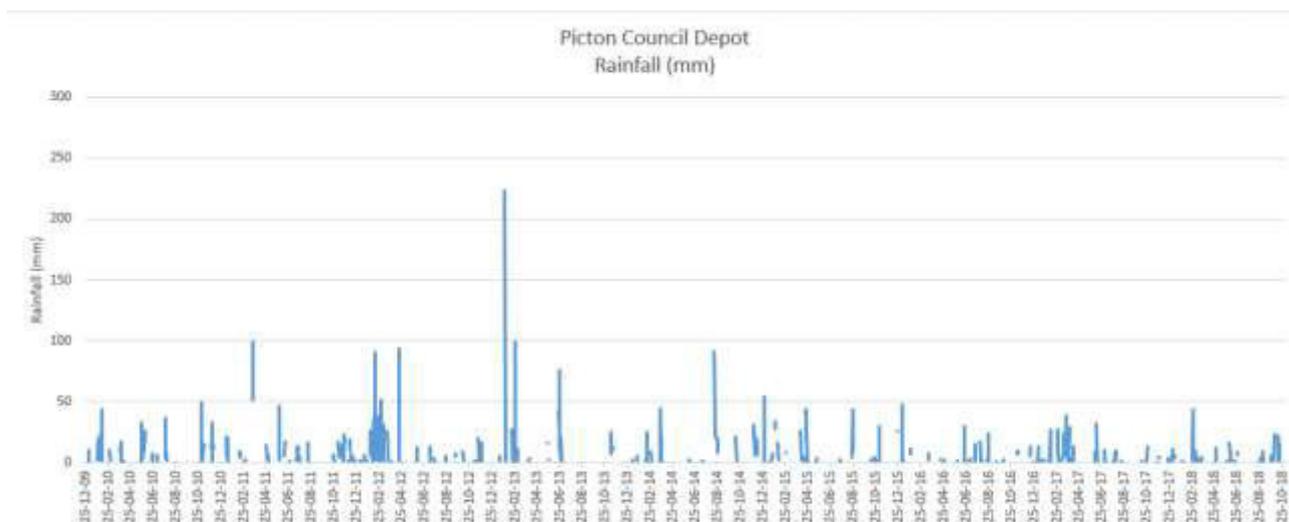
Figure 4: Picton Council Depot BoM Station Rainfall

Rainfall data for the Picton Council Depot BoM station is shown on Figure 4.

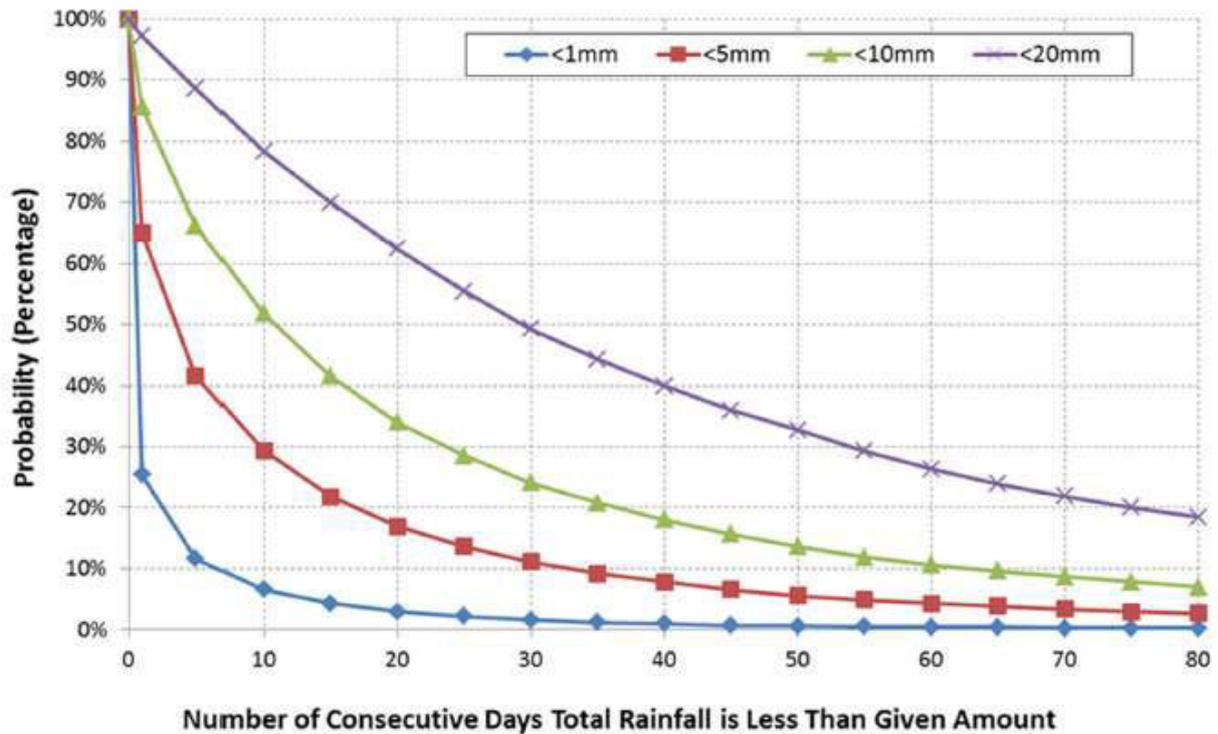
Figure 5: Low Rainfall Persistence Characteristics

The probability of low rainfall has been assessed using the Data Drill data suite, which shows, in Figure 5, the probability of low rainfall periods as the percentage of time that the total rainfall for different numbers of consecutive day periods has been less than or equal to the amount shown. There is a 50% chance that 20mm of rainfall or less will fall in any 30 day period. There is also a 30% chance that 5mm or less will fall in any 10 day period. This indicates that the area in the vicinity of Redbank Creek has a relatively low probability of persistent dry/low rainfall.

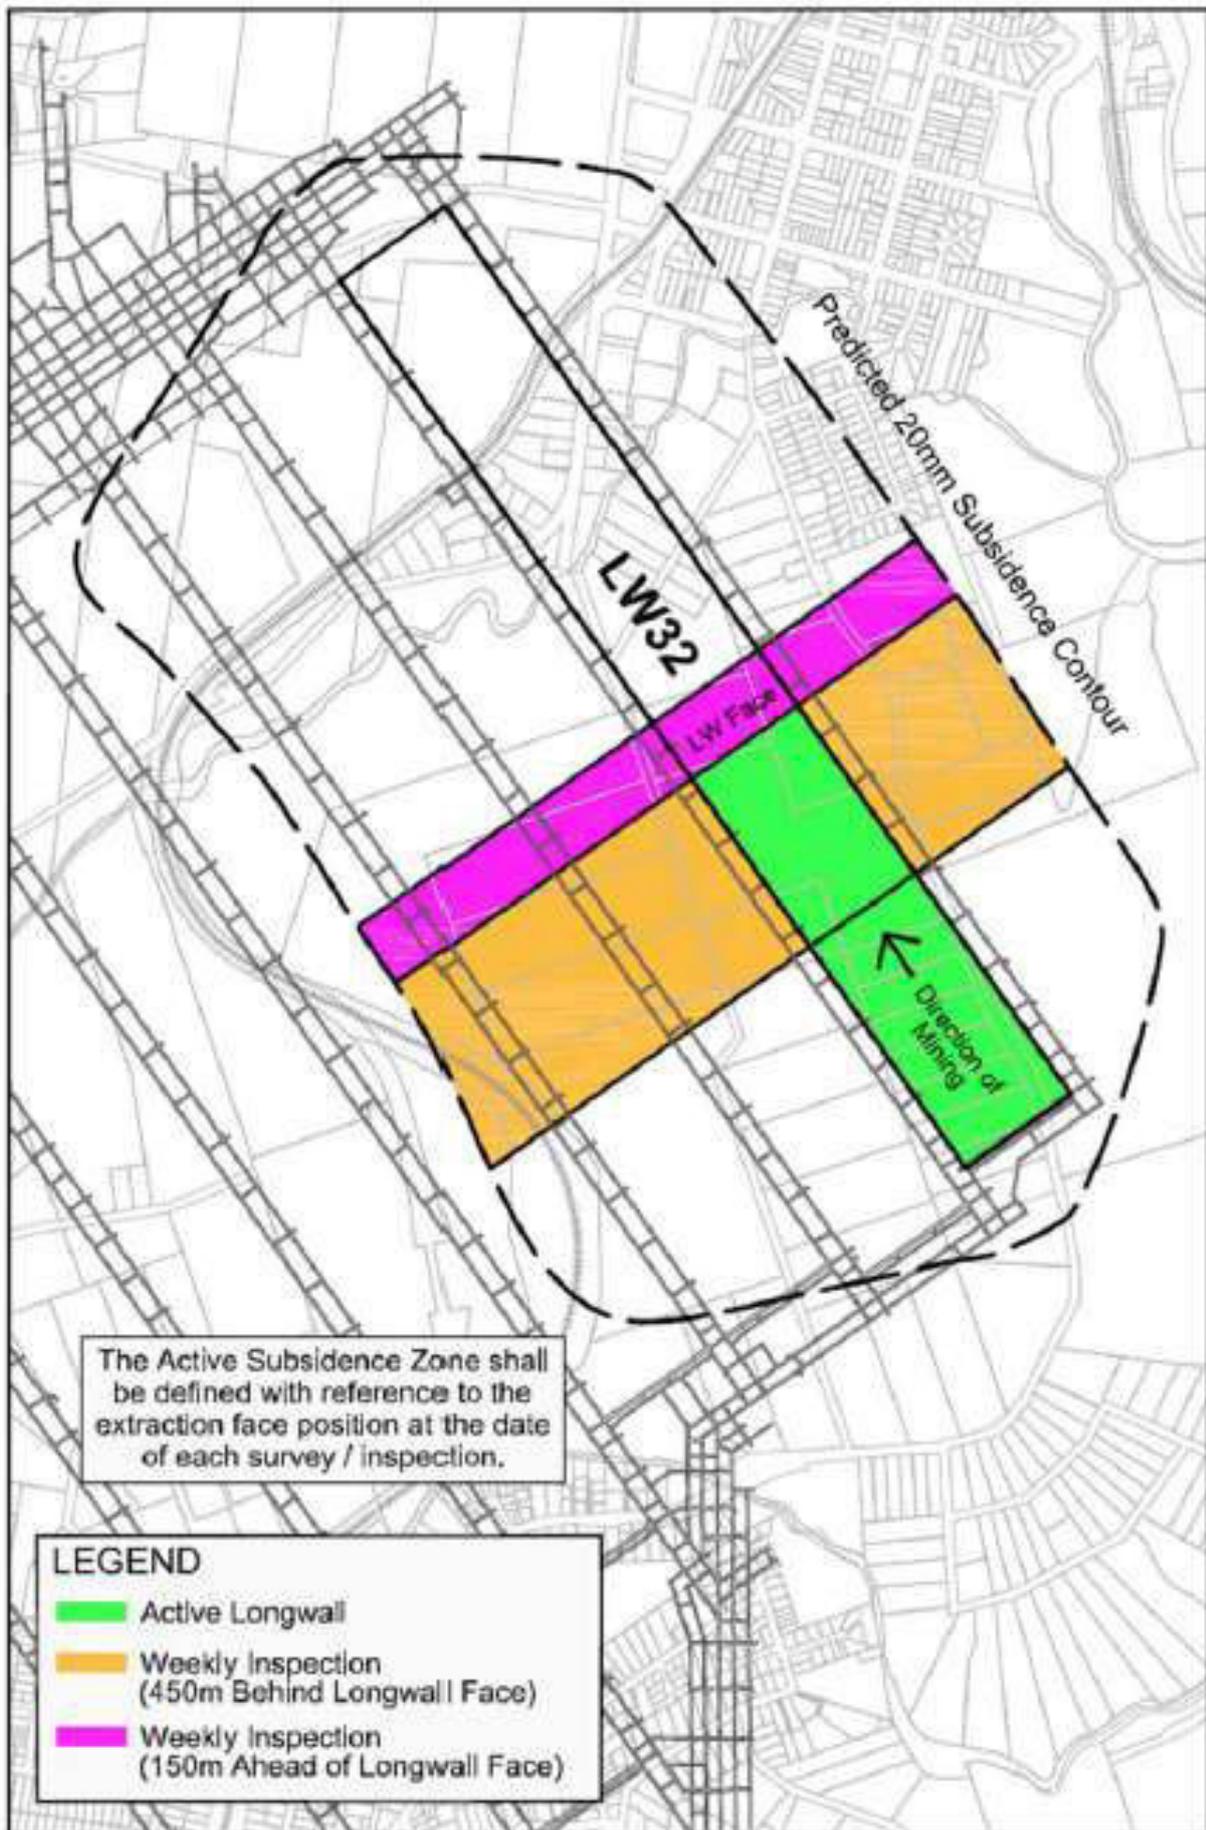
Figure 6: Diagrammatic Representation of Active Subsidence Zone

As a longwall progresses, subsidence begins to develop at a point in front of the longwall face and continues to develop after the longwall passes. The majority of subsidence movement typically occurs within an area 150 metres in front of the longwall face to an area 450 metres behind the longwall face.

This is termed the “*active subsidence zone*” for the purposes of this EMP, where surface monitoring is generally conducted. The active subsidence zone for each longwall is defined by the area bounded by the predicted 20 mm subsidence contour for the active longwall and a distance of 150 metres in front and 450 metres behind the active longwall face, as shown by **Figure 6**.

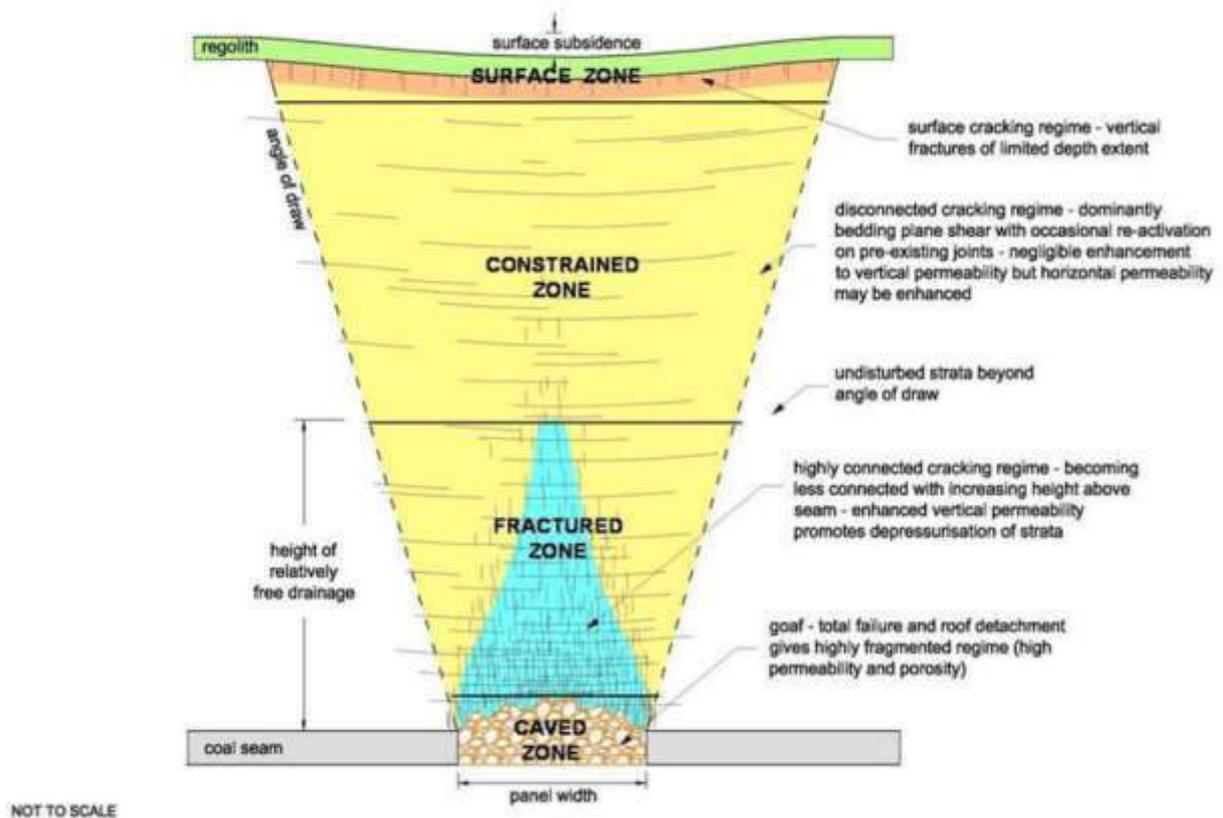
Figure 7: Conceptual Model of Caving and Fracturing

The caved material bulks and occupies a greater volume when it falls. A point is reached where, with increasing excavation width (W), the roof fall will choke itself off and act as a cushion to the overlying strata. It is known from theoretical calculations and field measurements that this caving height typically ranges from 3 to 10 times the mining height, depending on the nature of the roof strata. Highly-laminated strata tend to fall like a deck of cards and so have a low bulking factor, resulting in the caved zone extending to a considerable height. Falls comprising blocky material,

such as sandstone, tend to bulk up and choke off quickly. The caving height defines the limit of the caved zone shown on **Figure 7**.

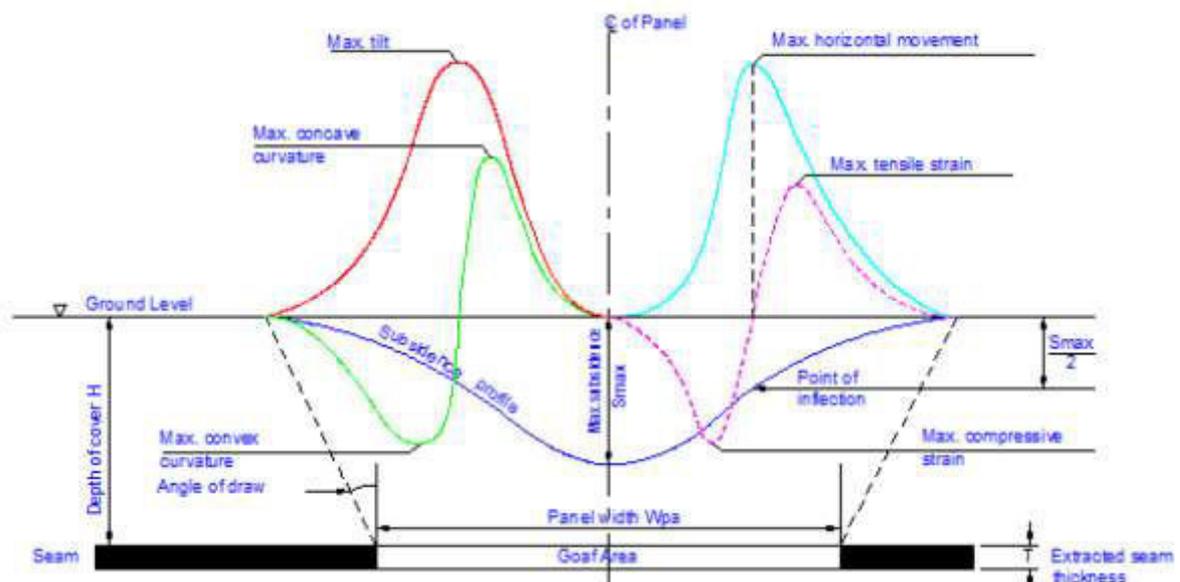
Figure 8: Subsidence Parameters

As mining approaches a site, the site will begin to tilt towards the excavation. Maximum tilt occurs at the point of inflection between concave and convex curvature. The amount of horizontal extension or compression induced over a given distance on the surface is expressed in terms of strain, as shown on **Figure 8**.

Strain is also expressed in terms of mm/m, that is, millimetres of stretch or millimetres of shortening per metre of distance. As the edge of an excavation is approached from the solid side, tensile strain begins to increase and builds up to a maximum value which usually occurs over the excavation. From that point, there is a graduation from the point of maximum tensile strain, through a point of zero strain, to a point of maximum compressive strain. Surface strain changes from tensile to compressive at the point of inflection.

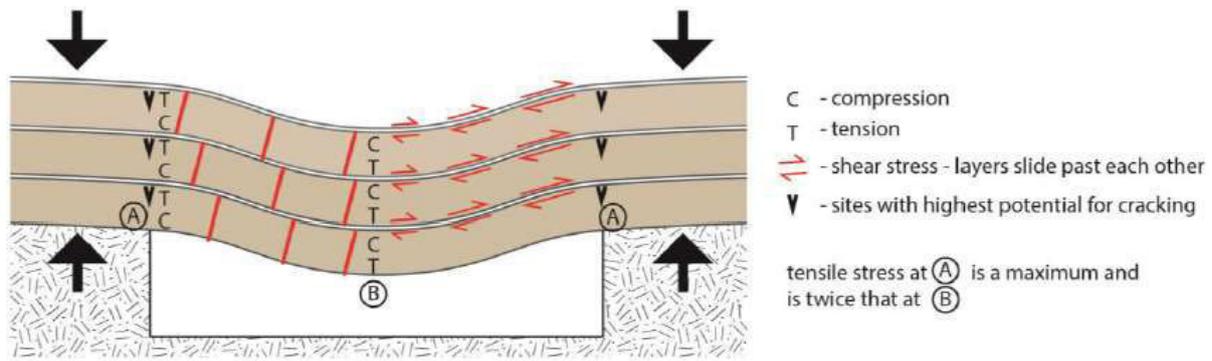
Figure 9: Shear Diagrammatic Representation

The near surface rocks over coal mine workings are usually comprised of laminated strata. In order for the strata to sag and subside, the individual strata have to slide past each other, as shown in **Figure 9**. This shear movement may or may not significantly enhance horizontal permeability. Additionally, when one face of a stratum is subjected to tension, its opposite face is subjected to compression. Because rocks have very low tensile strength (rocks are typically 10 to 30 times weaker in tension than compression), surfaces in tension are susceptible to fracturing and to the opening of pre-mining fractures.

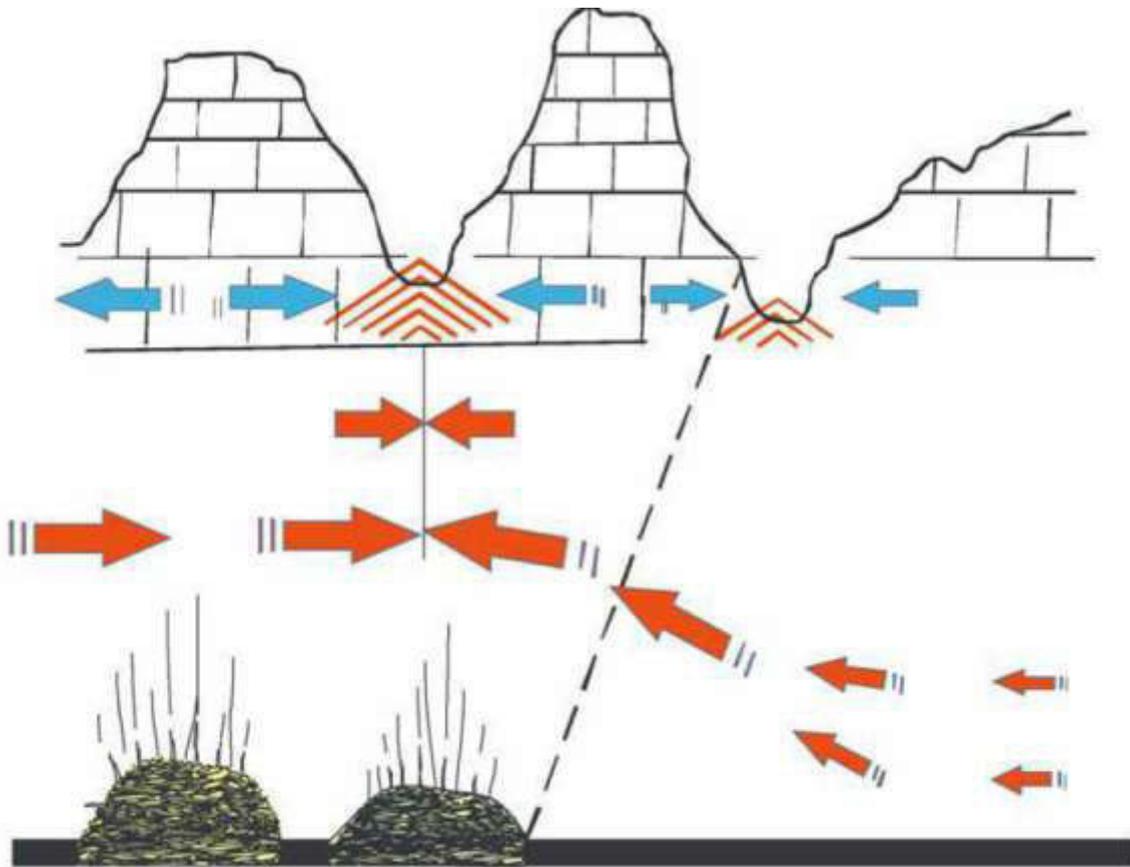
Figure 10: Valley Closure Conceptualisation

The dilation of the strata on either side of a topographic low point, such as creek channels, becomes concentrated at these topographic low points because there is freedom for the valley sides to move toward the valley and the confining pressures provided by the overburden strata to either side are not present at the creek line, as shown on **Figure 10**.

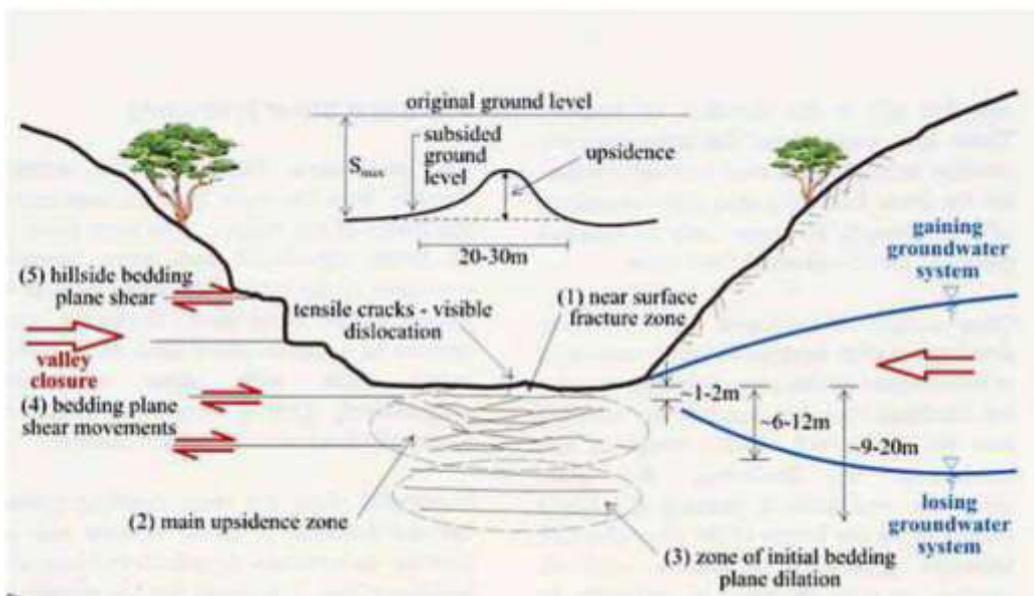
Figure 11: Mechanisms of Valley Closure and Upsidence

Buckling and shear in the near-surface strata, which leads to upsidence, can also generate an extensive network of fractures and voids in the valley floor. Ground movements due to conventional subsidence can also contribute to the formation of this network if the upsidence occurs within the angle of draw of the mine workings. The main fracture network extends to a depth of about 12 metres and bed separation extends to a depth of some 20 metres, as shown on Figure 11.

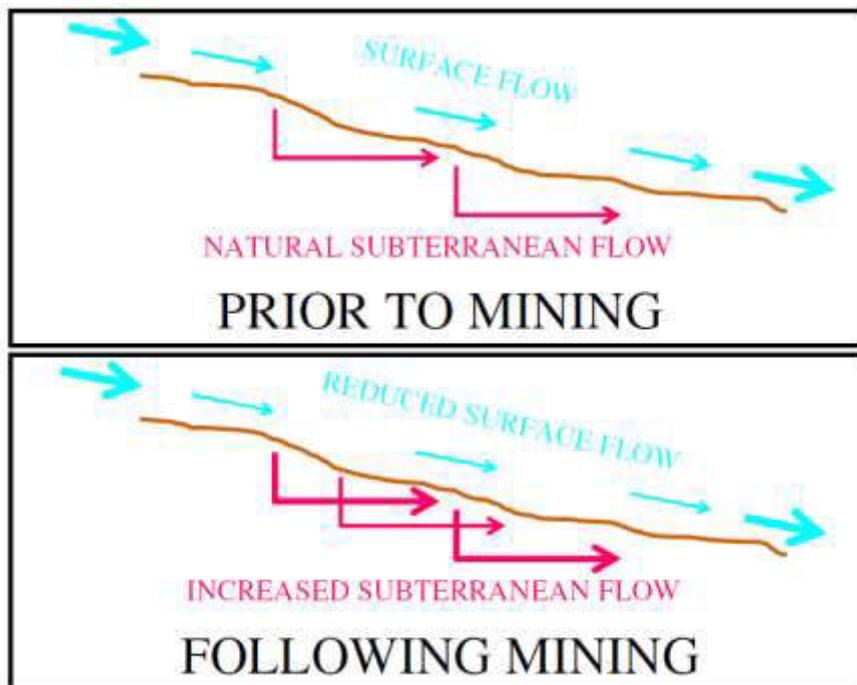
Figure 12: Diagrammatic Representation of Subterranean Flows

Mining-induced surface flow diversion into subterranean flows occurs where there is an upwards thrust of bedrock, resulting in fracturing of the rock and redirection of surface water through the dilated strata beneath it. The water reappears downstream of the fractured zone as the water is only redirected below the river bed for the extent of the subsidence induced fracturing, as outlined on **Figure 12**.

During periods of high flow such as immediately after heavy rain, frictional resistance requires an increase in head to drive the additional flow through the sub-surface fracture network. With sufficient flow, as occurs after heavy rain, this head increases to reach the surface and gives the appearance that flow has returned to the surface.

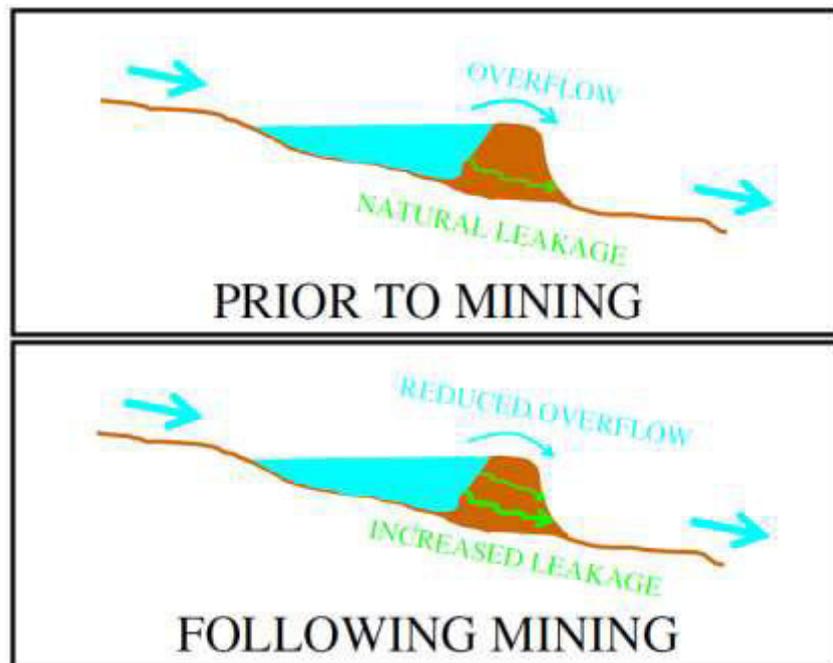
Figure 13: Diagrammatic Representation of Rockbar Leakage

Mining-induced surface flow diversion due to rockbar leakage occurs in a similar manner to the above mechanism, except that the rockbar is elevated above the rest of the river bed and the general water table. The rate of leakage is dependent, among other things, on the extent of horizontal fracturing within the depth of the rock bar and the water level. The rockbar leaks at a higher rate when the pool is full as there is access to all drainage paths and the water pressure is at its highest. However, as the pool level falls, the drainage rate reduces as the water pressure falls and access is restricted to drainage paths near the base of the rockbar, as outlined on **Figure 13**.

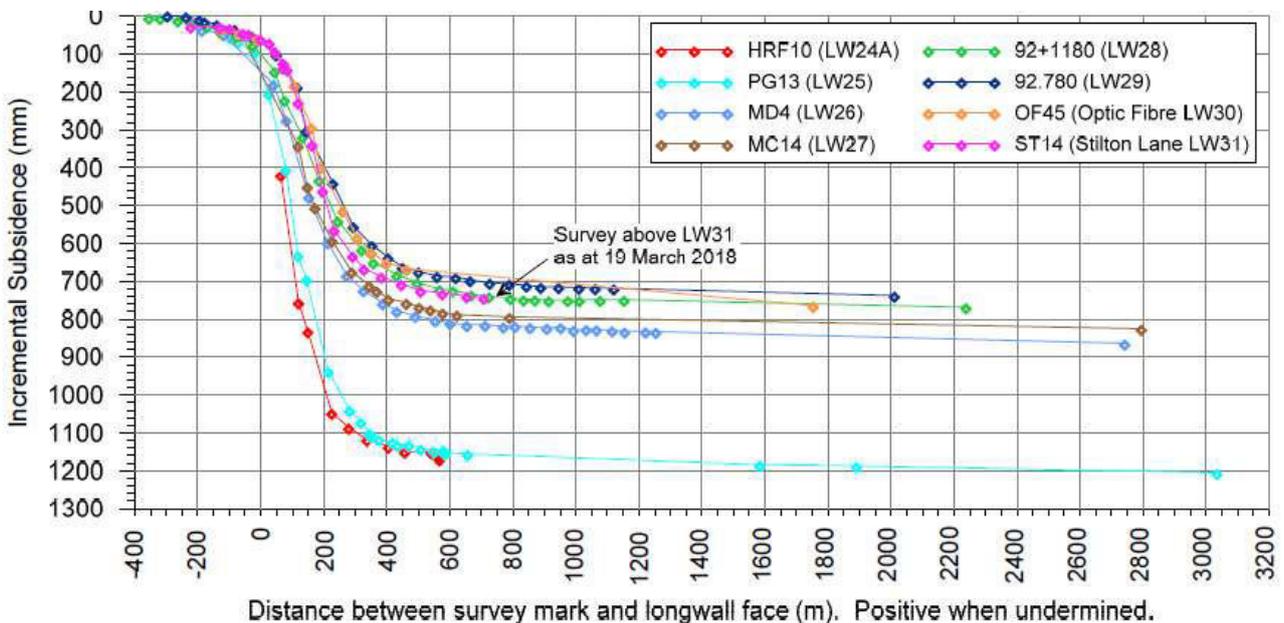
Figure 14: Observed Development of Subsidence Above Centrelines of Longwalls 24A to 31

Monitoring during the mining of Longwalls 28 to 31 has found that subsidence behaviour has returned to normal levels, as shown on **Figure 14**.

However, observed subsidence was greater than the predicted values over Longwalls 24A and the southern parts of Longwalls 25 to 27, likely to be associated with proximity to the Nepean Fault geological structure.

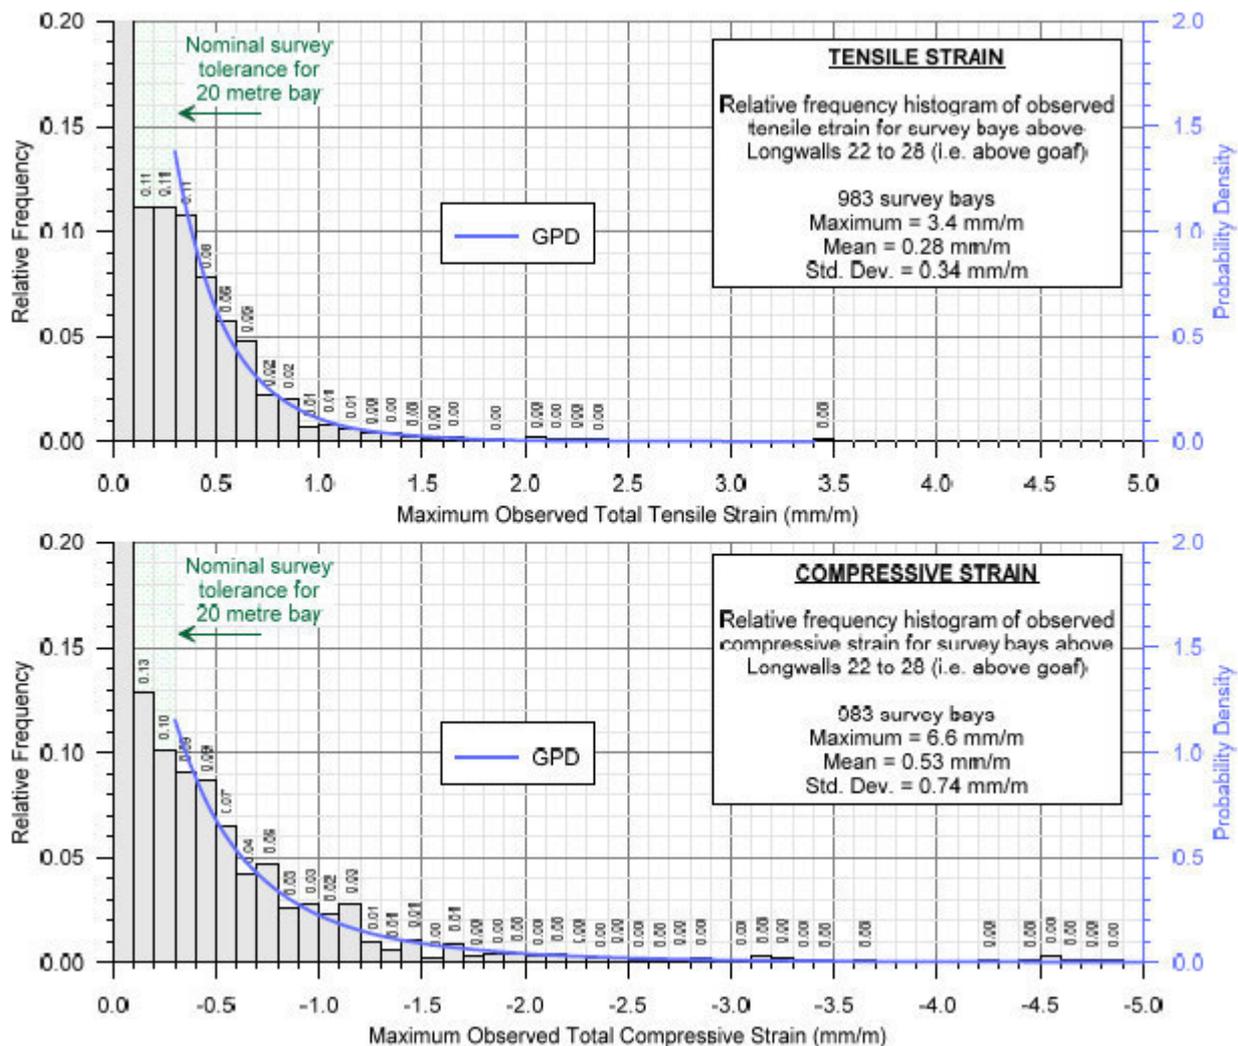
Figure 15: Distributions of Maximum Tensile and Compressive Strains above Goaf

The histogram of the maximum observed total tensile and compressive strains measured in survey bays above goaf at Tahmoor Mine is outlined in **Figure 15**.

The 95 % confidence levels for the maximum total strains that the individual survey bays above goaf experienced at any time during mining are 0.9 mm/m tensile and 1.8 mm/m compressive. The 99 % confidence levels for the maximum total strains that the individual survey bays above goaf experienced at any time during mining are 1.5 mm/m tensile and 3.5 mm/m compressive.

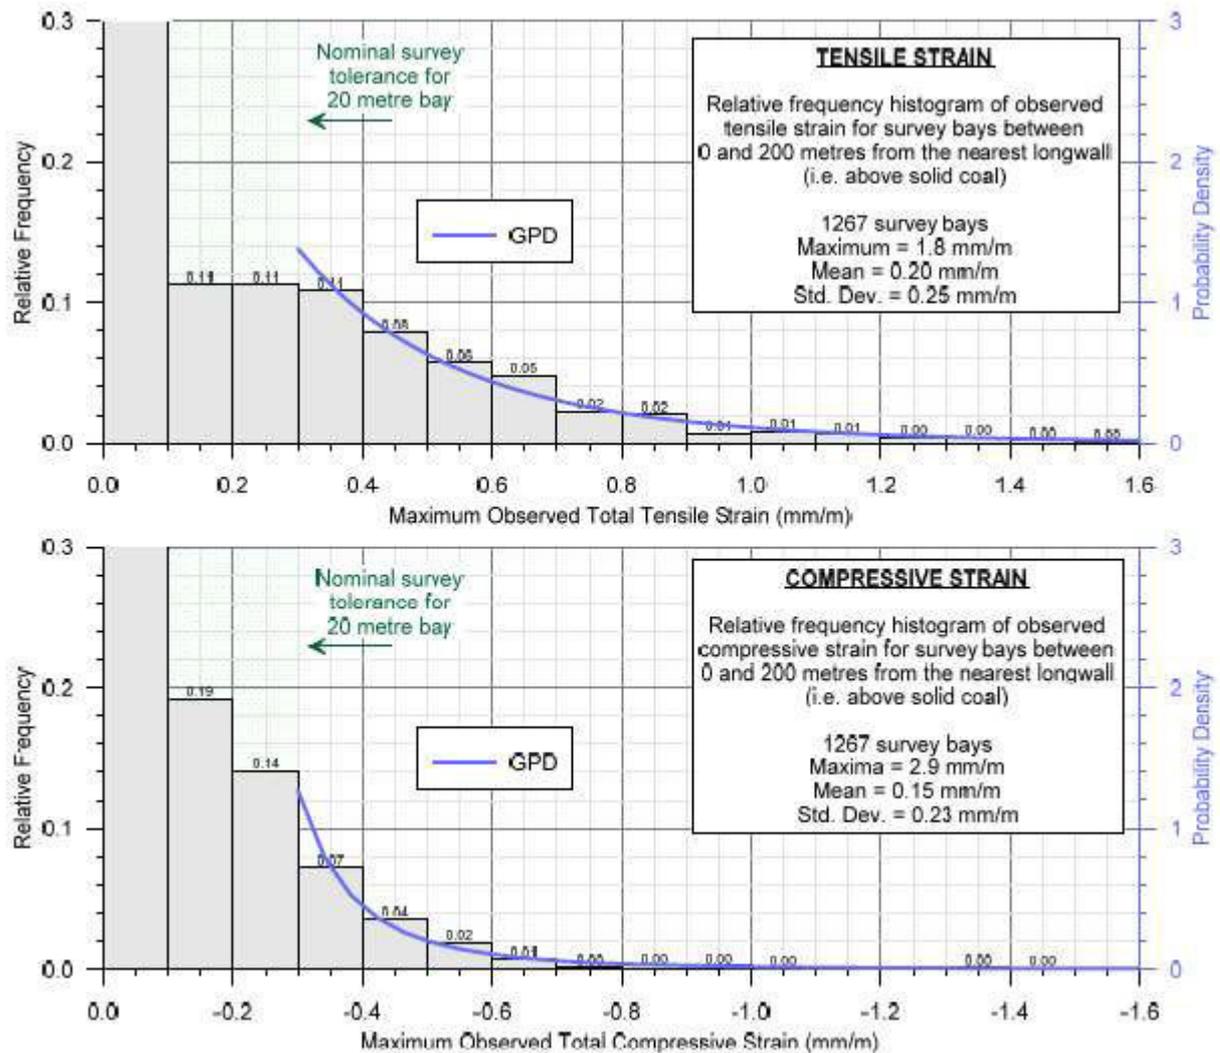
The 95 % confidence levels for the maximum total strains that the individual survey bays above solid coal experienced at any time during mining are 0.6 mm/m tensile and 0.5 mm/m compressive. The 99 % confidence levels for the maximum total strains that the individual survey bays above solid coal experienced at any time during mining are 1.1 mm/m tensile and 0.9 mm/m compressive.

Figure 16: Distributions of Measured Maximum Tensile and Compressive Strains Above Solid Coal

The histogram of the maximum observed tensile and compressive strains measured in survey bays above solid coal at Tahmoor Mine is outlined in Figure 16.
