Mine Operations Plan

Tahmoor Colliery

MINE OPERATIONS PLAN

(MOP) - Amendment G

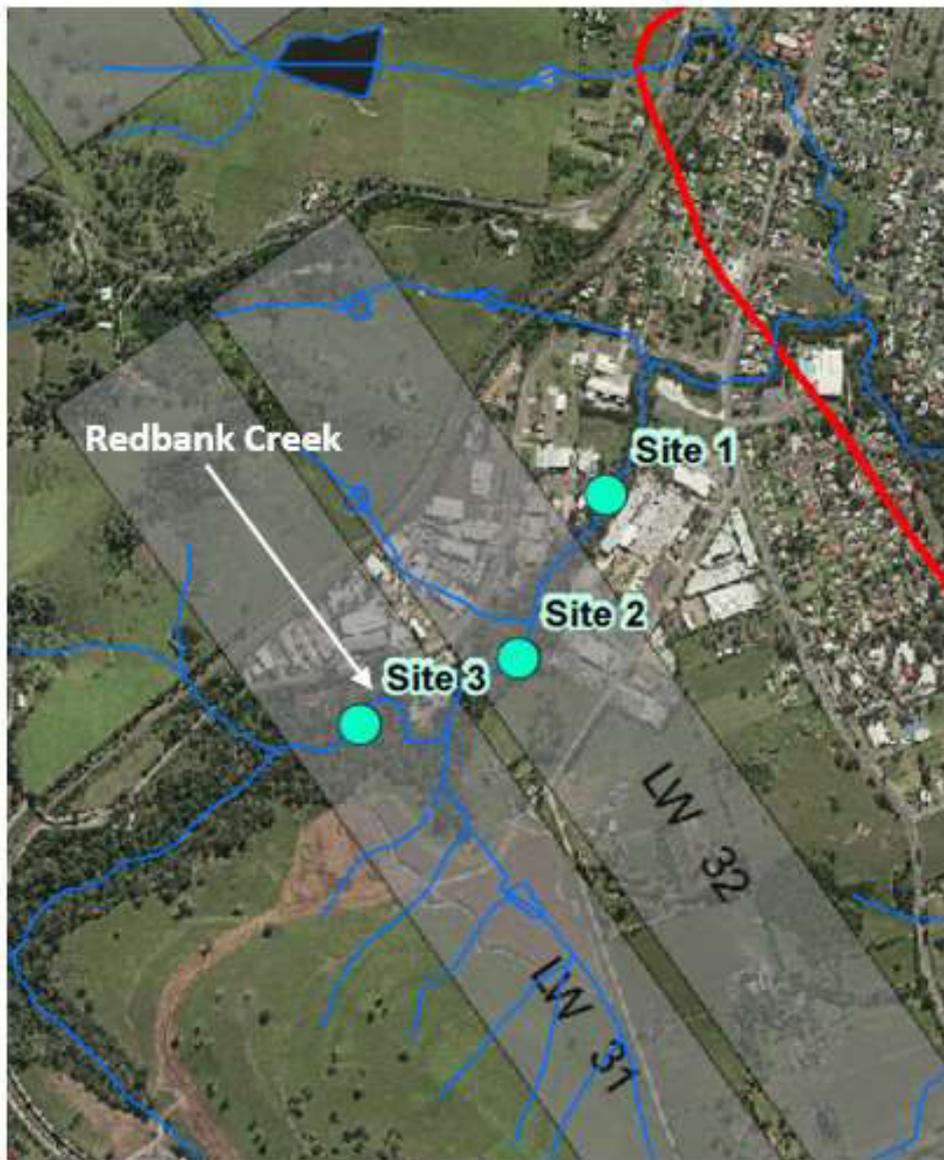
Figure 17: Redbank Creek – Aquatic Ecology Sites

Macrophyte occurrence varies between sites within Redbank Creek, as shown on **Figure 17** and outlined within the RCE inventory scores in **Table 8**. An RCE score below 20 indicates that the stream is in very poor condition. RCE Scores of 20-40 indicate a stream is in moderate condition and greater than 40 indicates a stream is considered to be in good condition with potential for higher biodiversity values.

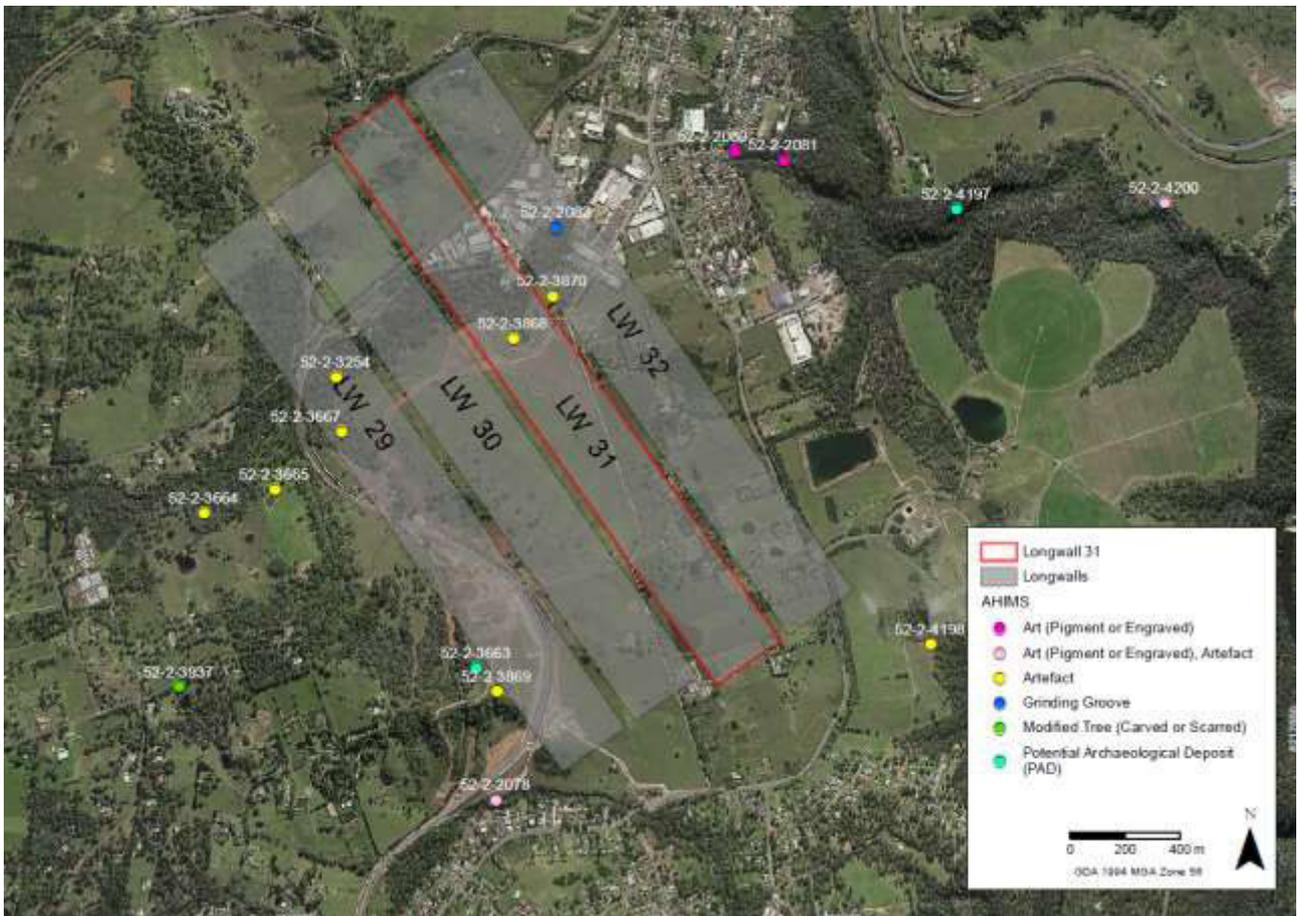
Figure 1: Aboriginal Archaeological Sites

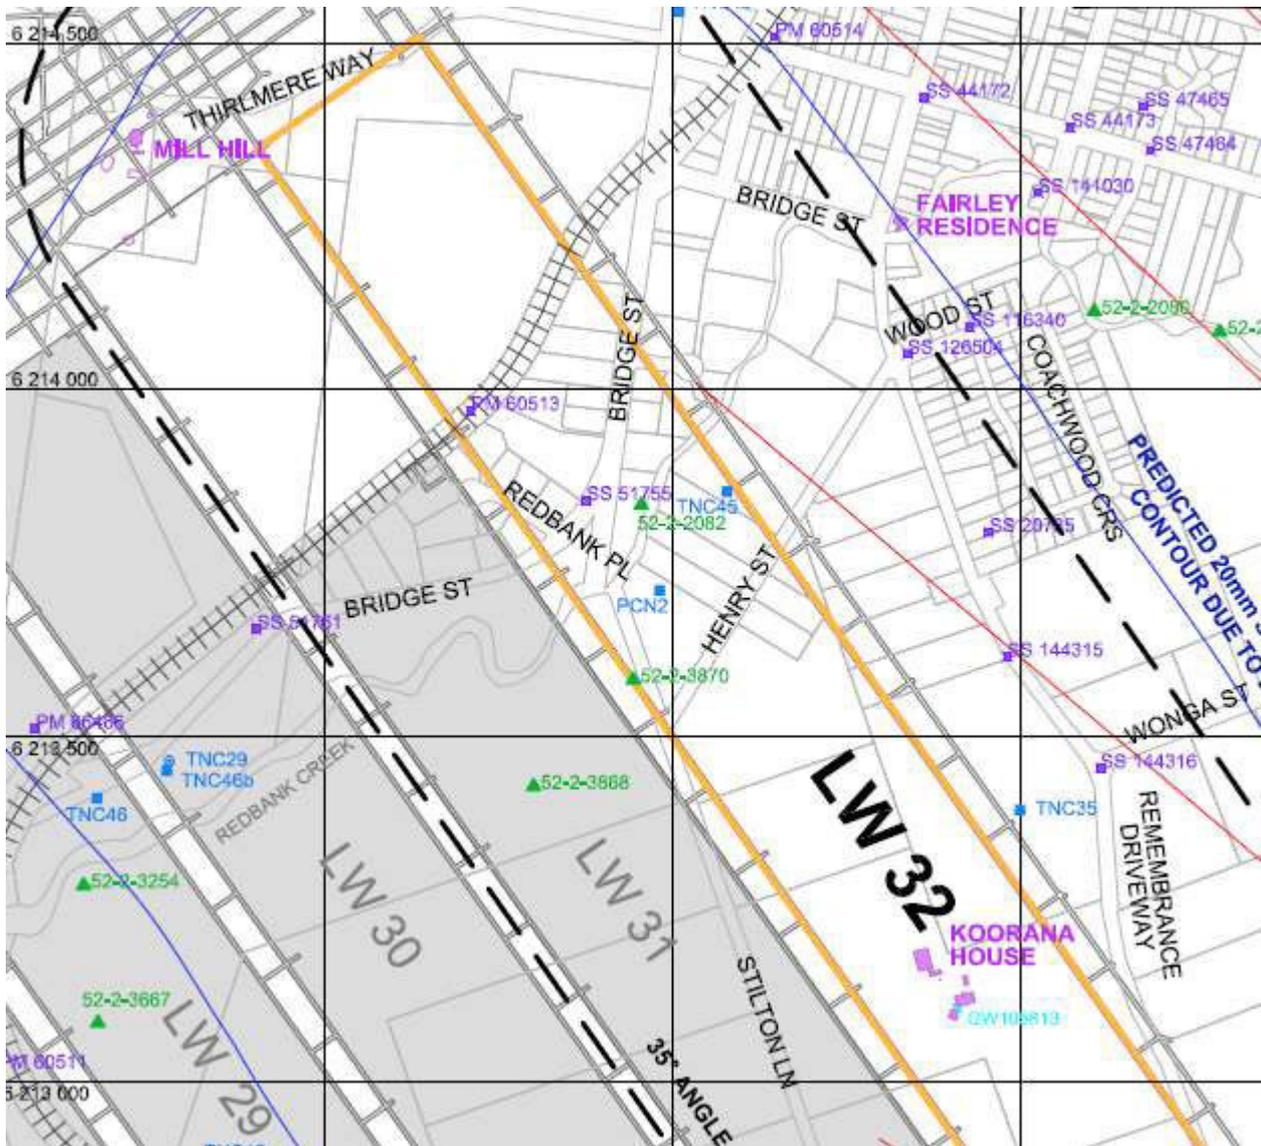
Figure 19: European Heritage Sites

Koorana House is located directly above proposed LW32 and Mill Hill located beyond the finishing end of proposed LW32, as shown on **Figure 19**.

The Fairley Residence, as shown on **Figure 19**, on Argyle Street is located approximately 400 metres to the side of LW32 and is expected to experience minor subsidence movements during the extraction of proposed LW32. A PSMP for Fairley House has been developed and implemented with the property owner.

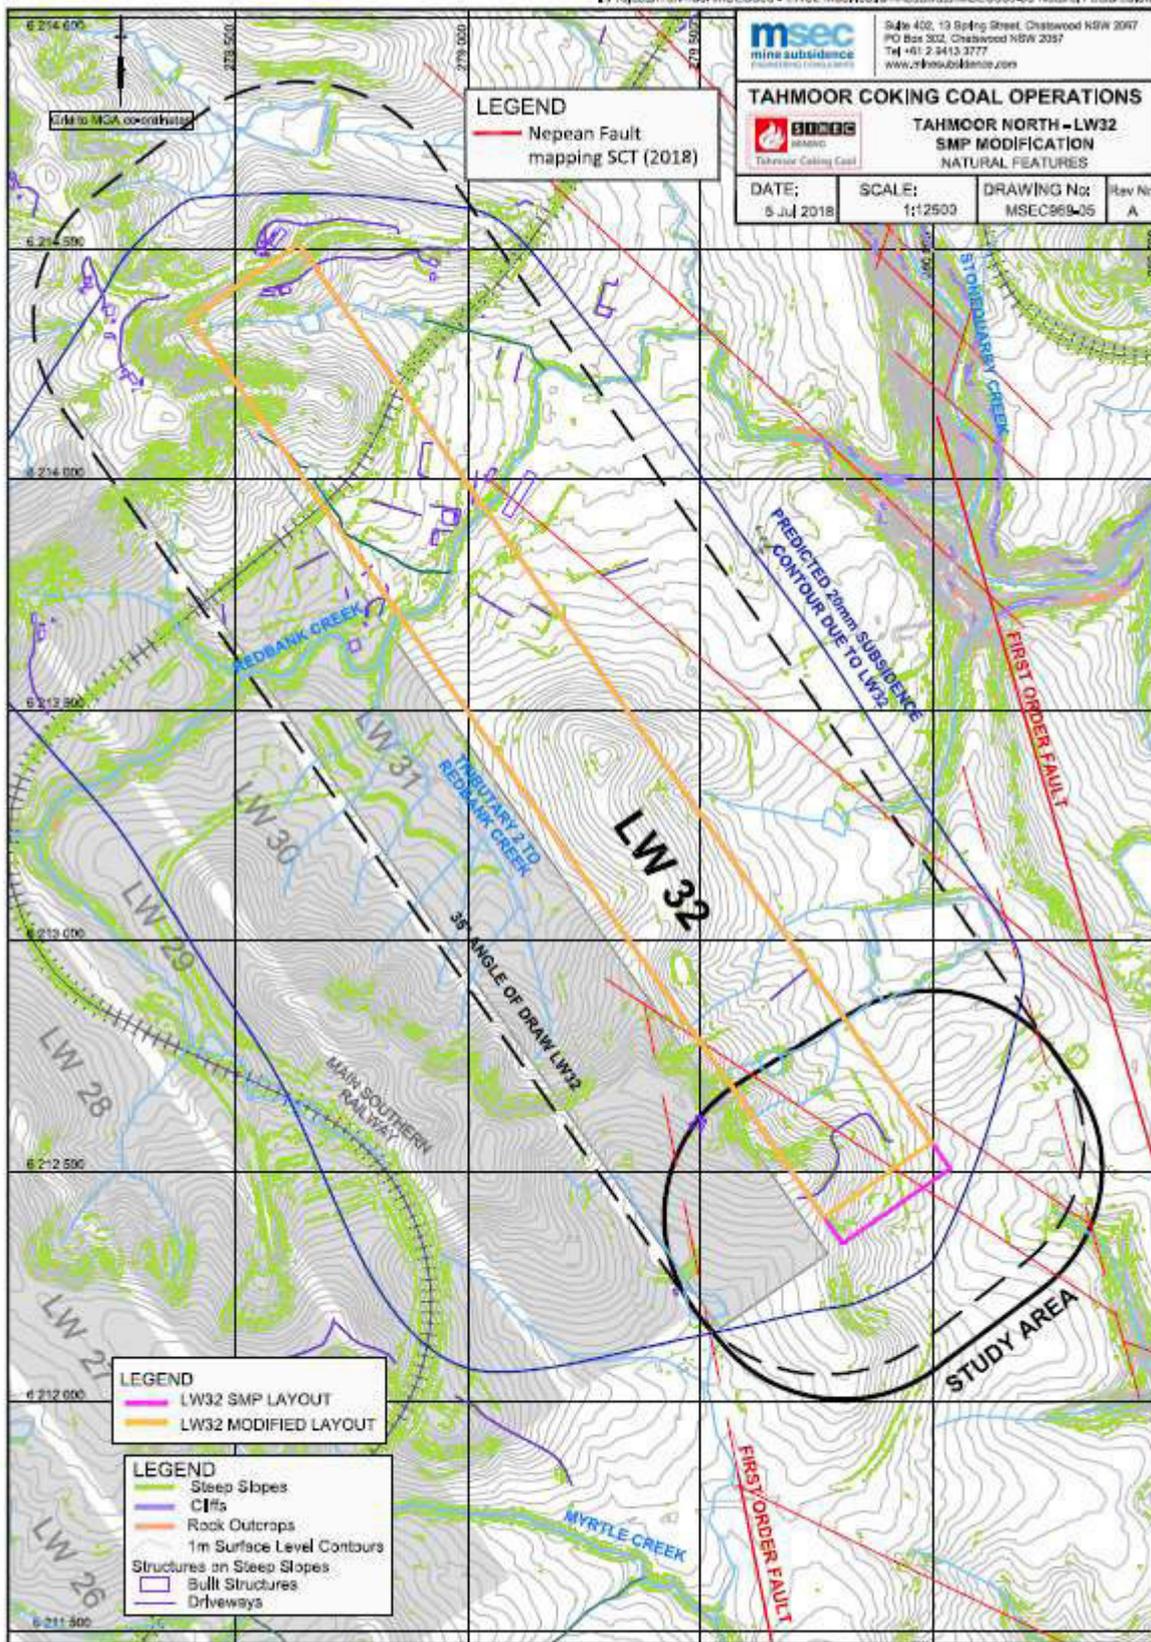
Figure 20: LW32 – Steep Slopes

The locations of the steep slopes are shown on **Figure 20**.

As shown on **Figure 20**, natural steep slopes exist directly above and adjacent to LW32 along the banks of Redbank Creek and along the sides of ridges, such as the Redbank Range and alongside Thirlmere Way. Some structures are located on or near steep slopes, with no impacts observed during the mining of Longwall 31.
