Fig. 6.36 Mushroom Tunnel

6.8. Potable Water Infrastructure

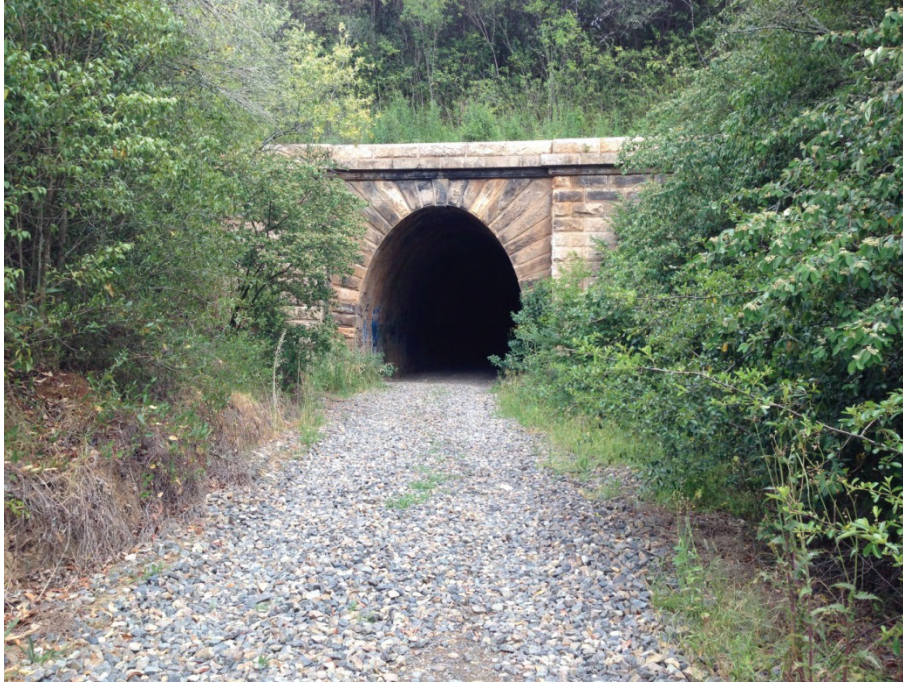
The Mushroom Tunnel is used as part of the vehicular access road along the Main Southern Railway. It is also occasionally used for heritage tours.

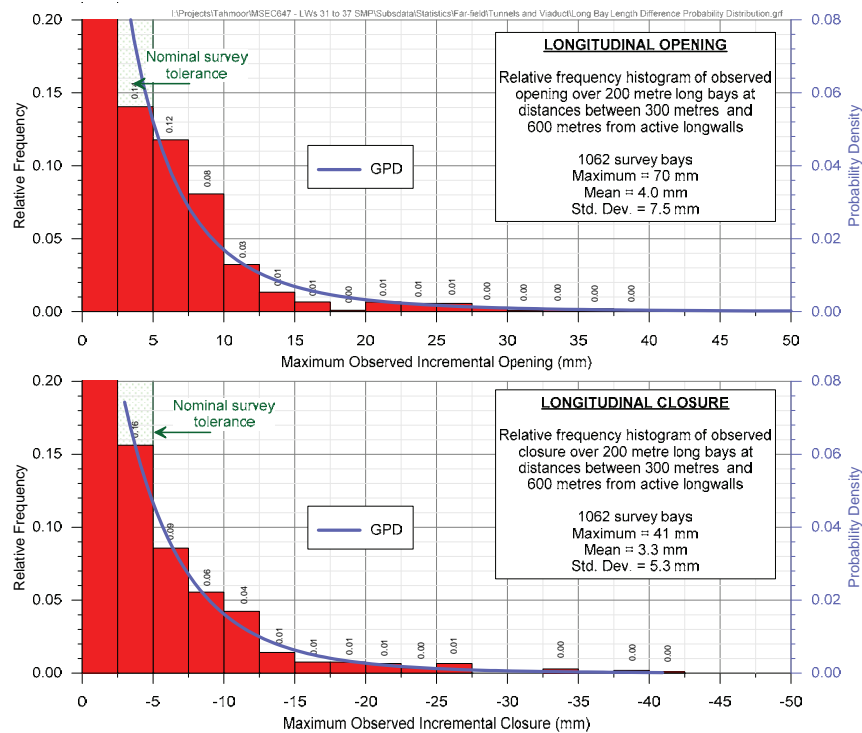
The histograms of the maximum observed incremental opening and closing movements for survey marks spaced at 200 metres ± 10 metres, at distances between 300 metres and 600 metres from active longwalls, are shown in Fig. 4.14. The *Generalised Pareto Distributions (GPDs)* which have been fitted to this data have also been shown in these figures.

Fig. 6.37 Distributions of the Maximum Observed Incremental Opening and Closure for Survey Marks Spaced at 200 metres \pm 10 metres at Distances between 300 metres and 600 metres from Active Longwalls

The maximum incremental longitudinal movements over the lengths of the tunnels, based on the fitted GPDs to the available ground monitoring data, are 16 mm opening and 14 mm closure, based on the 95 % confidence levels.

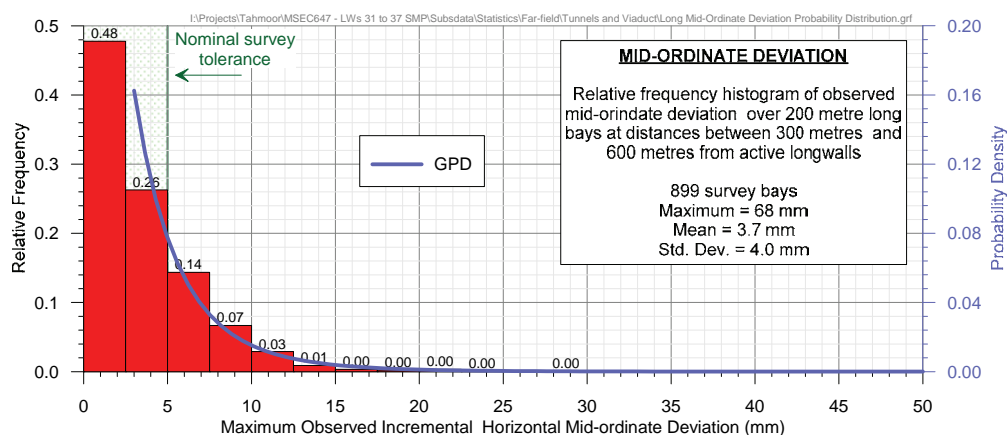
The histograms of the maximum observed incremental horizontal mid-ordinate deviation for three survey marks spaced a total of 200 metres \pm 10 metres, at distances between 300 metres and 600 metres from active longwalls, is shown in Fig. 4.16.

Fig. 6.38 Observed Incremental Horizontal Mid-Ordinate Deviation for Survey Marks Spaced a total of 200 metres \pm 10 metres at Distances between 300 metres and 600 metres from Active Longwalls

Mid-ordinate deviation is a measure of differential lateral movement, which is the change in perpendicular horizontal distance from a point to a chord formed by joining points on either side. A schematic sketch showing the mid-ordinate deviation of a peg compared to its adjacent survey pegs between two survey epochs is provided in Section 6.6.2.

The maximum incremental horizontal mid-ordinate deviation over the lengths of the tunnels, based on the fitted GPD to the available ground monitoring data, is 11 mm, based on the 95 % confidence level.

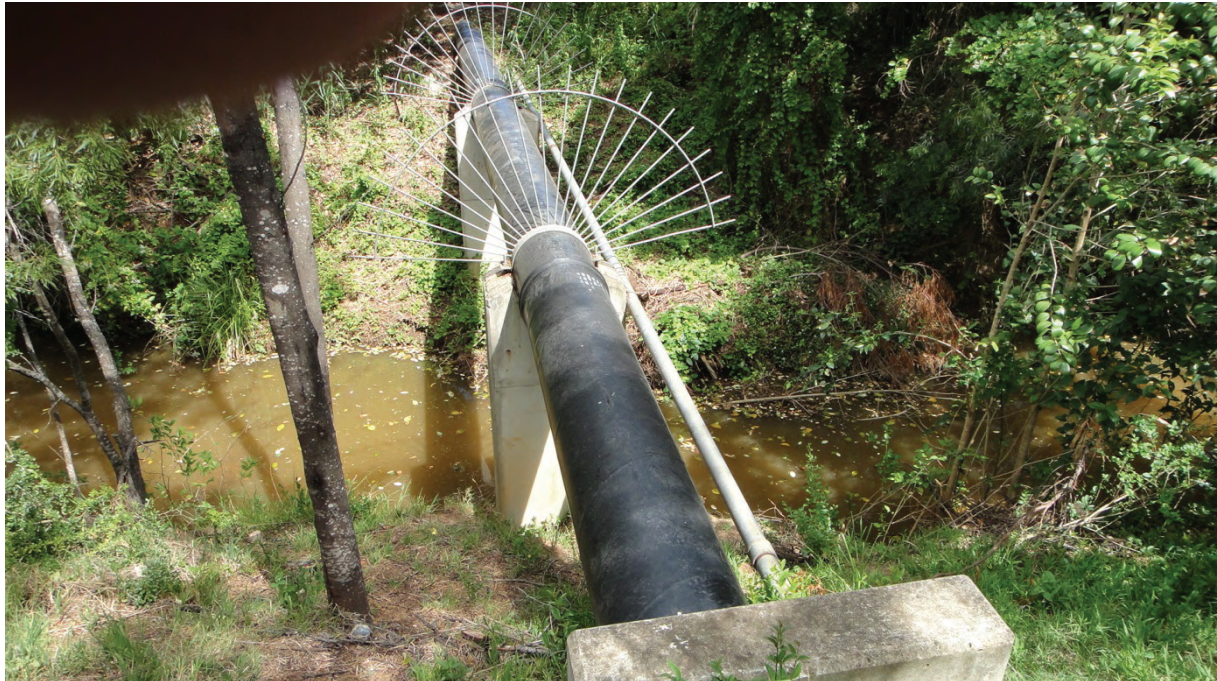
A 450 mm diameter pipe aqueduct for the Thirlmere Carrier is located over Redbank Creek within the SMP Area. The aqueduct is supported by reinforced concrete abutments with a central pier. A photograph of the aqueduct is shown in Fig. 6.39.

Fig. 6.39 Pipe Aqueduct for Thirlmere Carrier over Redbank Creek

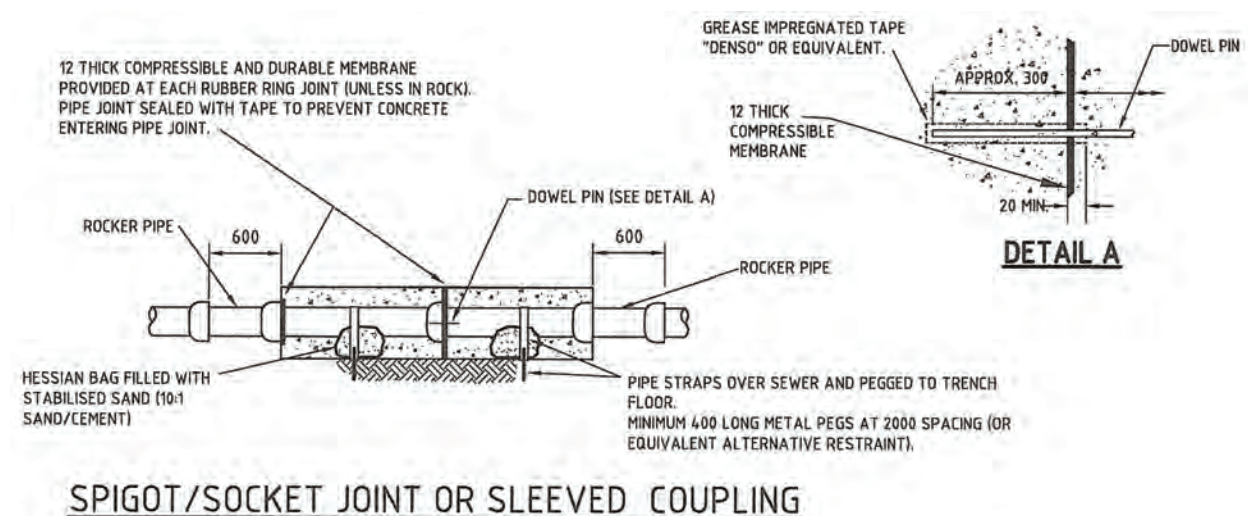
Extract of Sydney Water Standard Drawing No. SEW-1205-V

There are 16 sections of pipe (total length of 240 metres) that are concrete encased within the SMP Area. These encasements are typically found beneath driveways and structures. The encasement is designed to accommodate ground strains via 12 mm thick compressible and durable membranes installed at each pipe joint. A standard Sydney Water design detail is shown in Fig. 6.40.

Fig. 6.40 Typical Sydney Water design of concrete encased pipe

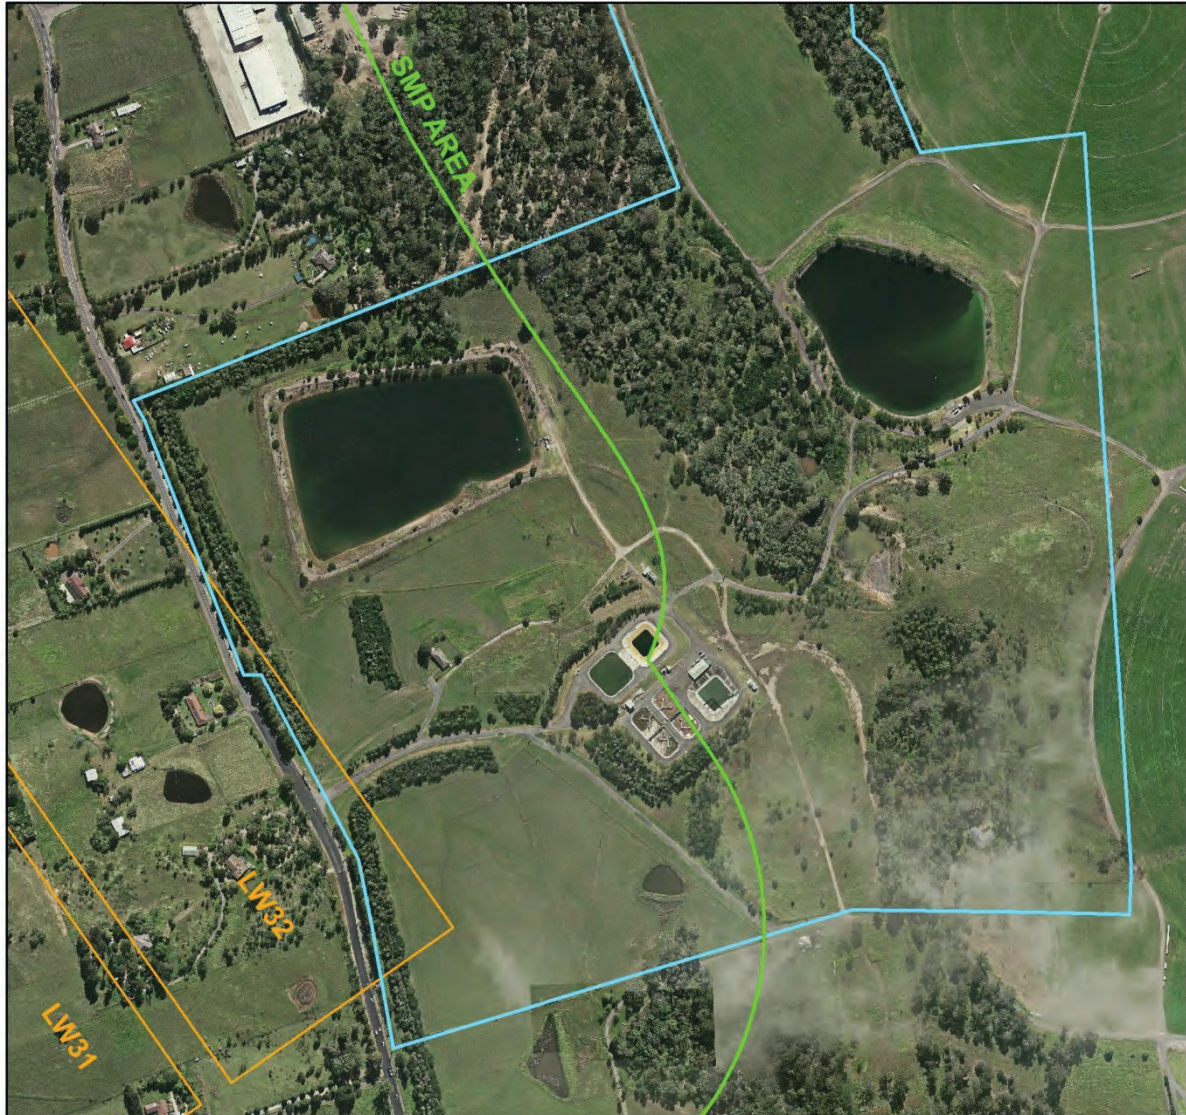
An aerial photograph of the Picton WRP is shown in Fig. 6.41. The plant includes a number of structures, skimmers and tanks and a number of treated water storage dams, which are connected by a network of pipes. The design of the Picton WRP was approved by the Mine Subsidence Board.

Fig. 6.41 Aerial photograph showing Picton Water Recycling Plant overlaid with proposed longwalls

The proposed longwalls do not mine directly beneath structures and dams at the Picton WRP but proposed Longwall 32 will extract directly beneath a portion of the property. The closest distance between the Picton WRP structures and proposed Longwall 32 is approximately 275 metres. The closest distance between the nearest storage dam and the proposed Longwall 32 is approximately 100 metres.

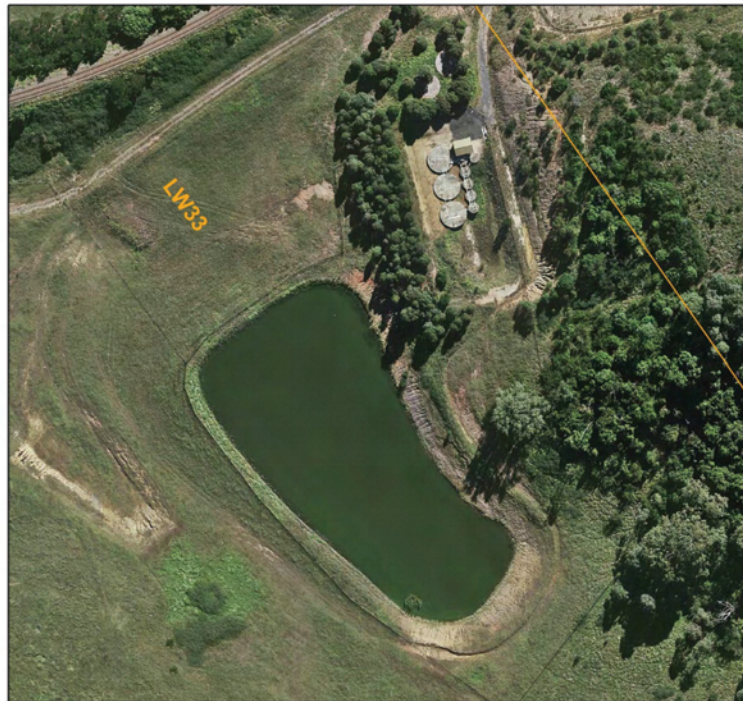
An aerial photograph of the Stonequarry Estate WTP is shown in Fig. 6.41. The plant includes an assortment of tanks and structures and a dam, which are connected by a network of pipes.

Fig. 6.42 Aerial photograph showing Wastewater Treatment Plant on Stonequarry Estate

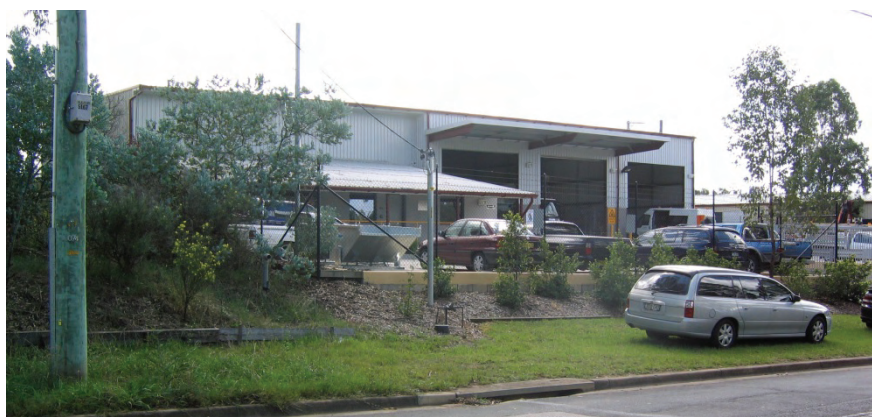
The Endeavour Energy Picton Field Service Centre (Ref. HH06/1) is located on Bridge Street, Picton. The Service Centre is located within the SMP Area directly above Longwall 31, as shown in Drawing No. MSEC647-21. The Service Centre is shown in Fig. 6.43 and includes:

- A double storey steel portal frame building with steel sheeting to walls and roof on a concrete slab;
- A single storey office building, constructed on a concrete slab with masonry walls with a steel roof;
- Concrete hardstand area retained by a low height retaining wall; and
- Security fencing including an electric remotely operated sliding entry gate.

**Fig. 6.43 Endeavour Energy Field Service Centre on Bridge Street, Picton**

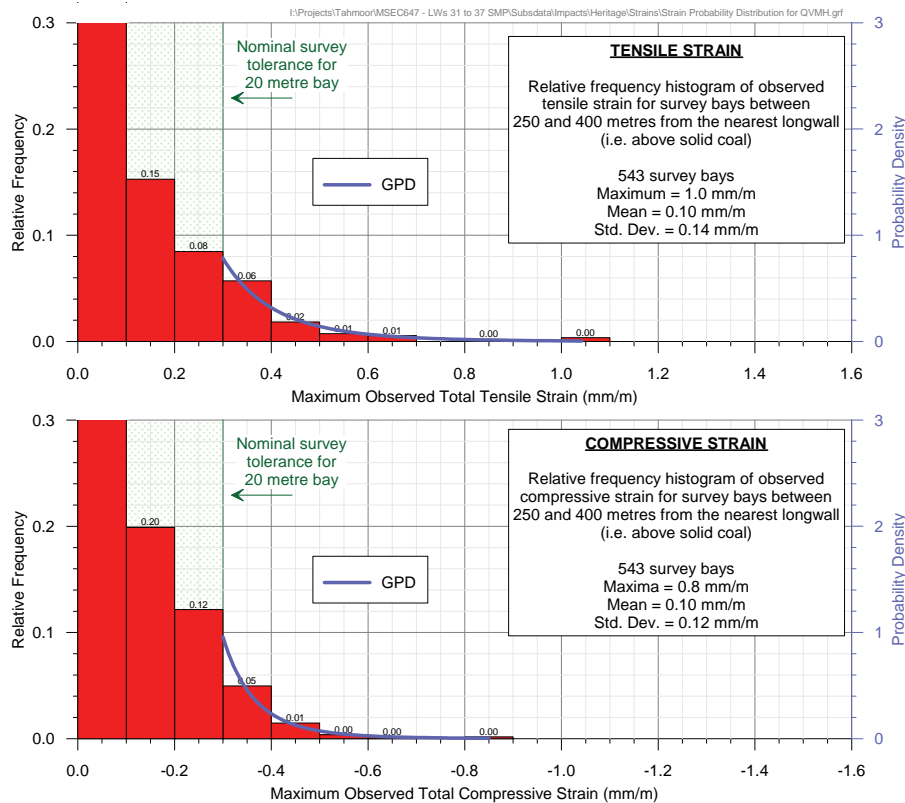
The building structures are located at distances between 250 metres and 400 metres from the proposed longwalls. The histogram of the maximum observed tensile and compressive strains measured at these distances from the longwalls at Tahmoor Colliery is provided in Fig. 6.46. The probability distribution functions, based on the fitted GPDs, have also been shown in this figure.

Fig. 6.46 Distributions of the Measured Maximum Tensile and Compressive Strains for Bays Located between 250 metres and 400 metres from Previous Longwalls at Tahmoor Colliery

Confidence levels have been determined from the empirical strain data using the fitted GPDs. In the cases where survey bays were measured multiple times during a longwall extraction, the maximum tensile strain and the maximum compressive strain were used in the analysis (i.e. single tensile strain and single compressive strain measurement per survey bay).

The building structures are located at distances between 210 metres and 400 metres from the proposed longwalls. The histogram of the maximum observed tensile and compressive strains measured at similar distance from the longwalls at Tahmoor Colliery is provided in Fig. 6.46. The predicted strains based on the 95 % confidence levels are less than 0.5 mm/m tensile and compressive, which is similar to the order of survey tolerance, i.e. not measurable.

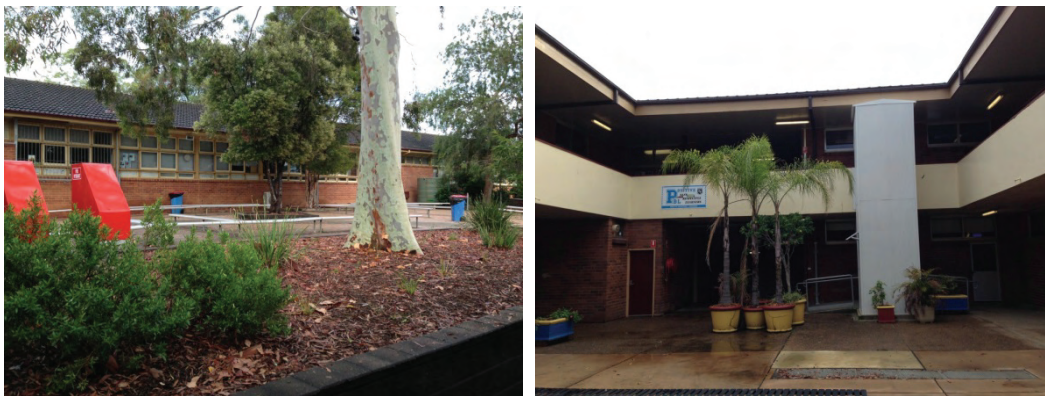
The main building structures are: the classrooms (refer to Fig. 6.47) which are single and double storey structures; the main hall (refer to Fig. 6.48) which is a single storey structure with portal framed roof with metal sheeting; demountable classrooms (refer to Fig. 6.49); covered walkways and outdoor learning areas (refer to Fig. 6.50); and amenities including mixed use courts (refer to Fig. 6.51).

Fig. 6.47 Typical Classroom Buildings

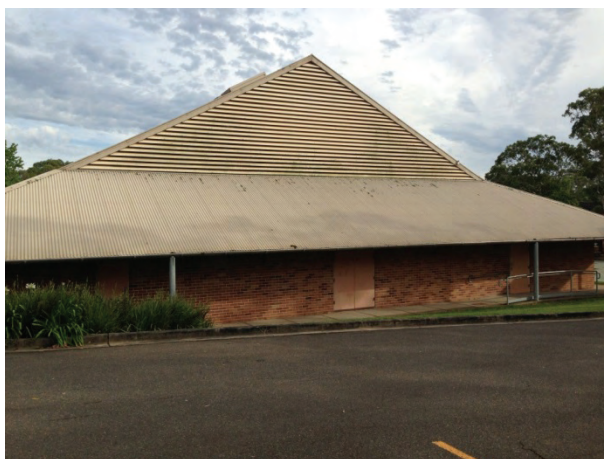
Fig. 6.48 School Hall

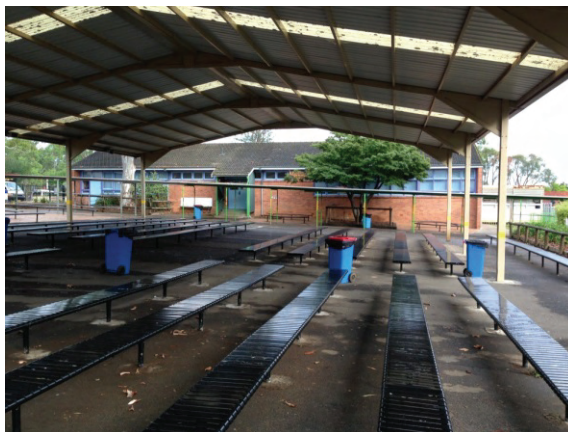
- a. Single storey brick veneer classrooms;
- b. Ductile steel framed structural steel walkways with structural steel roofing;
- c. Demountable type structures;
- d. Ductile steel framed structural steel COLA's with structural steel roofing
- e. Structural steel framed multi-purpose hall with perimeter articulated cavity brickwork of relatively recent construction constructed on a concrete raft slab;
- f. Two-storey classroom building, consisting of reinforced concrete framed beam and column structure;
- g. Single storey articulated masonry structure with an internal structural steel frame on a reinforced concrete raft slab; and
- h. Structural steel framed administration building, which has perimeter concrete block walls and clad metal walls, constructed on a concrete raft slab.

Fig. 6.50 Covered Walkways and Covered Outdoor Learning Area

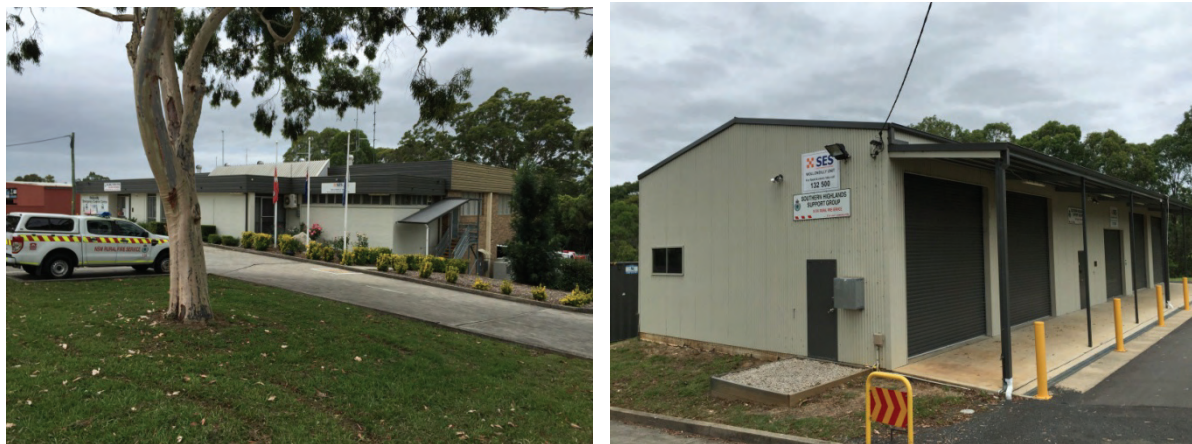
The Wollondilly Emergency Control Centre (WECC) for the Rural Fire Services and SES is located at 65 Bridge Street, Picton, and is directly above the proposed Longwall 32. The building structures include the: Emergency Control Centre Building (Ref. HH25a to HH25d) which is a single storey brick structure with metal sheet roof; and the garage (Ref. HH29a/b) which is a steel framed shed with metal roof and wall cladding. Photographs of these building structures are provided in Fig. 6.54.

Fig. 6.54 Wollondilly Emergency Control Centre Building Structures

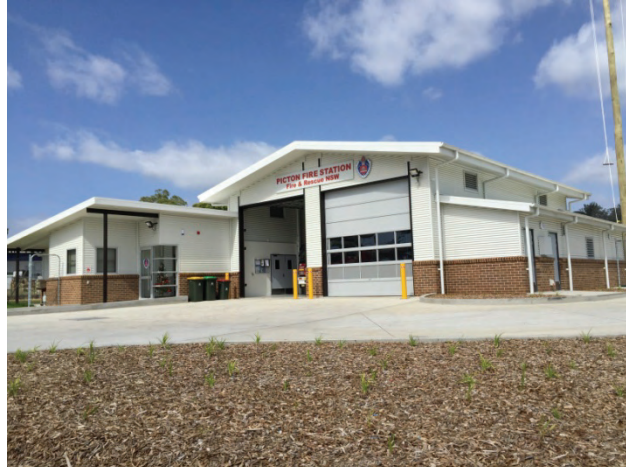
The Picton Fire Station is located on Argyle Street, at a distance of 250 metres north-east of the proposed Longwall 32. The station building comprises structural steel portal frames, with metal sheet roof and wall cladding and low level perimeter brick walls. A photograph of the station is provided in Fig. 6.55.

Fig. 6.55 Picton Fire Station

The building is predicted to experience 60 mm vertical subsidence resulting from the proposed mining. Whilst the structure could experience low levels of vertical subsidence, it is not expected to experience any measurable tilts, curvatures or strains, even if the predictions were exceeded by a factor of 2 times.

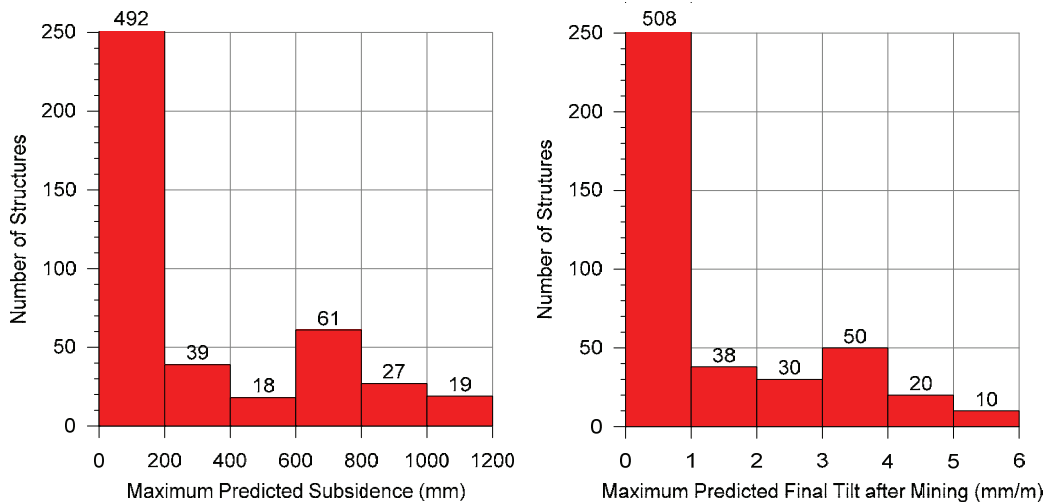
The maximum predicted values of conventional subsidence, tilt and curvature for the rural structures, after the completion of each of the proposed longwalls, are included in Tables D.02 to D.08, in Appendix D. The distributions of the maximum predicted conventional subsidence, tilt and curvature for the structures within the SMP Area, resulting from the extraction of the proposed longwalls, are illustrated in Fig. 6.56 and Fig. 6.57.

Fig. 6.56 Maximum Predicted Conventional Subsidence and Final Tilt for the Rural Structures

Predictions of subsidence, tilt and curvature have been made at the centroid and each vertex of each structure, as well as eight equally spaced points radially placed around each centroid and vertex at a distance of 20 metres. In the case of a rectangular shaped structure, predictions have been made at a minimum of 45 points within and around the structure. The maximum predicted subsidence parameters have been extracted from these predictions during and after each longwall, and have been used to assess the likely impacts.

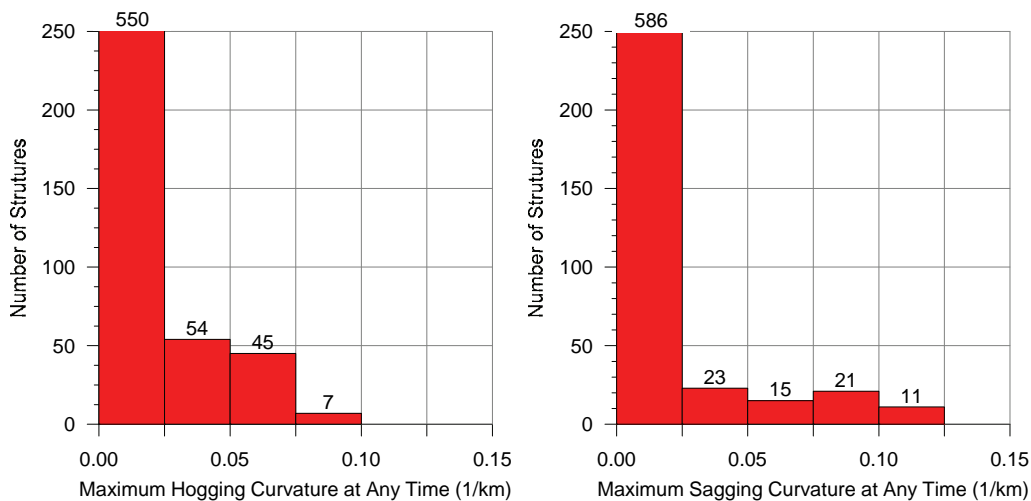
Fig. 6.57 Maximum Predicted Conventional Hogging Curvature (Left) and Sagging Curvature (Right) for the Rural Structures

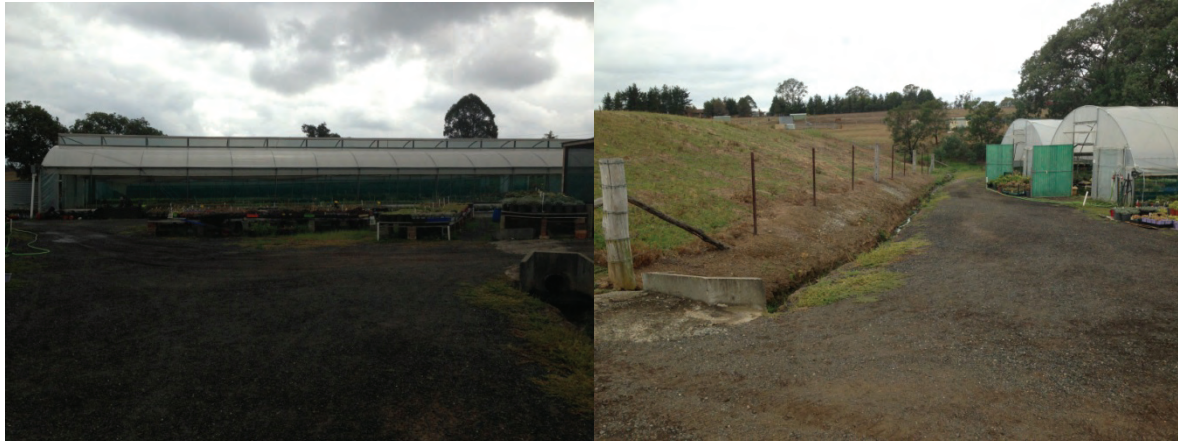
Fig. 6.58 Market Garden Shade Structures on Property GG38

The property Ref. GG38 on Stilton Lane has nine market garden shade structures (Refs. GG38e to GG38n) which house succulent plants. These structures are located partially above the approved Longwall 30 and adjacent to the proposed Longwall 31. Photographs of the shade structures are provided in Fig. 6.58.

The shade structures are predicted to experience up to: 450 mm vertical subsidence; 4.5 mm/m tilt (i.e. 0.5 %, or 1 in 220); and 0.04 km⁻¹ hogging and sagging curvatures (i.e. minimum radius of curvature of 25 kilometres).

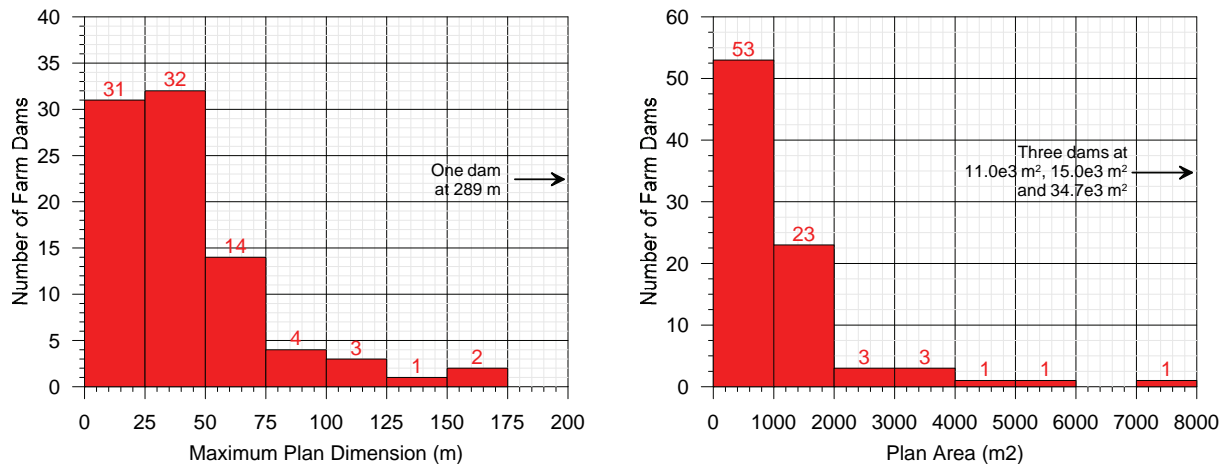
Fig. 6.59 Distributions of Longest Lengths and Surface Areas of the Farm Dams

There are 88 farm dams which have been identified within the SMP Area. The locations of the dams are shown in Drawing Nos. MSEC647-27 and MSEC647 – Maps 01 to 48, and details are provided in Table D.09, in Appendix D. The locations and sizes of the farm dams were determined from an aerial photograph of the area. The distributions of the longest lengths and surface areas of the farm dams within the SMP Area are shown in Fig. 6.59.

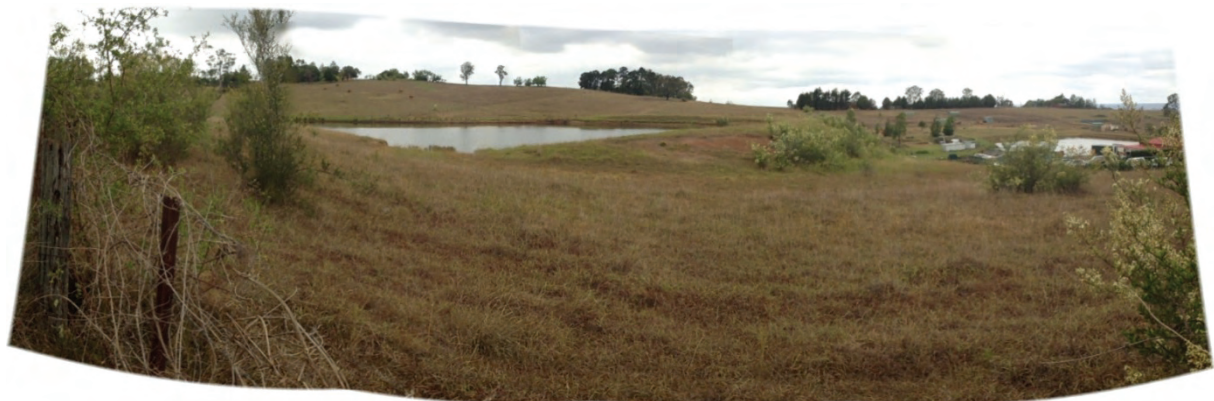
Fig. 6.60 Dam Ref. GG37a

- Dam Ref. GG37a is partially located above the proposed Longwall 31 and has a surface area of 11,000 m² and has a dam wall height of approximately 8 metres (refer to Fig. 6.60). There is a second dam located immediately downstream (Ref. GG38d), which is also partially located above the proposed Longwall 31, and has a surface area of 4,570 m². Both these dams are located upstream of the structures and infrastructure associated with the Market Garden farm on Stilton Lane (refer to Section 6.15.6);

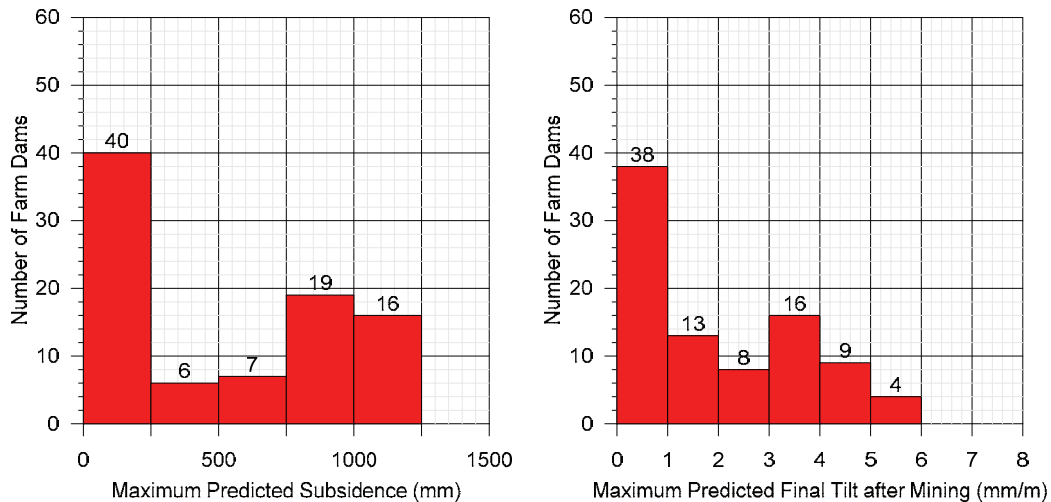
Fig. 6.61 Maximum Predicted Conventional Subsidence and Final Tilt for the Farm Dams

The distributions of the maximum predicted conventional subsidence, tilt and curvature for the farm dams within the SMP Area, resulting from the extraction of the proposed longwalls, are illustrated in Fig. 6.61 and Fig. 6.62.

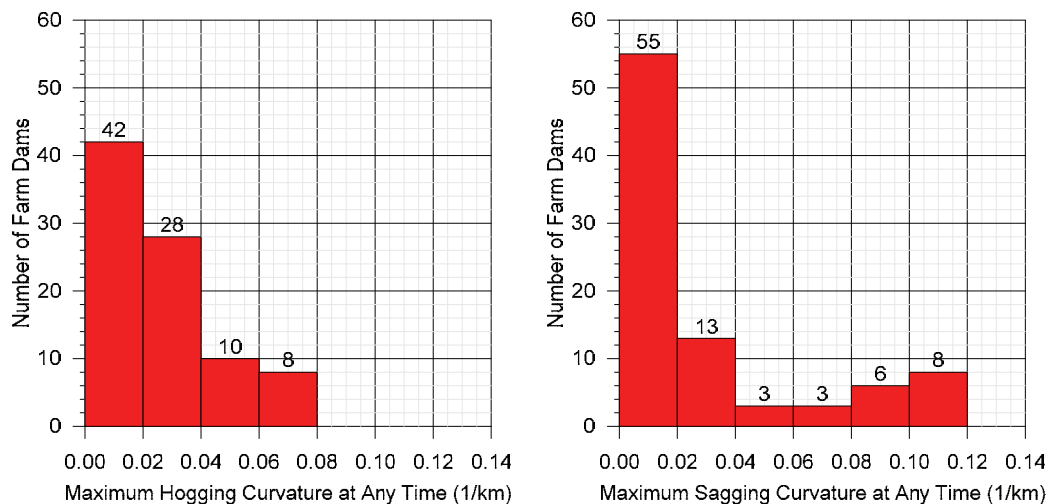
Fig. 6.62 Maximum Predicted Conventional Hogging Curvature (Left) and Sagging Curvature (Right) for the Farm Dams

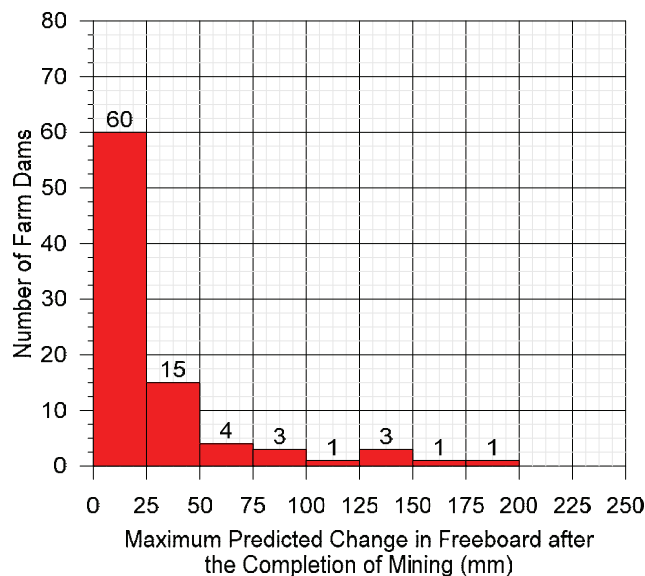
Fig. 6.63 Predicted Total Changes in Freeboards for the Farm Dams due to LW22 to LW37

The maximum predicted changes in freeboard at the farm dams within the SMP Area were determined by taking half the difference between the maximum predicted subsidence and the minimum predicted subsidence around the perimeters of the dams. The maximum predicted changes in freeboard at the farm dams within the SMP Area are provided in Table D.09, in Appendix D, and are illustrated in Fig. 6.63.

The maximum predicted total change in freeboard at the farm dams is 200 mm, which occurs at Dam Ref. PTH_105_d01 after the extraction of the proposed Longwall 34. Changes in freeboard of 150 mm also occur at Dam Refs. GG04a, GG37a, GG38d and PTH_031_d01. The predicted changes in freeboard are relatively small and are unlikely, therefore, to result in any significant reductions in the capacities of the farm dams.

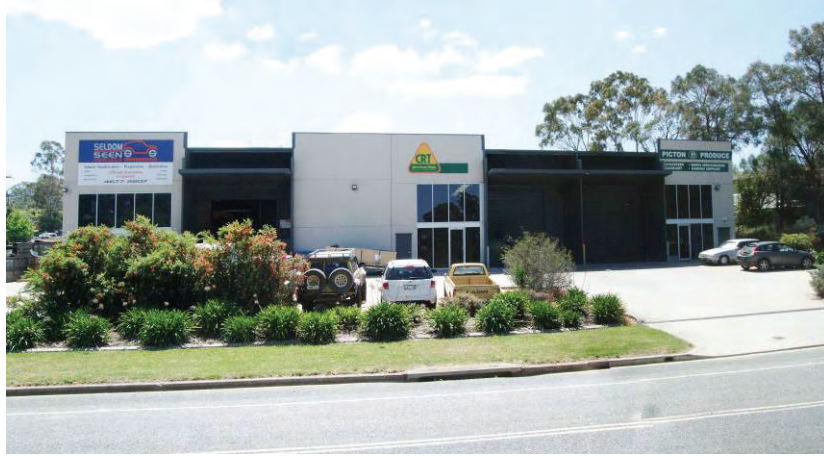
Fig. 6.64 Front elevation of concrete tilt panel structure

Photographs showing a range of structure types within the SMP Area are provided in Fig. 6.64 to Fig. 6.67.

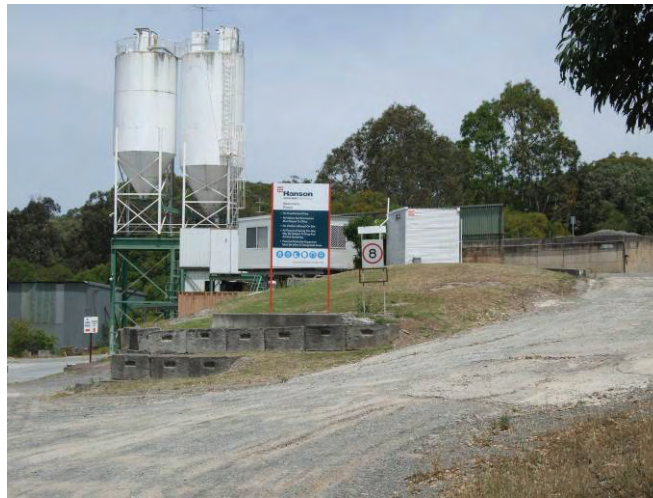
Fig. 6.65 Hoppers for concrete batching plant

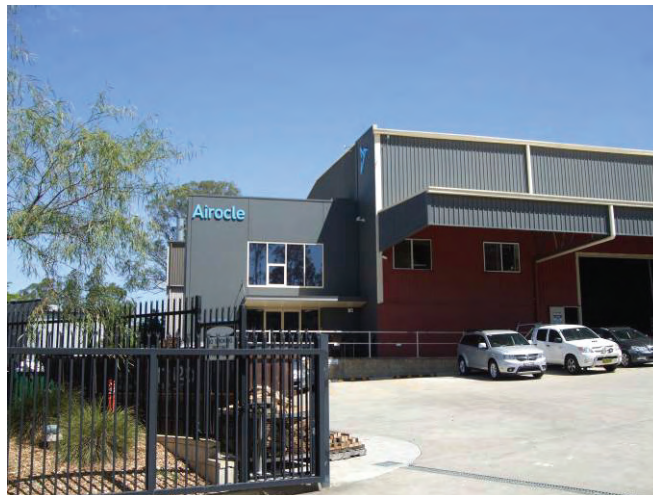
Fig. 6.66 Large structural steel portal frame with metal cladding

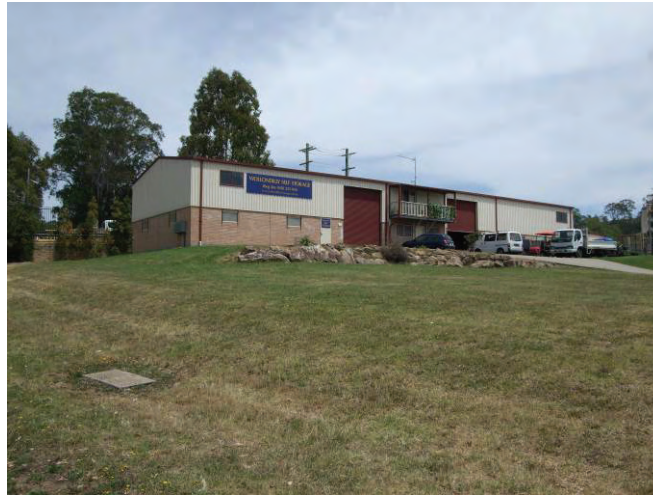
Fig. 6.67 Structure with articulated perimeter cavity brickwork and clad metal framed walls around a ductile steel portal frame

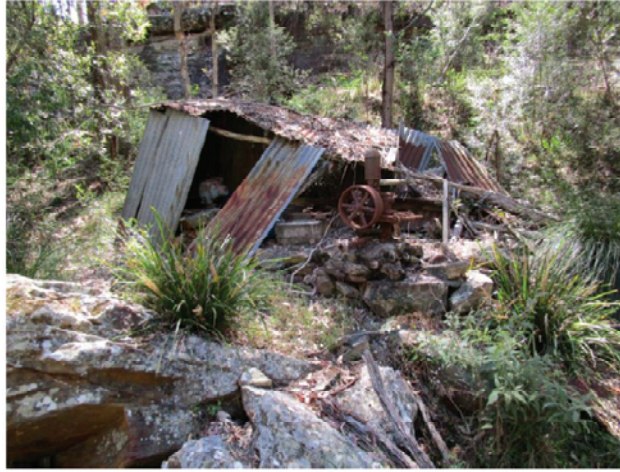
Fig. 6.71 Pump House at Matthews Creek (Source: Niche, 2014c)

The pump house and weir at Matthews Creek are located 330 metres south-west of the proposed LW37. The pump house is a collapsed corrugated iron structure built on a timber frame on top of large sandstone blocks, located 10 to 15 metres from the weir. The pump is still standing and there are other relics in the ruins. The pump appears to still be operational. The weir appears to be dry wall, built from sandstone blocks, with a concrete render (Niche, 2014c). A photograph of the pump house is provided in Fig. 6.71 (Source: Niche, 2014c).

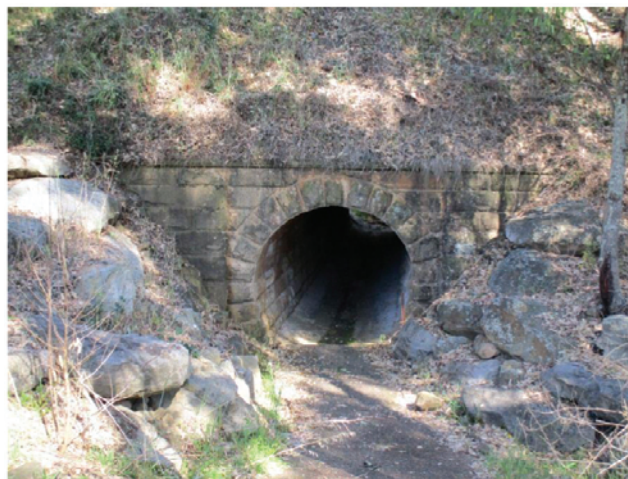
Fig. 6.72 Sandstone Culvert at Matthews Creek, Picton to Mittagong Loop Line (Source: Niche, 2014c)

The sandstone culvert at a tributary of Matthews Creek, on the Picton to Mittagong Loop Line (chainage 88.98 km), is formed from sandstone blocks. The culvert is recorded as being in good condition (Niche, 2014c). A photograph of the culvert is provided in Fig. 6.72 (Source: Niche, 2014c).

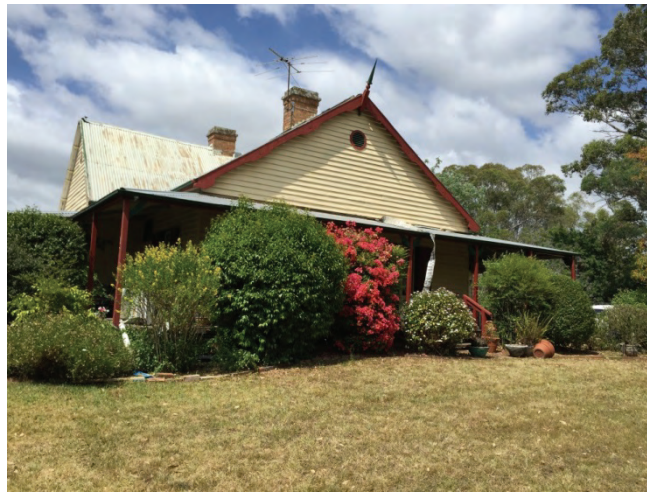
Fig. 6.74 Mill Hill, Miller's House (Ref. V06a)

Miller's House (Structure Ref. V06a) is located around 100 metres from the end of Longwall 31. The items of heritage significance consist of a single-storey weatherboard house, and archaeological relics. The weatherboard house sits on brick and steel piers, and is therefore inherently structurally flexible, making it less prone to subsidence impact. A photograph of the house is provided in Fig. 6.74.

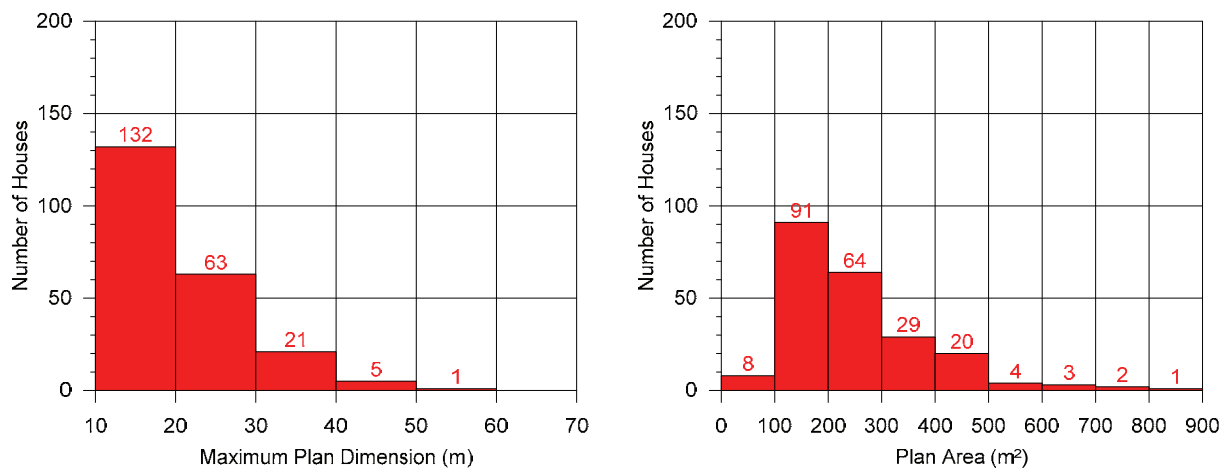
Fig. 6.77 Distribution of Houses by Maximum Plan Dimension and Plan Area

The distributions of the maximum plan dimensions and plan areas of the houses within the SMP Area are provided in Fig. 6.77. The majority of the houses are between 10 metres and 30 metres long, with an average length of around 21 metres. The majority of the houses have plan areas between 80 m² and 810 m², with an average area of around 250 m².

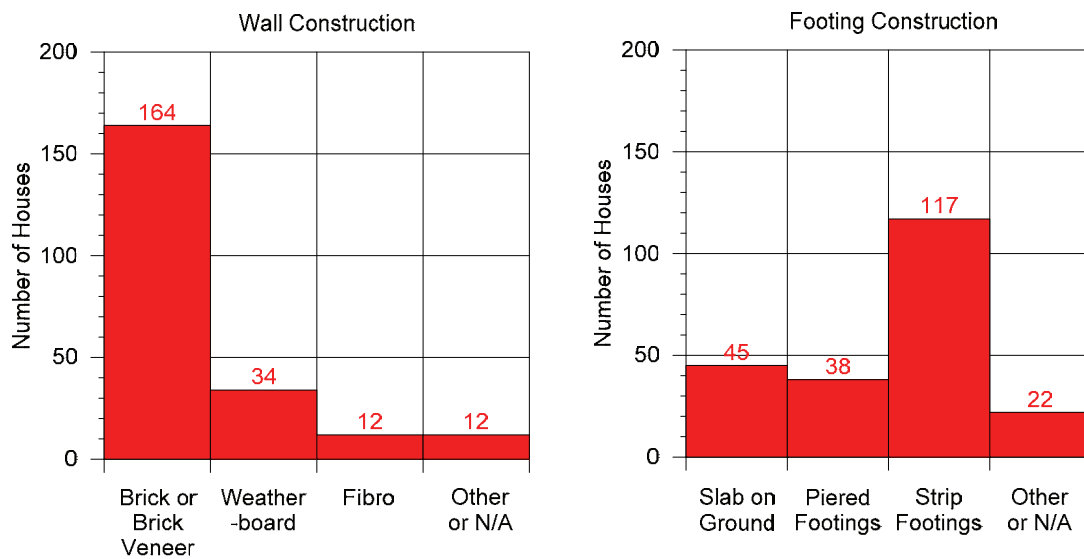
**Fig. 6.78 Distributions of Wall and Footing Construction for Houses within the SMP Area**

The distributions of the wall and footing constructions of the houses within the SMP Area are provided in Fig. 6.78. The majority of the houses within the SMP Area are either brick or brick-veneer construction and are founded on strip footings.

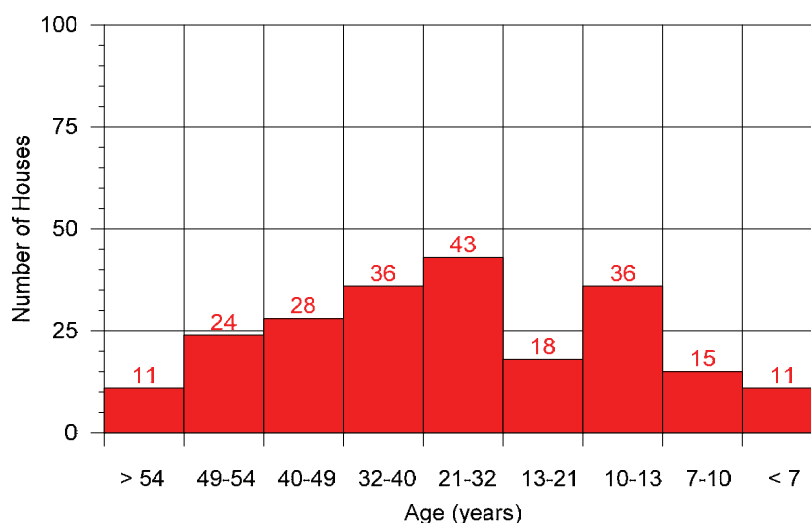
**Fig. 6.79 Distribution of Houses by Age**

A histogram showing the distribution of houses by age is shown in Fig. 6.79. A map showing the spatial distribution of structures by age of house is provided in Drawing No. MSEC647-28. It can be seen from this figure, that the newest houses are predominately located above the proposed LW36 and LW37, with older houses predominately located above the proposed Longwalls 31 and 32.

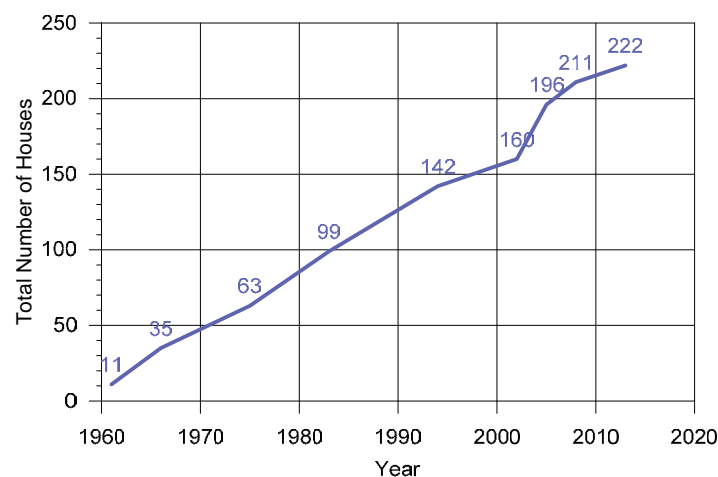
Fig. 6.80 Total Number of Houses within the SMP Area with Time

The statistics on building age provide a reasonable indication of the rate of growth of houses within the SMP Area. The total number of houses within the SMP Area with time is illustrated in Fig. 6.80.

The highest rate of construction occurred between 2002 and 2005, with 36 houses constructed during this period, which equates to a maximum rate of 12 houses per year. However, since this time the rate of construction has decreased. There were 80 houses constructed over the past 20 years, which equates to an average rate of construction of approximately four houses per year.

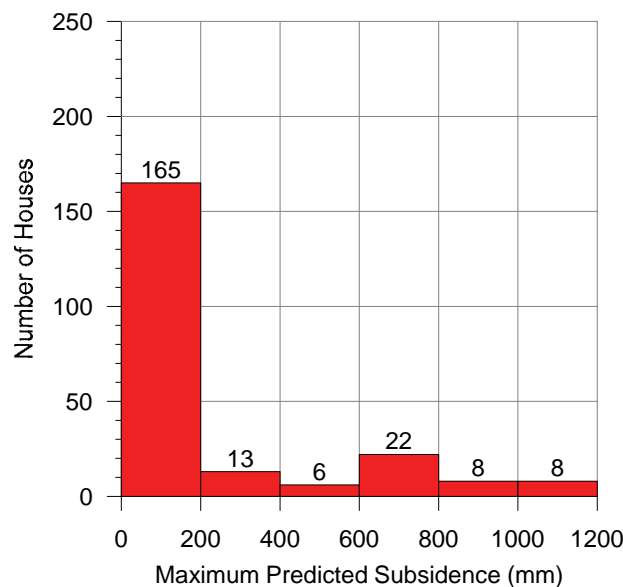
Fig. 6.81 Maximum Predicted Conventional Subsidence for the Houses within the SMP Area

The distribution of the predicted conventional subsidence parameters for the houses within the SMP Area are illustrated in Fig. 6.81, Fig. 6.82 and Fig. 6.83 below.

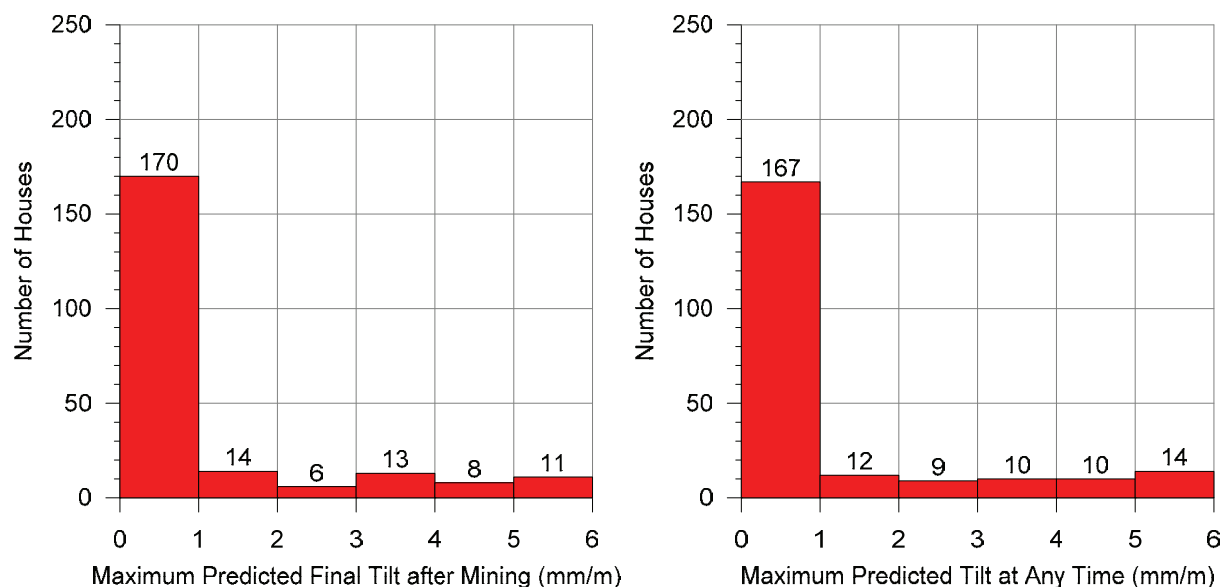
Fig. 6.82 Maximum Predicted Conventional Tilts After the Extraction of All Longwalls (Left) and Maximum Predicted Conventional Tilts After the Extraction of Any Longwall (Right)

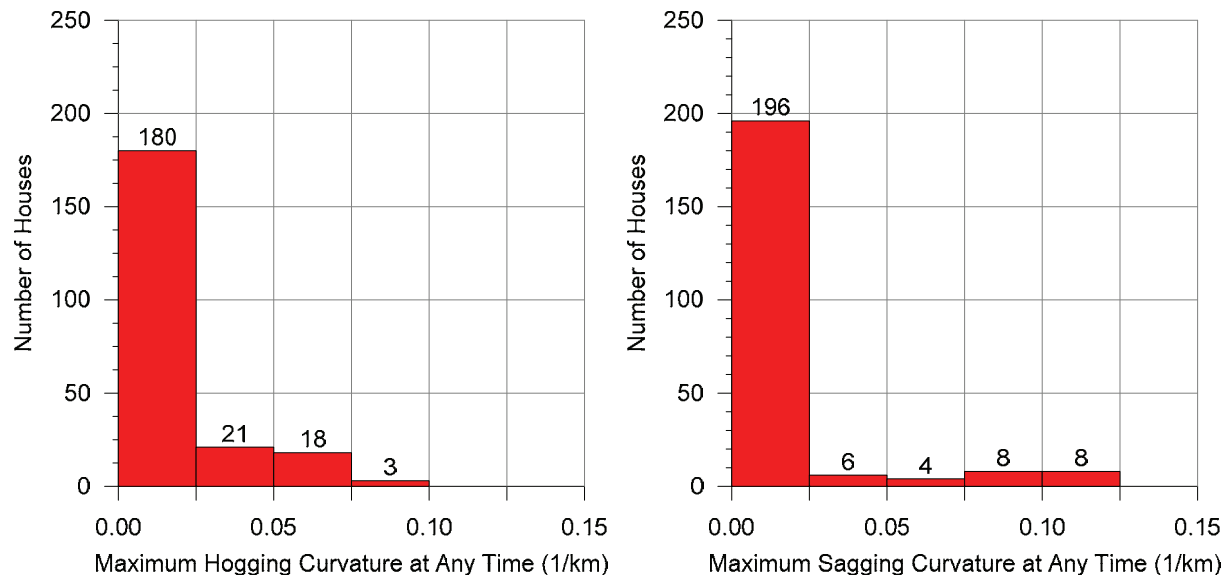
Fig. 6.83 Maximum Predicted Conventional Hogging Curvature (Left) and Sagging Curvature (Right) for the Houses within the SMP Area
