Fig. 6.36 Mushroom Tunnel

6.8. Potable Water Infrastructure

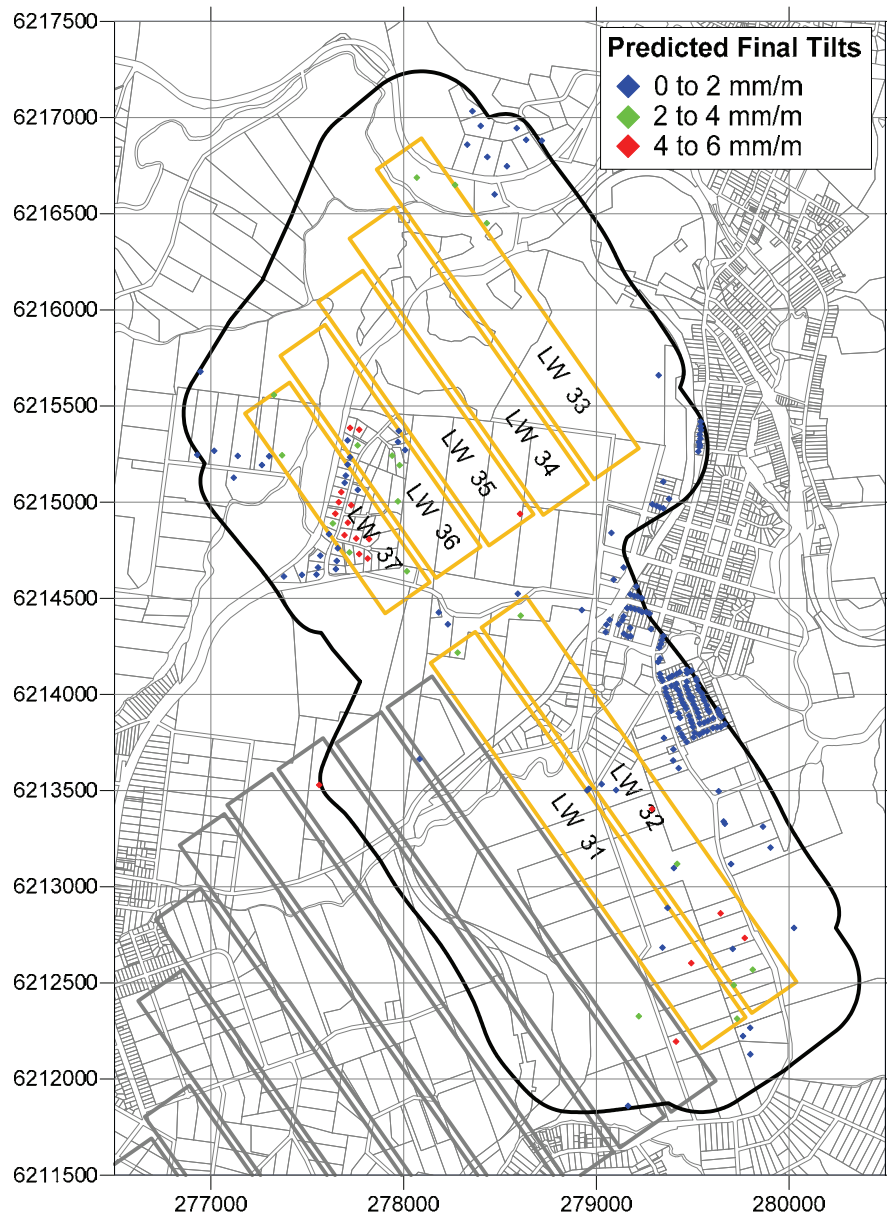
Fig. 6.84 Distribution of Predicted Final Tilts for the Houses within the SMP Area

The maximum predicted tilt for the houses within the SMP Area is 6 mm/m. The predicted final tilts for the majority of the houses (i.e. 170 structures, or 77 % of the total) are less than 1 mm/m, as most are located outside the extents of the proposed longwalls. The distribution of predicted final tilts for the houses within the SMP Area is provided in Fig. 6.84.

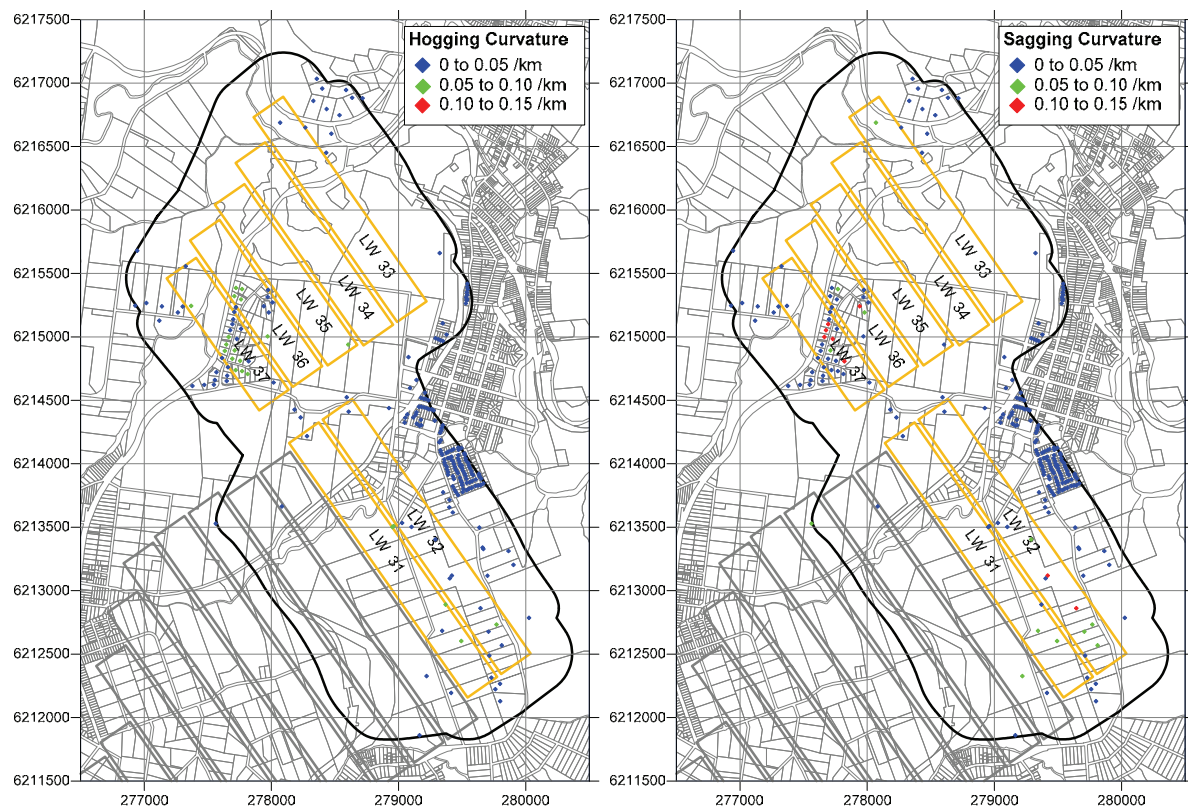
Fig. 6.85 Distributions of Maximum Predicted Curvatures for the Houses within the SMP Area

The maximum predicted curvatures for the houses within the SMP Area are 0.08 km^{-1} hogging and 0.11 km^{-1} sagging, which represent minimum radii of curvatures of 13 kilometres and 9 kilometres, respectively. The predicted curvatures for the majority of the houses (i.e. 178 structures, or 80 % of the total) are less than 0.03 km^{-1} , as most are located outside the extents of the proposed longwalls. The distributions of the maximum predicted curvatures for the houses within the SMP Area are provided in Fig. 6.85.

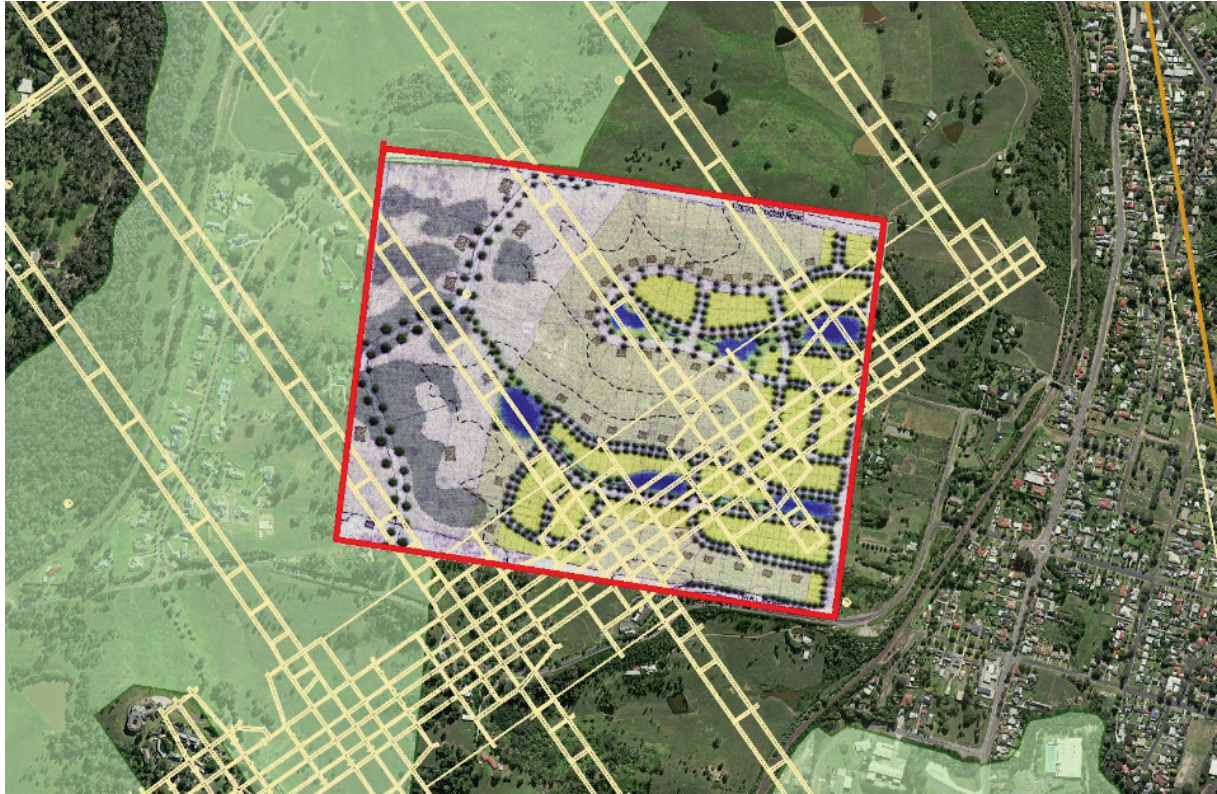
Fig. 6.86 Indicative Subdivision Layout for Proposed Clearview Development above proposed Longwalls 33 to 37

The location of the proposed Clearview Development in relation to the proposed longwalls is shown in Drawing No. MSEC647-27. If the proposal is approved an additional 426 blocks would be located within the SMP Area, partially above the proposed Longwalls 33 to 37. The property is currently not within a declared Mine Subsidence District.

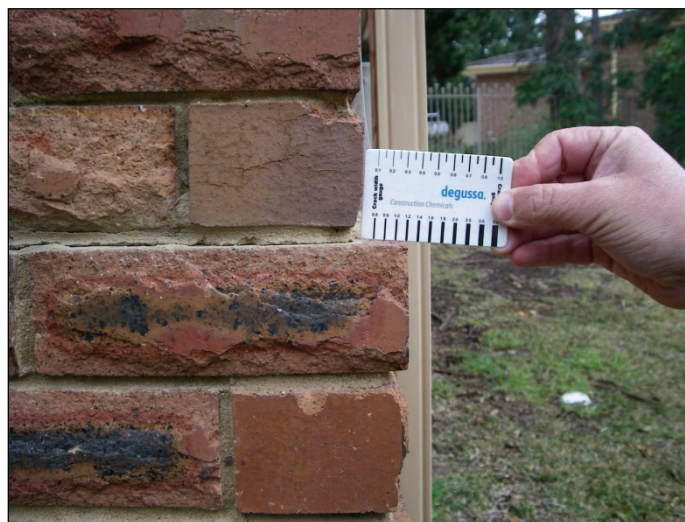
Fig. C.1 Example of slippage on damp proof course

Approximately 30 houses have experienced slippage along the damp proof course in Tahmoor. Slippage on some houses is relatively small (less than 10 mm) though substantial slippage has been observed in a number of cases, such as shown in Fig. C.1 below.

Under the previous classification method, the “crack” width of the slippage may be very small (Category 1) but the distortion in the brickwork is substantial. Moreover, the extent of work required to repair the impact is substantial as it usually involves re-lining the whole external skin of the structure. Such impacts would be considered Category 4 based on extent of repair but only Category 1 or 2 based on maximum crack width.

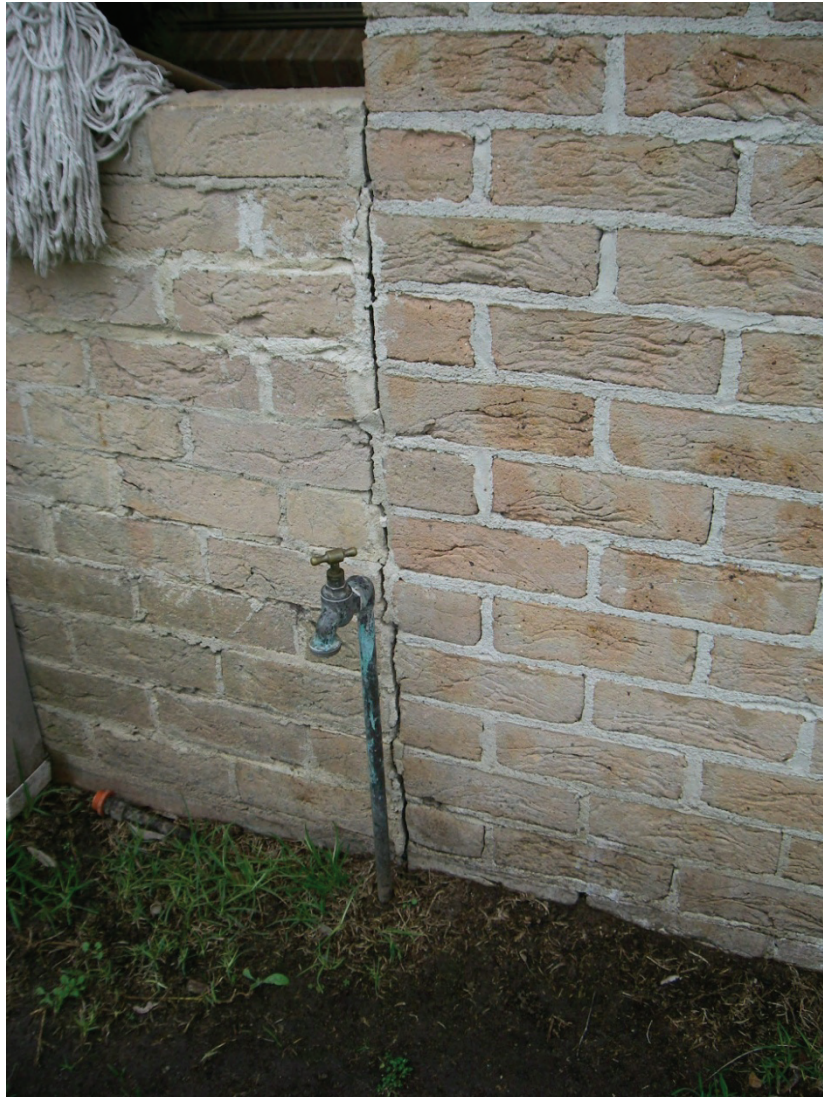
Fig. C.2 Example of crack in mortar only

In some cases, cracks are observed in mortar only. For example, movement joints in some structures have been improperly filled with mortar instead of a flexible sealant, as shown in Fig. C.2. In these situations, the measured crack width may be significant but the impact is relatively simple to repair regardless of the crack width.

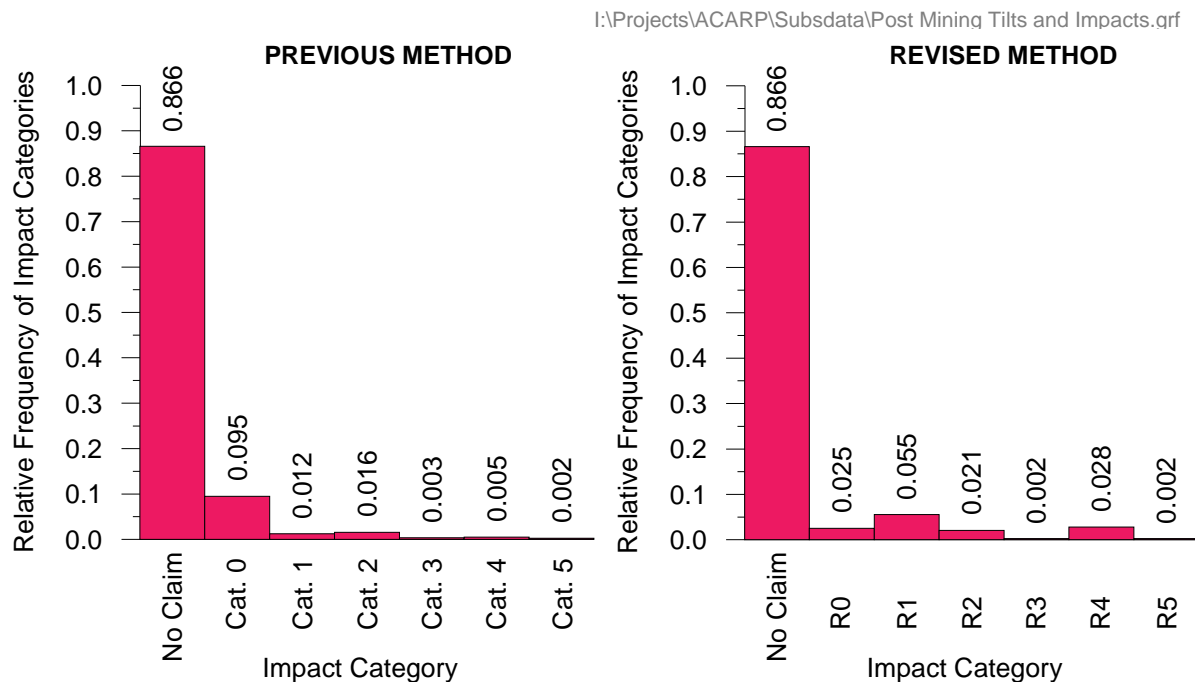
Fig. C.3 Comparison between Previous and Revised Methods of Impact Classification

A comparison between the previous and revised methods is shown in Fig. C.3.

It can be seen that there was an increased proportion in the higher impact categories using the revised method. This is brought about mainly by the recorded slippage on damp proof courses, which are classified as either Category 3 or Category 4 when they were previously classified as Category 1 or 2.

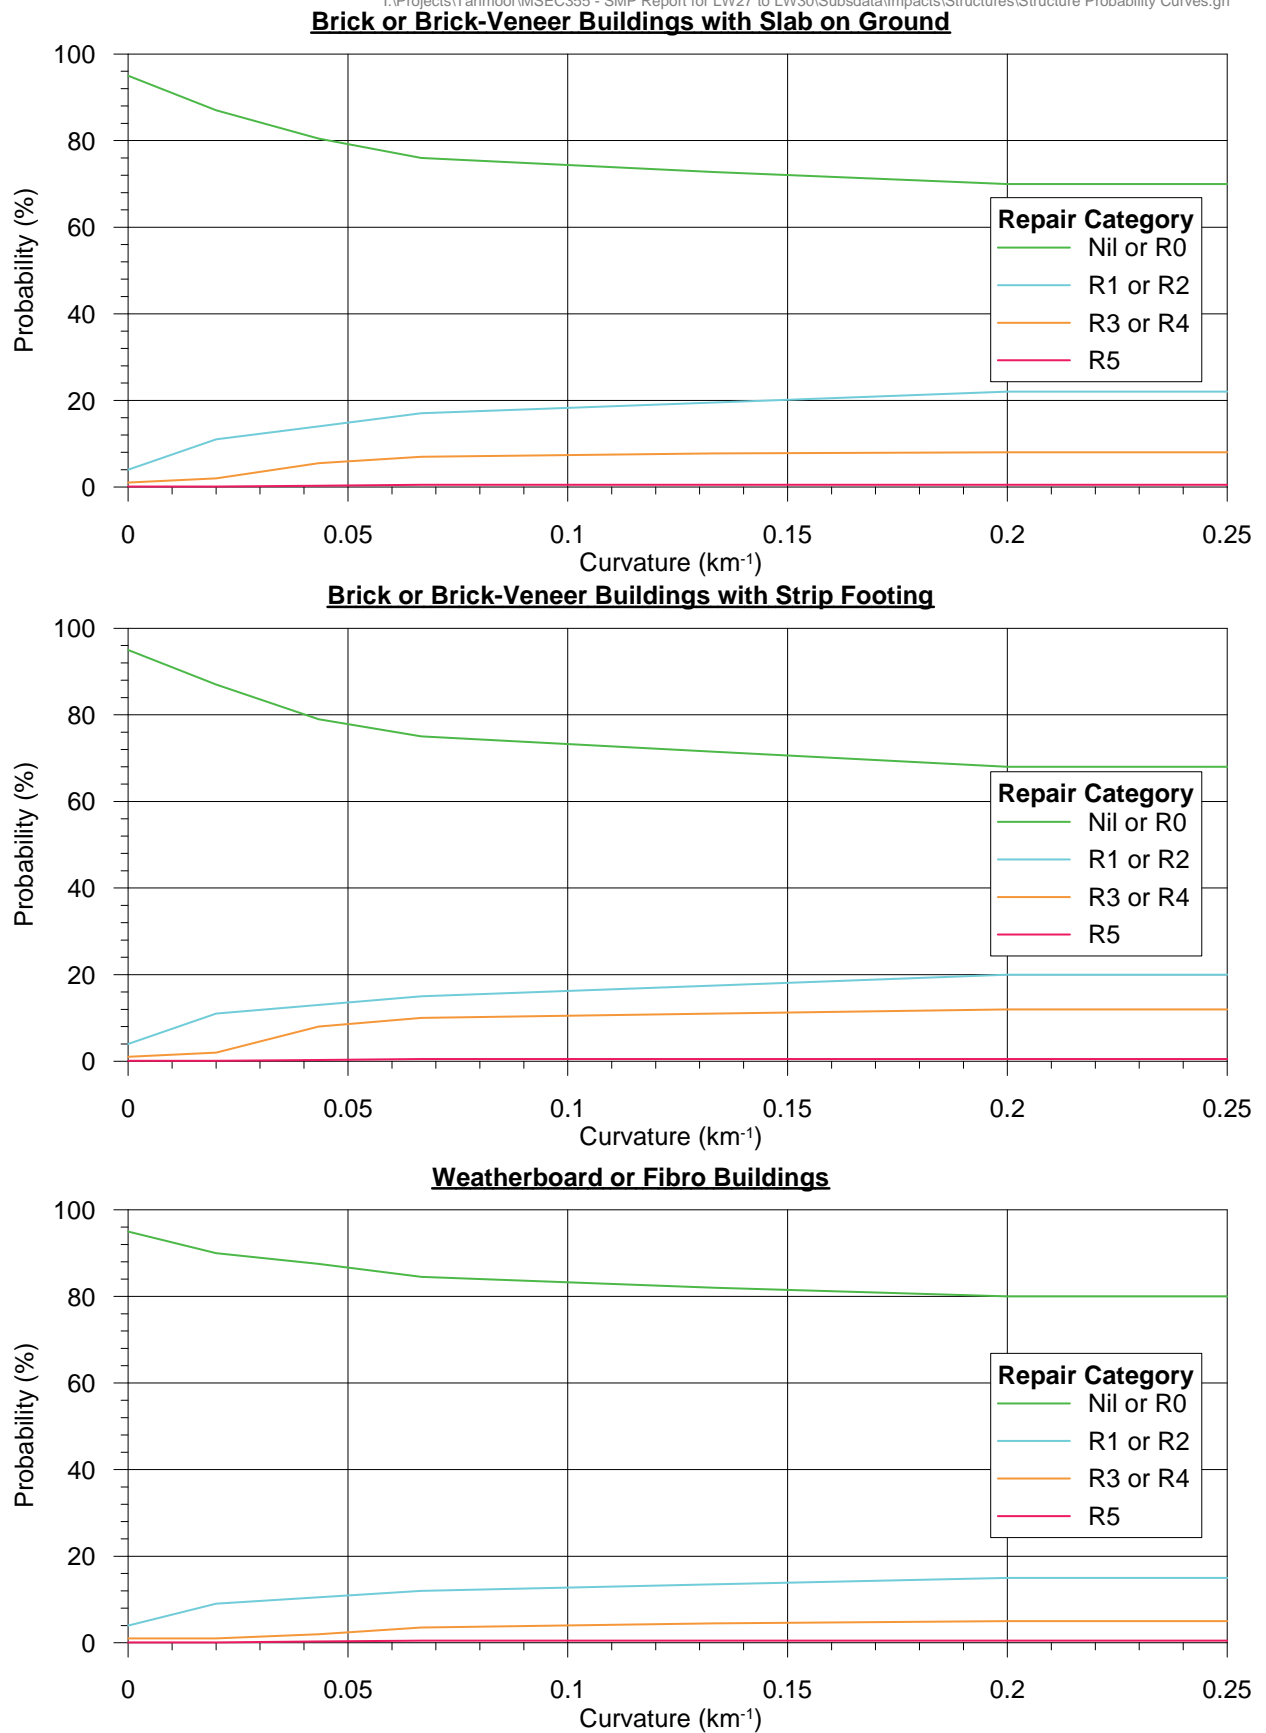
Fig. C.4 Probability Curves for Impacts to Buildings

The ranges provided in Table C.5 have been converted into a set of probability curves to remove artificial discontinuities that are formed by dividing curvatures into three categories. These are shown in Fig. C.4. The probability curves are applicable for all houses and civil structures.

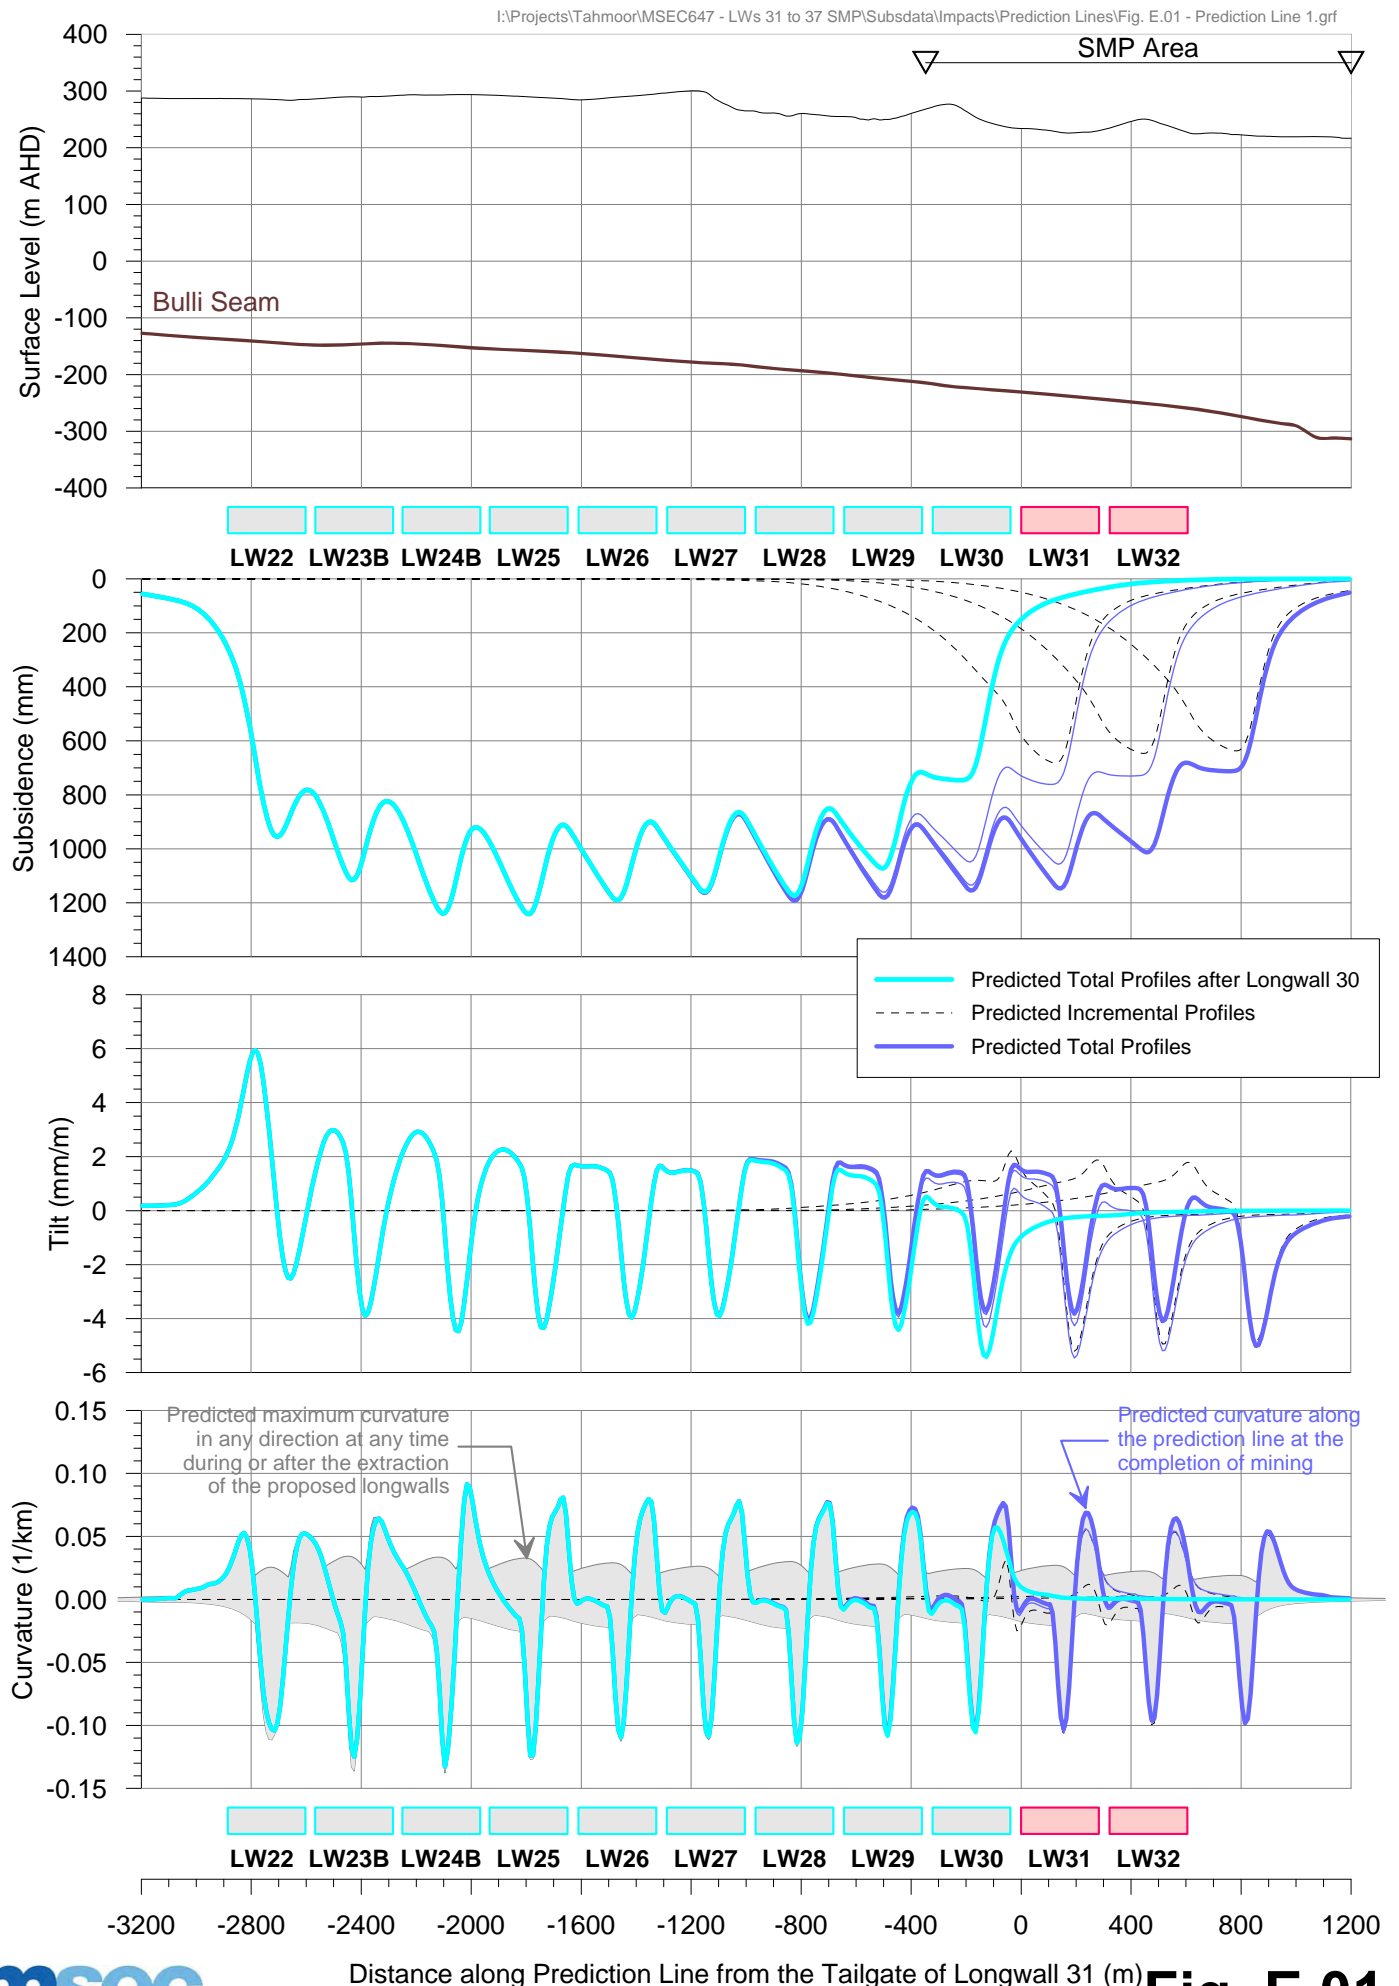
Predicted Profiles of Conventional Subsidence, Tilt and Curvature along Prediction Line 1 Resulting from the Extraction of Longwalls 22 to 32

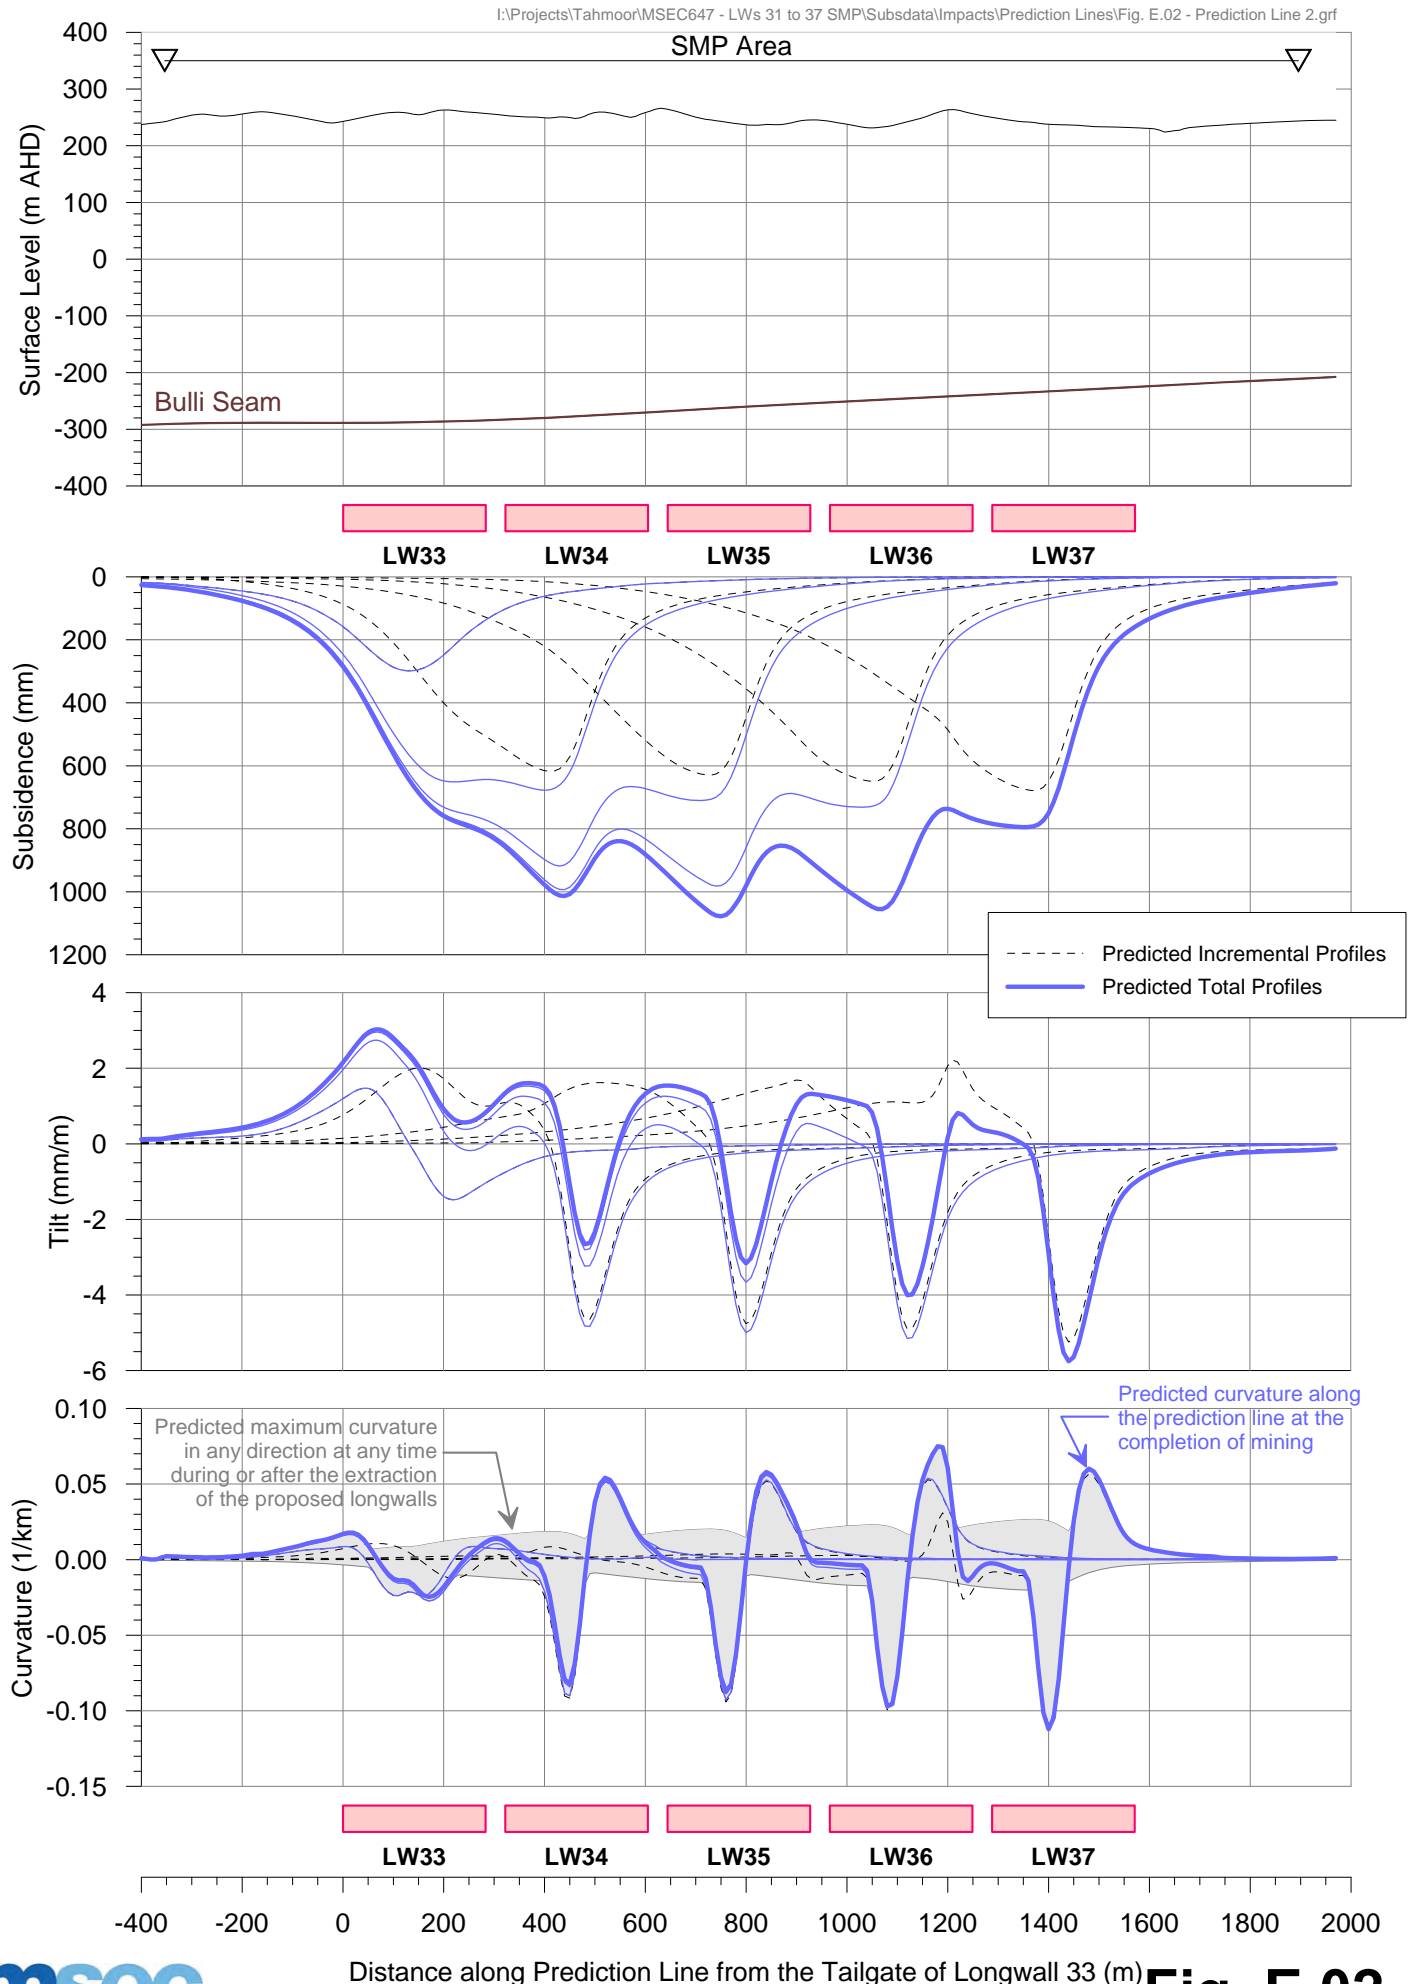
Predicted Profiles of Conventional Subsidence, Tilt and Curvature along Prediction Line 2 Resulting from the Extraction of Longwalls 33 to 37

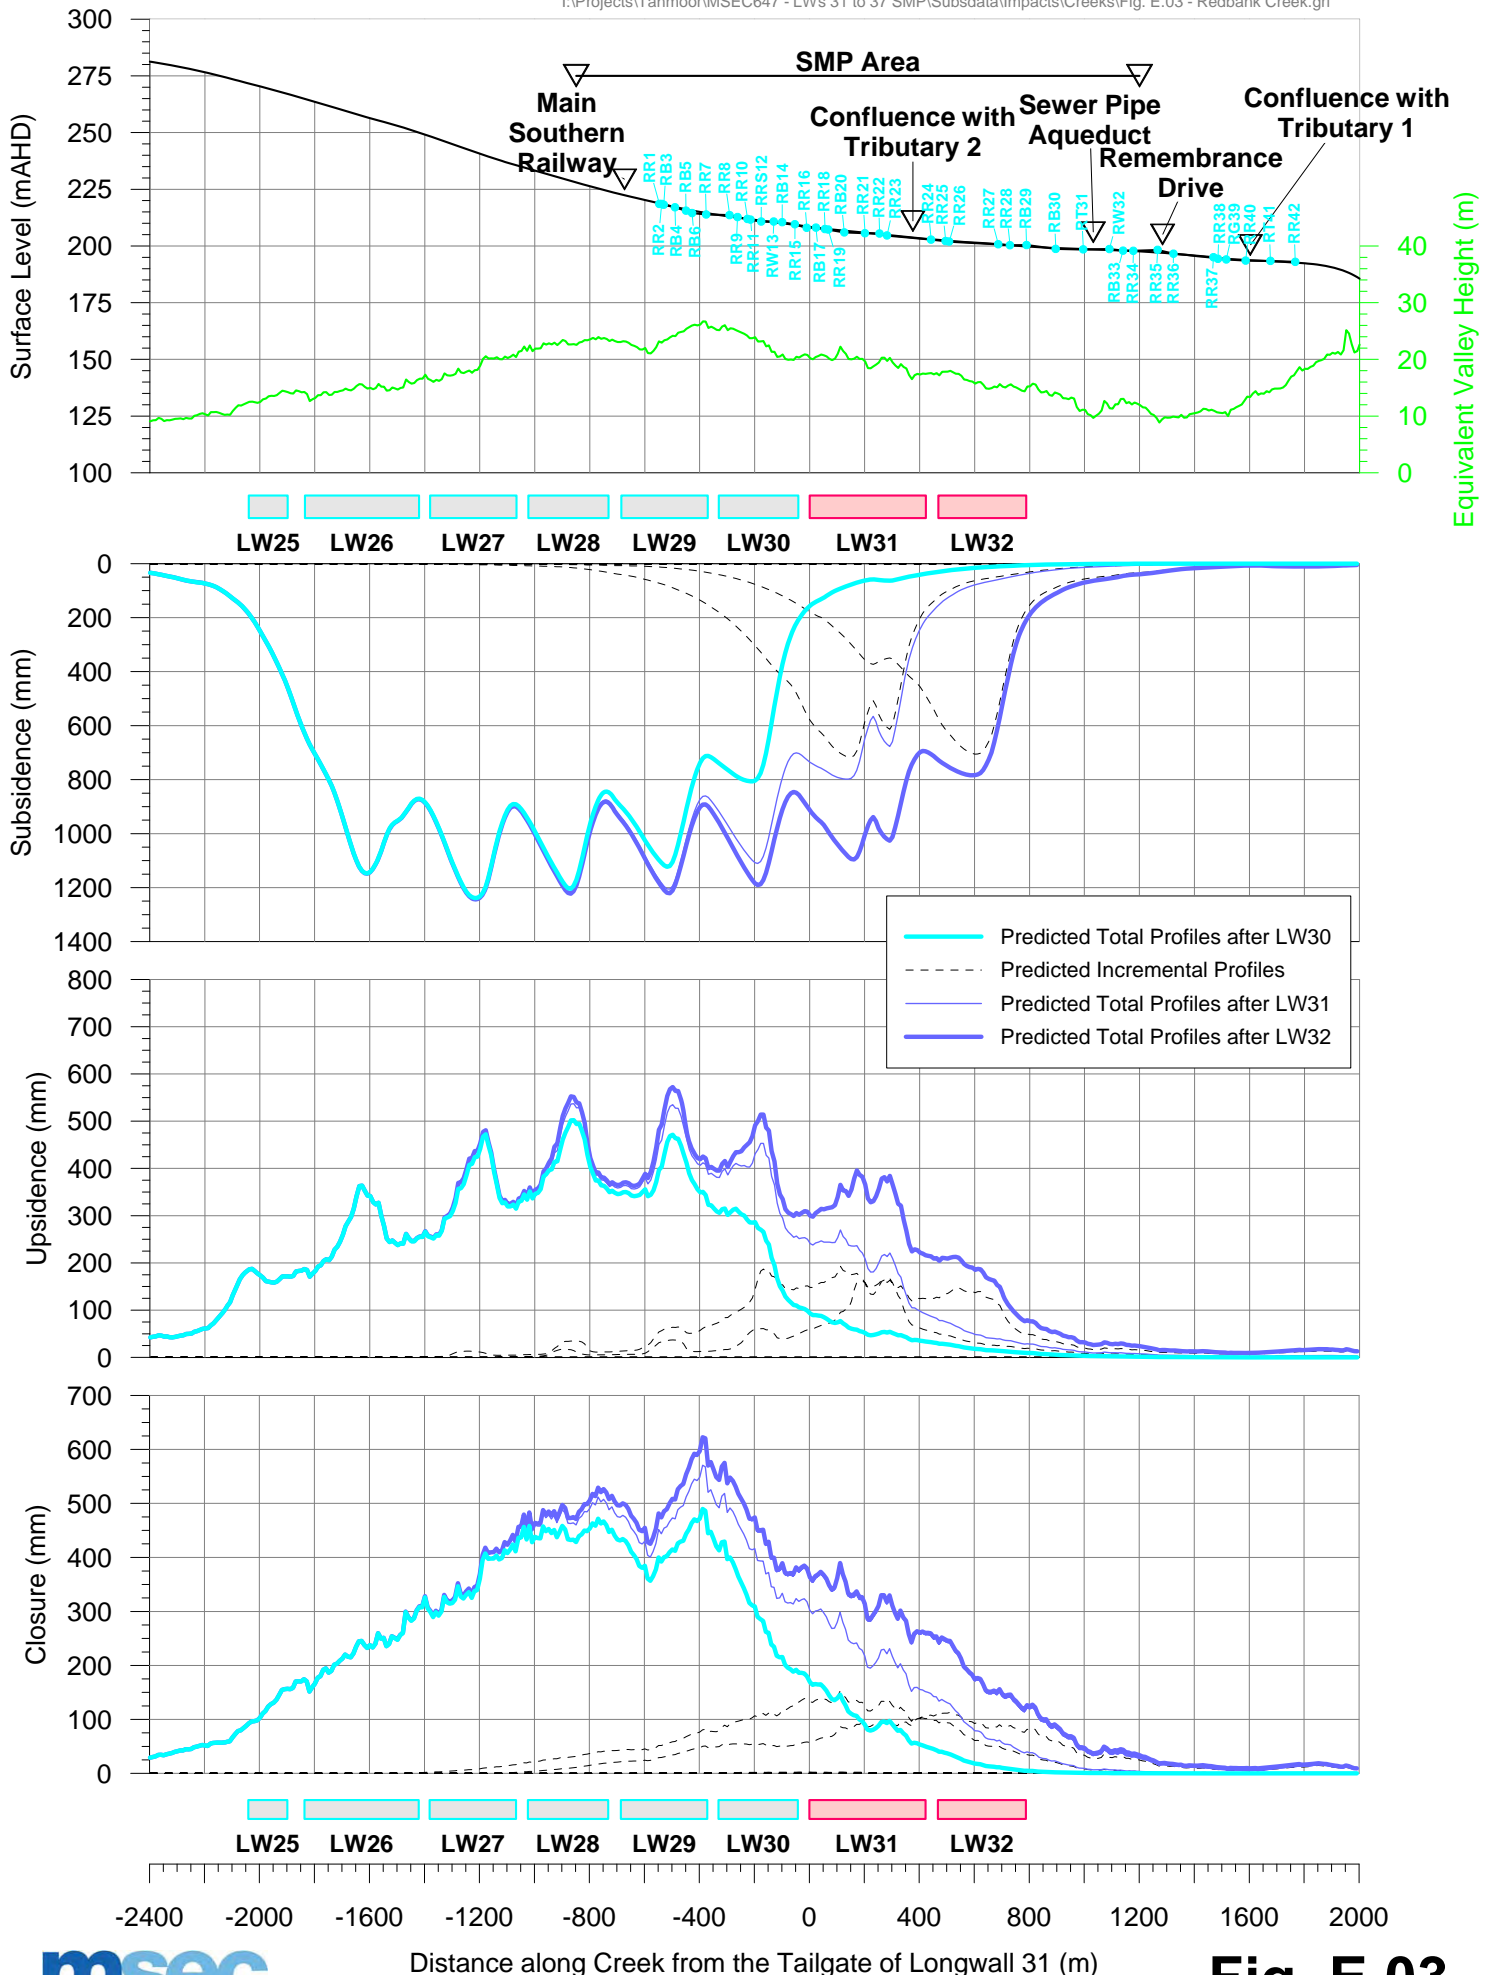
Predicted Profiles of Subsidence, Upsidence and Closure along Redbank Creek Resulting from the Extraction of Longwalls 22 to 37

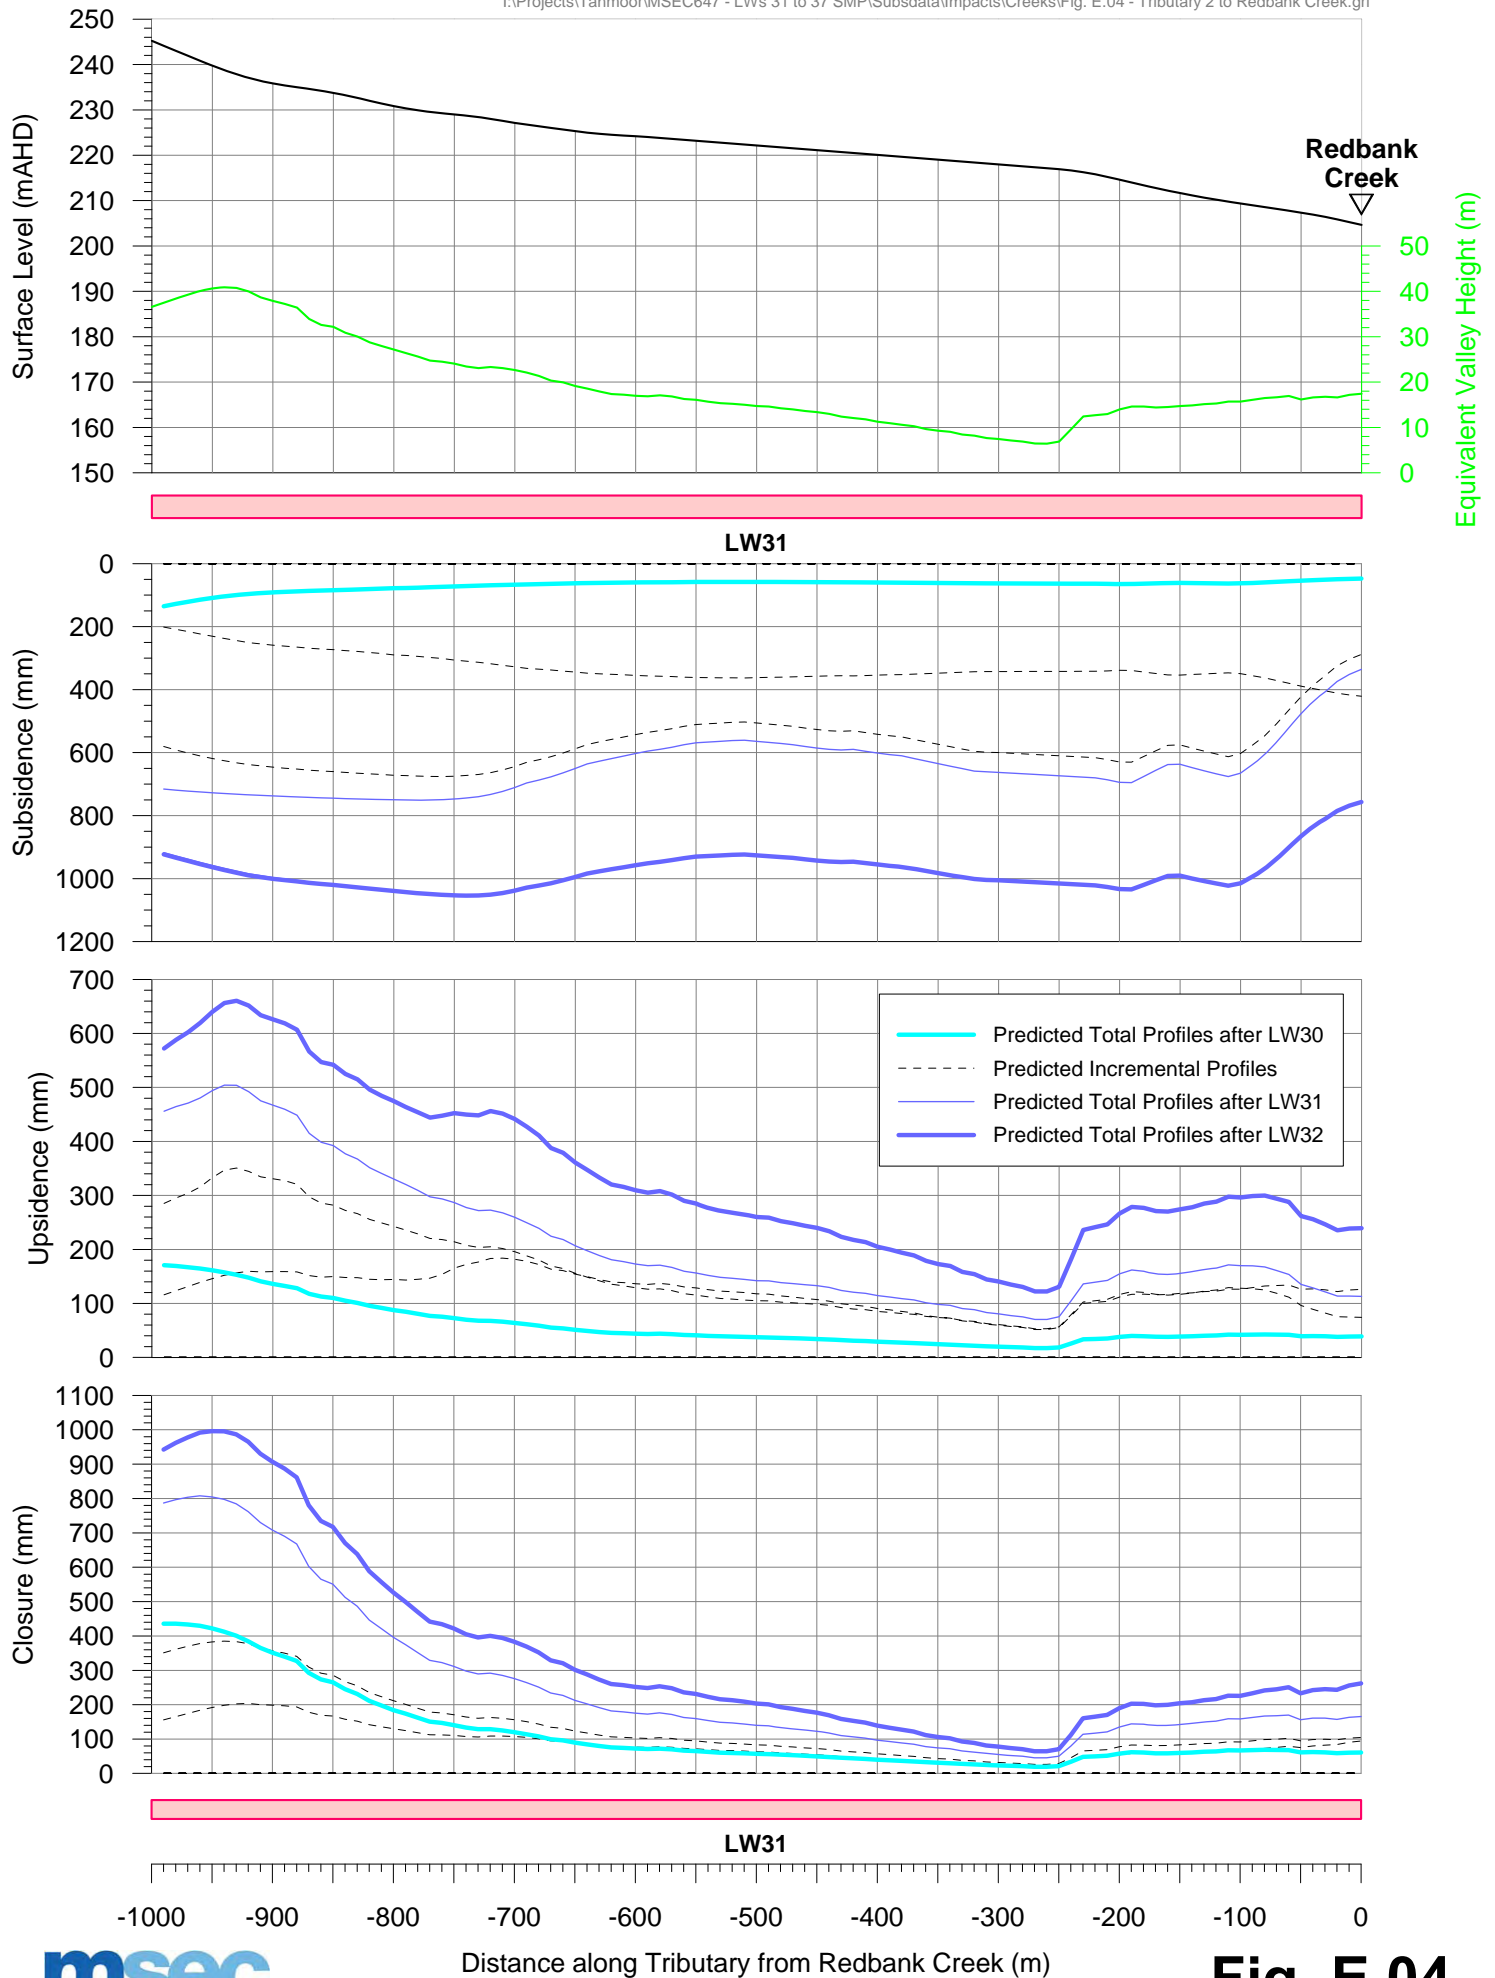
Predicted Profiles of Subsidence, Upsidence and Closure along Tributary 2 to Redbank Creek Resulting from the Extraction of Longwalls 22 to 37

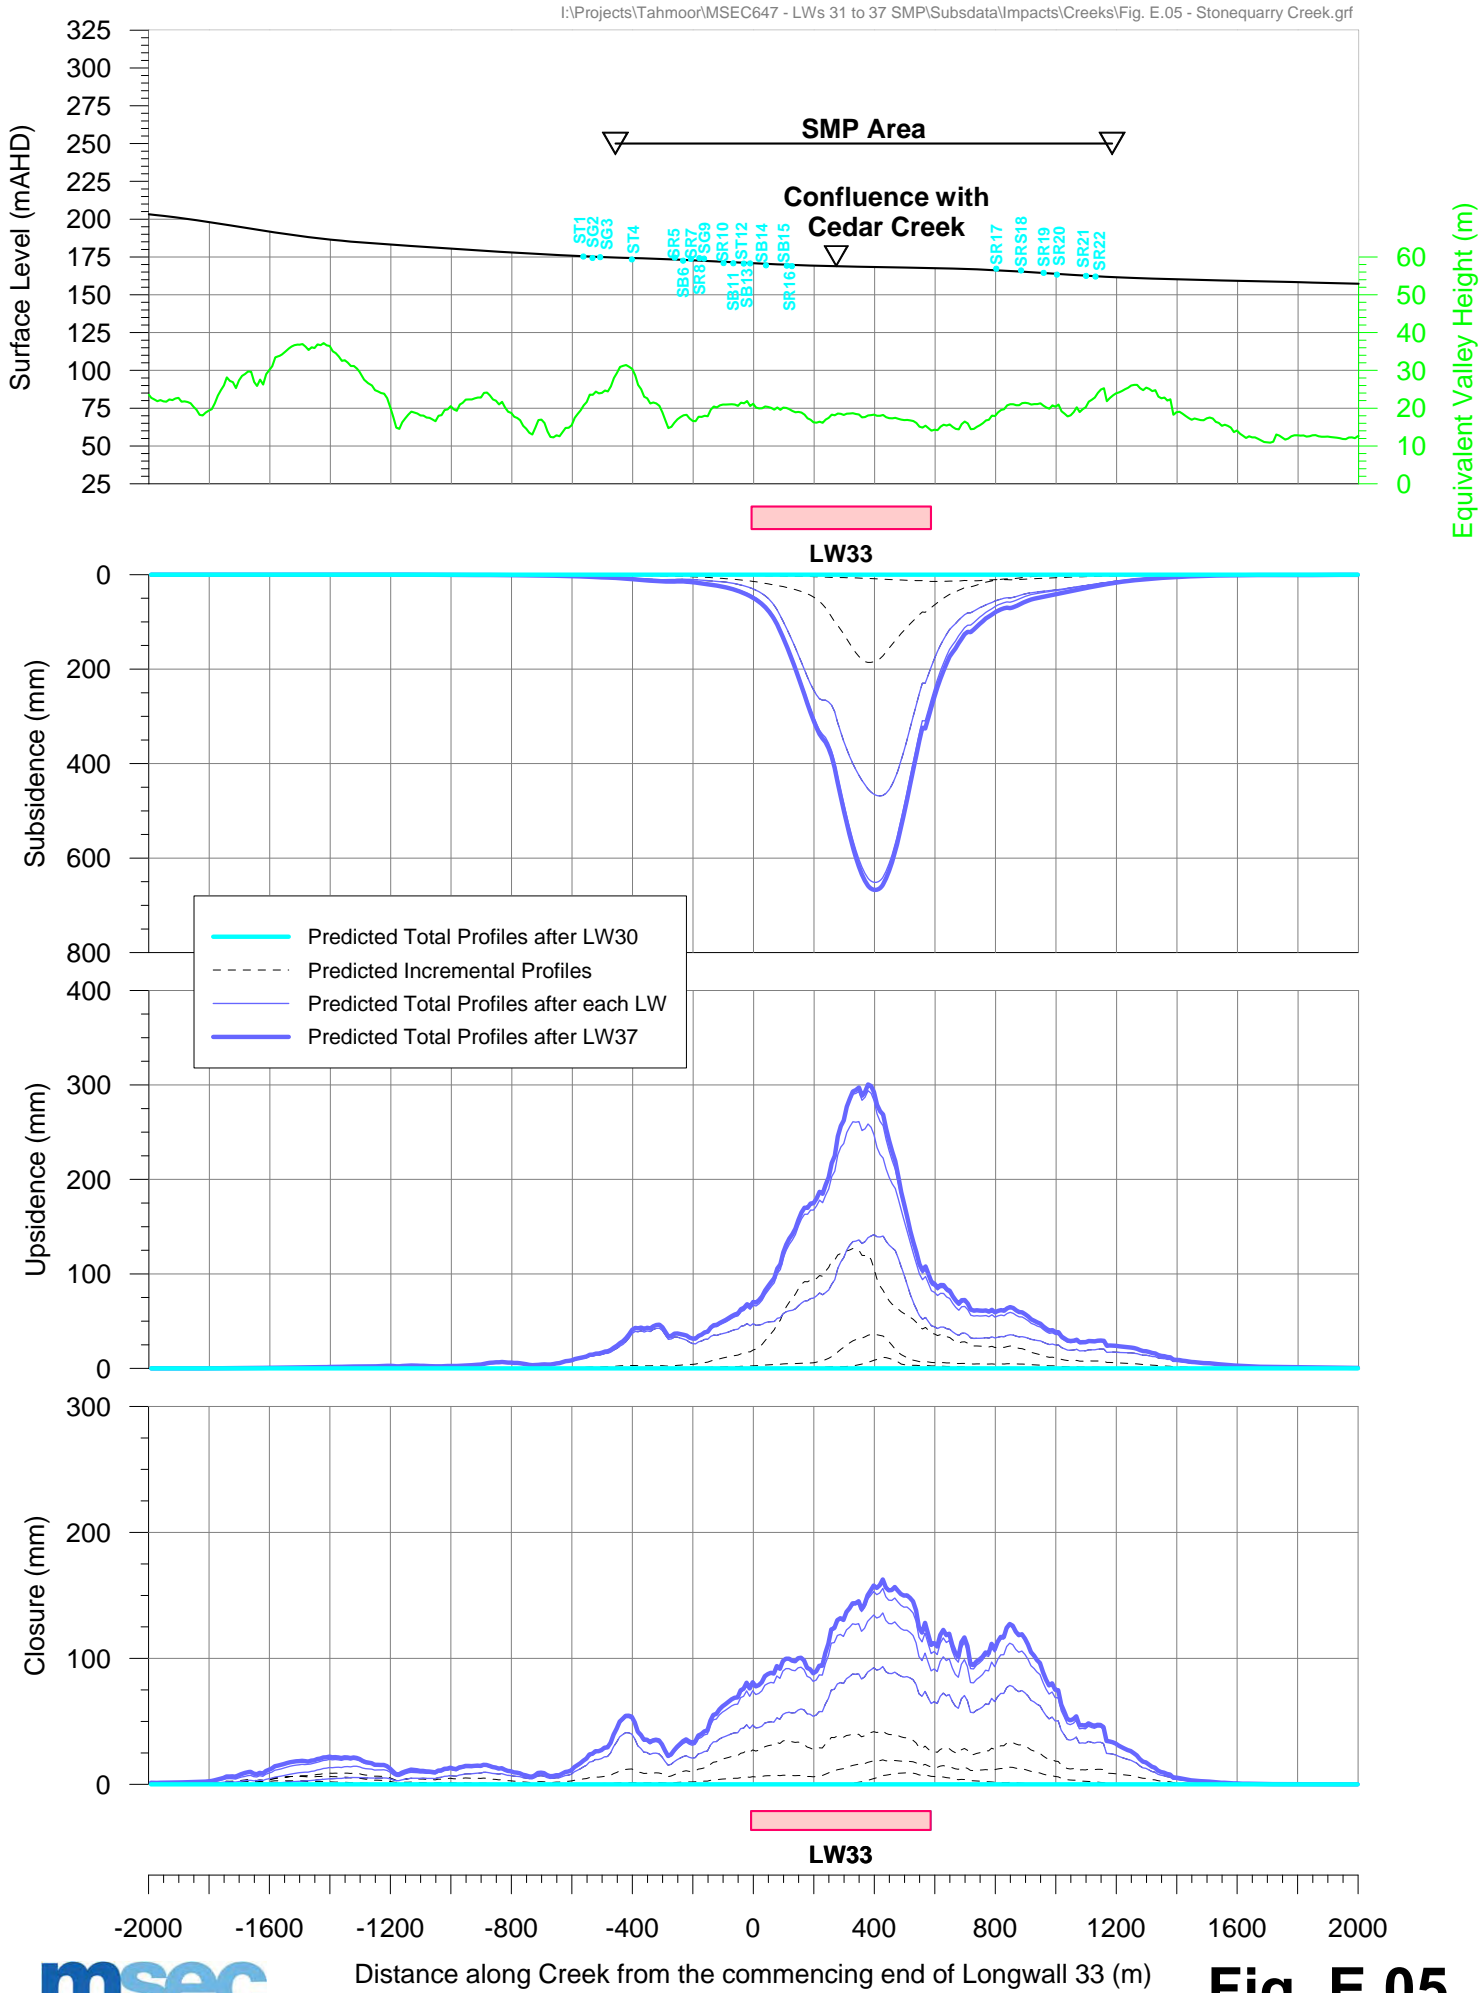
Predicted Profiles of Subsidence, Upsidence and Closure along Stonequarry Creek Resulting from the Extraction of Longwalls 22 to 37
