Fig. 6.36 Mushroom Tunnel

6.8. Potable Water Infrastructure

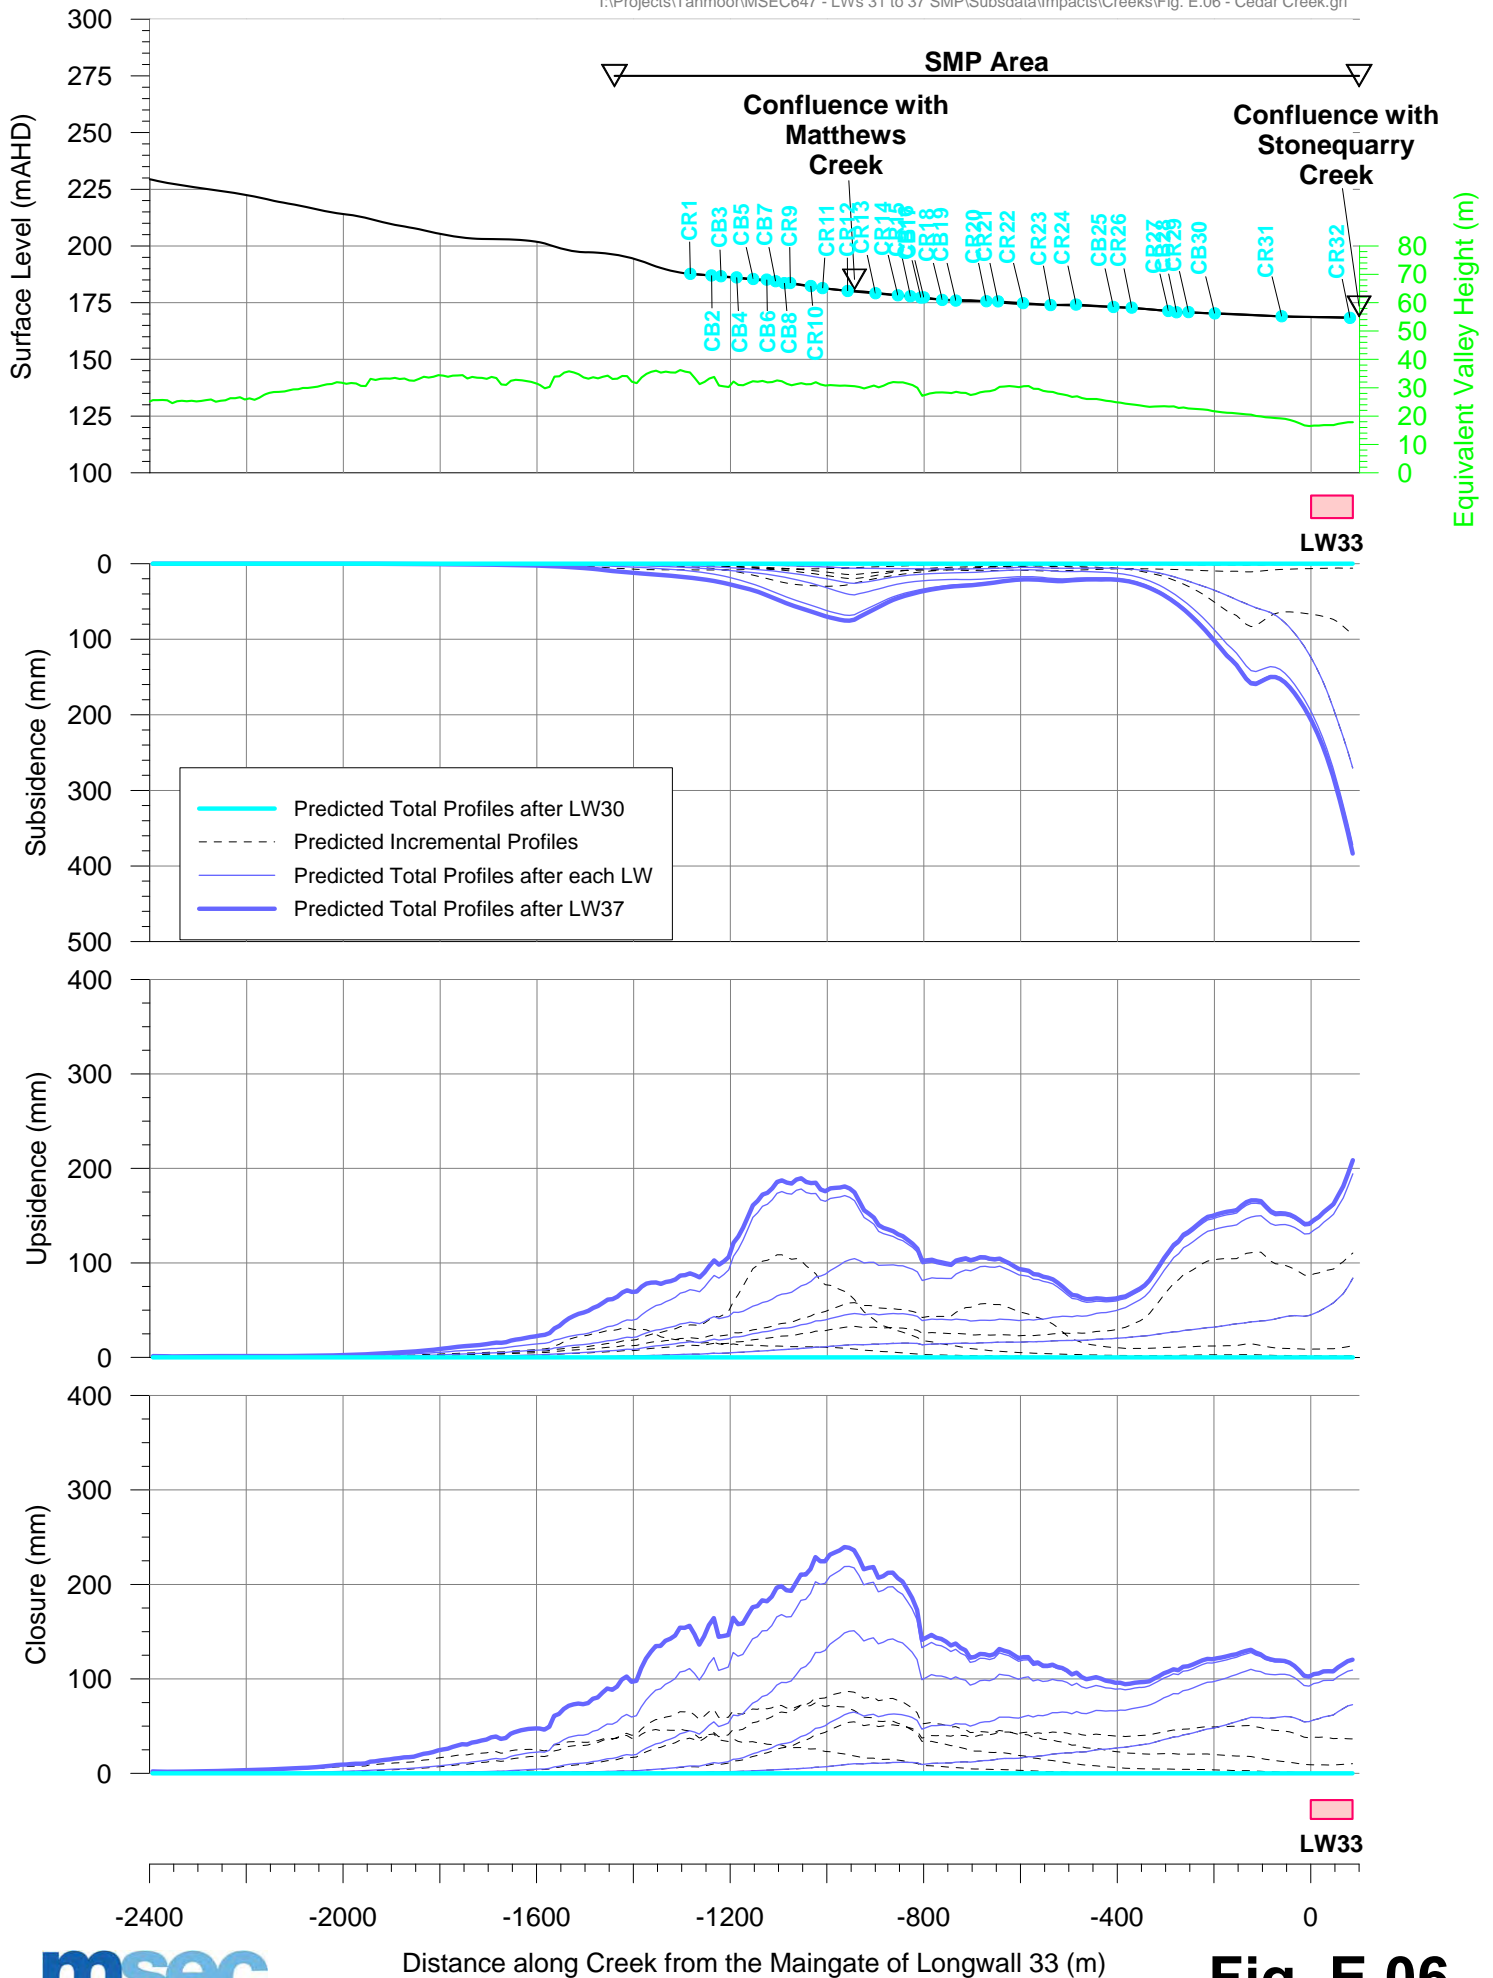
Predicted Profiles of Subsidence, Upsidence and Closure along Cedar Creek Resulting from the Extraction of Longwalls 22 to 37

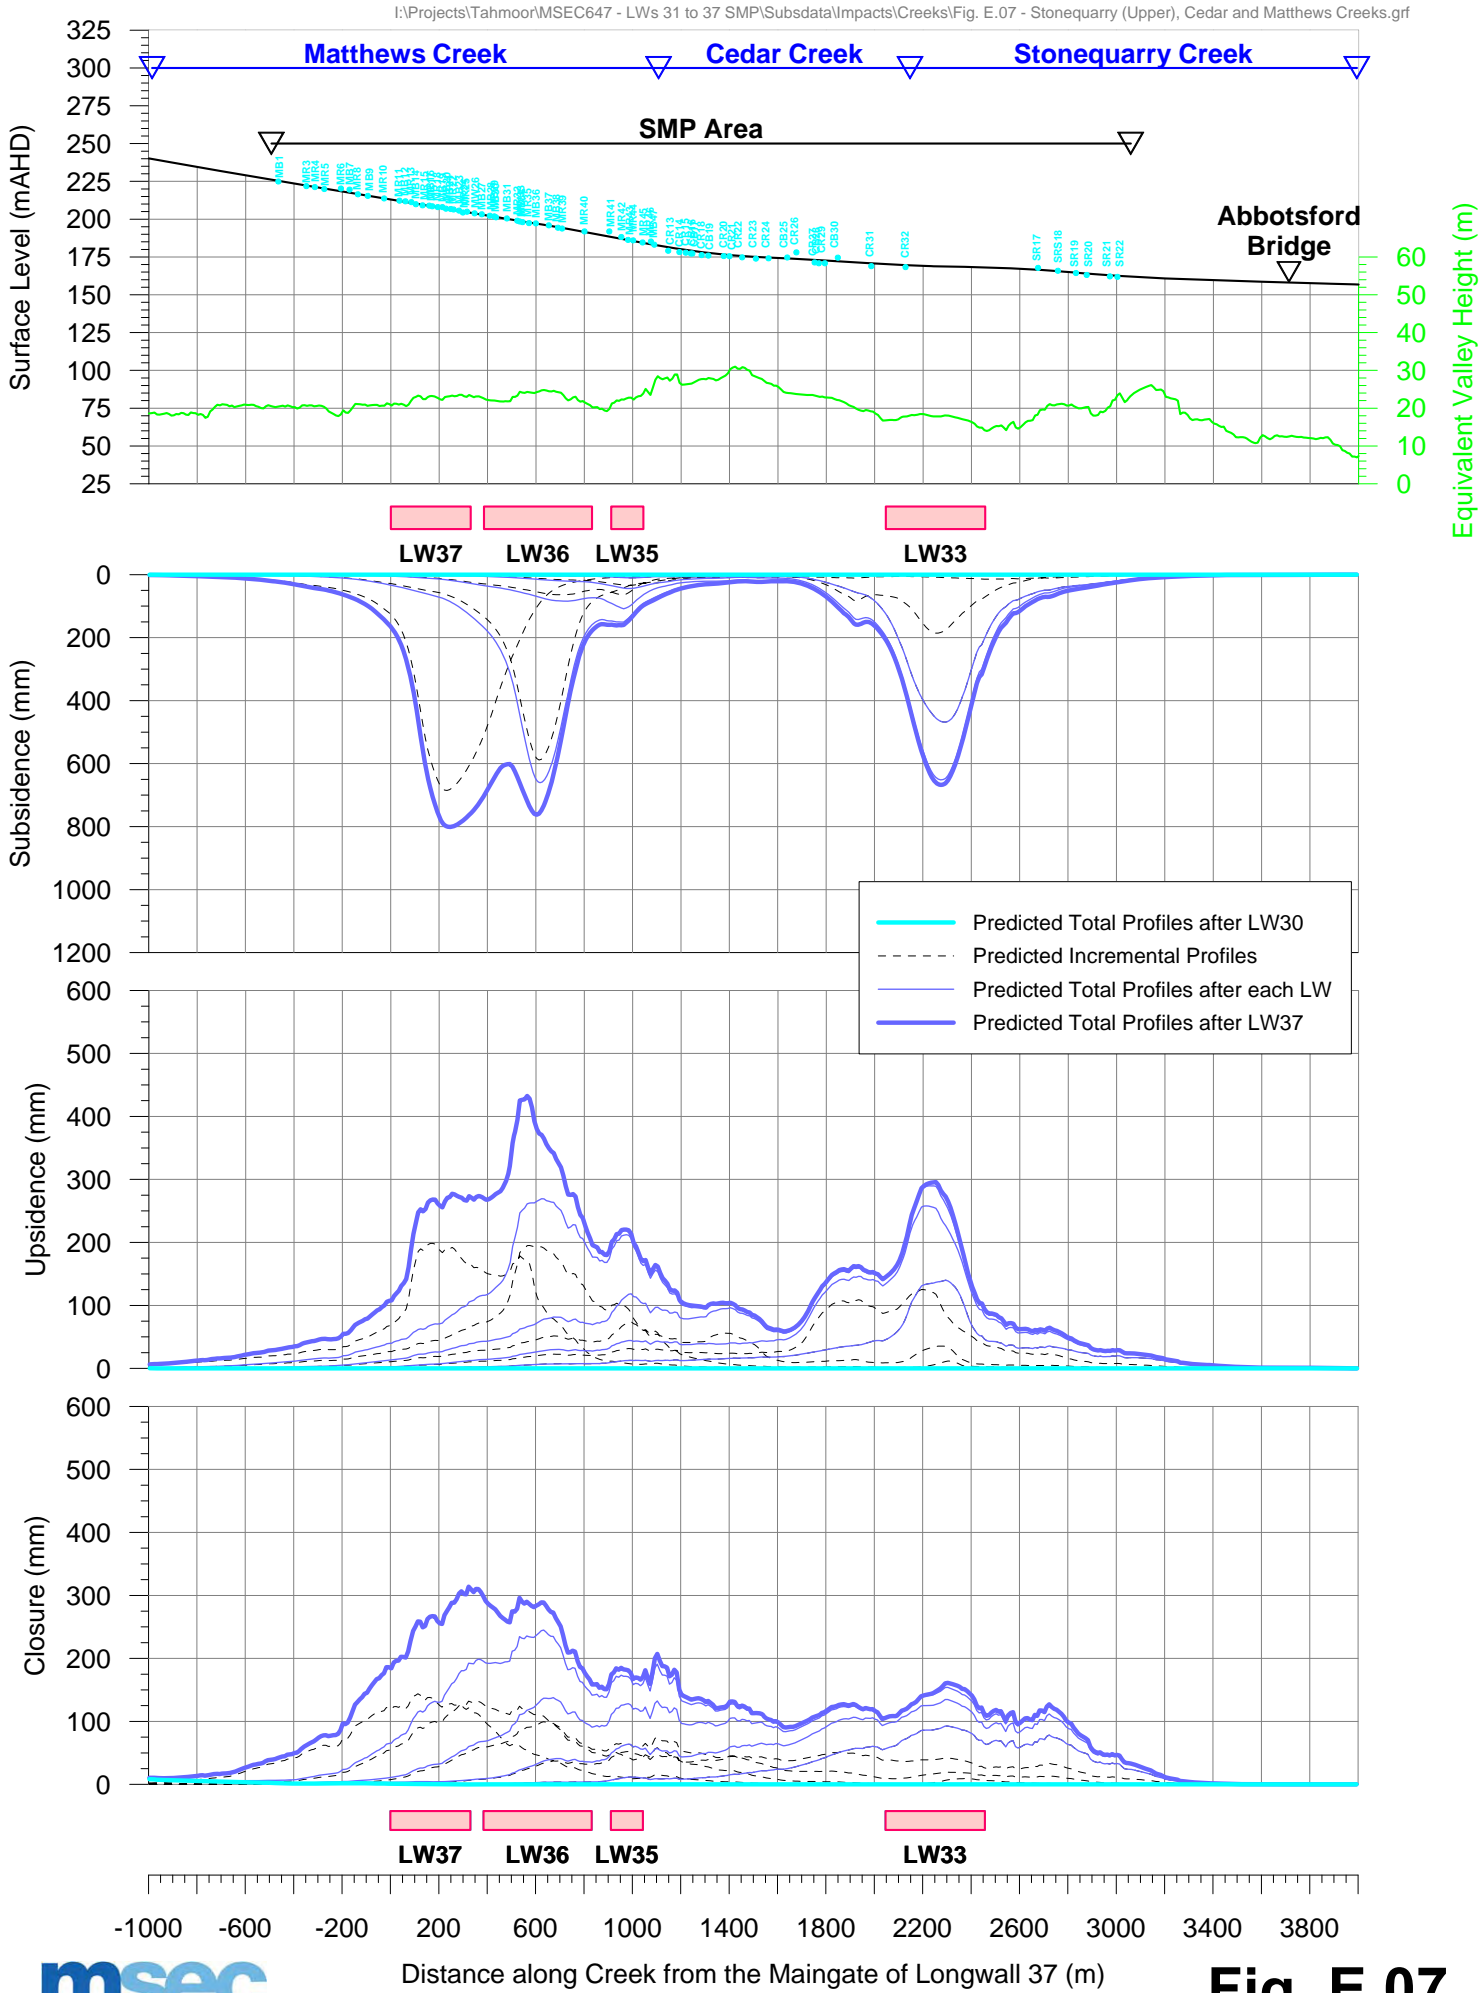
Fig. E.06

Predicted Profiles of Subsidence, Upsidence and Closure along Stonequarry (Upper), Cedar and Matthews Creeks Resulting from the Extraction of Longwalls 22 to 37

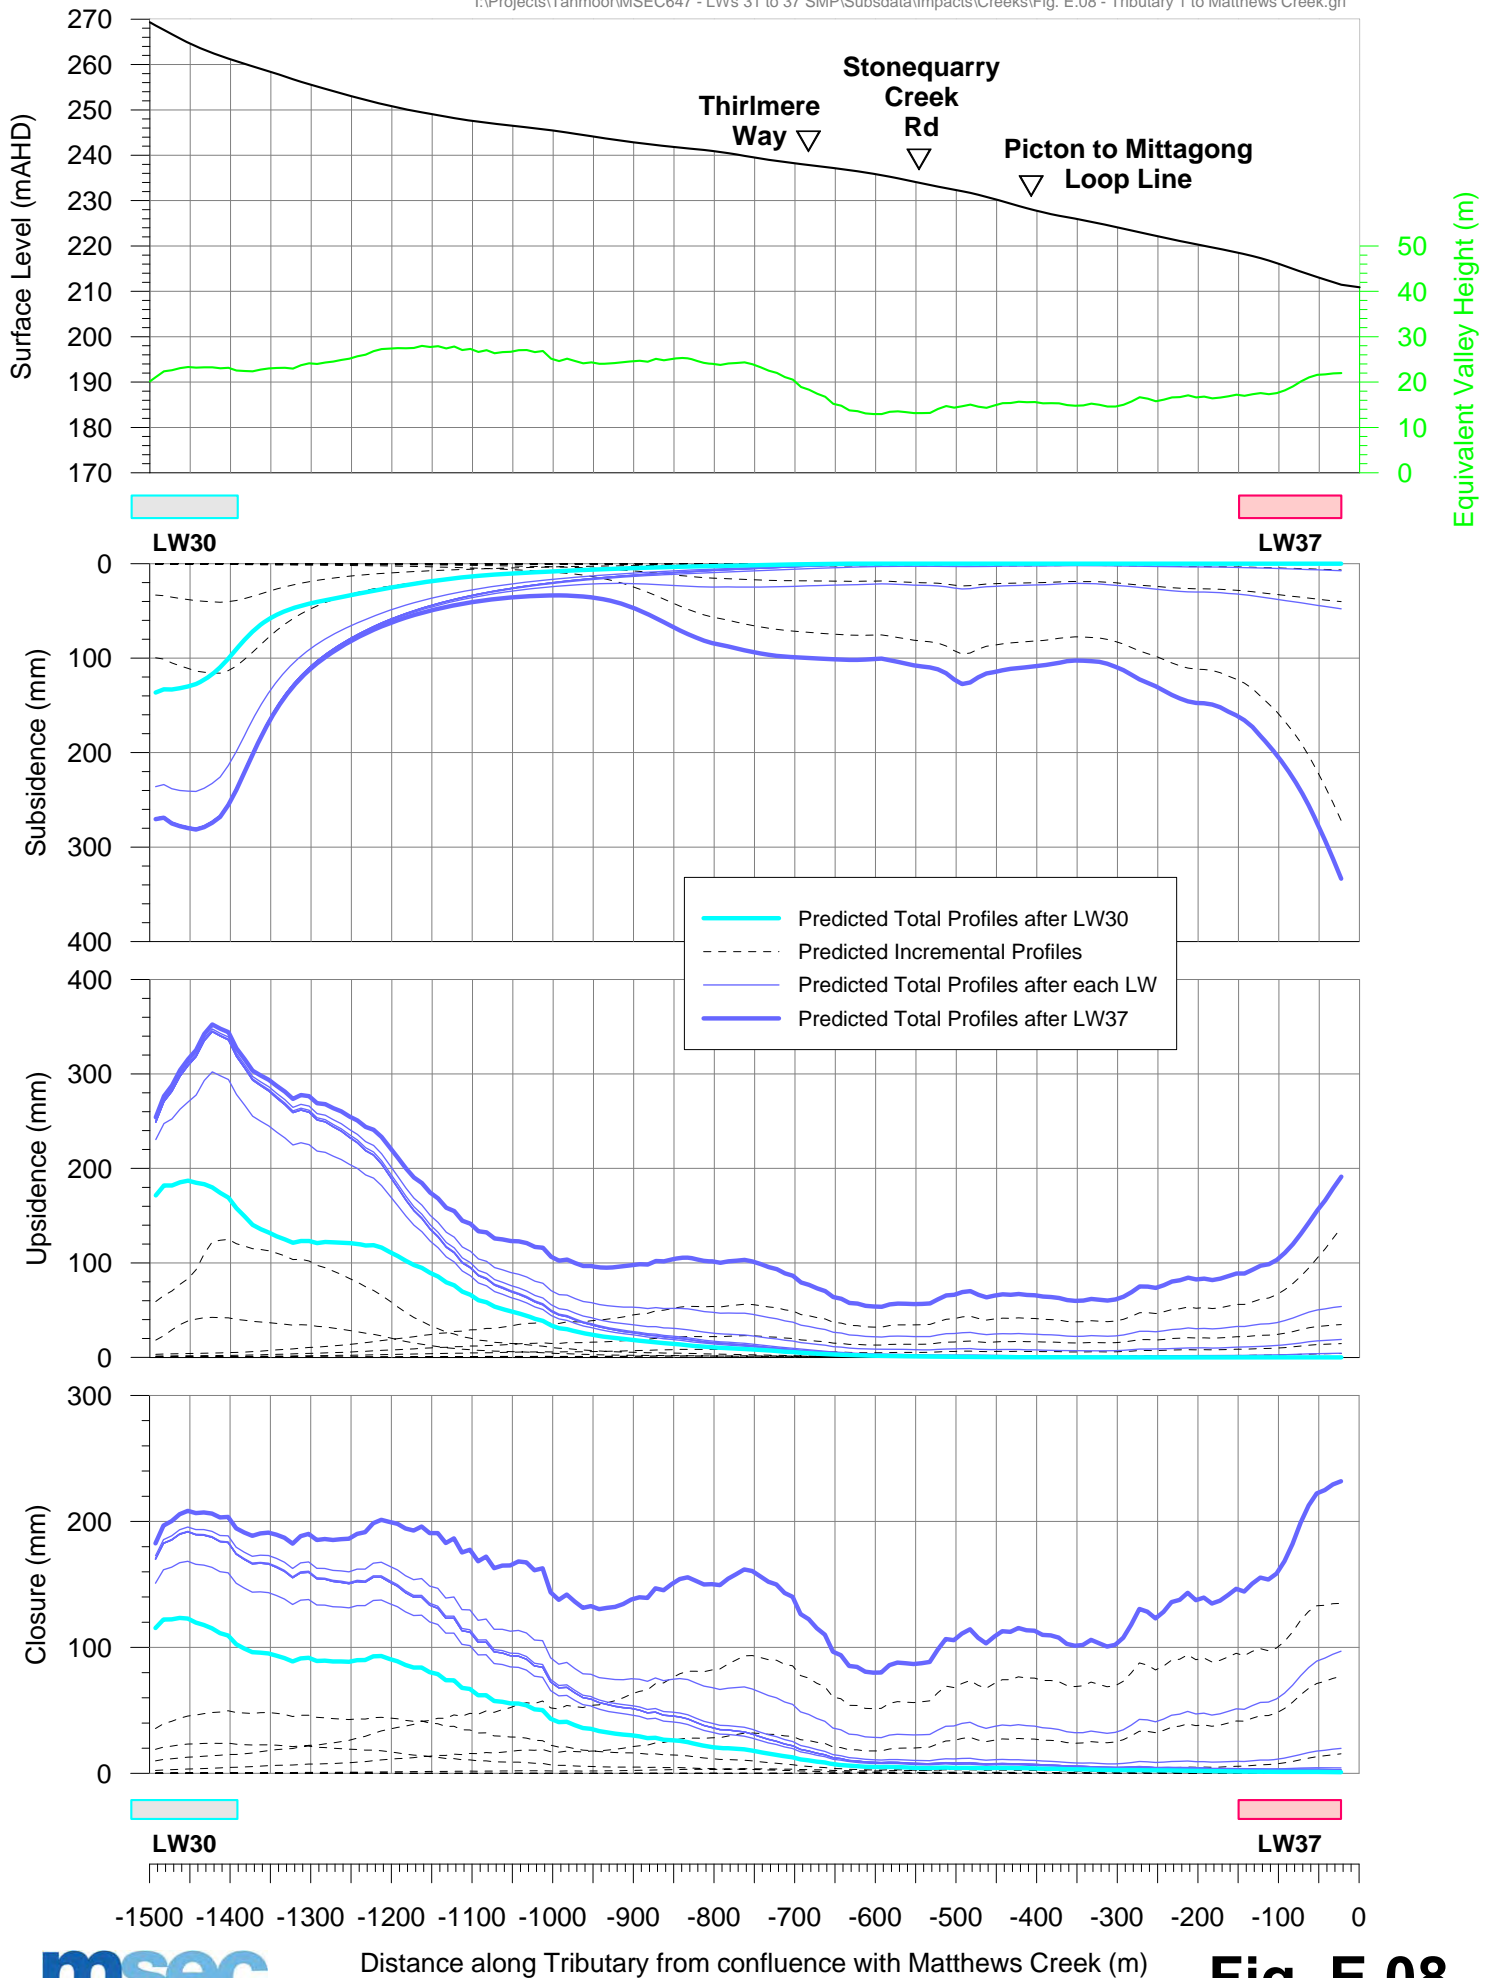
Predicted Profiles of Subsidence, Upsidence and Closure along Tributary 1 to Matthews Creek Resulting from the Extraction of Longwalls 22 to 37

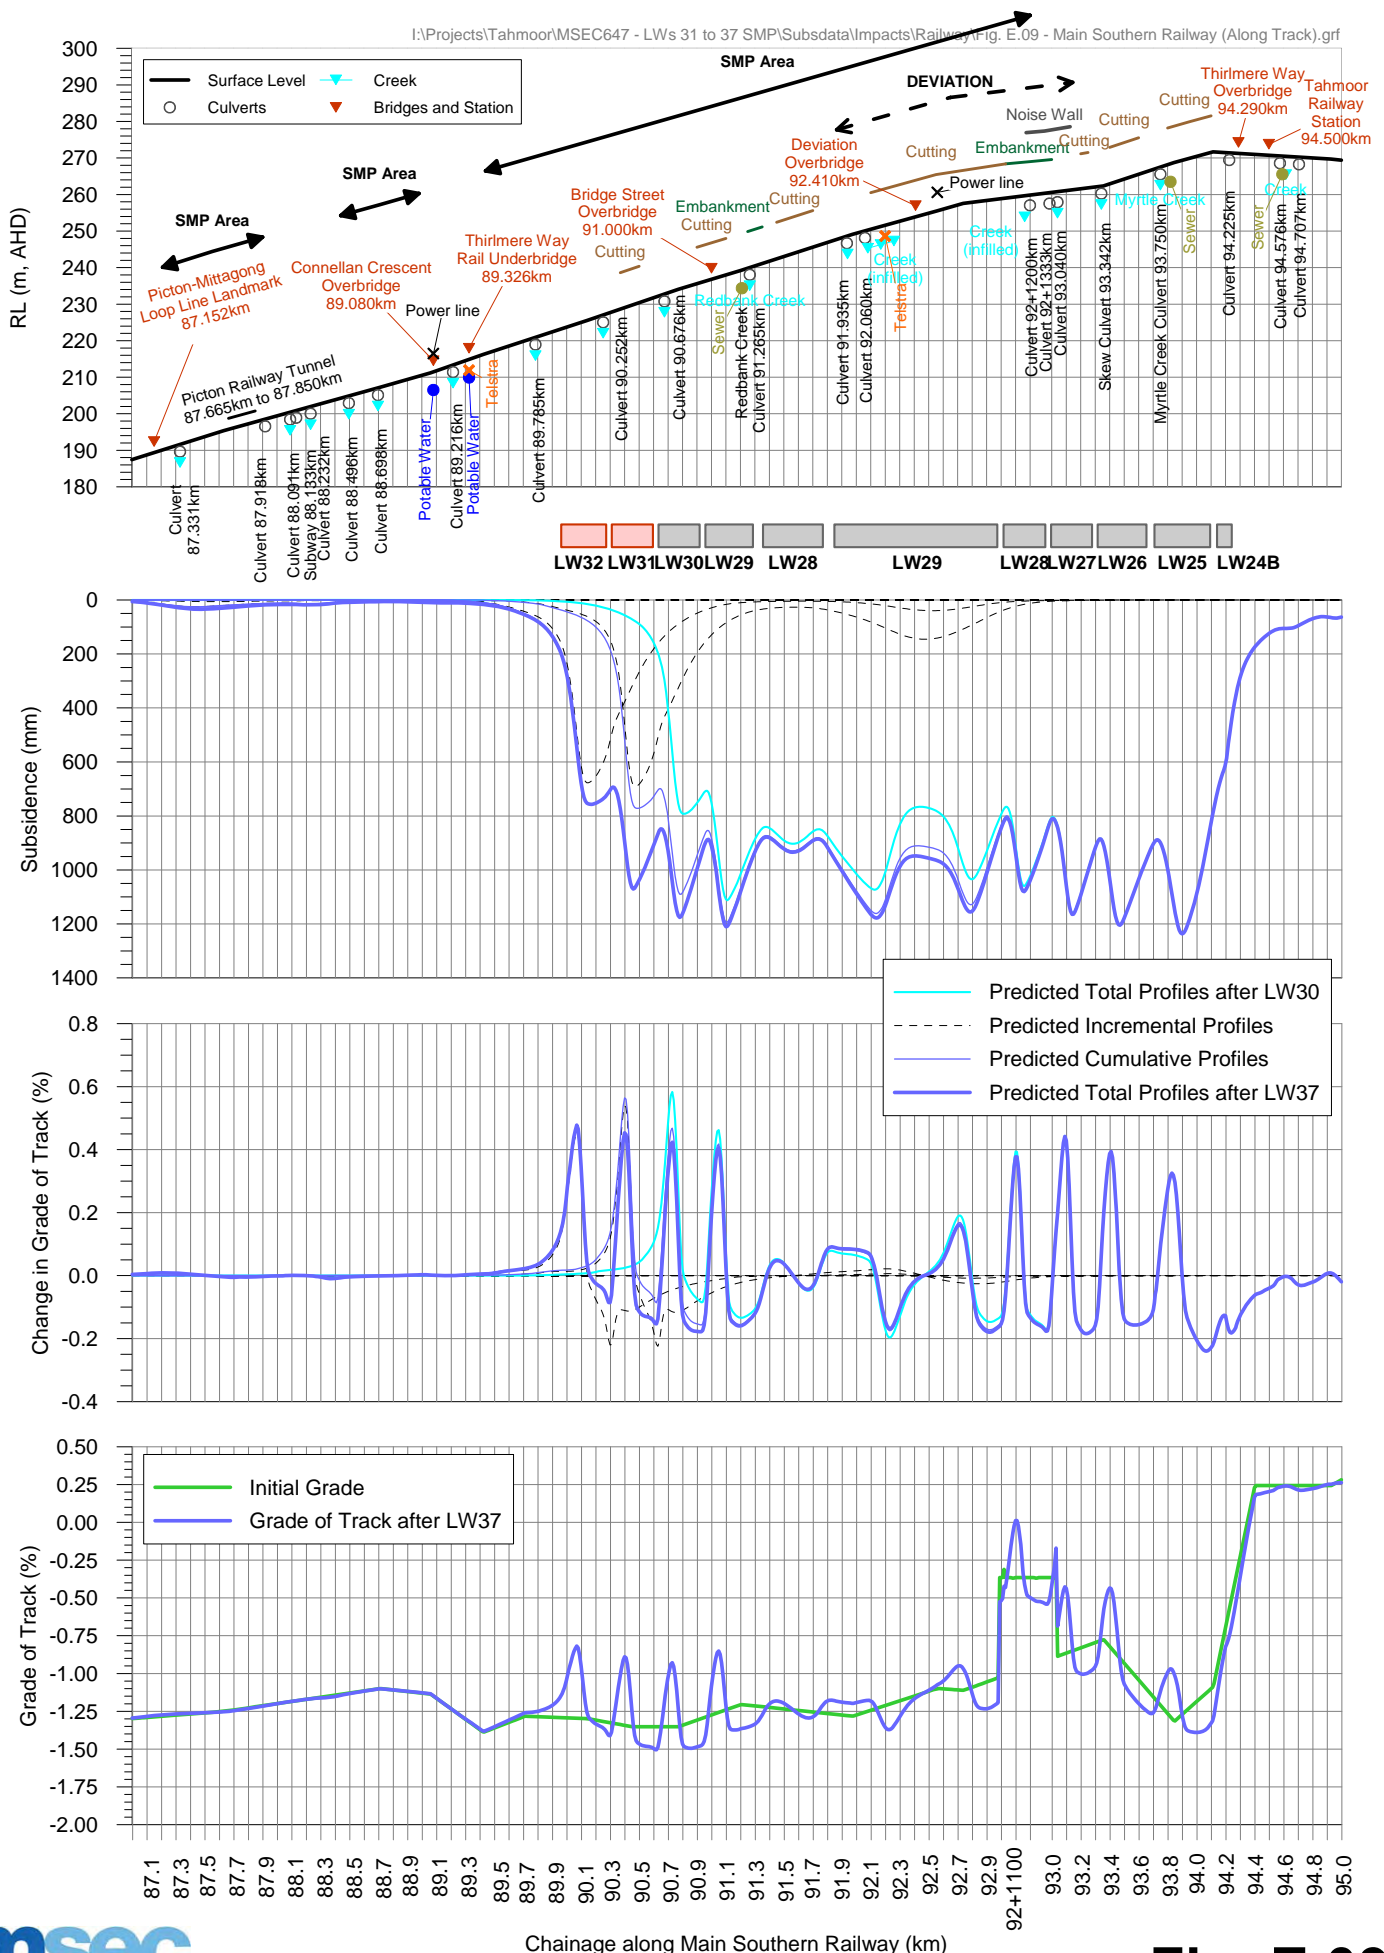
Predicted Movements Along the Alignment of the Main Southern Railway Resulting from the Extraction of Longwalls 22 to 37

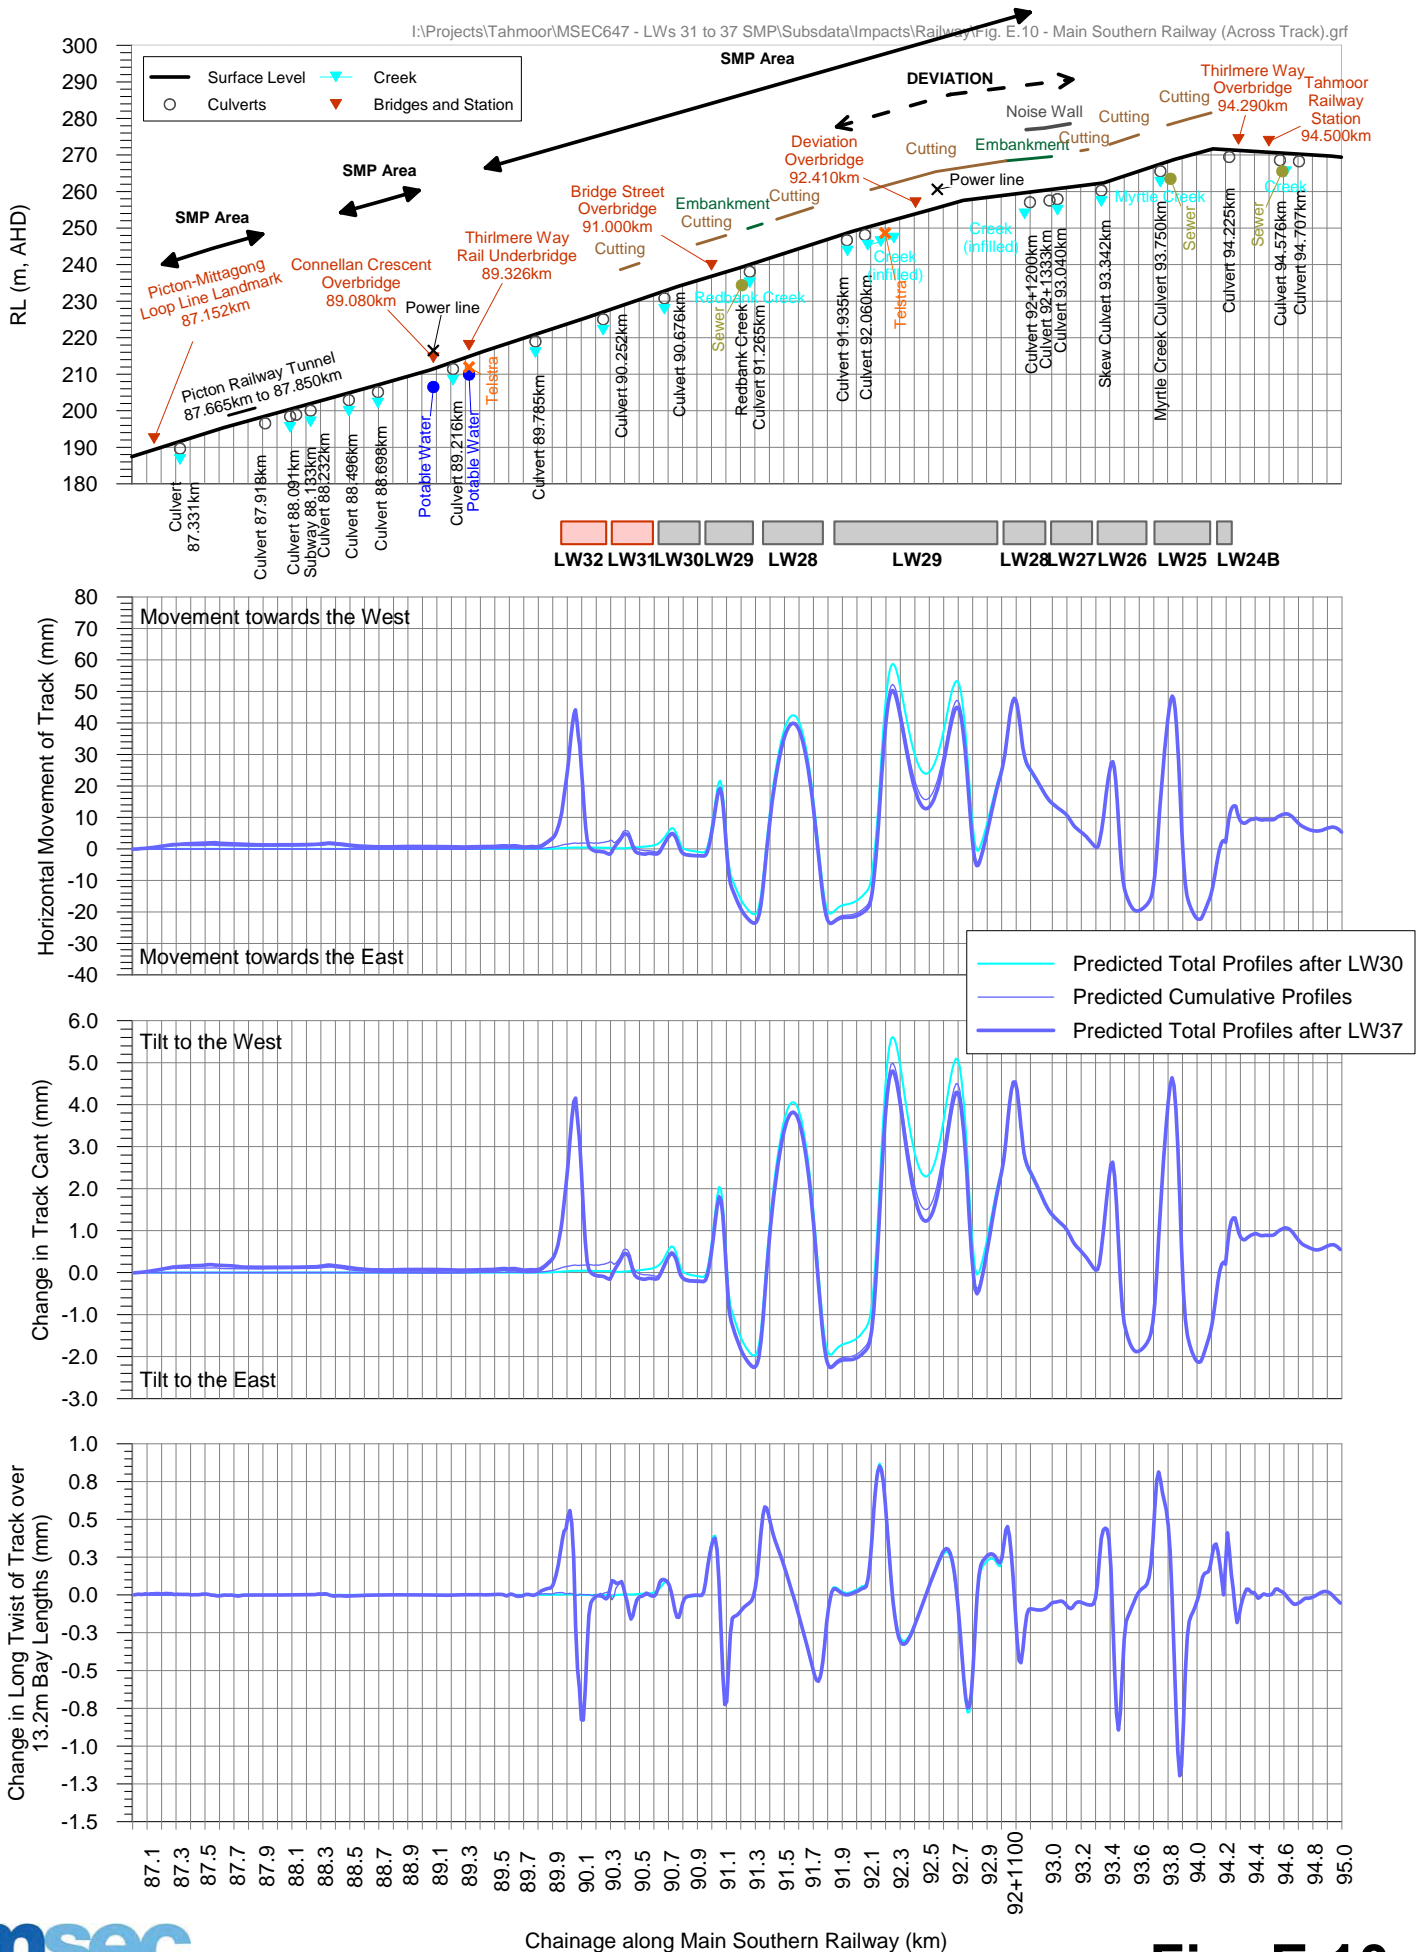
Predicted Movements Across the Alignment of the Main Southern Railway Resulting from the Extraction of Longwalls 22 to 37

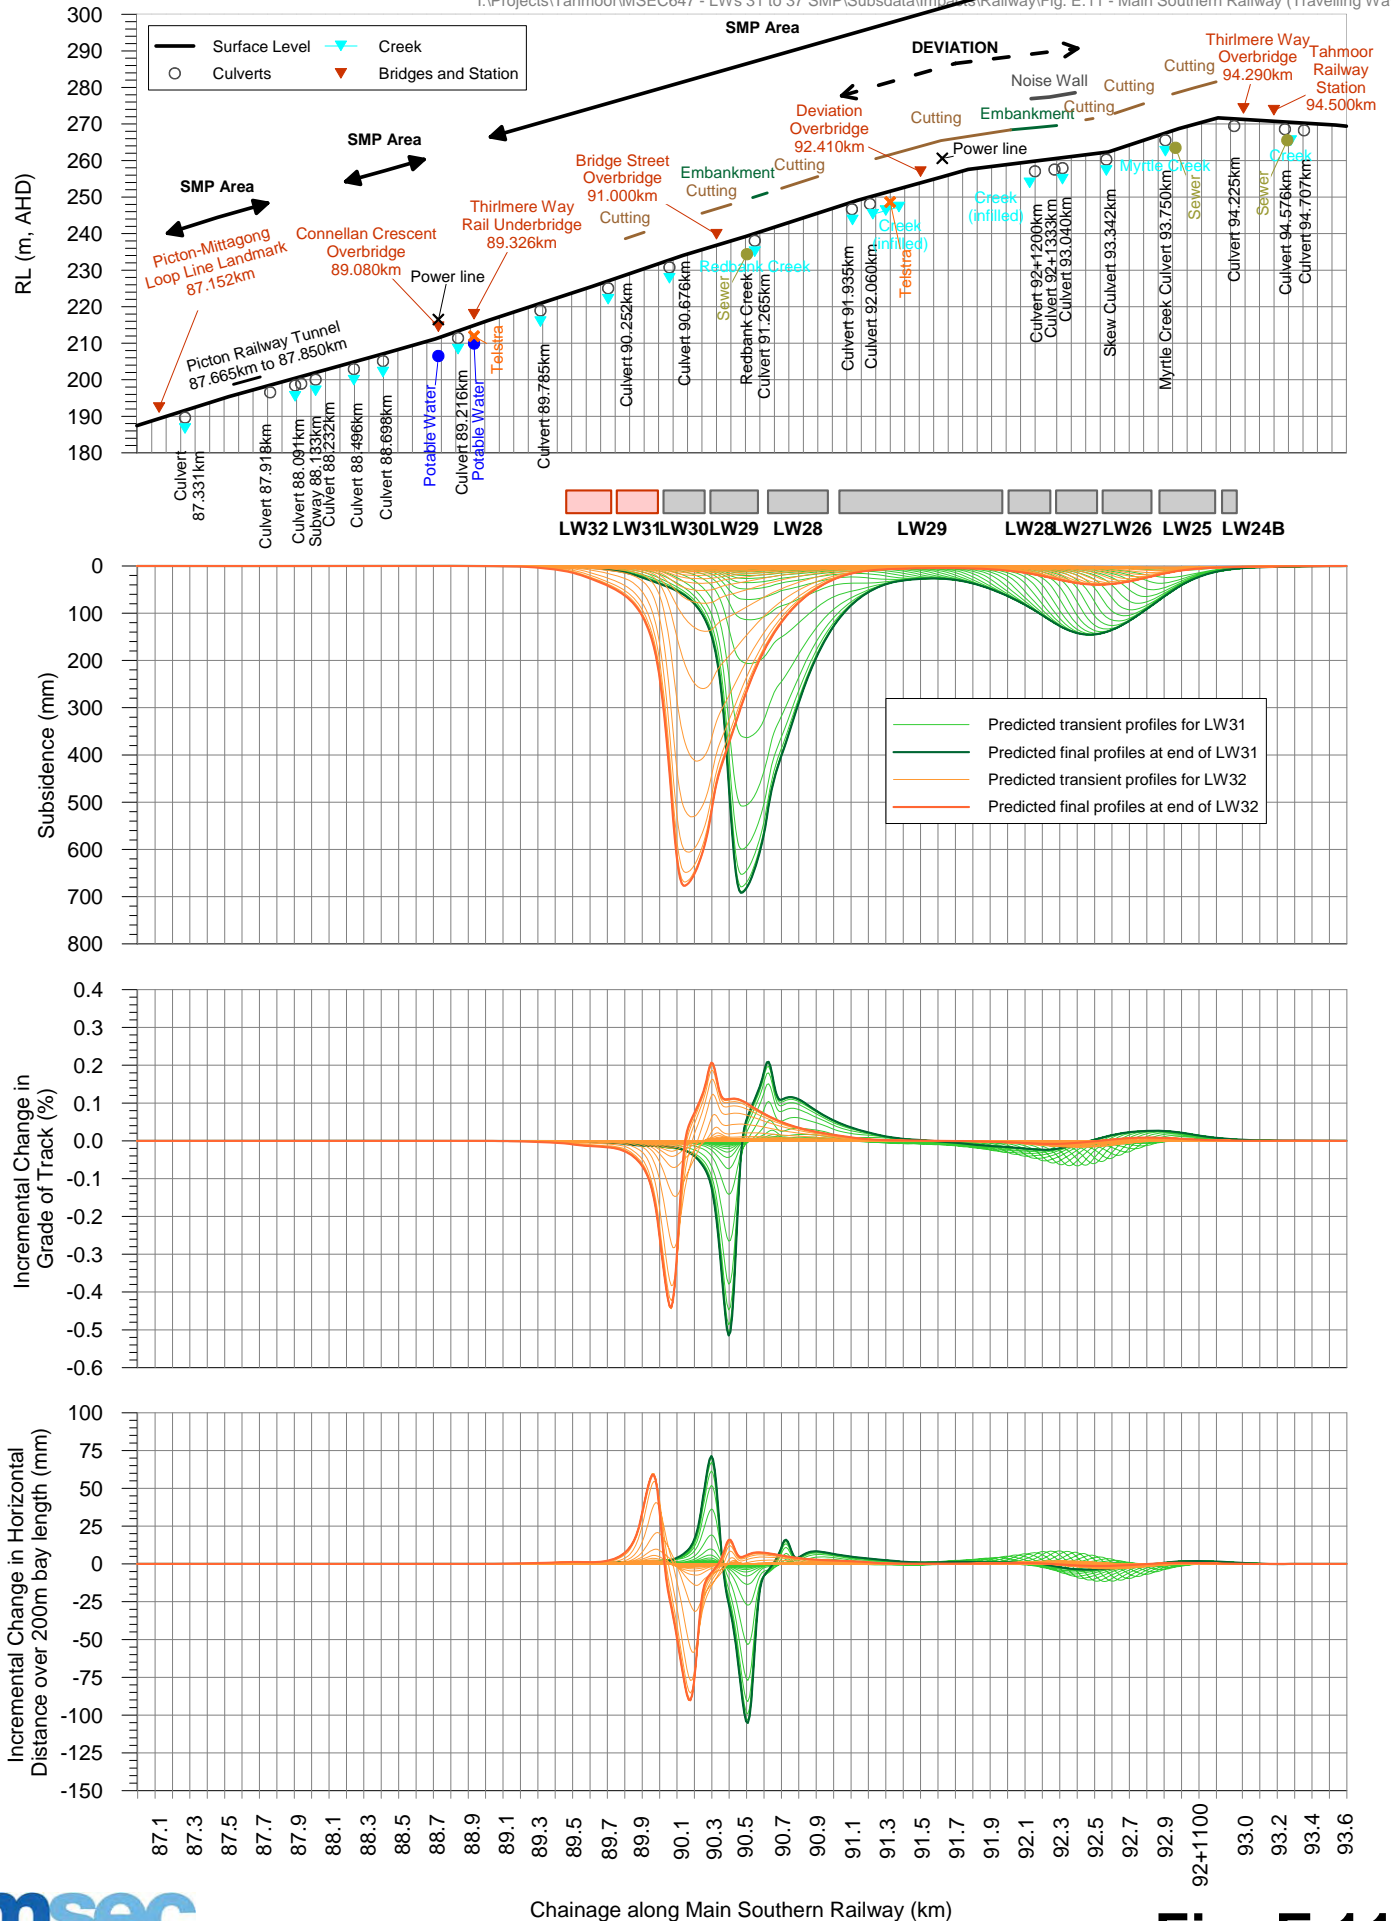
Predicted Travelling Subsidence, Changes in Grade and Long Bay Lengths along the Main Southern Railway Resulting from the Extraction of Longwalls 31 and 32

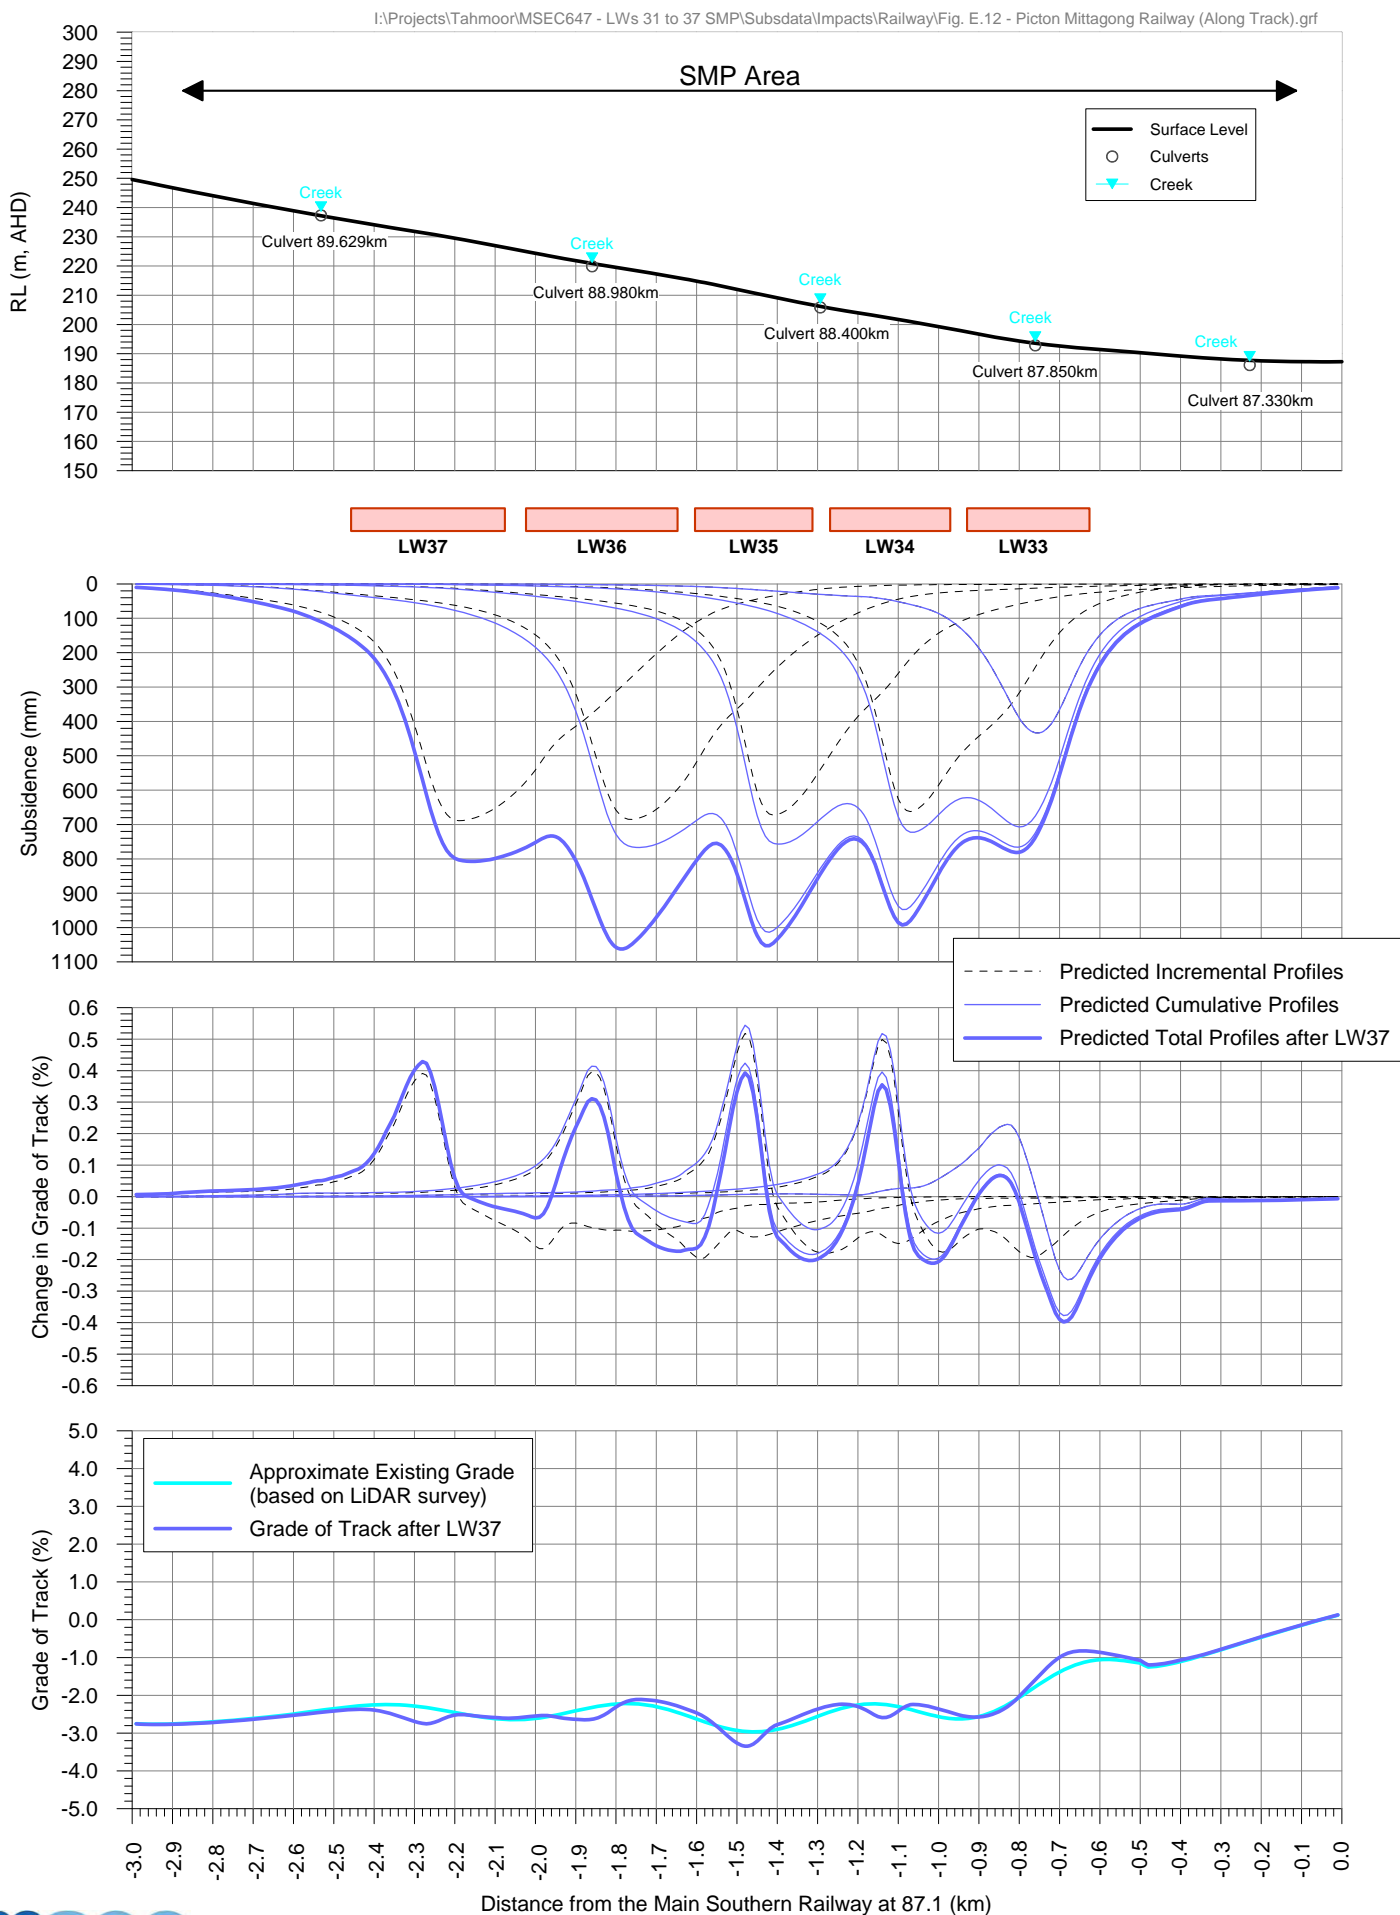
Predicted Movements Along the Alignment of the Picton to Mittagong Loop Line Resulting from the Extraction of Longwalls 22 to 37

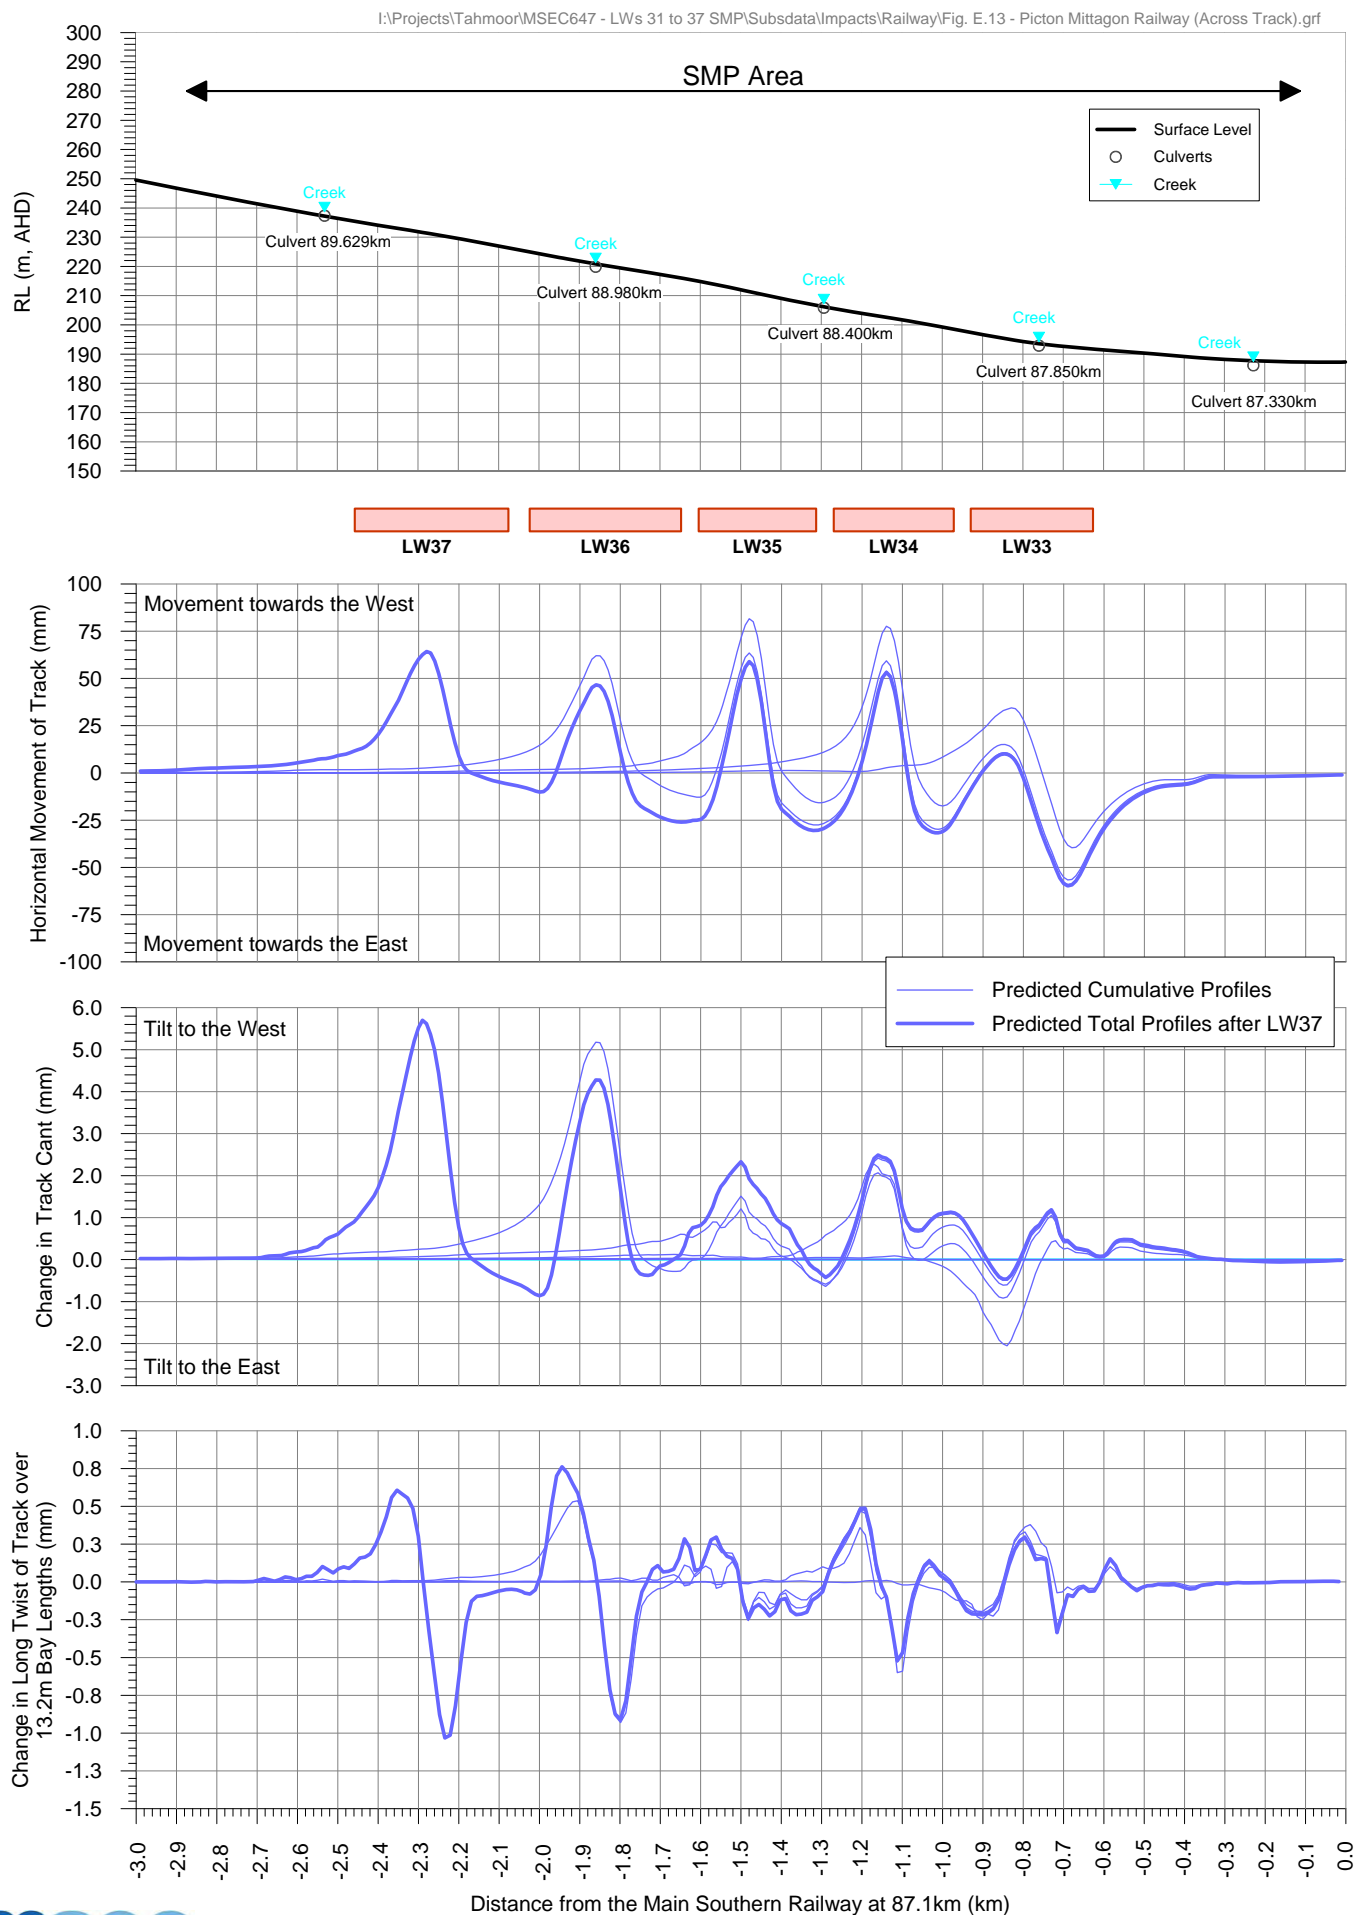
Predicted Movements Across the Alignment of the Picton to Mittagong Loop Line Resulting from the Extraction of Longwalls 22 to 37
