Fig. 6.36 Mushroom Tunnel

6.8. Potable Water Infrastructure

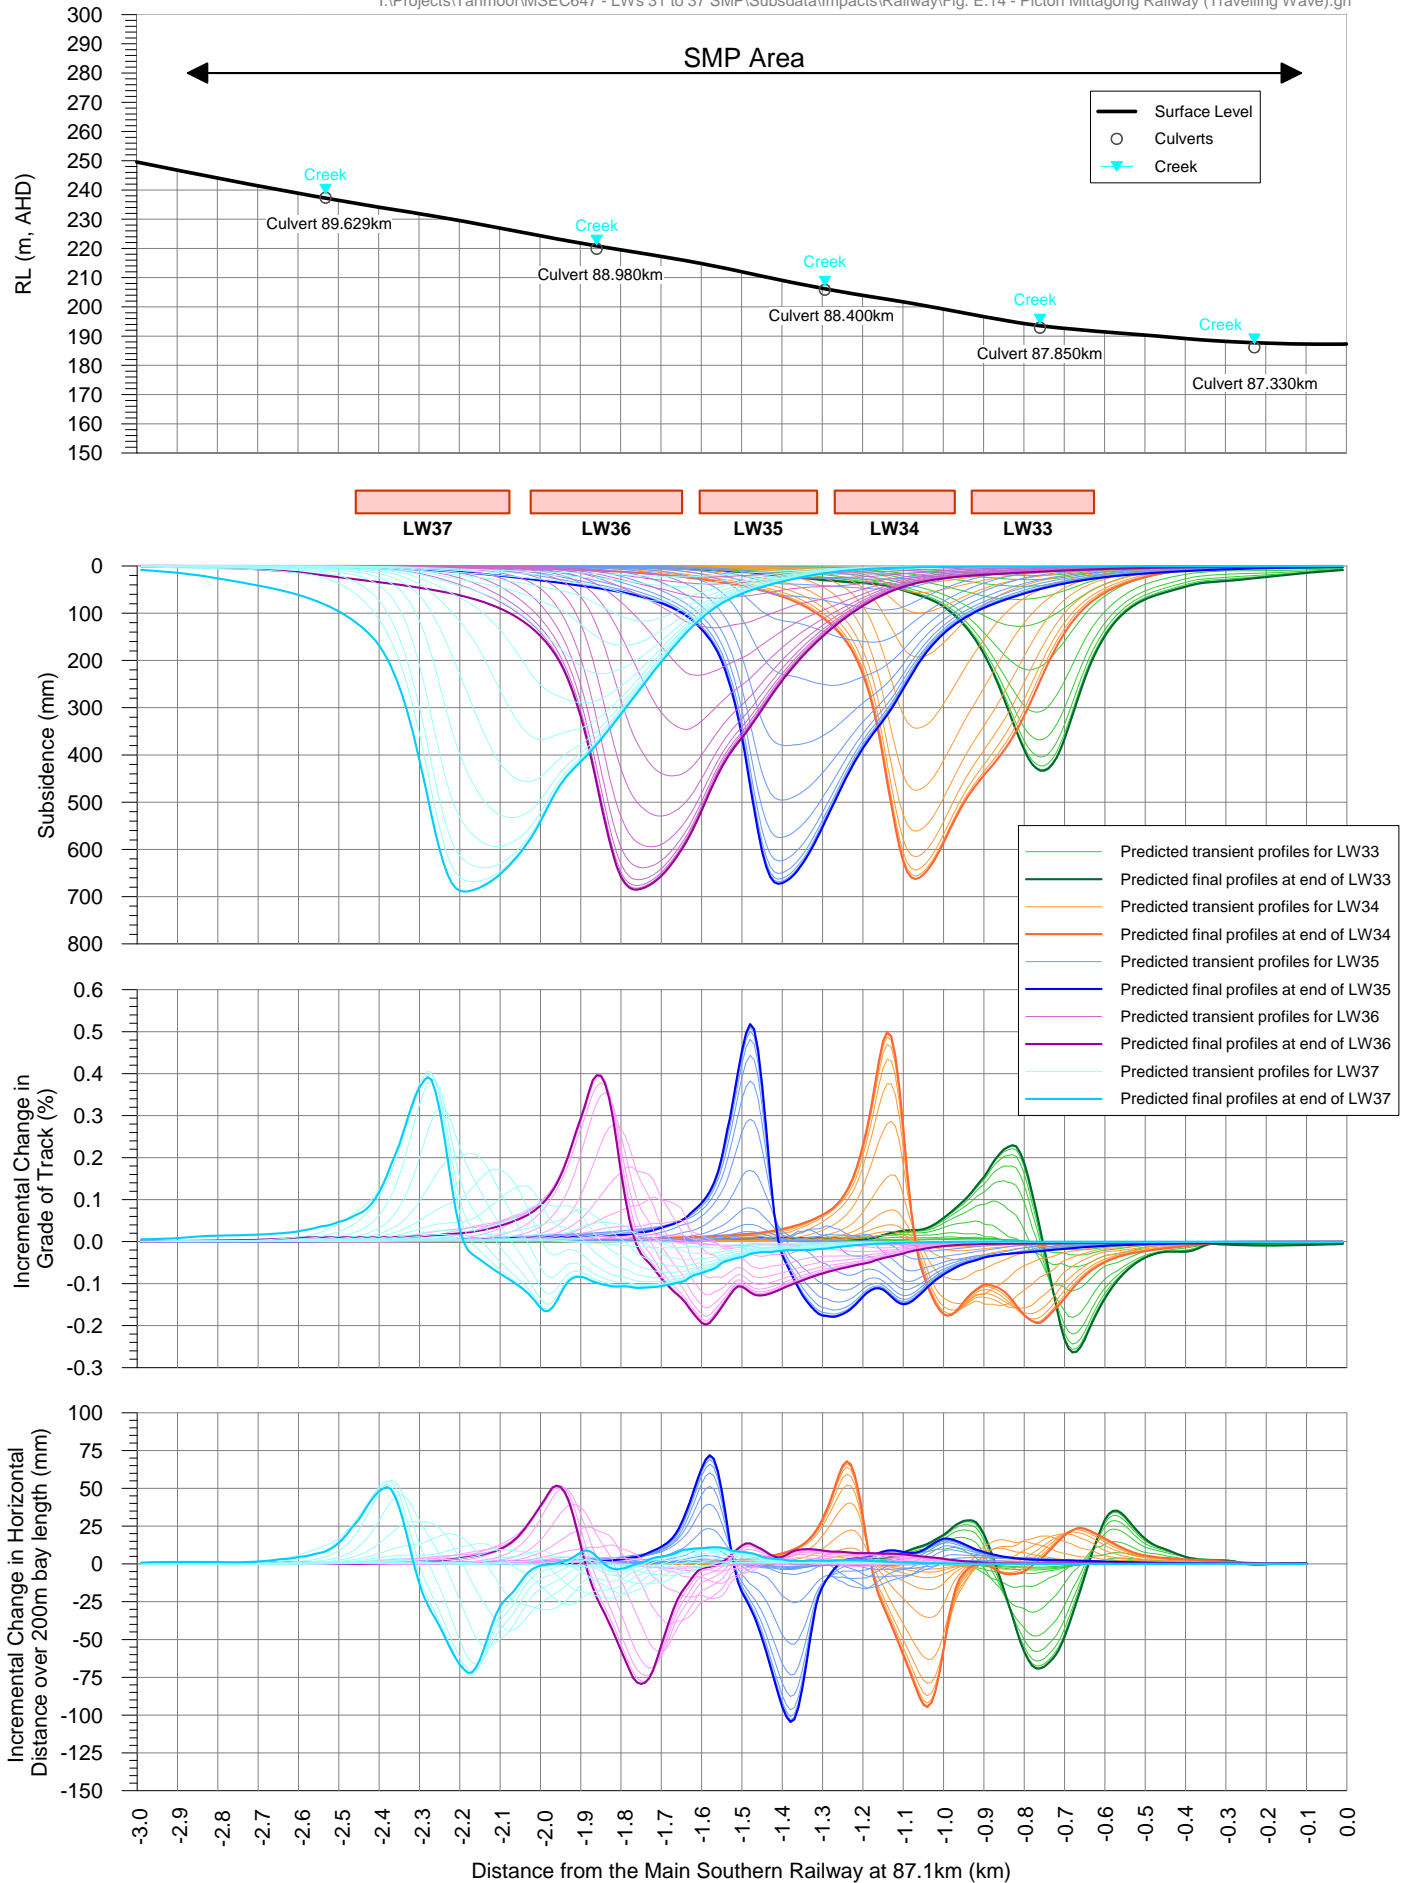
Predicted Travelling Subsidence, Changes in Grade and Long Bay Lengths along the Picton to Mittagong Loop Line Resulting from the Extraction of Longwalls 33 to 37

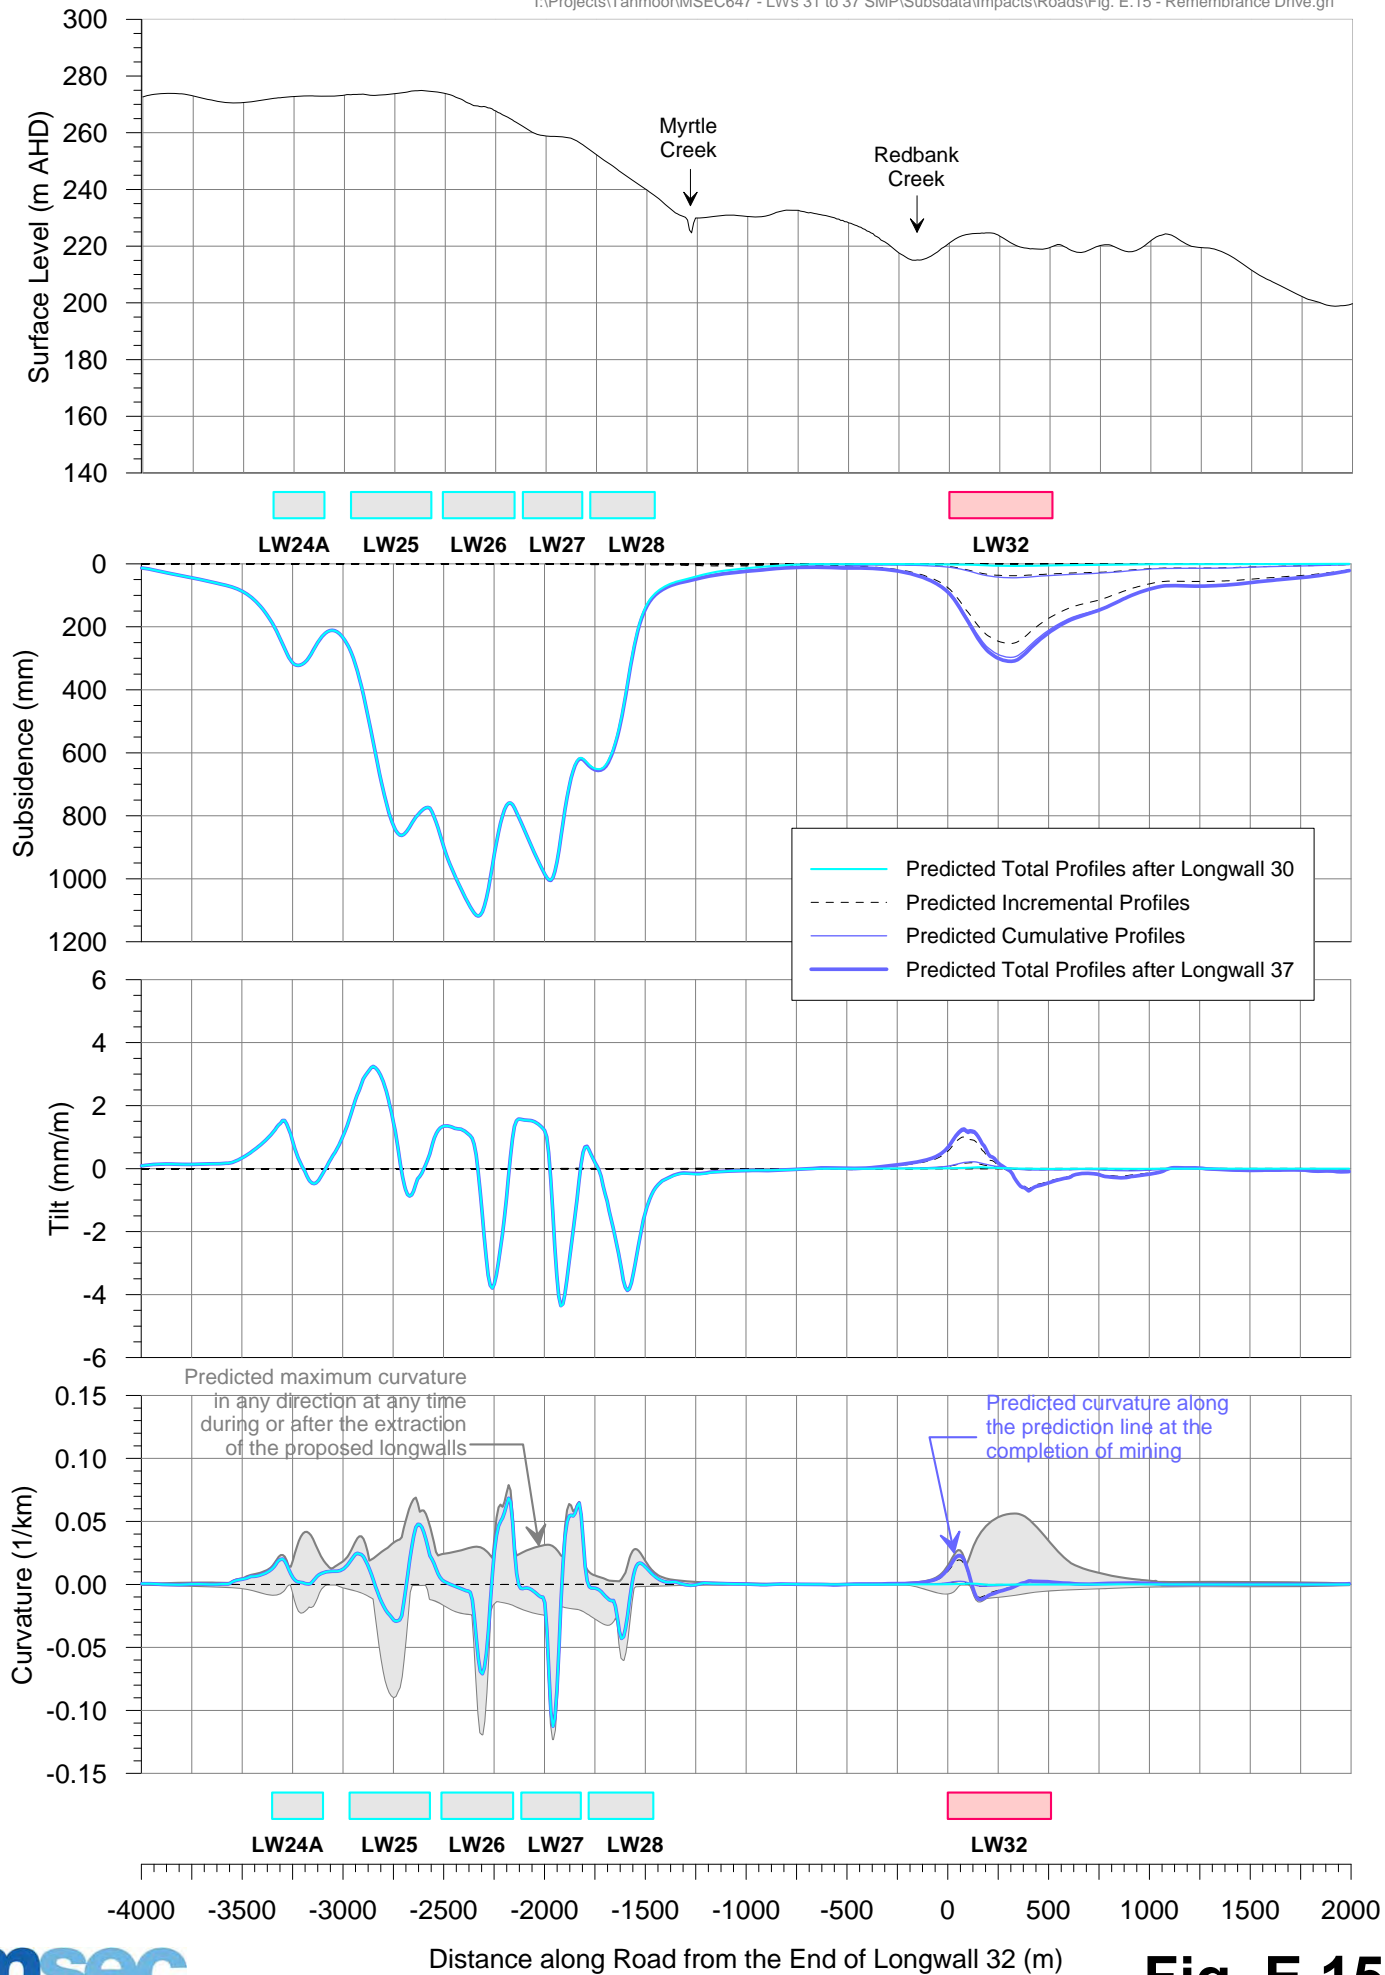
Predicted Profiles of Conventional Subsidence, Tilt and Curvature along Remembrance Drive Resulting from the Extraction of Longwalls 22 to 37

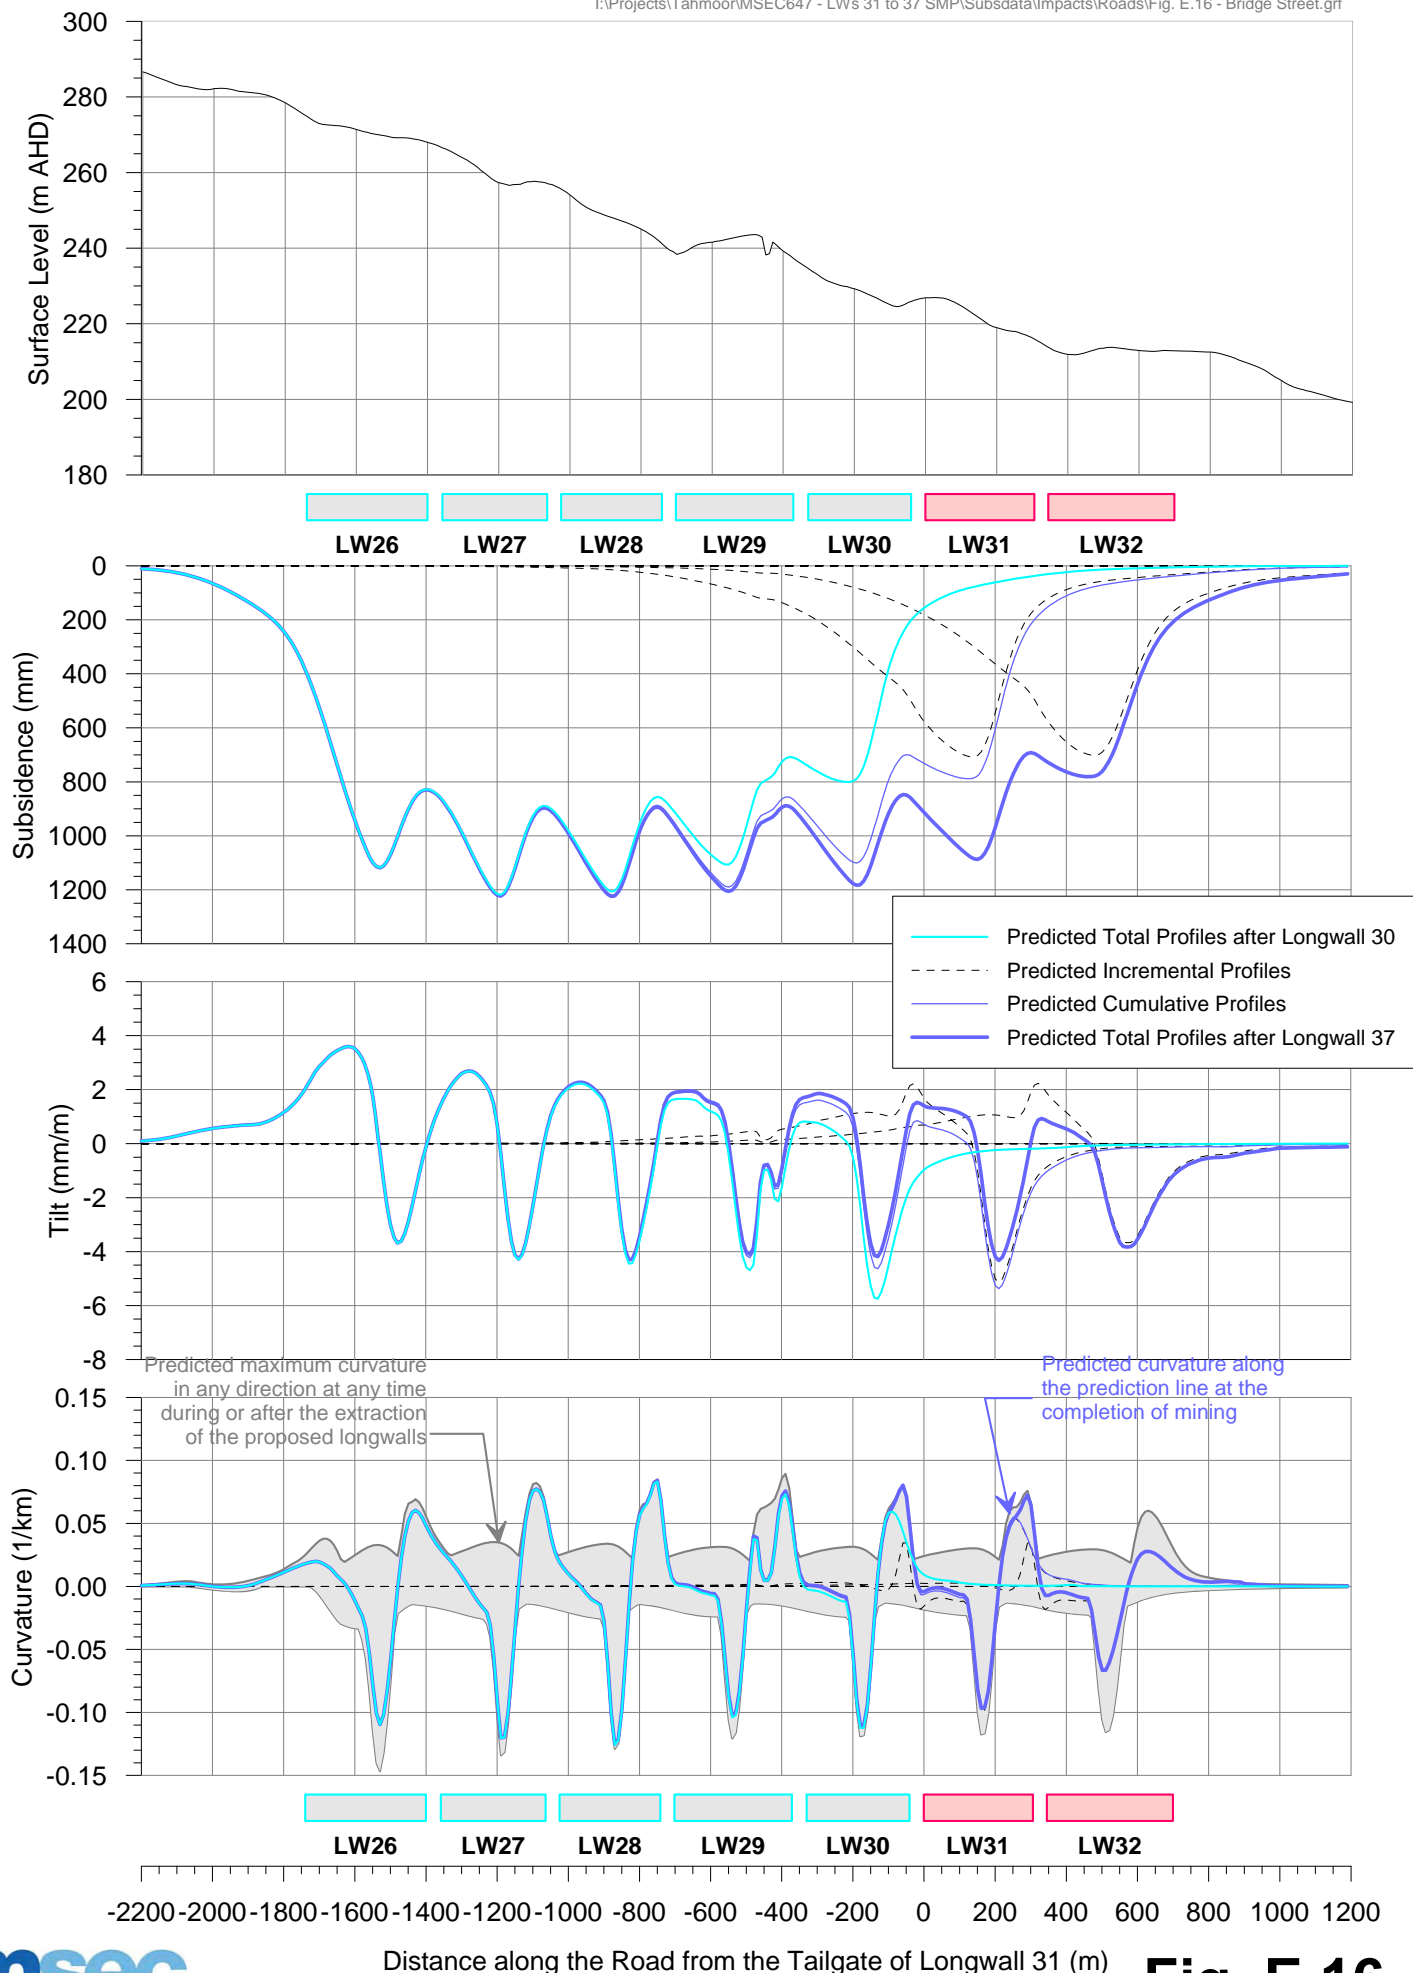
Predicted Profiles of Systematic Subsidence, Tilt and Curvature along Bridge Street Resulting from the Extraction of Longwalls 22 to 37

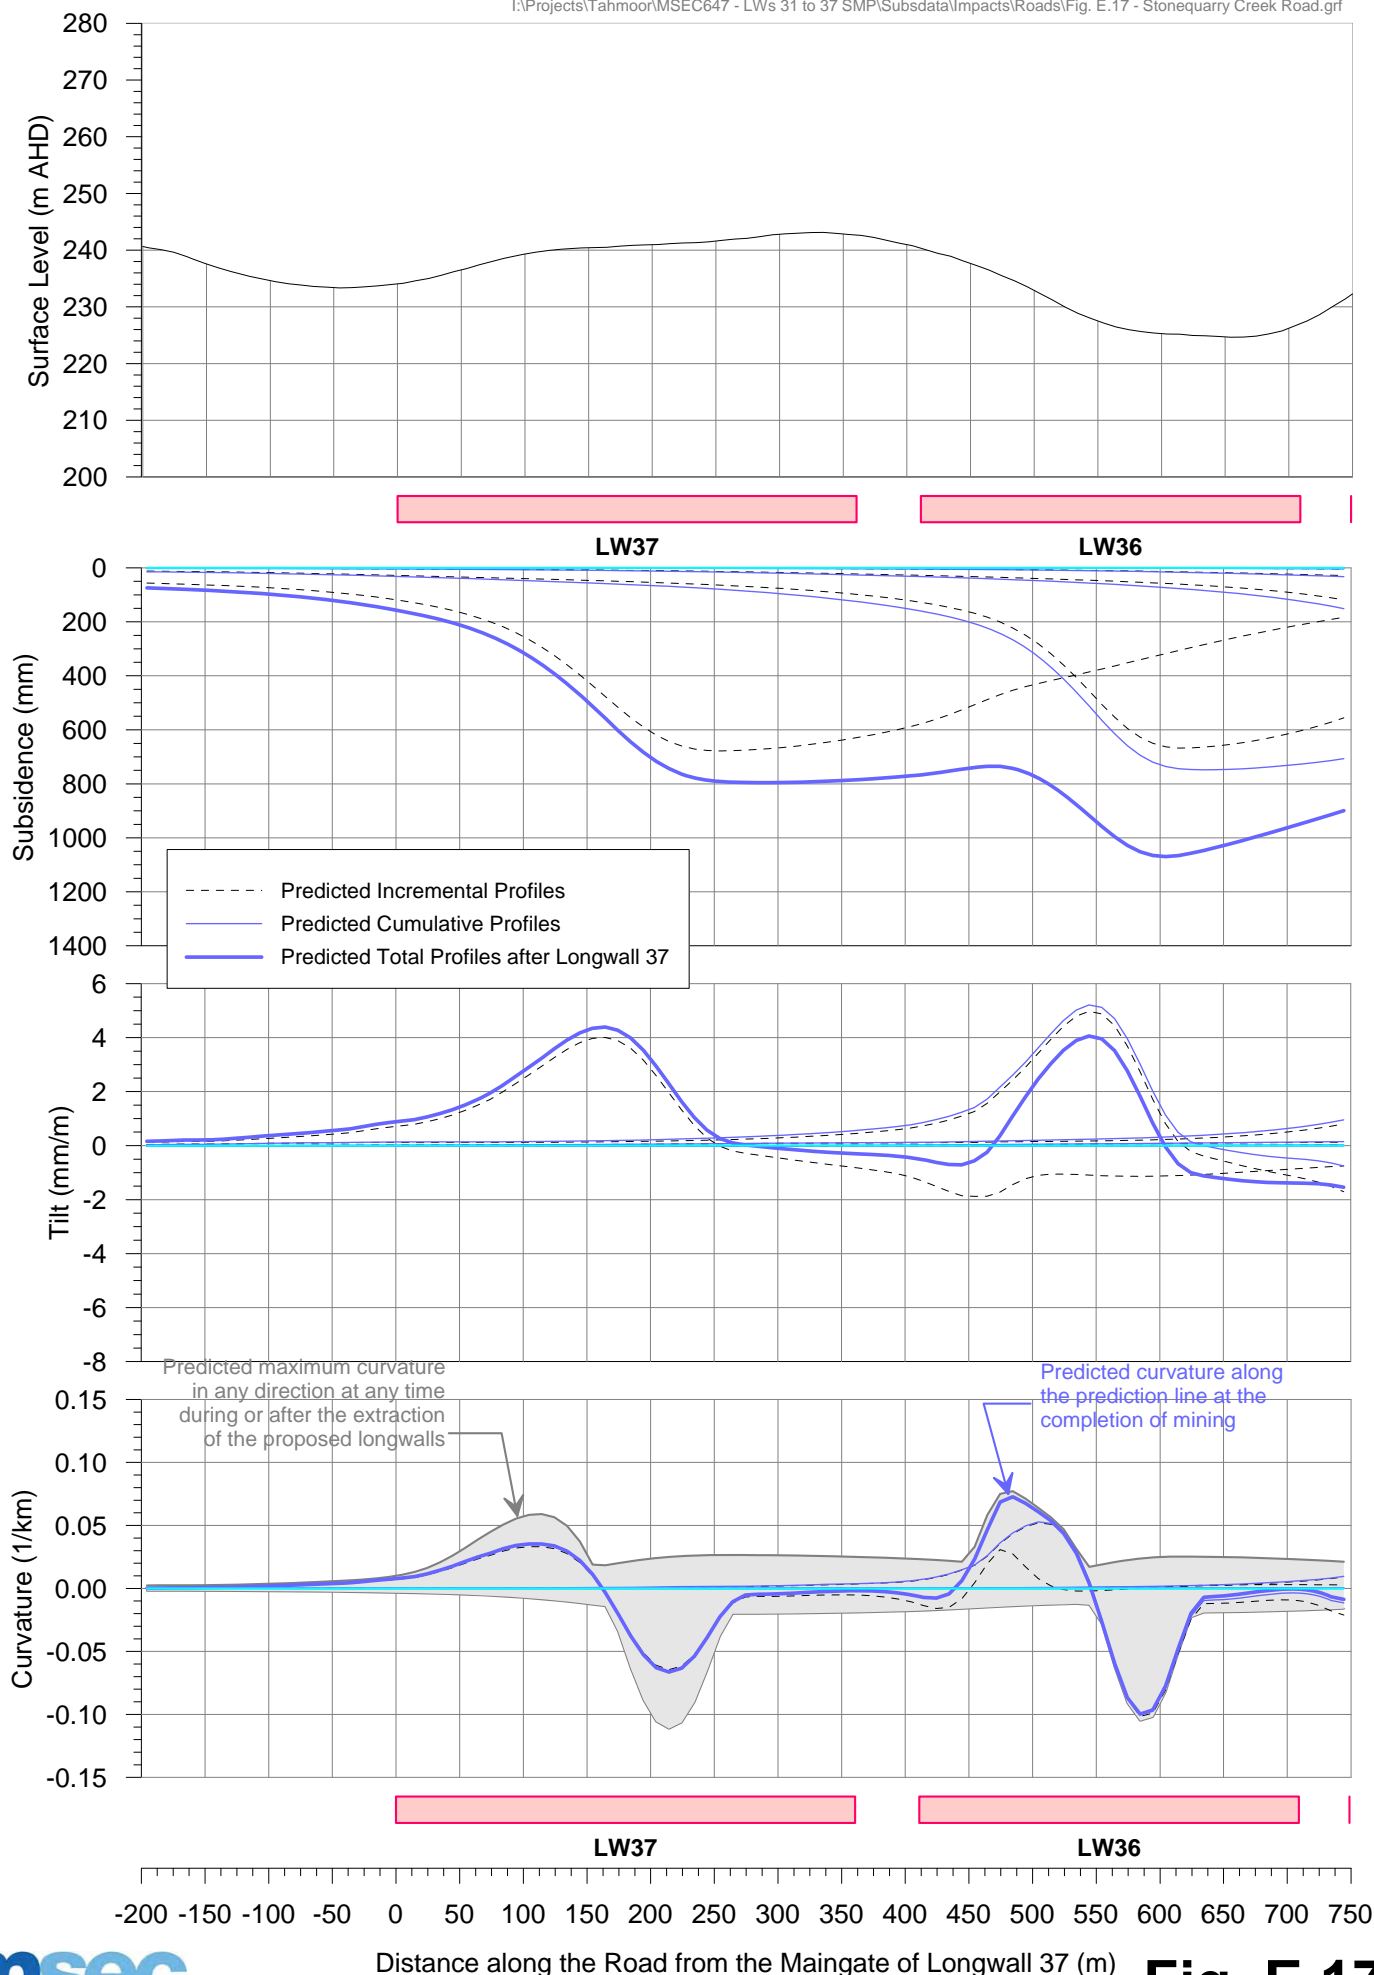
Predicted Profiles of Systematic Subsidence, Tilt and Curvature along Stonequarry Creek Road due to the Extraction of Longwalls 22 to 37

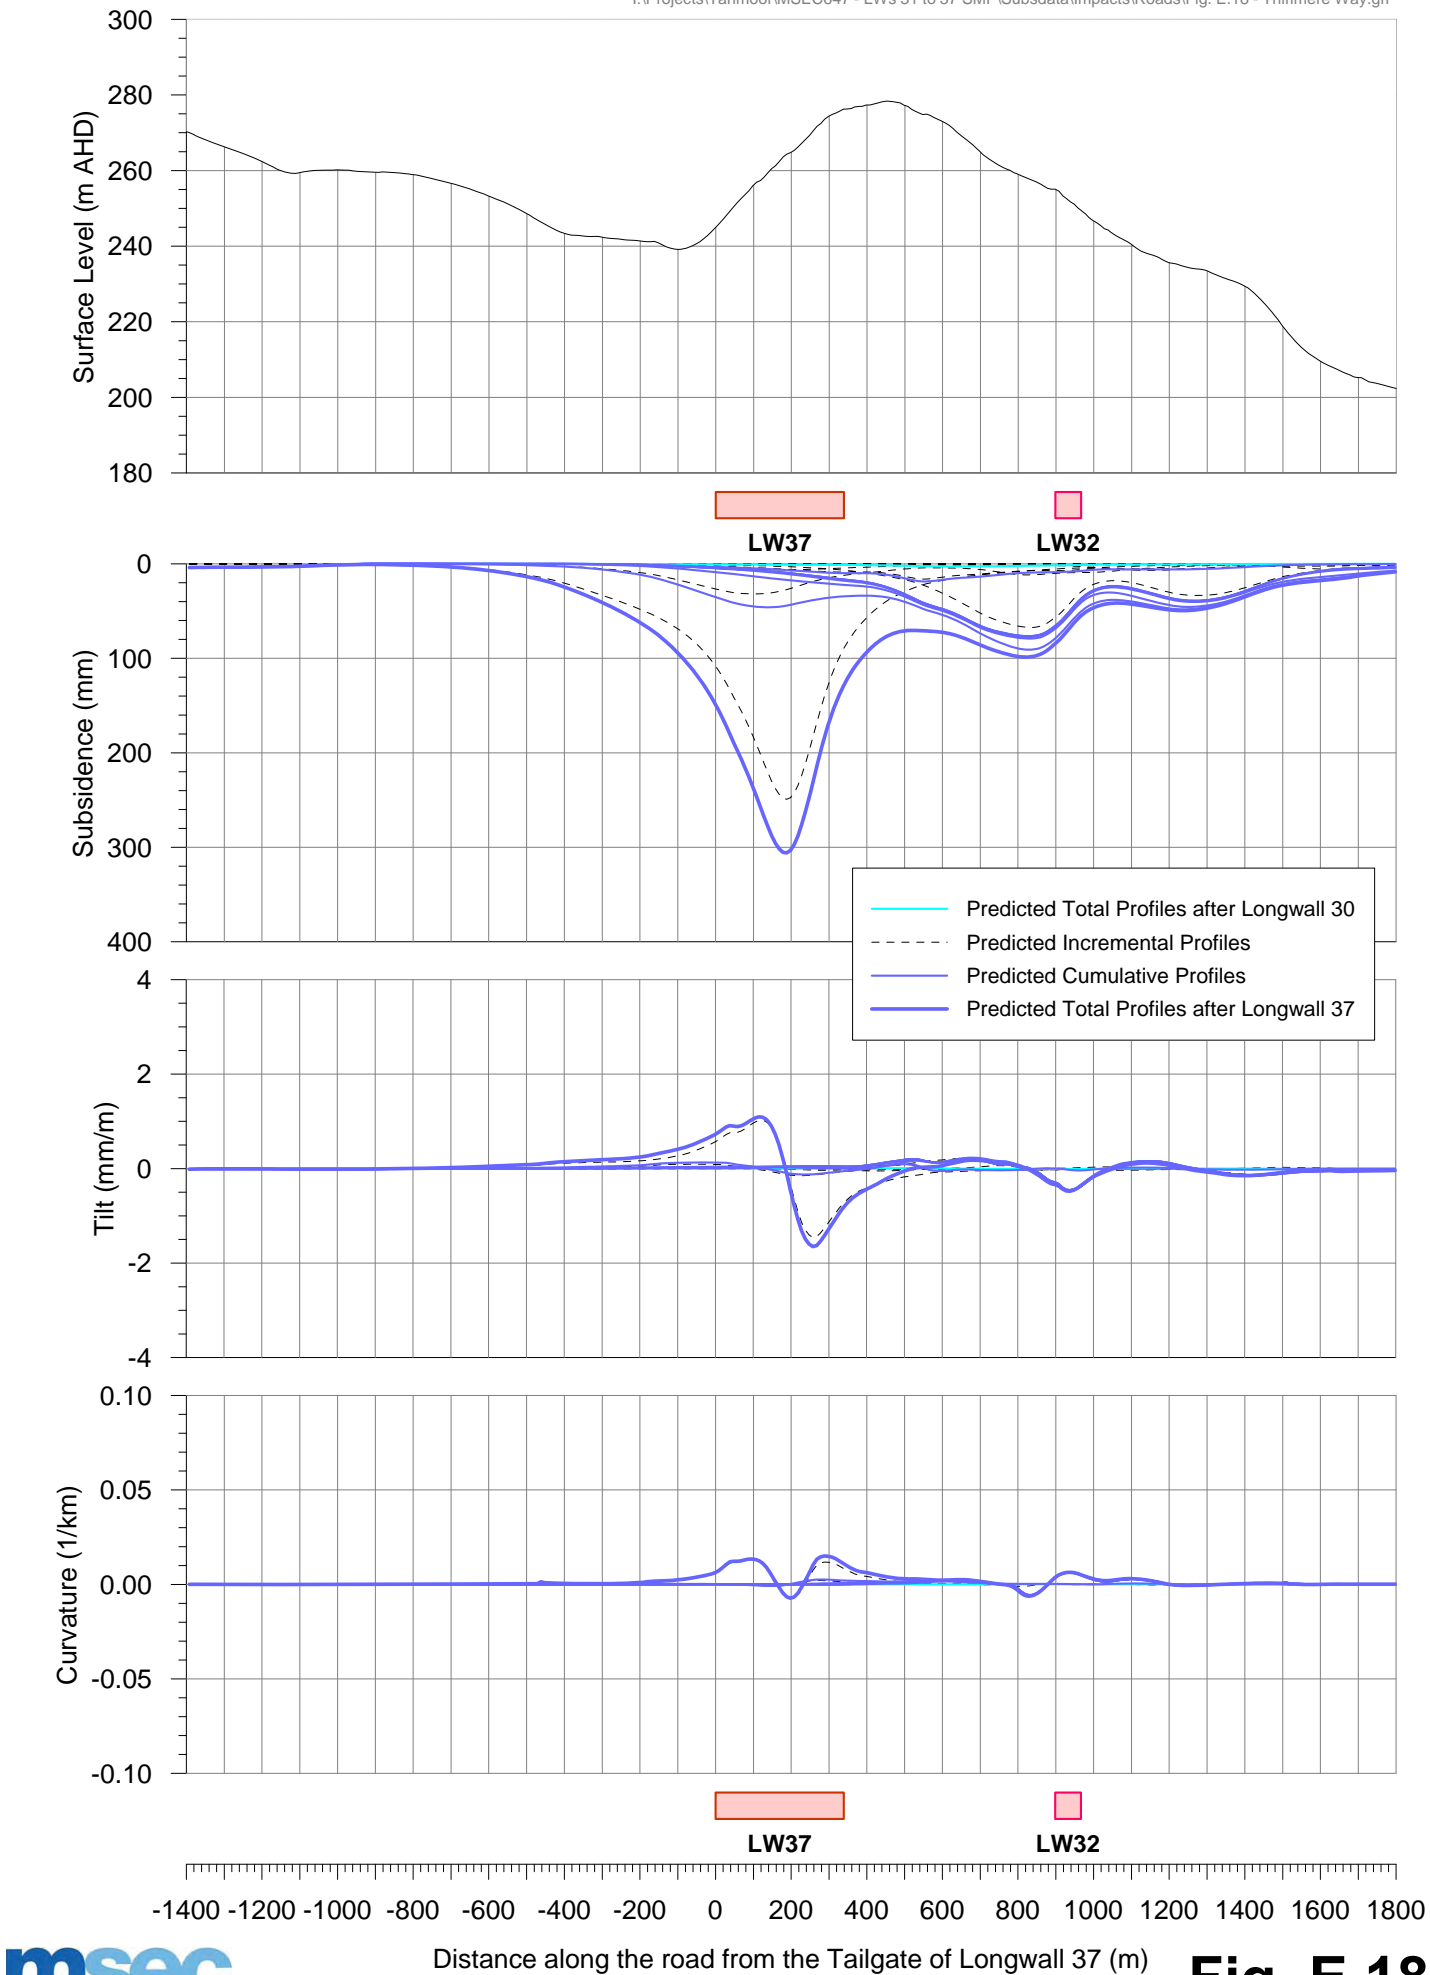
Predicted Profiles of Systematic Subsidence, Tilt and Curvature along Thirlmere Way Resulting from the Extraction of Longwalls 22 to 37

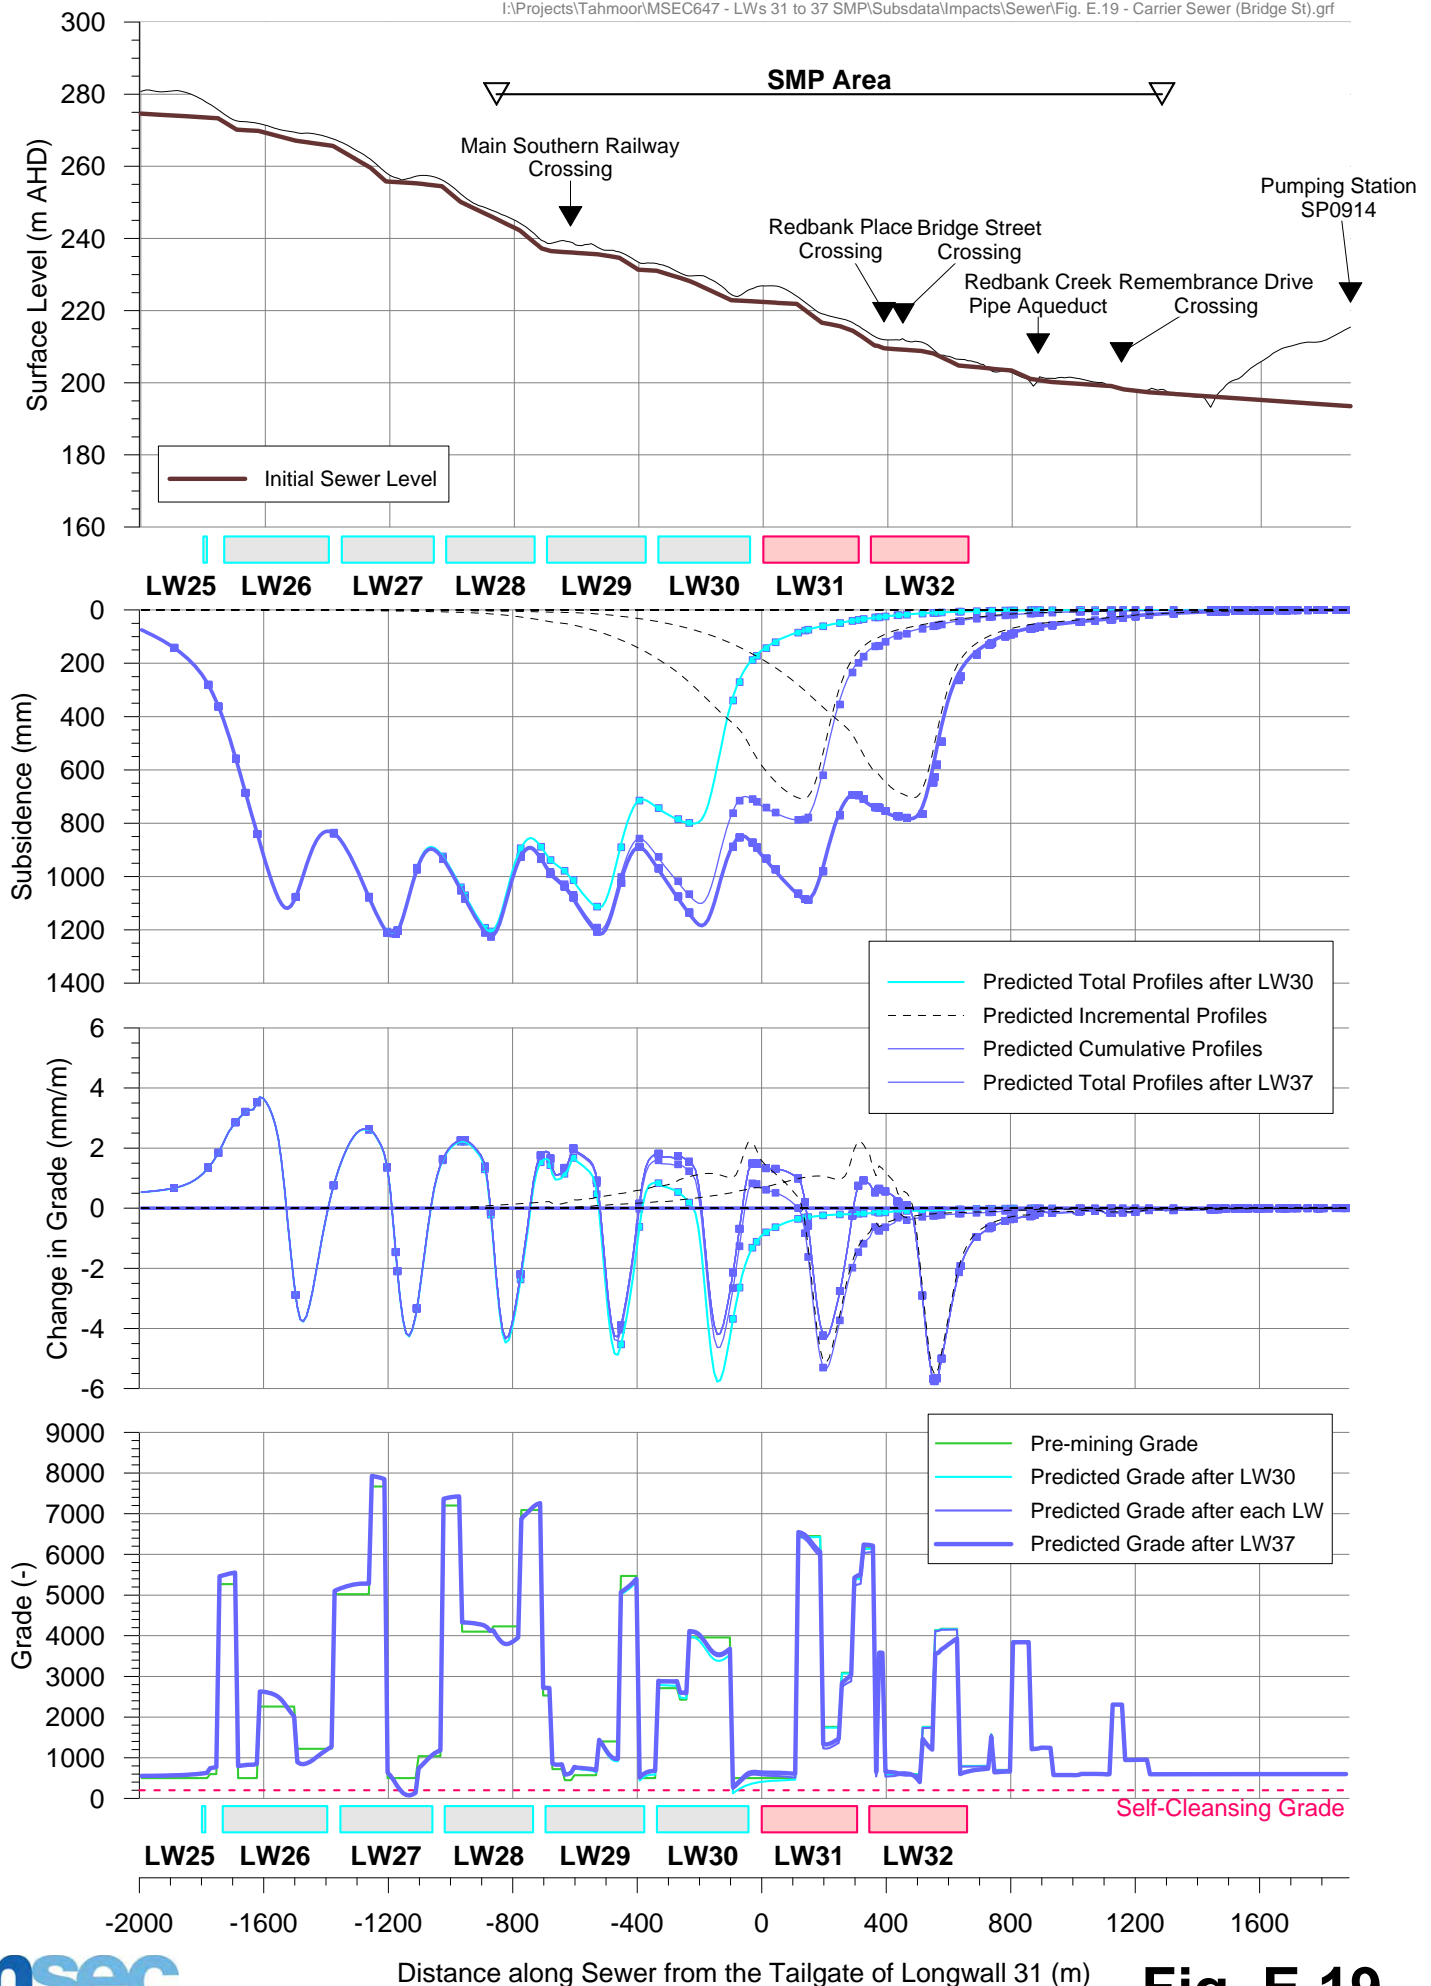
Predicted Profiles of Systematic Subsidence and Changes in Grade along Thirlmere Carrier Sewer Resulting from the Extraction of Longwalls 31 to 37

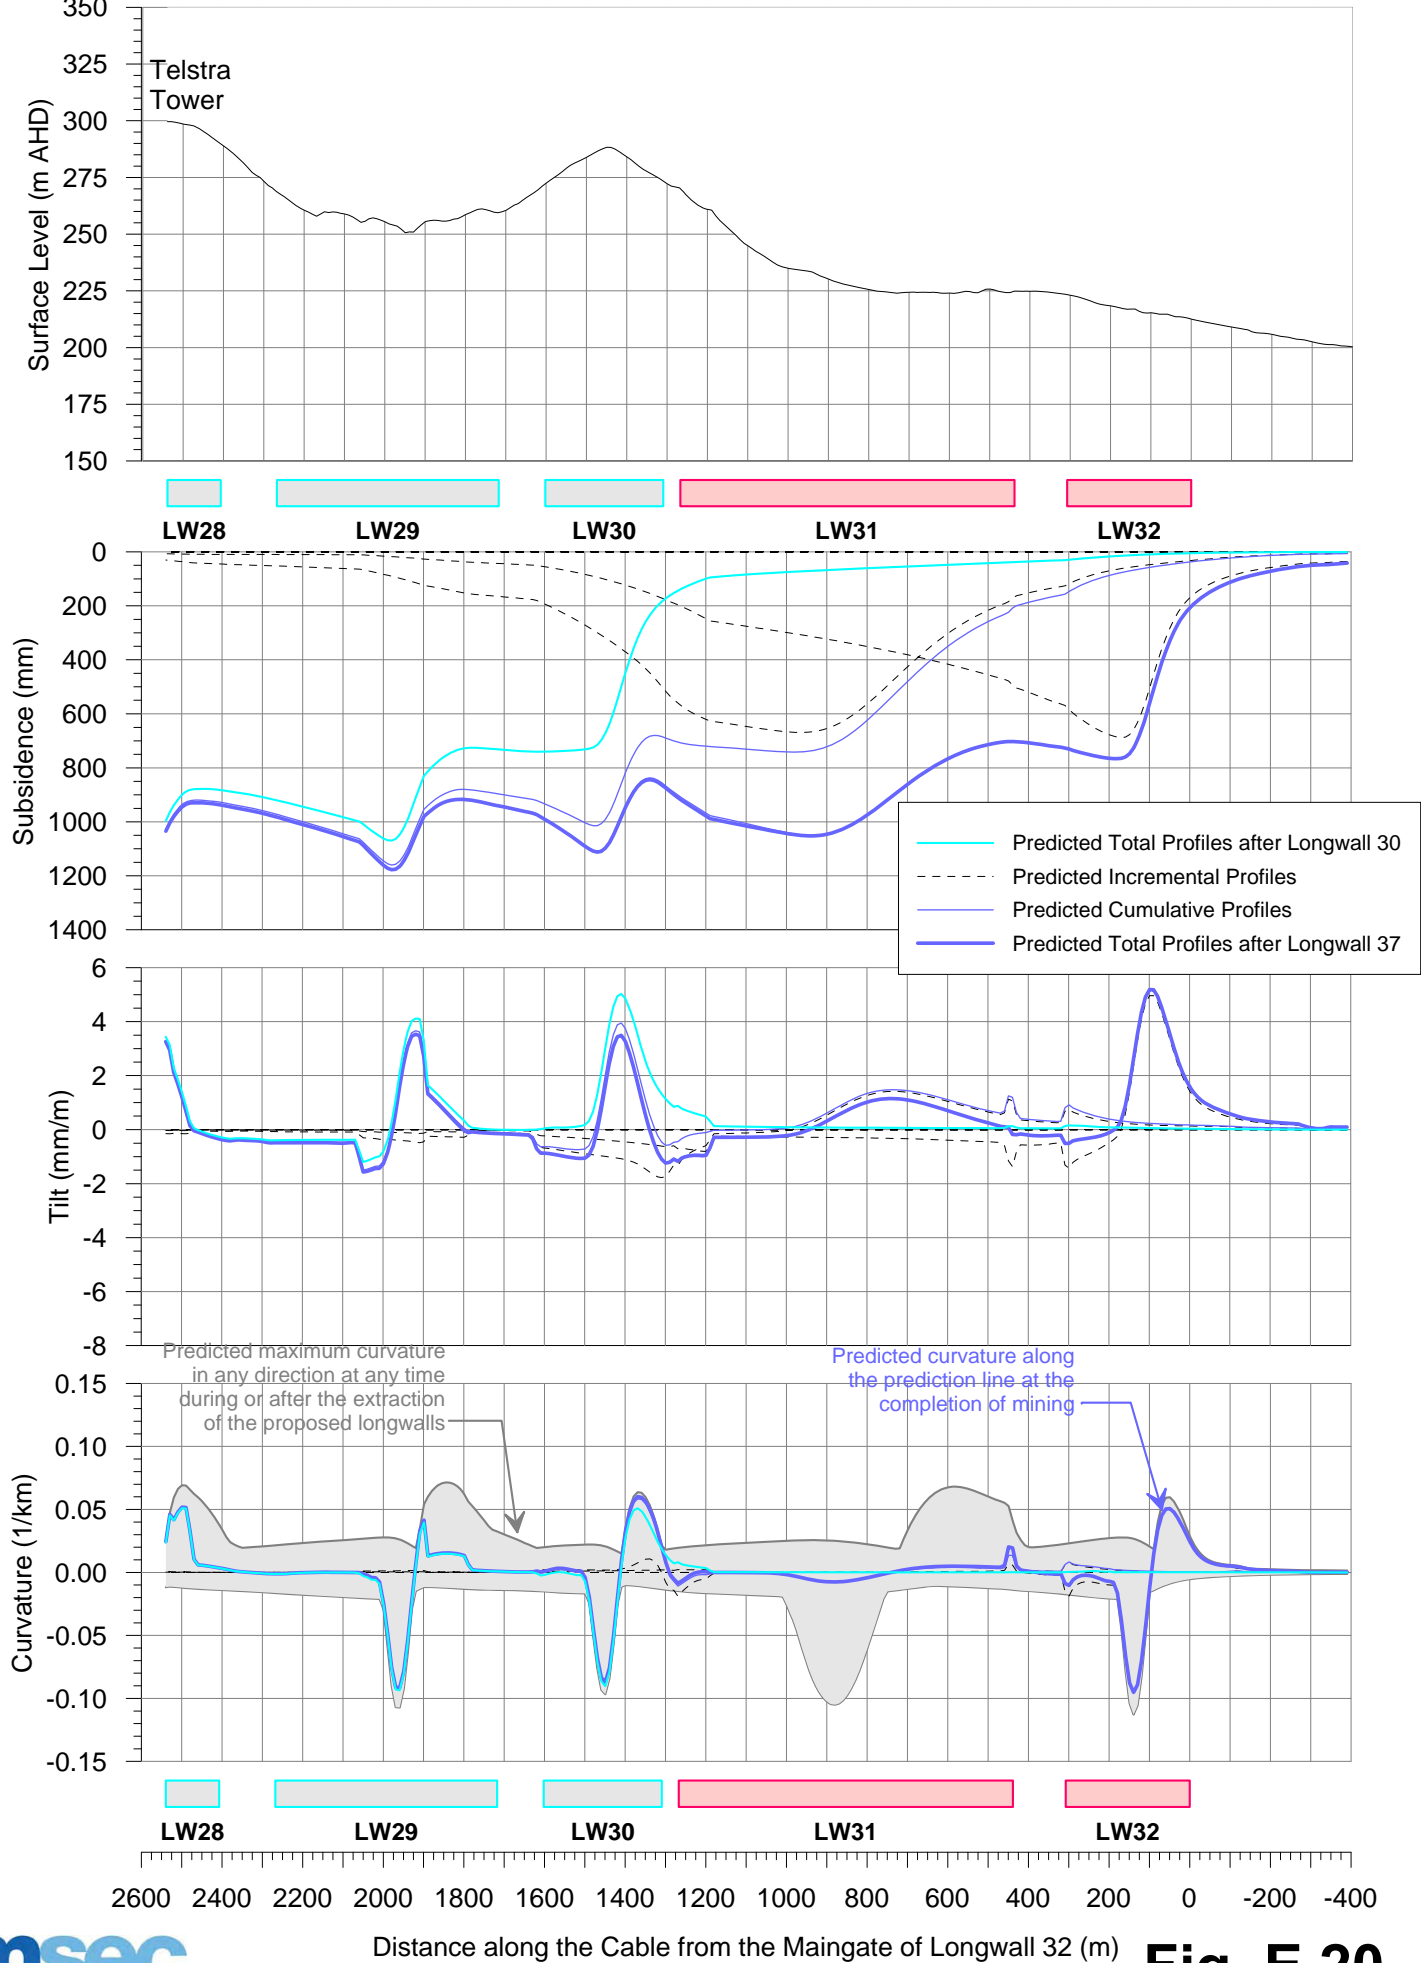
Predicted Profiles of Conventional Subsidence, Tilt and Curvature along the Optical Fibre Cable due to the Extraction of Longwalls 22 to 37

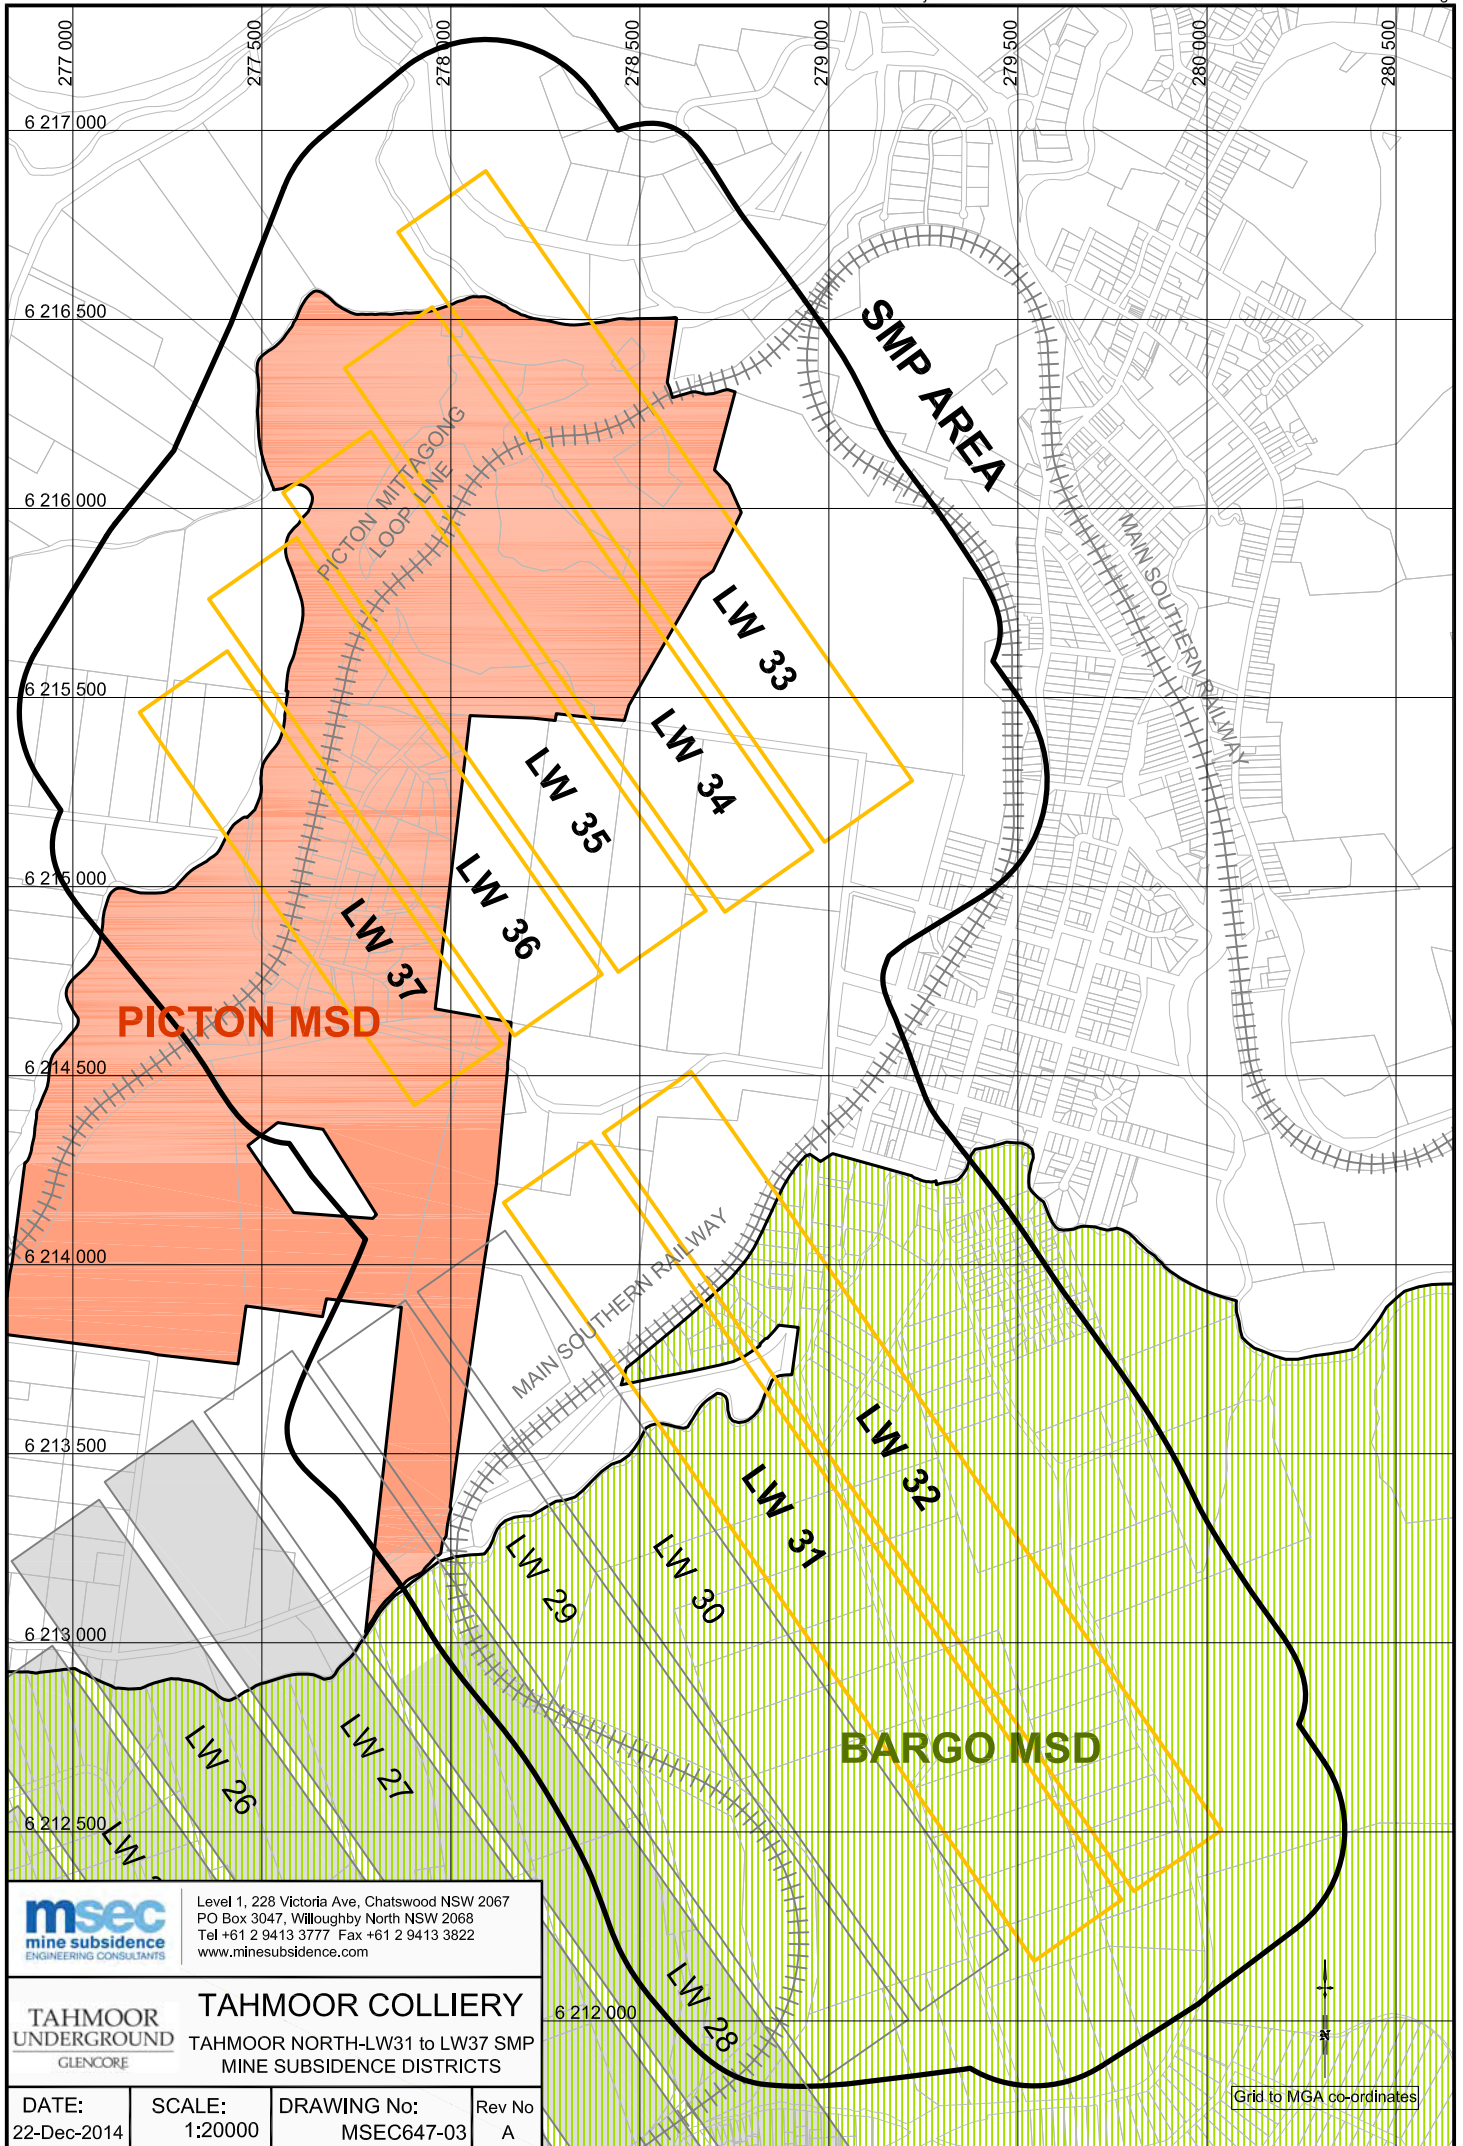
<p>Level 1, 228 Victoria Ave, Chatswood NSW 2067 PO Box 3047, Willoughby North NSW 2068 Tel +61 2 9413 3777 Fax +61 2 9413 3822 www.minesubsidence.com</p>			
<p>TAHMOOR COLLIERY TAHMOOR NORTH-LW31 to LW37 SMP MINE SUBSIDENCE DISTRICTS</p>			
DATE: 22-Dec-2014	SCALE: 1:20000	DRAWING No: MSEC647-03	Rev No A
