Fig. 6.36 Mushroom Tunnel

6.8. Potable Water Infrastructure

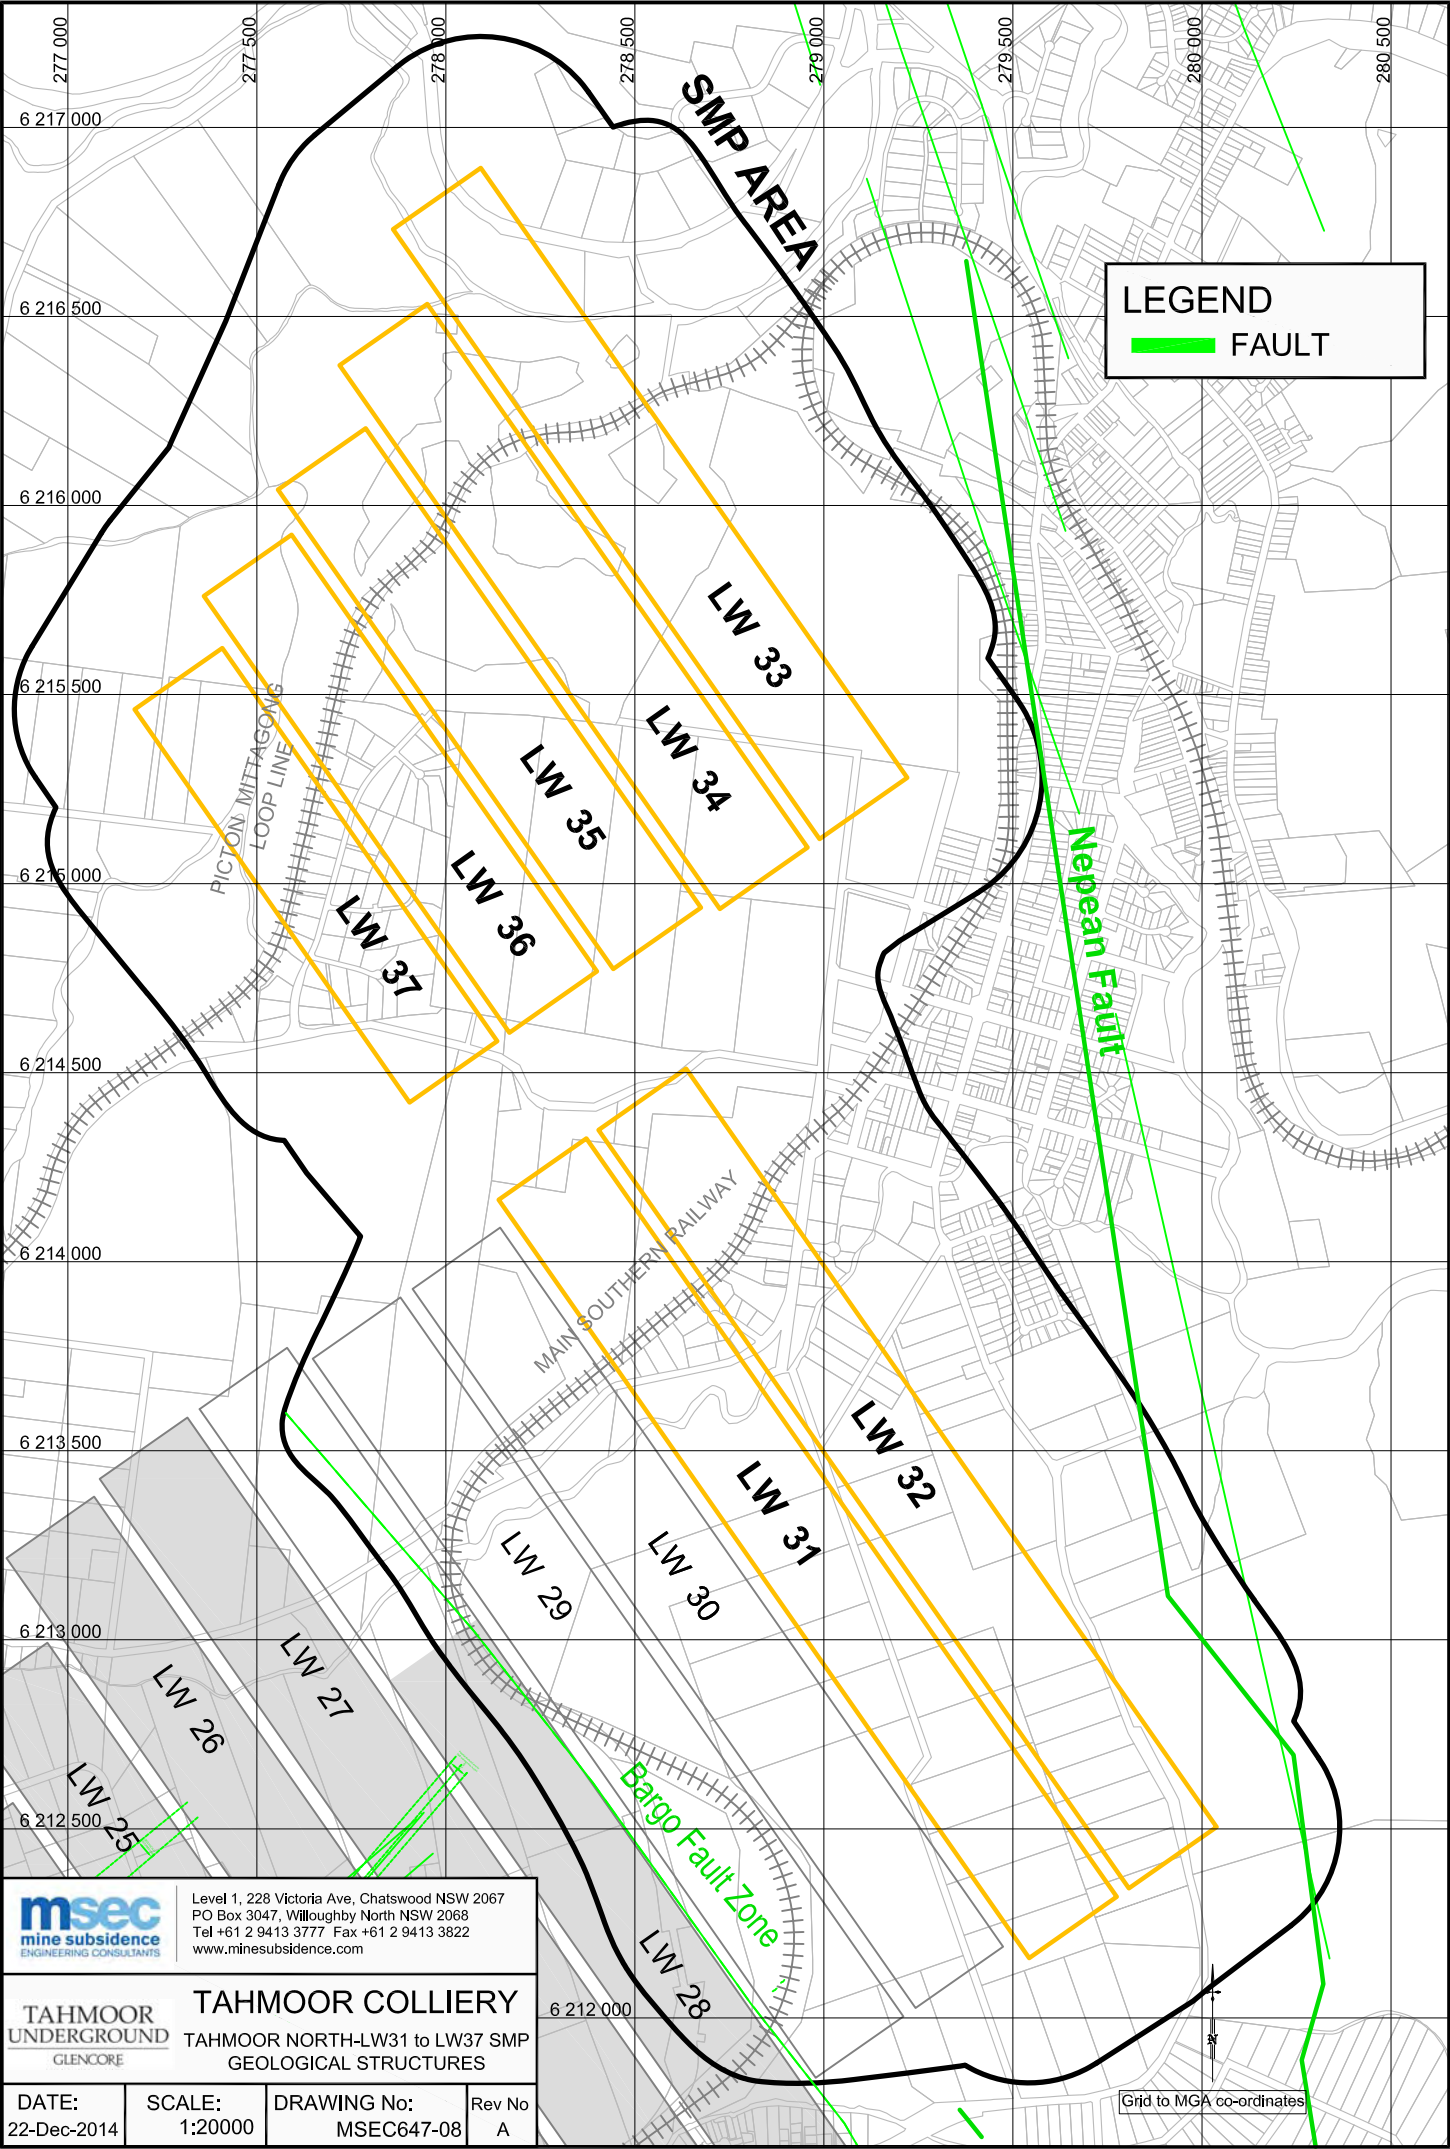
DEPTH OF COVER CONTOURS ARE IN METRES

TAHMOOR COLLIERY
 TAHMOOR NORTH-LW31 to LW37 SMP
 GEOLOGICAL STRUCTURES

DATE: 22-Dec-2014	SCALE: 1:20000	DRAWING No: MSEC647-08	Rev No A
----------------------	-------------------	---------------------------	-------------

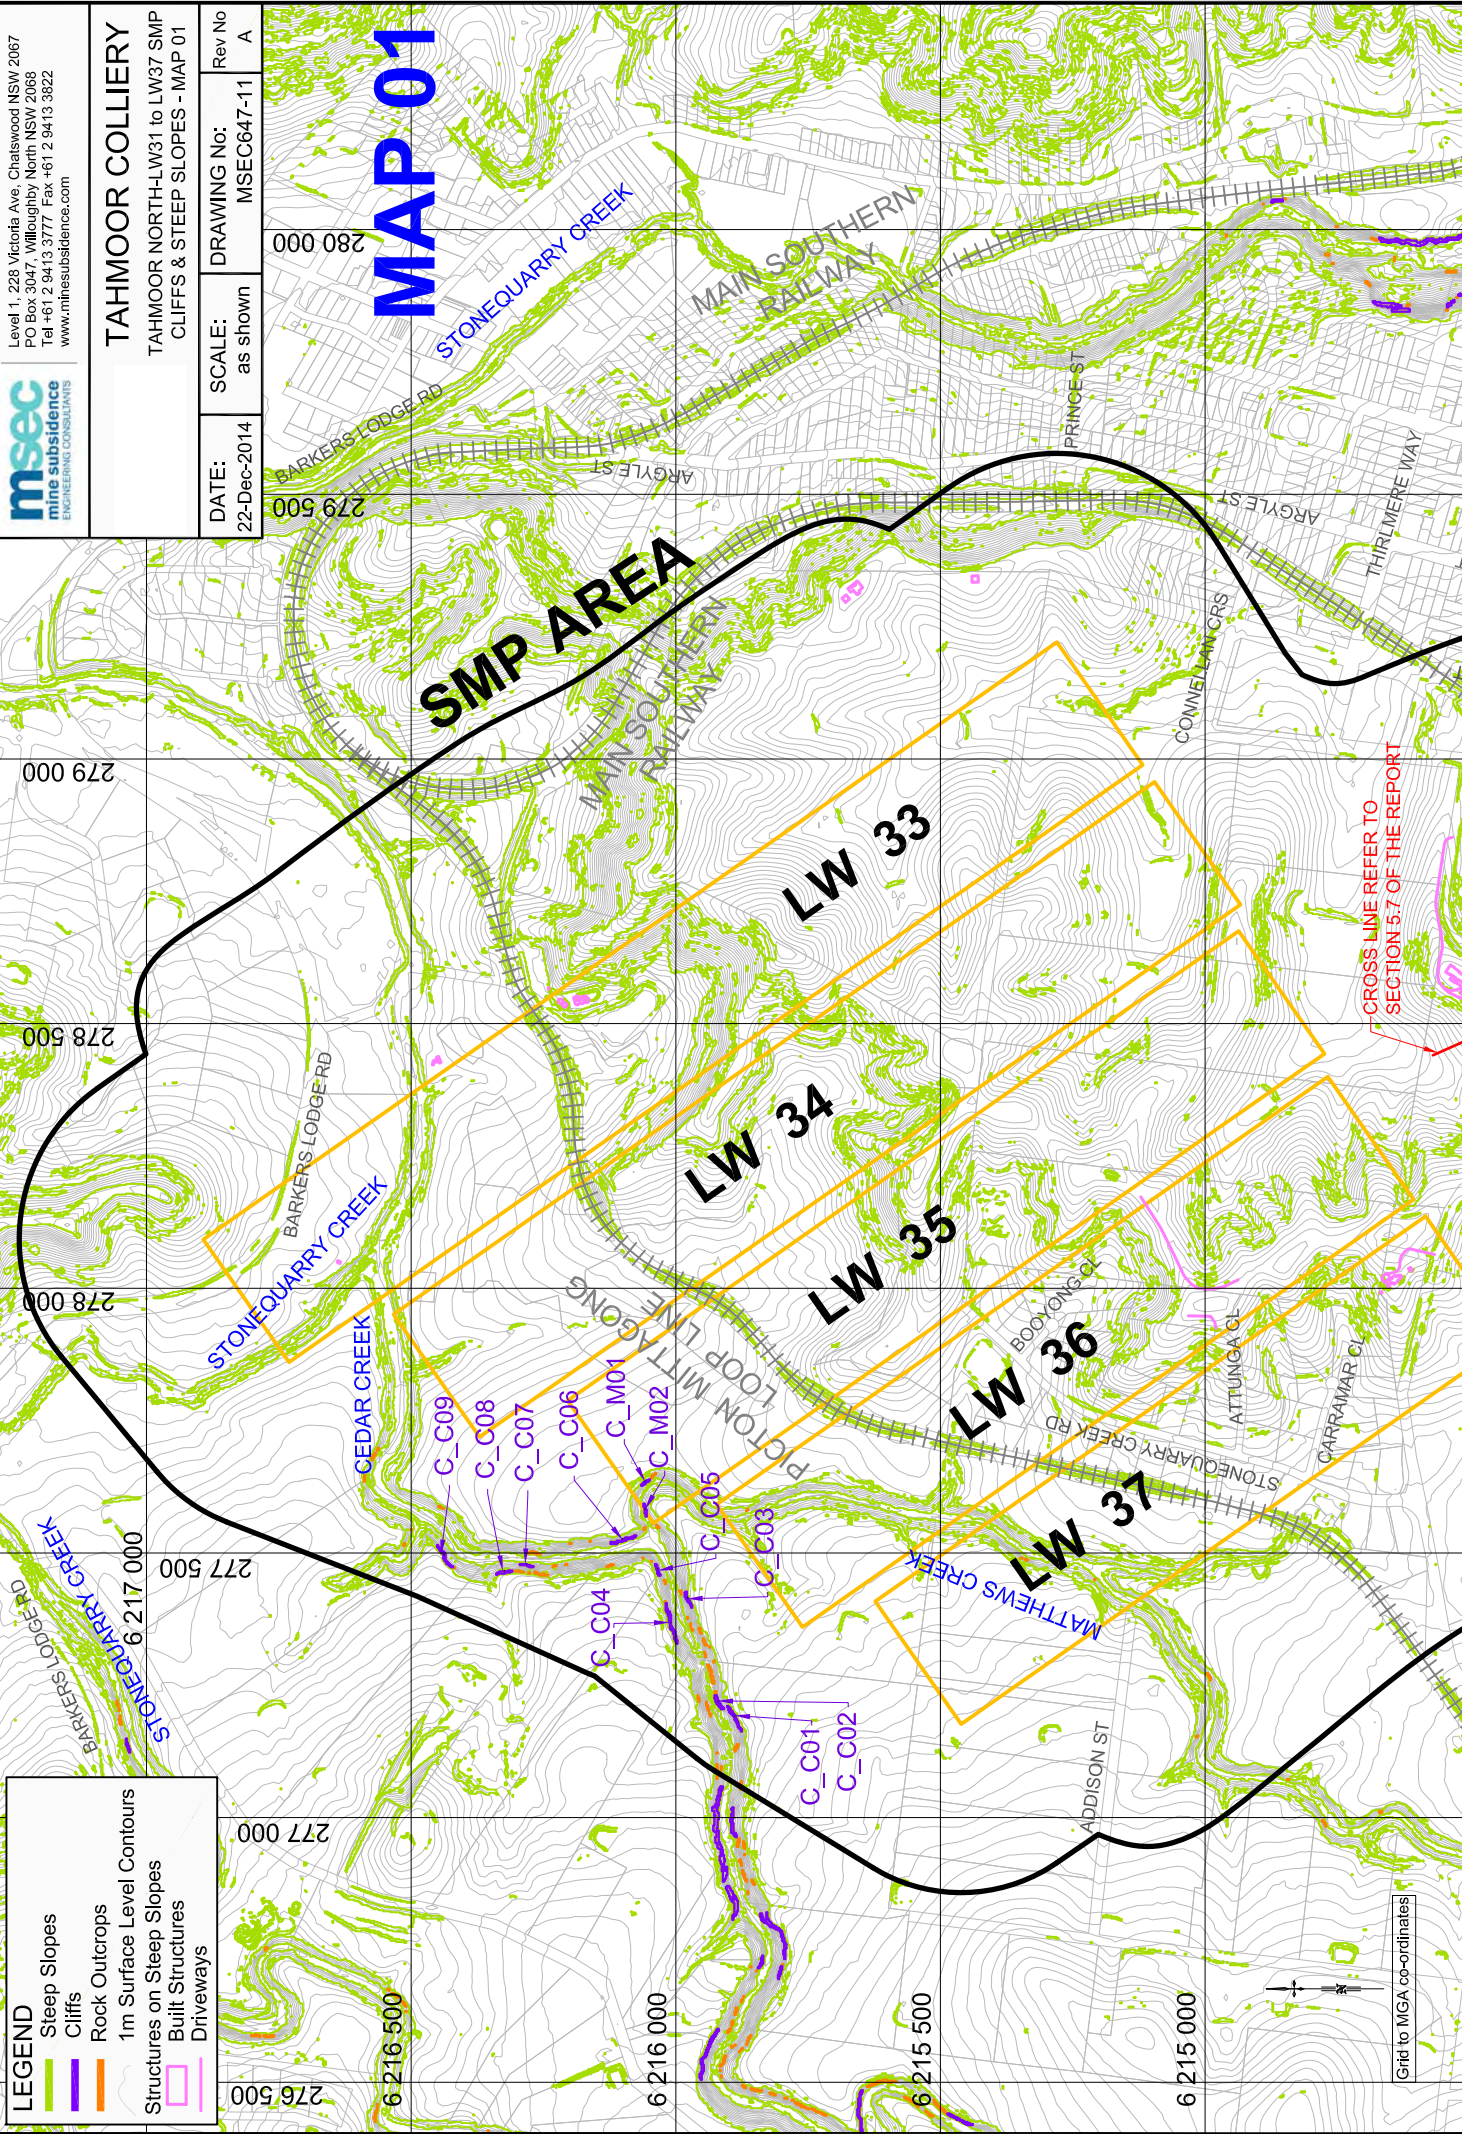
MAP 01

CROSS LINE REFER TO
SECTION 5.7 OF THE REPORT

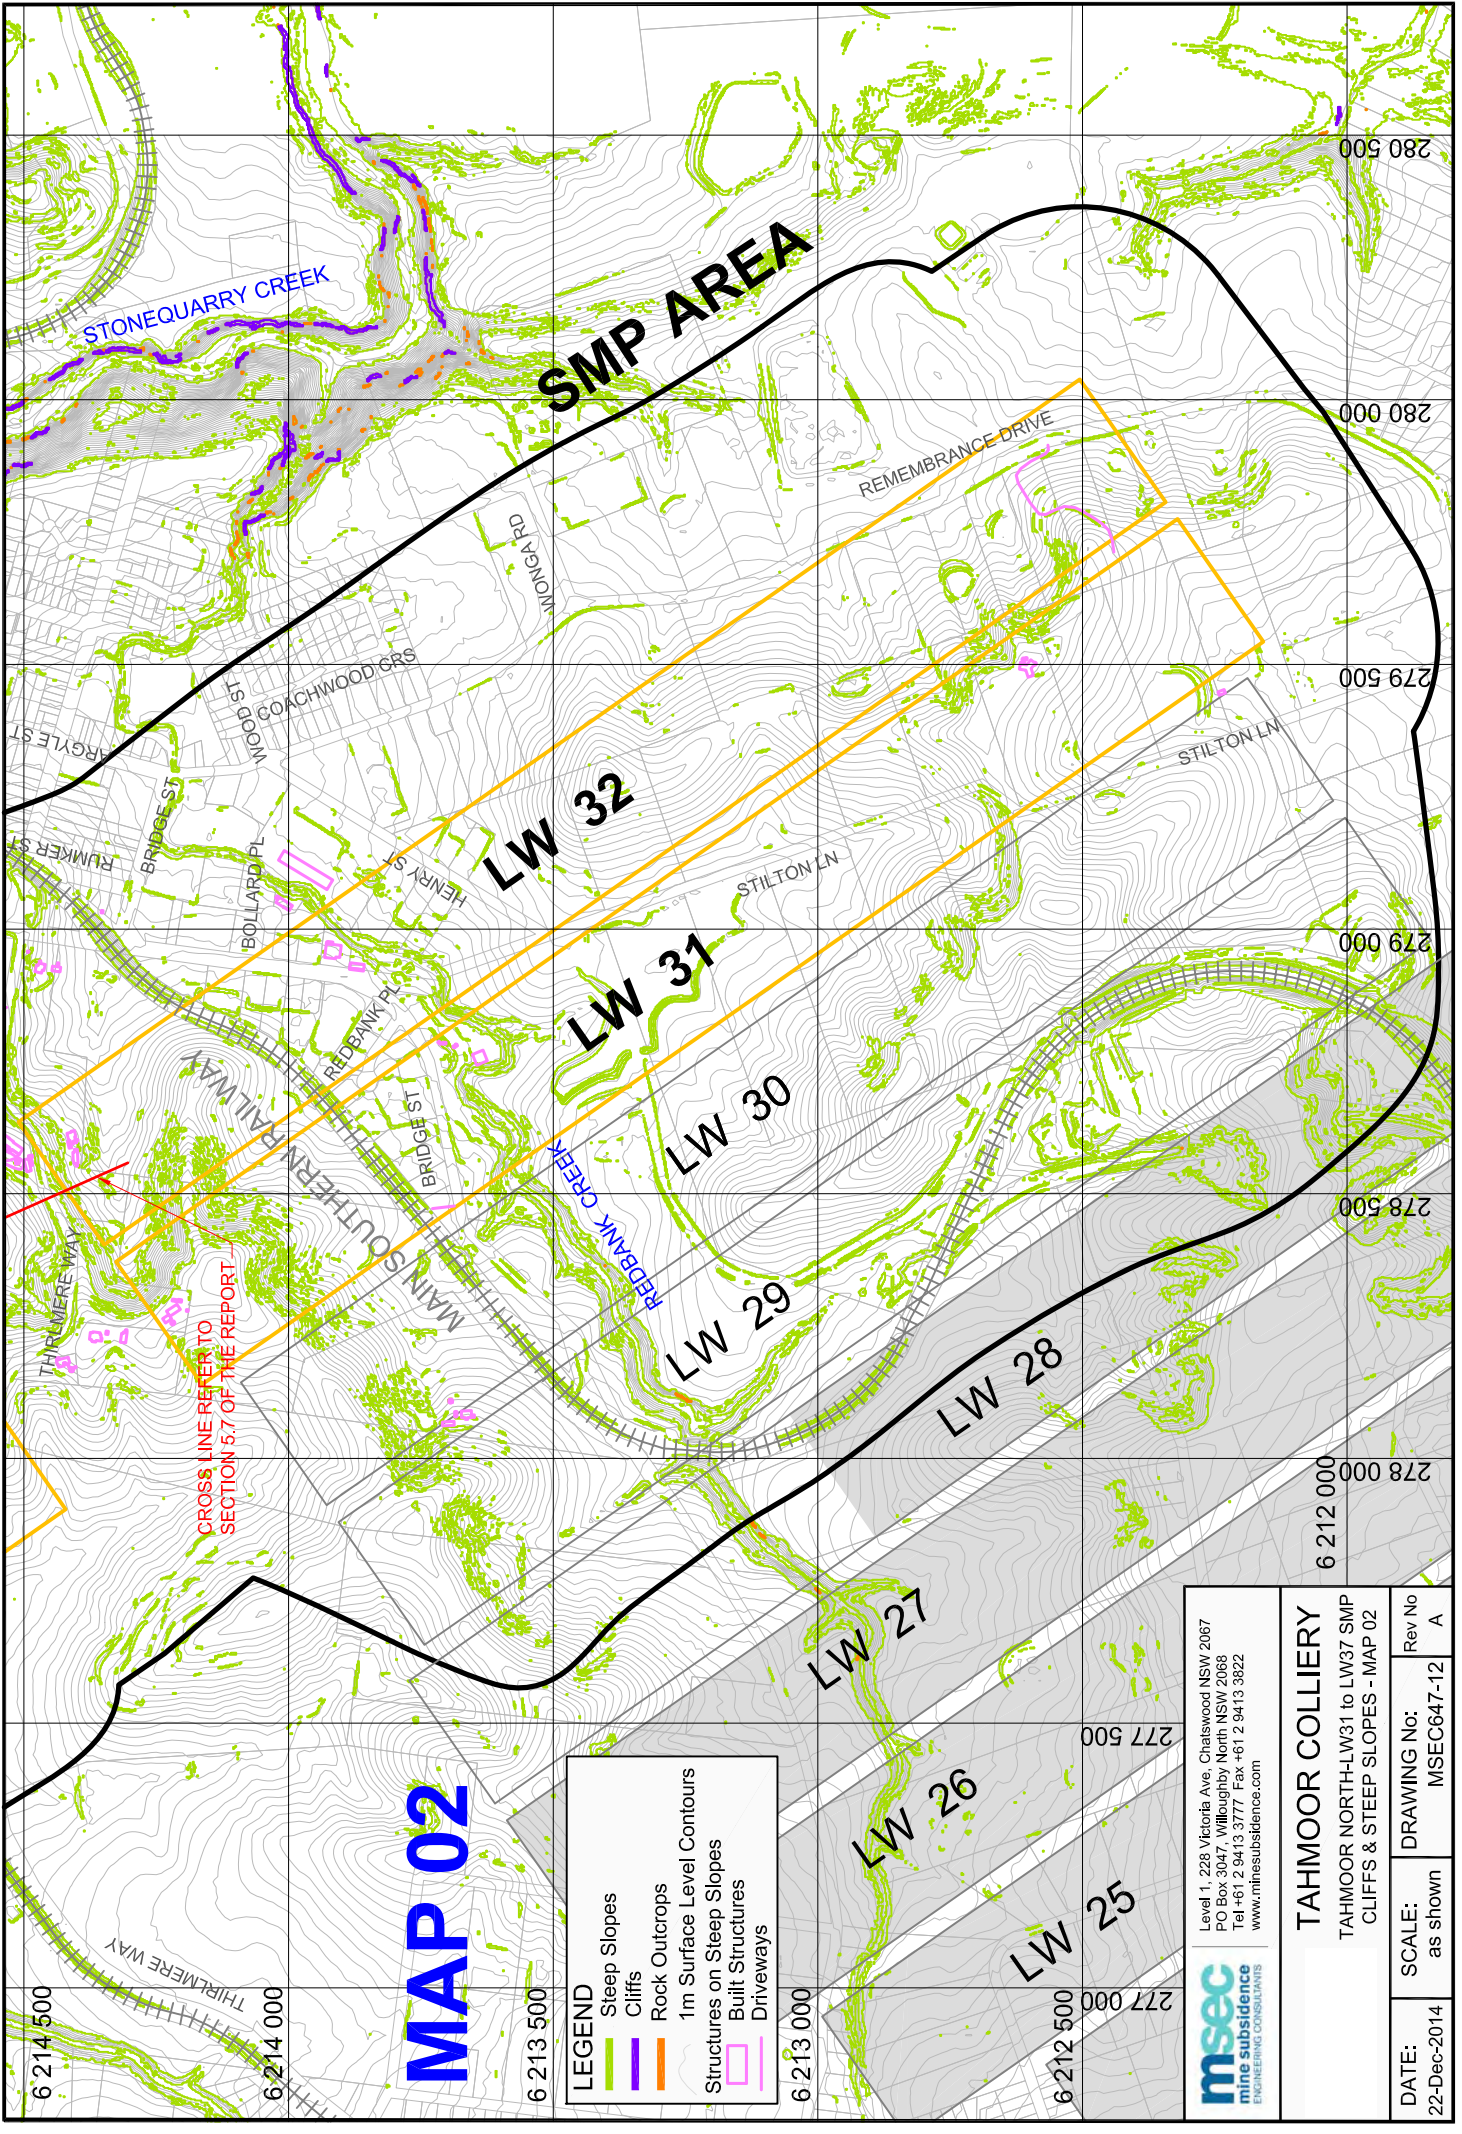
TAHMOOR COLLIERY			
TAHMOOR NORTH-LW31 to LW37 SMP CLIFFS & STEEP SLOPES - MAP 02			
DATE:	SCALE:	DRAWING No:	Rev No
22-Dec-2014	as shown	MSEC647-12	A

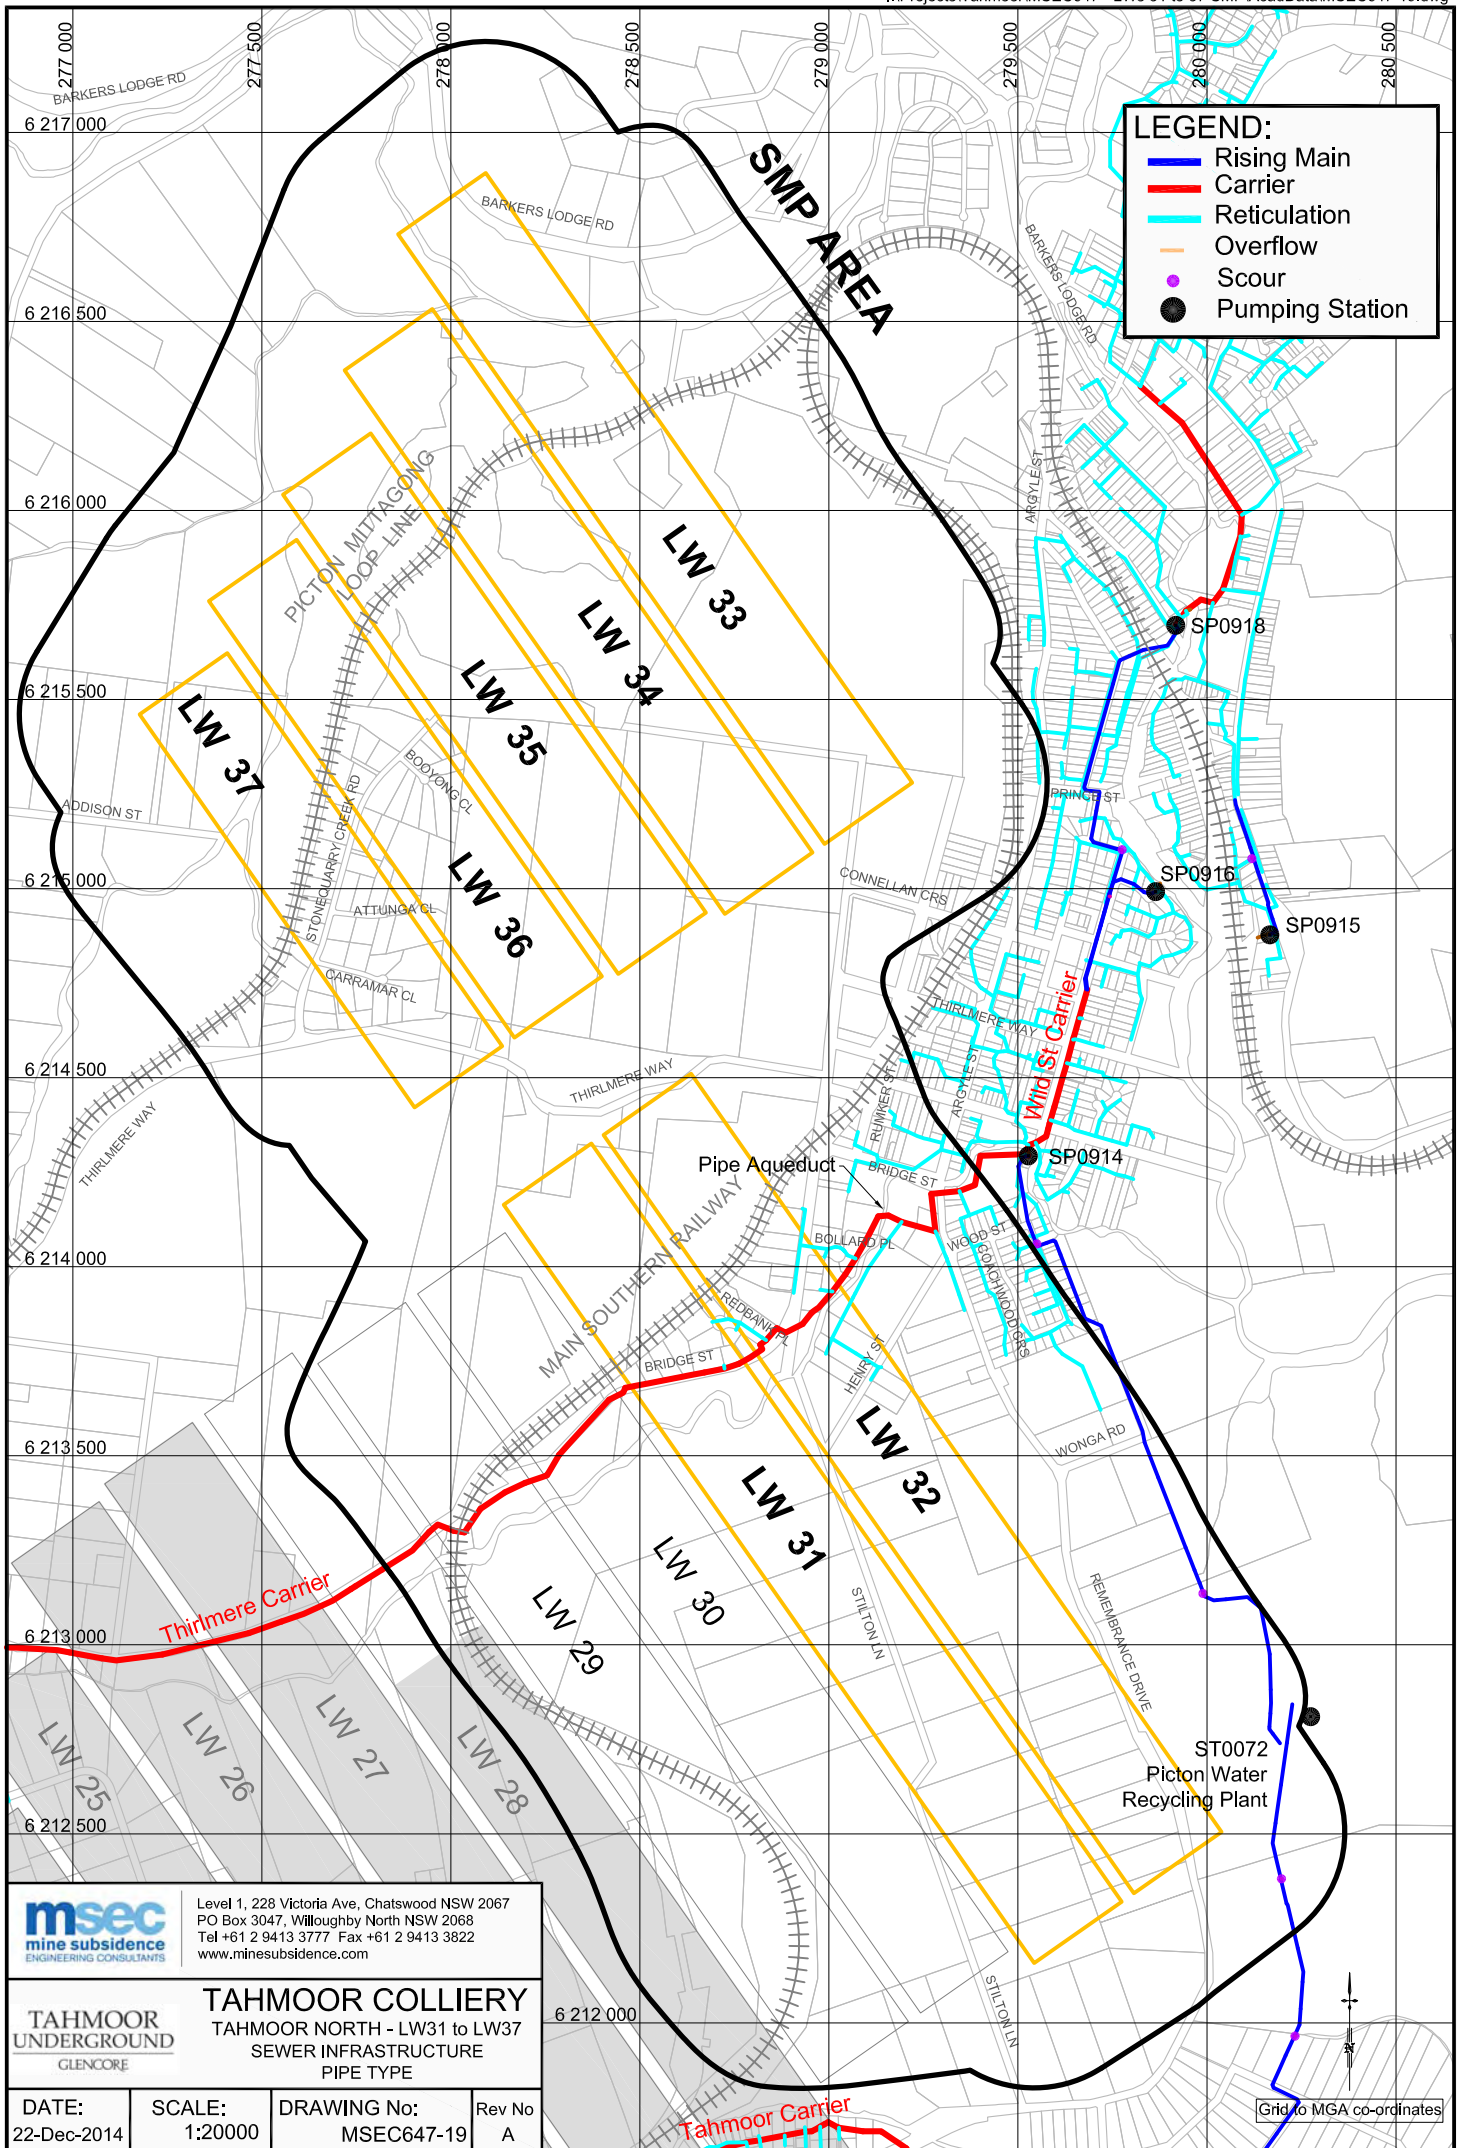
TAHMOOR COLLIERY
TAHMOOR NORTH - LW31 to LW37
SEWER INFRASTRUCTURE
PIPE TYPE

DATE: 22-Dec-2014	SCALE: 1:20000	DRAWING No: MSEC647-19	Rev No A
----------------------	-------------------	---------------------------	-------------
