SIMEC Mining:
**Tahmoor South
Longwalls S1A to S6A**

Management Plan for potential impacts to Built Structures

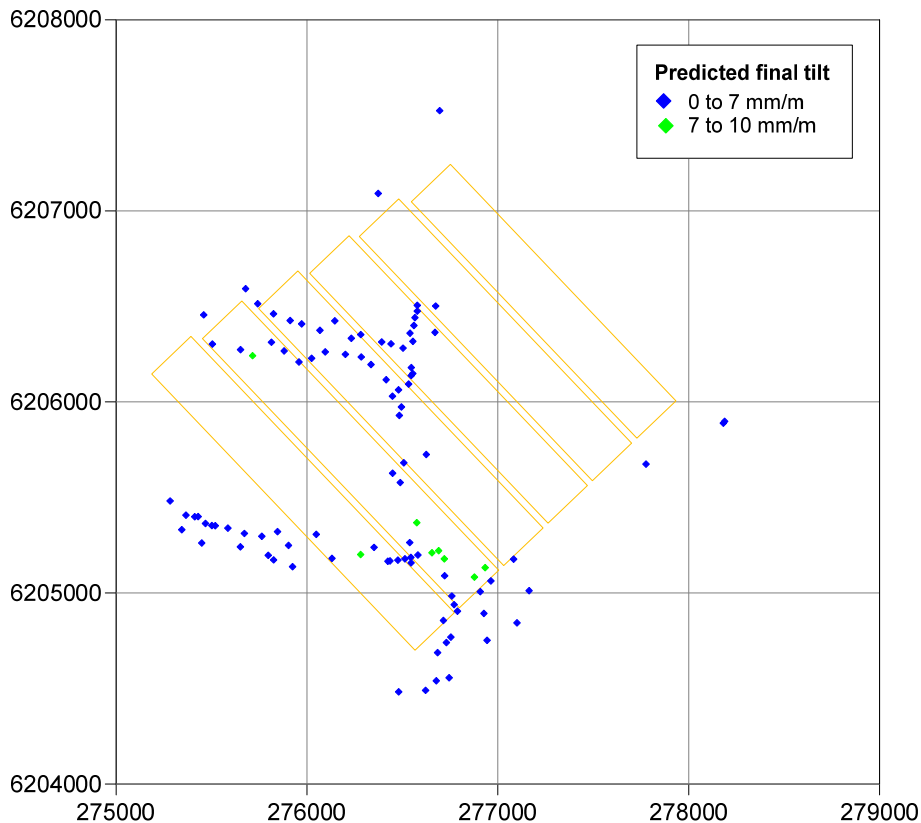
Fig. 4.3 Distribution of predicted final tilts for the houses within the Study Area at the completion of mining

It can be seen from the above figure, that the houses with predicted final tilts greater than 7 mm/m are located above proposed LWs S5A and S6A near the commencing ends of the longwalls.

The distribution of predicted final tilts for the houses within the Study Area is provided in Fig. 4.3. The greatest tilts occur at eight houses located directly above LW S5A and S6A.
