1. Introduction

This document provides an update on the status of Tahmoor Coal's measures to manage potential risks to built structures during the extraction of LWs S1A to S6A. The risk management measures are described in the *Management Plan for potential impacts to Built Structures*, Plan No. MSEC1193-09, Revision B, which will be referred in this document as the "Management Plan".

**TAHMOOR SOUTH PROJECT
 EXTRACTION PLAN
 LW S1A TO LW S6A
 SUBSIDENCE MONITORING**

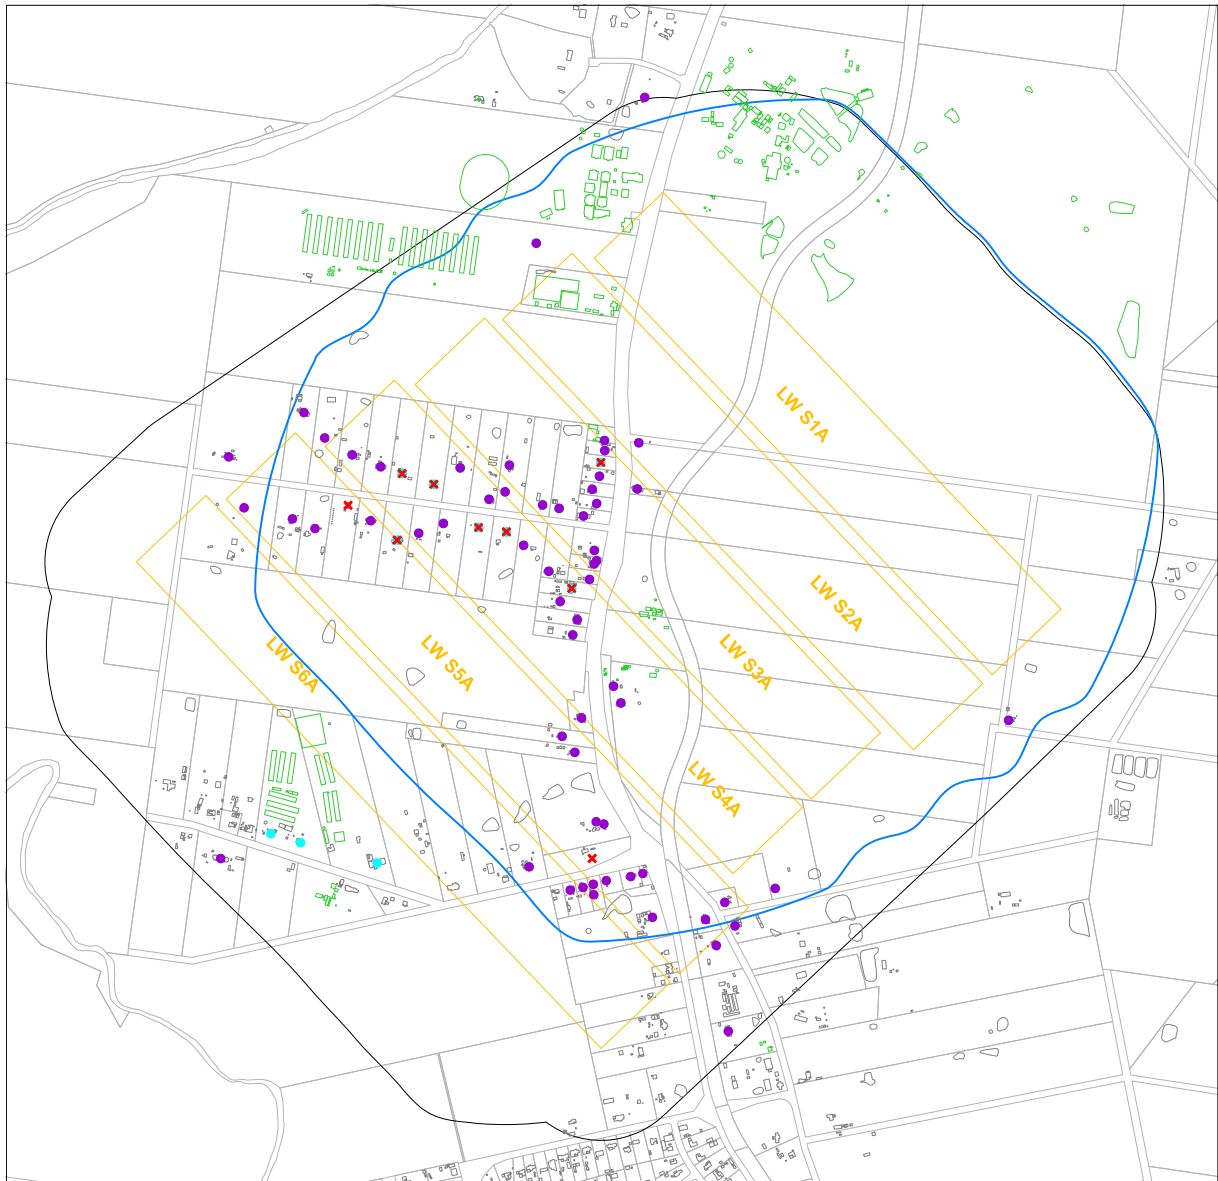
Figure 1 Residential structures where hazard identification inspections have been completed

The locations of residential structures where hazard identification inspections were completed by John Matheson & Associates prior to commencement of extraction of LW S1A were shown in Fig. 6.2 of the Management Plan. An updated map showing the locations of completed hazard identification inspections is provided in Figure 1.

A total of 9 properties have either refused or not responded to Tahmoor Coal's requests to conduct a pre-mining hazard identification inspection. The locations of these properties are also shown in Figure 1.

Note: all properties that are predicted to experience more than 20 mm of incremental subsidence have been offered a pre-mining hazard identification inspection.

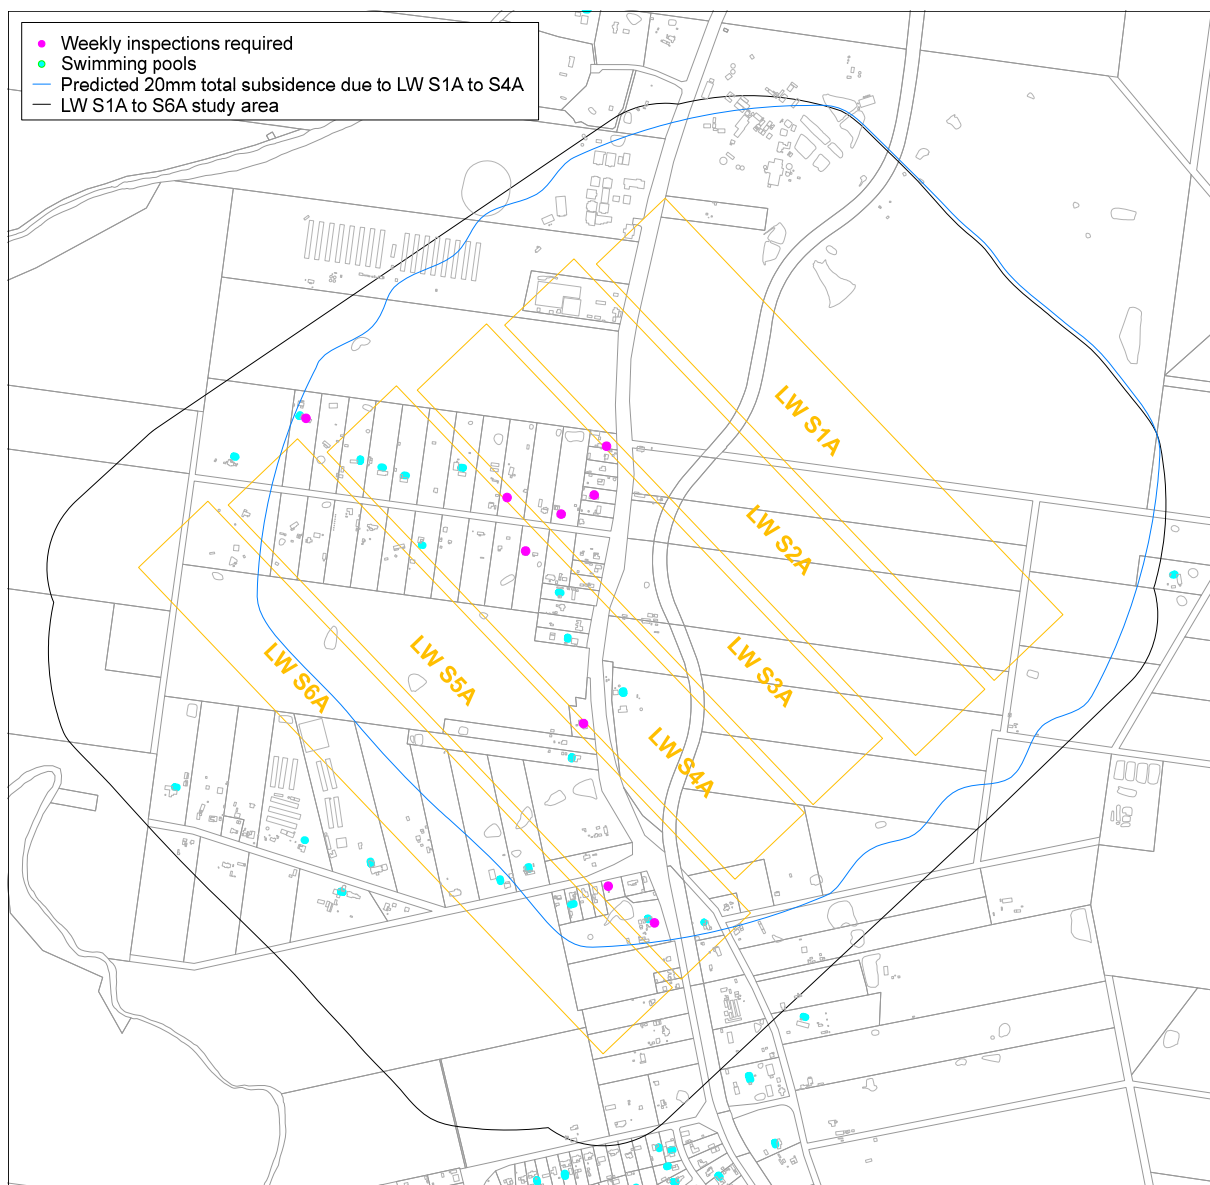
Figure 2 Planned weekly visual inspections during active subsidence

When conducting its review of the pre-mining hazard inspections, the SRG recommended that weekly visual inspections be conducted at some properties, as summarised in Table A.1. The locations of properties where weekly visual inspections were planned to be conducted prior to the commencement of LW S1A were shown in Figure 6.3 of the Management Plan. An updated map showing the locations of planned weekly visual inspections is provided in Figure 2

Two pools that were previously identified in Fig. 6.3 of the Management Plan have since been removed and, therefore, no longer require weekly visual inspections.

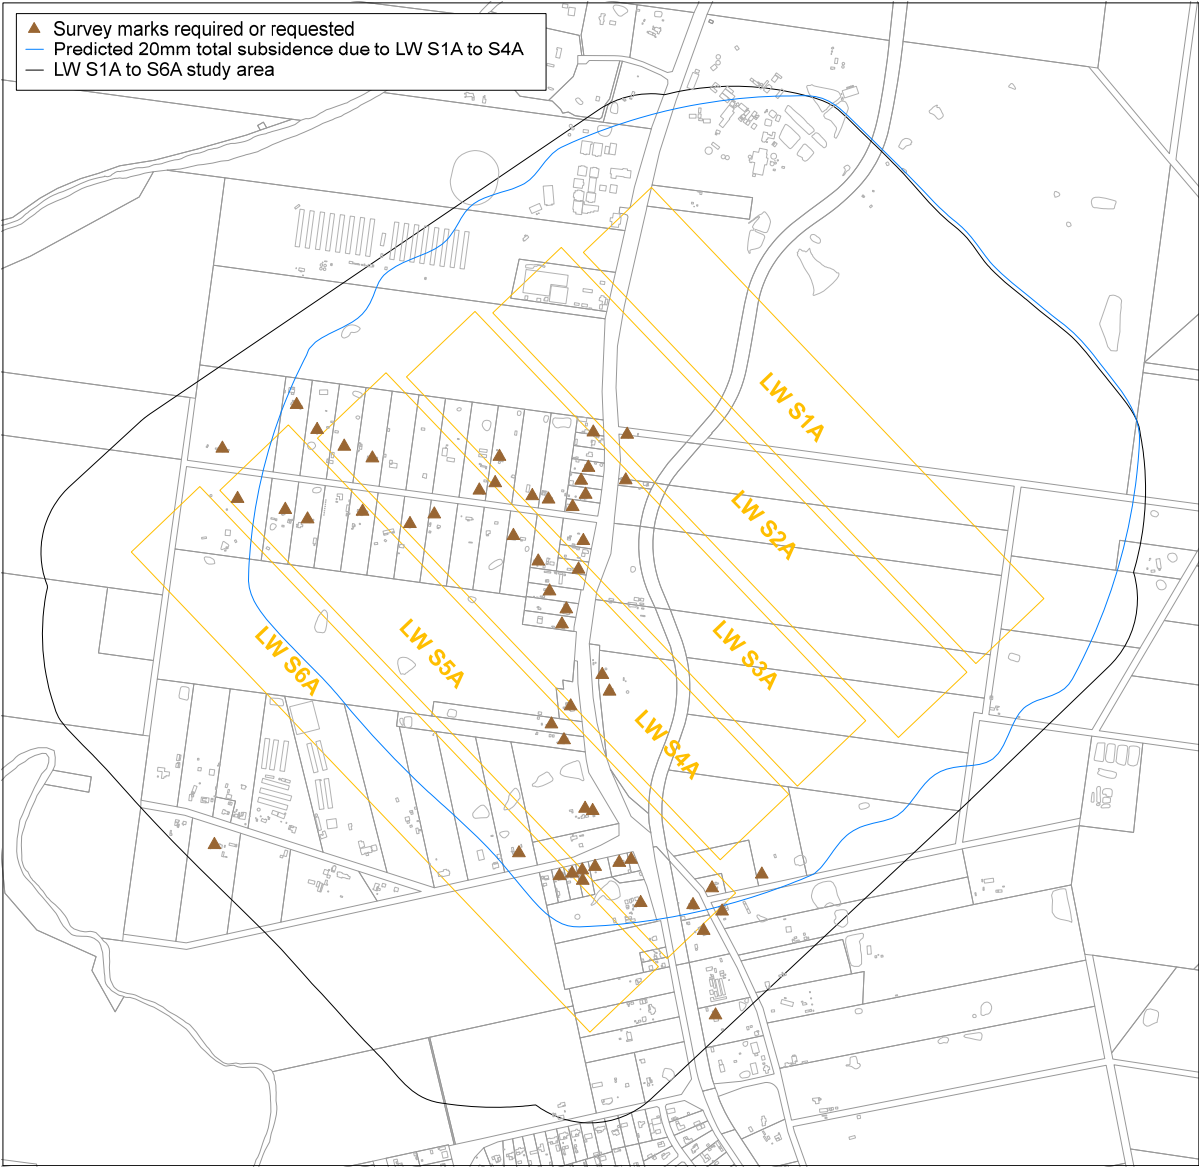
Figure 3 Properties for which survey marks are required or have been requested

The locations of properties that have agreed to install survey prior to the commencement of extraction of LW S1A were shown in Fig. 6.5 of the Management Plan. An updated map of Fig. 6.5 is provided in Figure 3.
