LAND MANAGEMENT PLAN - TAHMOOR SOUTH DOMAIN - LONGWALLS SOUTH 1A - SOUTH 7A

Tahmoor Coal Pty Ltd

Document Title: Tahmoor South Domain
Longwalls South 1A – South 7A
Land Management Plan

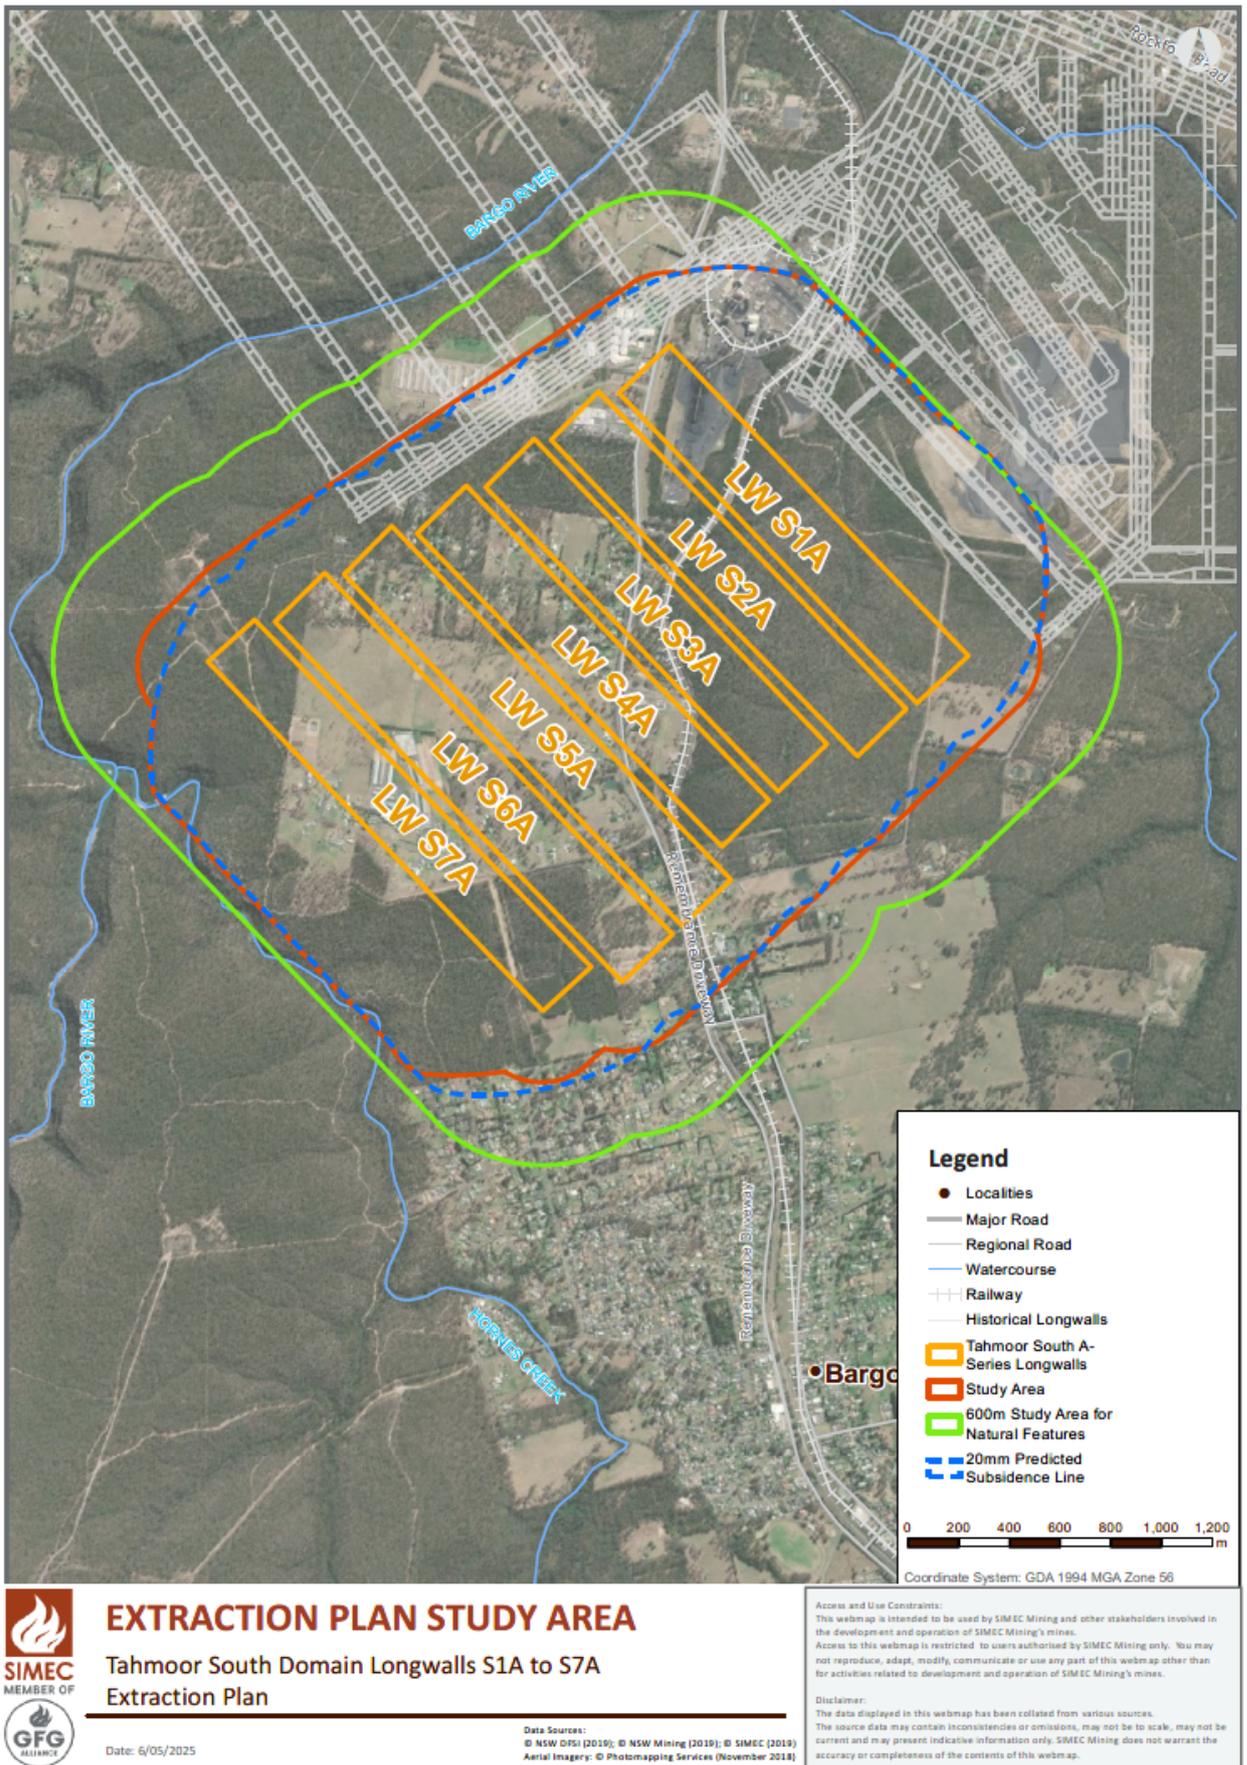
Figure 2 Extraction Plan Study Area

The Study Area applicable to this management plan consists of a combination of the predicted 20 millimetre (mm) Total Subsidence Contour and the 35° Angle of Draw Line as shown in **Figure 2**. Relevant environmental features within a 600 metre (m) buffer from extraction that could be susceptible to far-field or valley related movements have also been included for consideration.

The location of LW S1A-S7A and associated Study Area are illustrated in **Figure 2**.

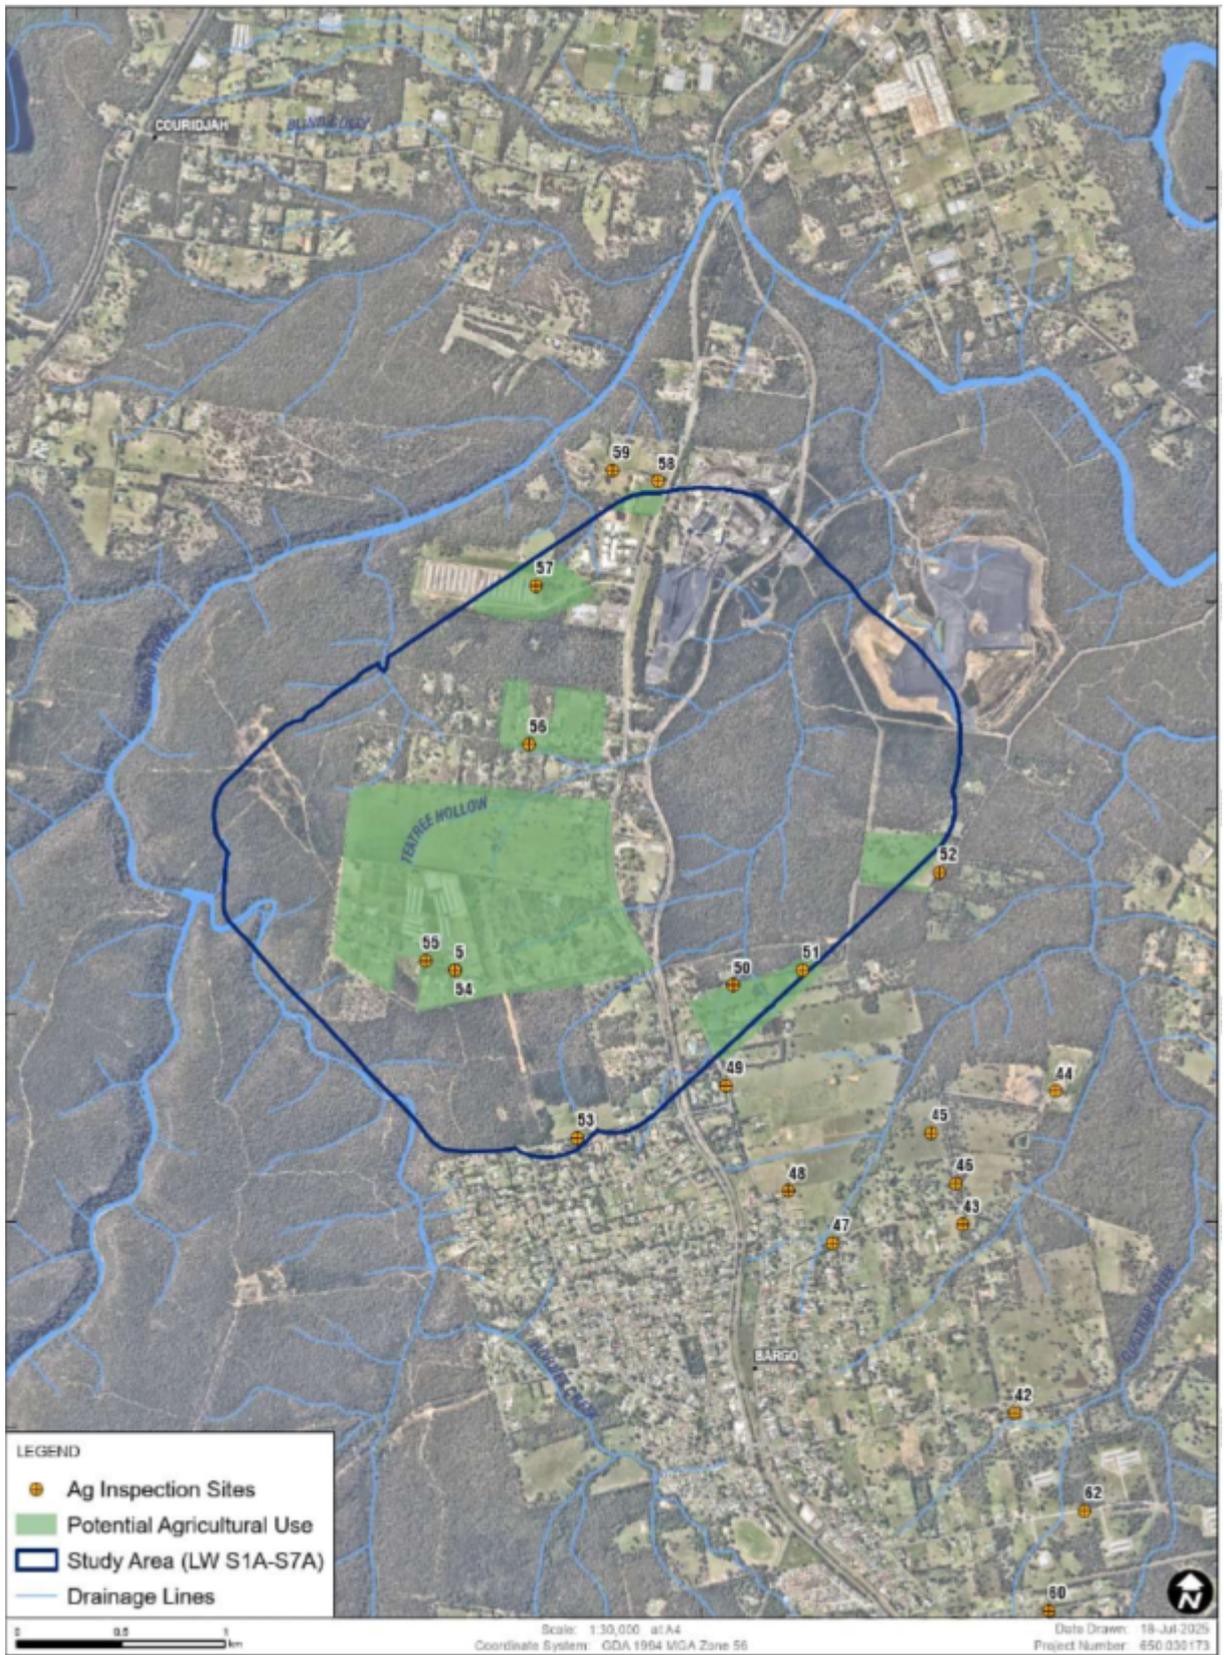
Figure 5 Agricultural Land in the Study Area (SLR, 2025)

Only a minor portion of the Study Area is comprised of cleared pastoral land (approximately 27%) that may be suitable for agricultural enterprises (refer **Figure 5**). The remainder of the land is comprised of thick native vegetation along riparian zones and steep slopes, along with mine disturbance areas, and small holdings used as rural residential land (SLR, 2025).

Agricultural monitoring will be completed from fixed photo points, as identified in **Figure 5** as agricultural inspection points. The location and number of these fixed photo points may change due to land access.

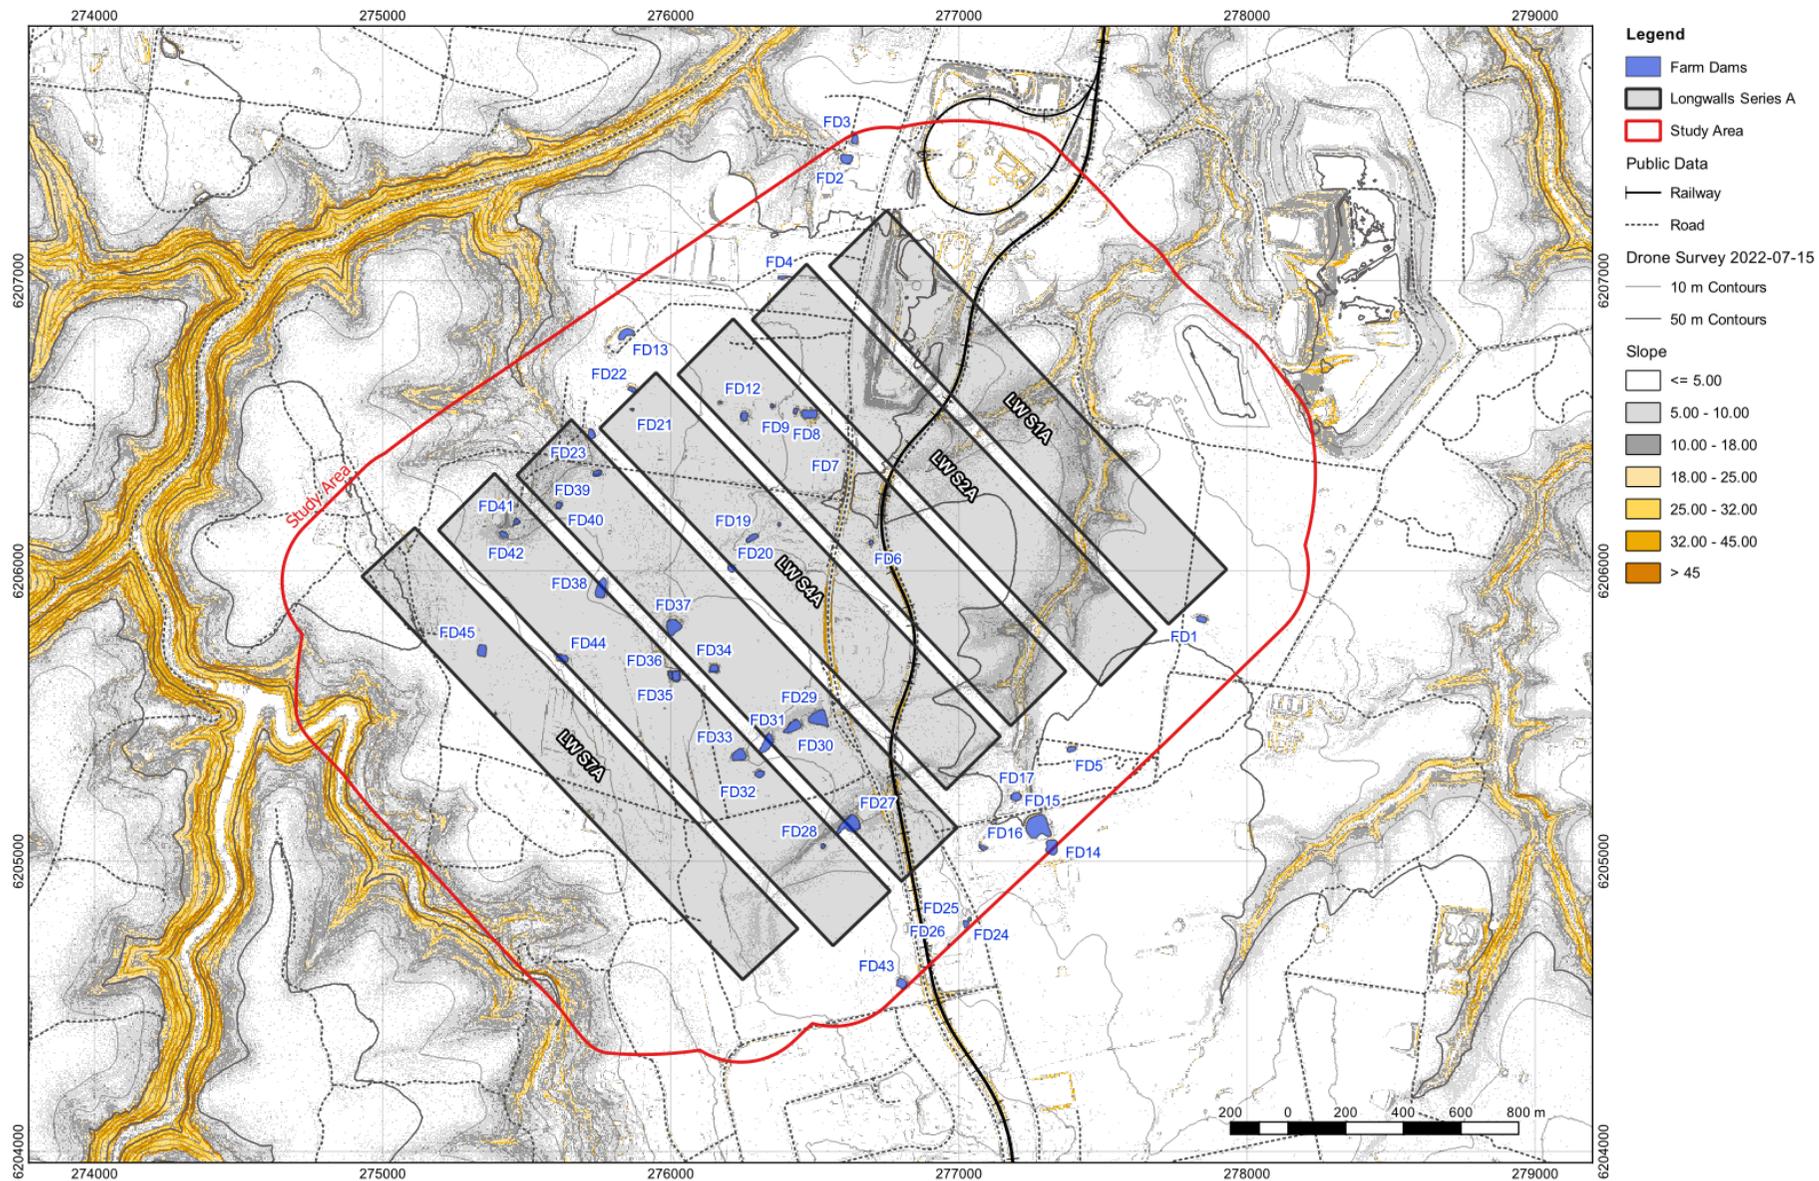
Figure 6 Study Area Farm Dams

A total of 45 farm dams have been identified within the Study Area, the locations of which are shown in **Figure 6**. The farm dams have been identified as typically shallow (less than three metres deep), of earthen construction and established by localised cut and fill operations within natural watercourses (MSEC, 2022).

A subsidence monitoring program for landscape features will be implemented to monitor the impacts and consequences of subsidence effects on during the extraction of LW S1A-S7A. The details of this monitoring program are provided in **Table 11**, and the locations of monitoring sites are illustrated in **Figure 3 and Figure 6**.

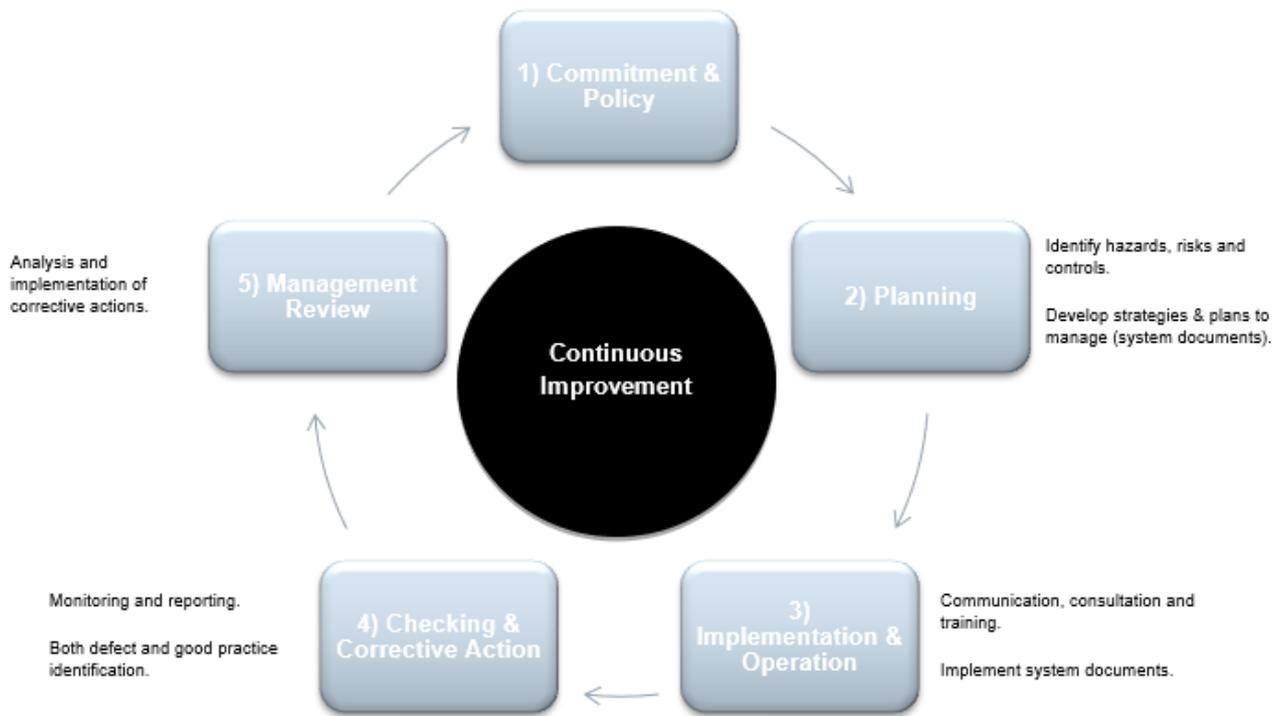
Figure 7 Continuous Improvement Model

Tahmoor Coal have adopted the "Plan-Do-Check-Act" model as shown in **Figure 7**. This model will be applied to all aspects of Tahmoor Coal's environmental management and is utilised to embed the continuous improvement process in all system documents.
