SIMEC Mining:
**Tahmoor South
Longwalls S1A to S7A**

Management Plan for potential impacts to Sydney Water Potable Water Infrastructure

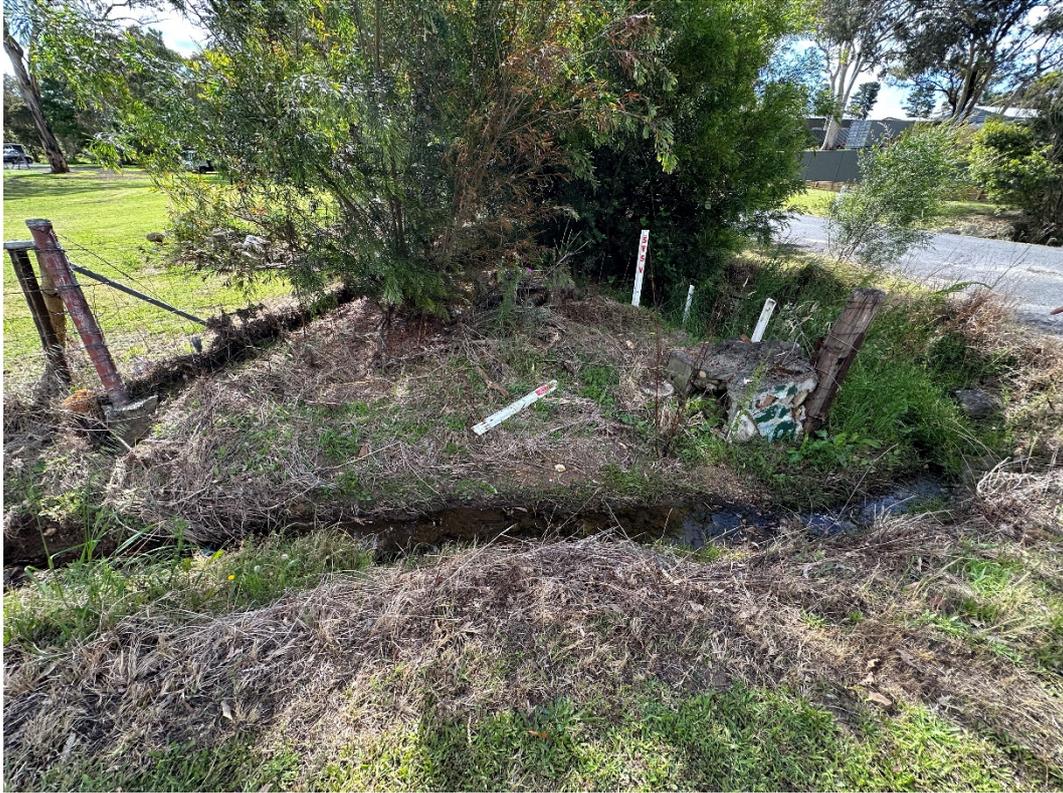
The pipeline runs within private properties, except where it crosses the creek and Caloola Road, as shown in Drawing No. MSEC1193-03-07. A Google Streetview image of the intersection is shown in Fig. 3.15 and a photograph of the Sydney Water pit is shown in Fig. 3.16.

It can be seen that the water main is located upstream of the road embankment but approximately 10 metres away from the toe of the embankment. In the event of a water leak, water will drain through the twin culverts under the embankment and is extremely unlikely to erode the embankment.

Fig. 3.16 Sydney Water pit for potable water main at intersection of Remembrance Drive and Caloola Road

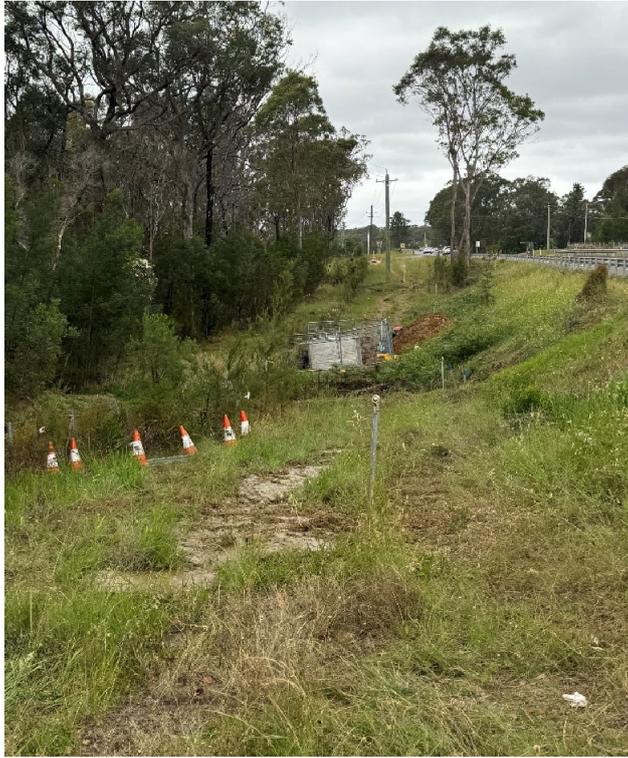
Fig. 3.18 View of Creek 2 excavation site to install joints

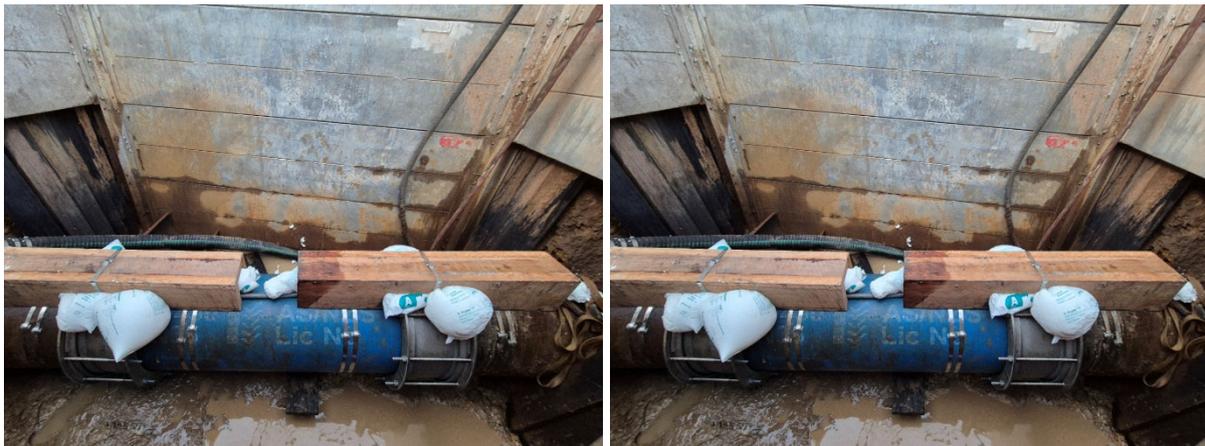
- Installation of Gibault expansion joints on both sides of Creek 2; and
- Displacement sensors have been installed on the joints.

Photographs of the Gibault joints and displacement sensors are shown in Fig. 3.19.

Fig. 3.19 Gibault joints and sensors at Creek 2

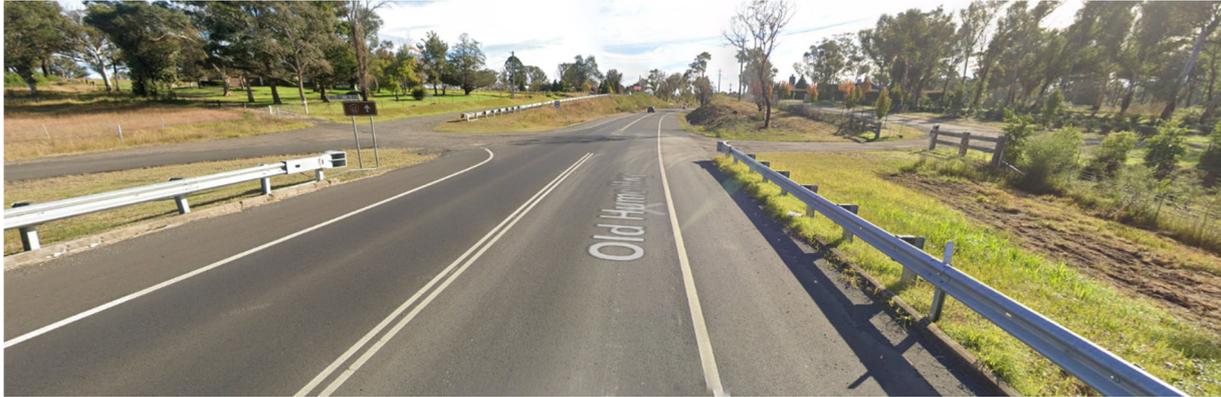
The 450 mm diameter CICL water main crosses beneath Remembrance Drive between Caloola and Yarran Roads, directly above the chain pillar between LW S4A and S5A, as shown in Drawing No. MSEC1193-04-01 and Fig. 3.17. The crossing consists of direct buried CICL pipe sections with two right angle bends at a cut-fill interface along Remembrance Drive.

Sydney Water's GIS shapefiles indicate the pipes are direct buried CICL pipe sections that are not concrete encased. There is good access at both ends of each crossing, as shown in Fig. 3.20.

Fig. 3.20 Google Streetview image of crossing beneath Remembrance Drive

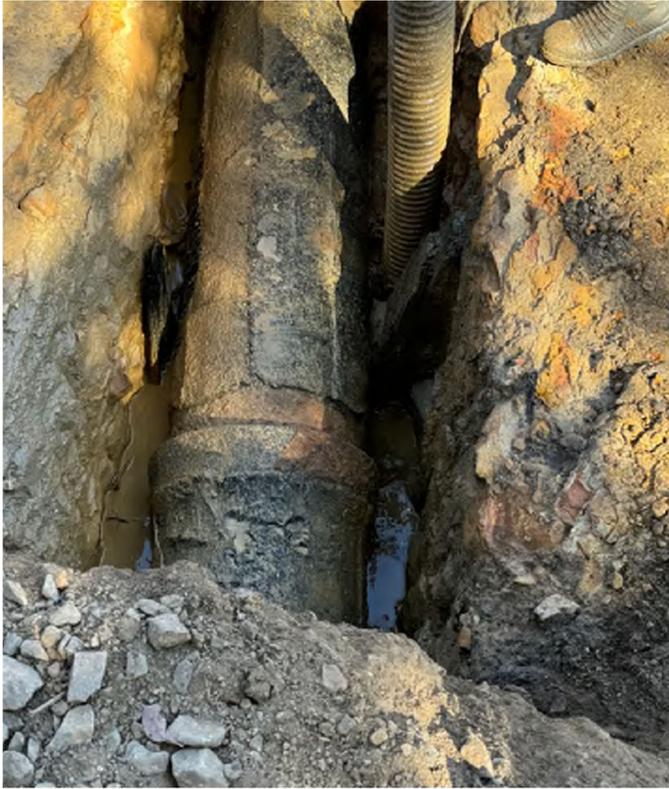
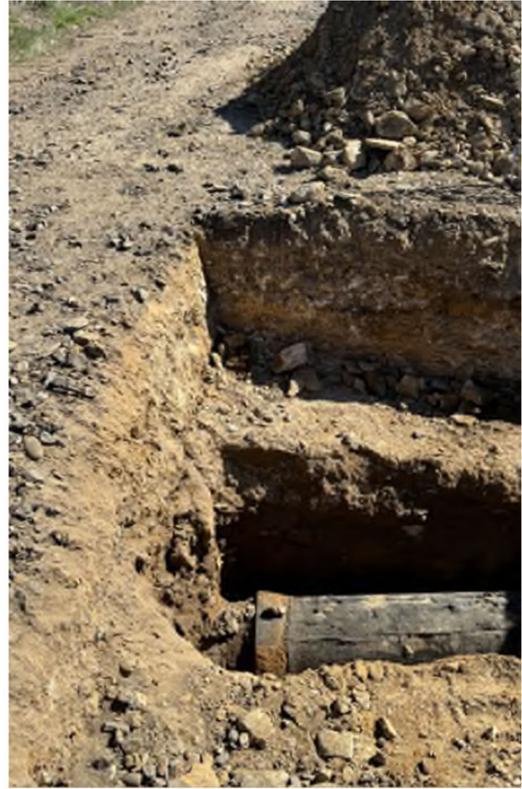
Fig. 3.22 Exposed CI/CL water main on western side of Railway crossing (Up side)

Photographs of the exposed CI/CL pipework beyond the ends of the concrete encasement are provided in Fig. 3.22 and Fig. 3.23.

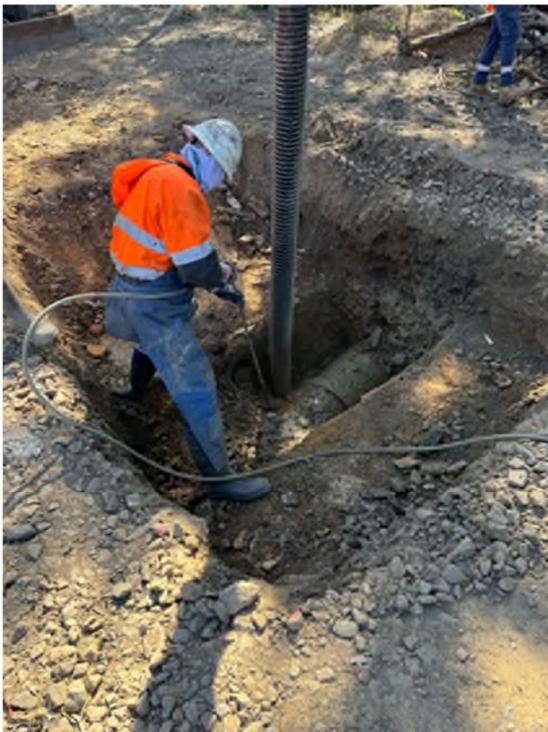
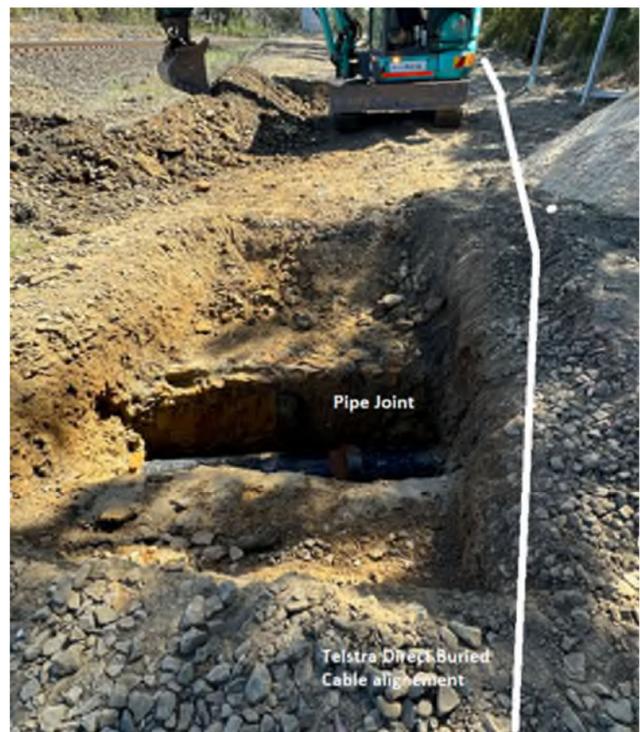
Fig. 3.23 Exposed CI/CL water main on eastern side of Railway crossing (Down side)

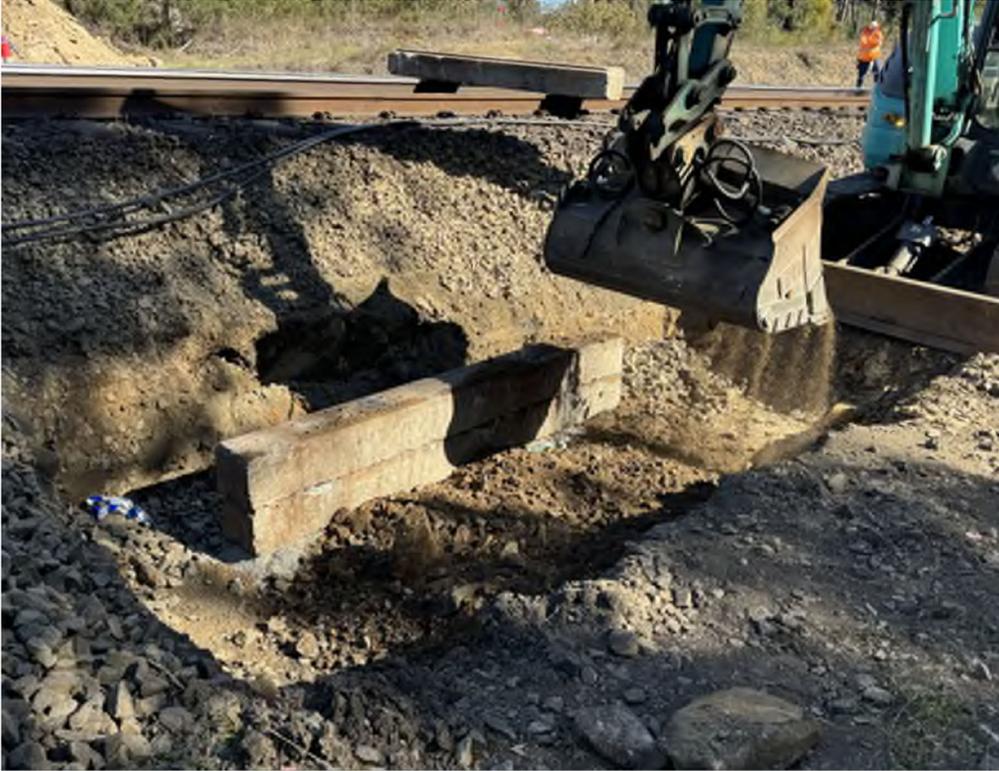
Fig. 3.24 Concrete bearers placed on concrete bags above pipework and backfilled

On 14 and 15 September 2024, Tahmoor Coal in consultation with railway operator ARTC, constructed concrete washout barriers within the ballast formation directly above the ends of the concrete encased pipework. The washout barriers provide protection to the track from washout in the unlikely event of leakage of the water main.

Photographs of the buried concrete washout barriers are provided in Fig. 3.24 and Fig. 3.25

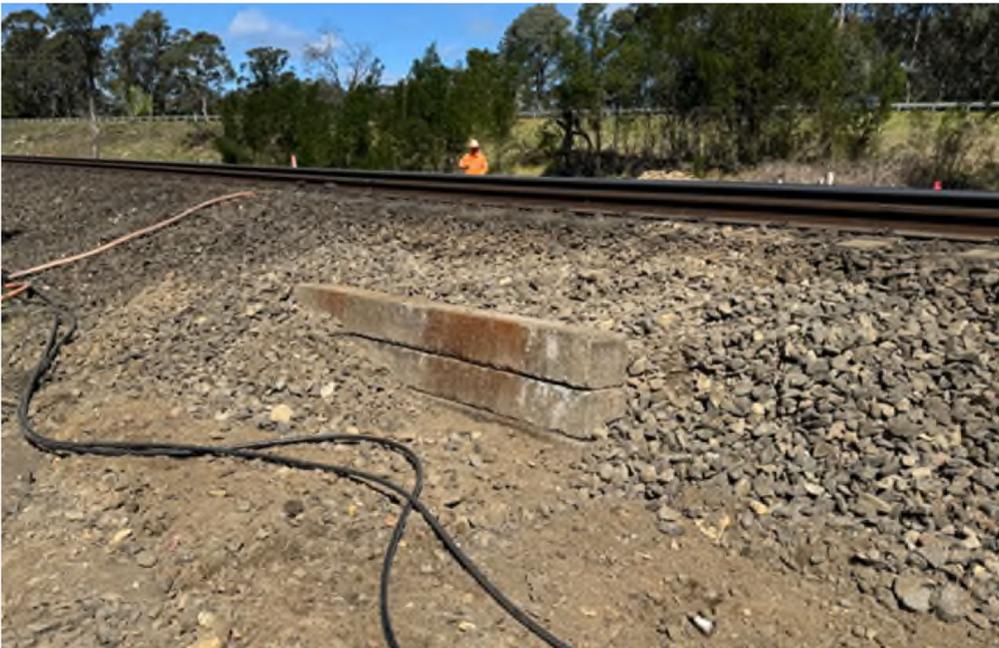
Fig. 3.25 Finished concrete washout barriers in track ballast shoulder

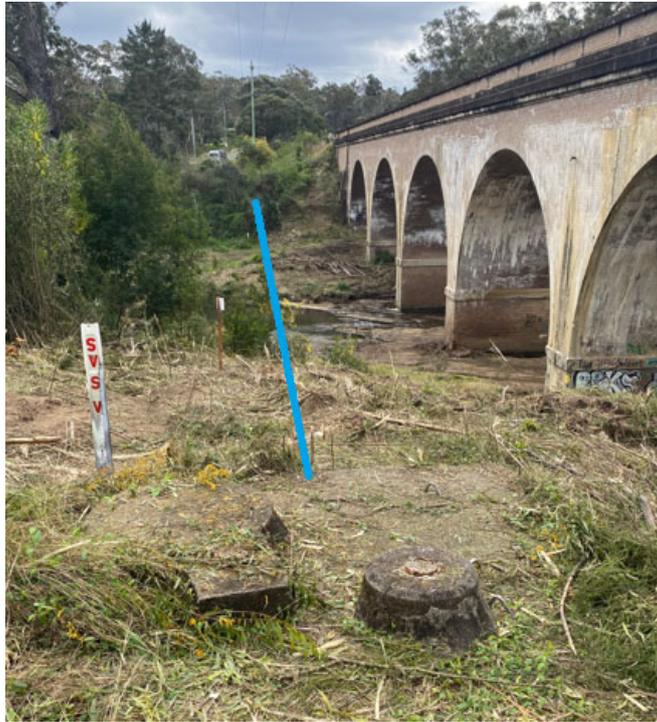
Fig. 3.27 Photograph of buried crossing of 450 mm CICL water main beneath the Bargo River adjacent to the Main Southern Railway Viaduct

Sydney Water potable water pipelines are buried in the creek bed near these bridges and this Management Plan includes measures to manage the pipeline crossings that are located near these bridges. A photograph of the buried crossing beneath the Bargo River adjacent to the Main Southern Railway Viaduct is shown in Fig. 3.27.
