SIMEC Mining:
**Tahmoor South
Longwalls S1A to S7A**

Management Plan for potential impacts to Built Structures

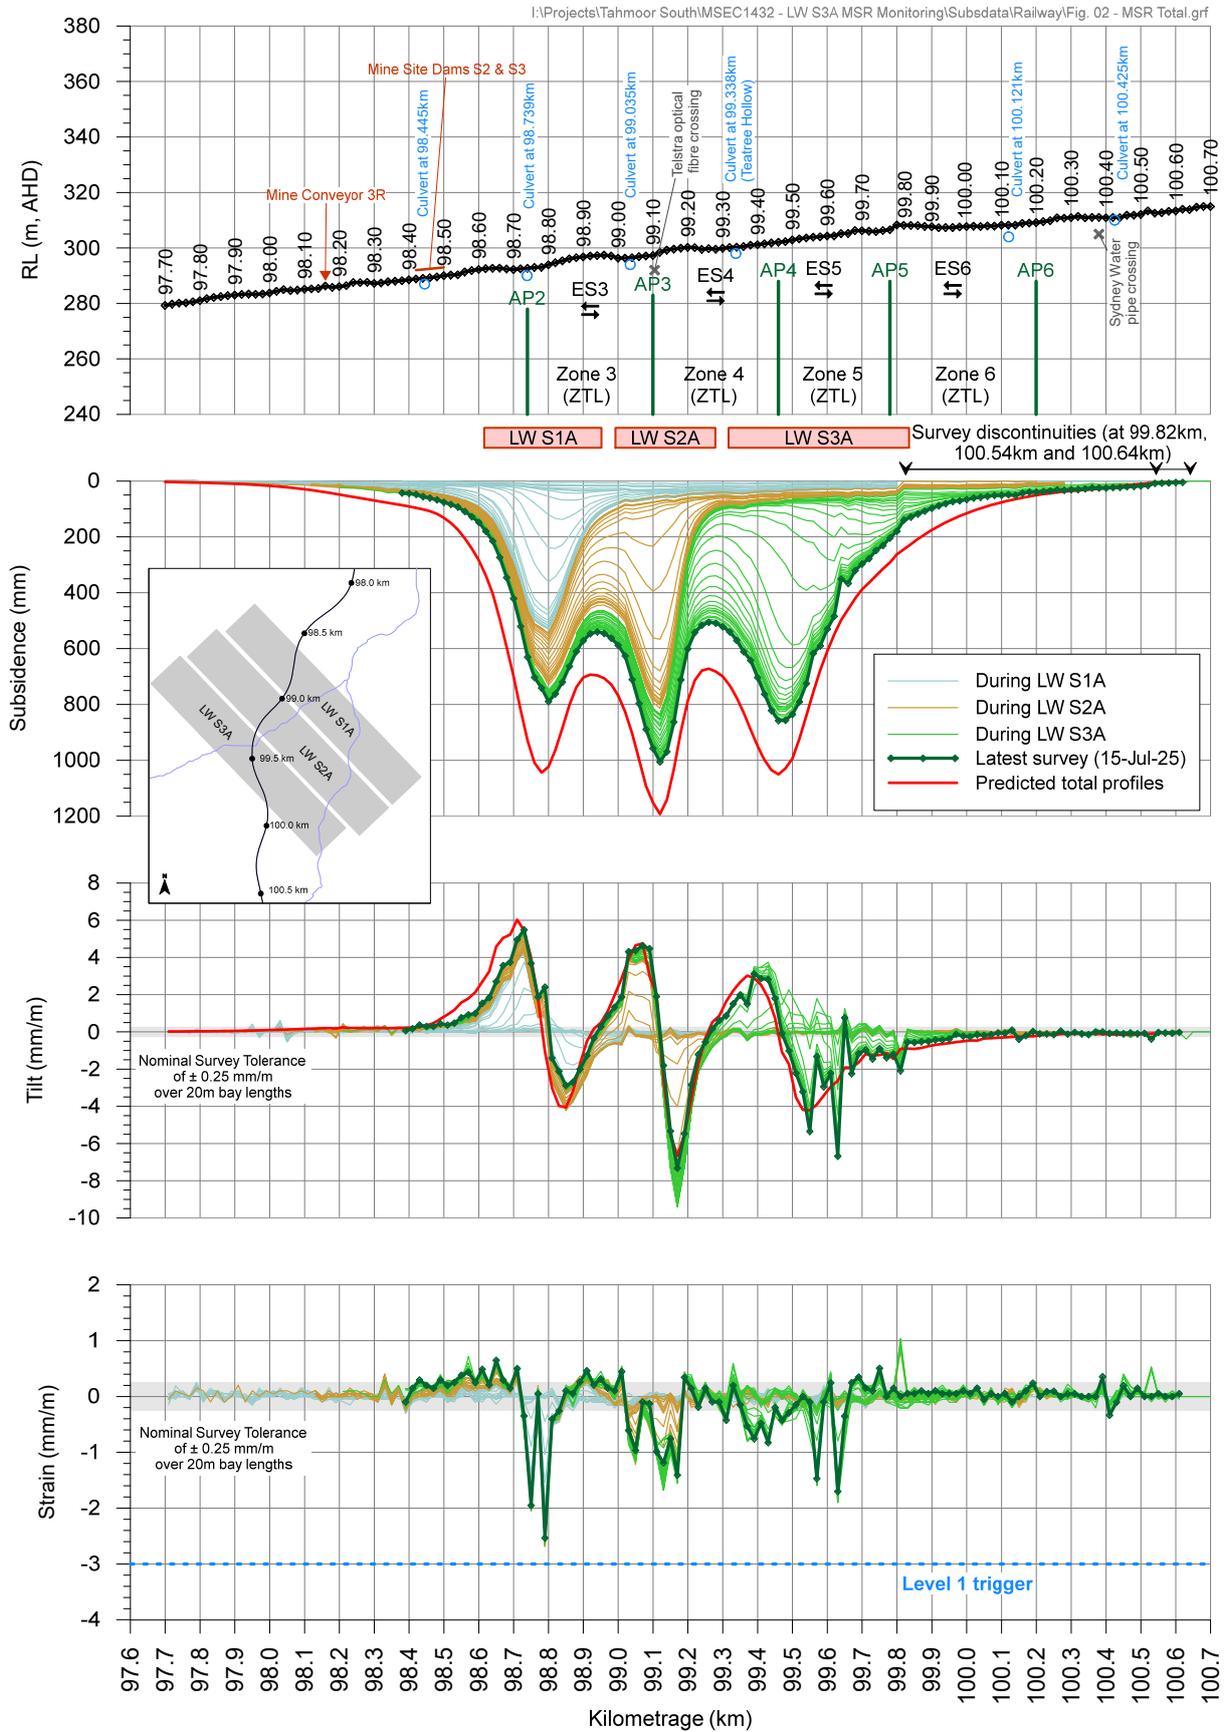
Fig. 2.5 Observed subsidence along Main Southern Railway during the mining of LW S1A-S3A

Monitoring during the mining of LW S3A measured subsidence movements within predictions, as shown in Fig. 2.3. Maximum subsidence was measured at Peg MS99500 which is located along the Main Southern Railway and above the centreline of LW S3A. Whilst observed subsidence along the Main Southern Railway has been less than predicted, a bump was observed in the subsidence profile along with a corresponding increased compressive strain at one location, as shown in Fig. 2.5.

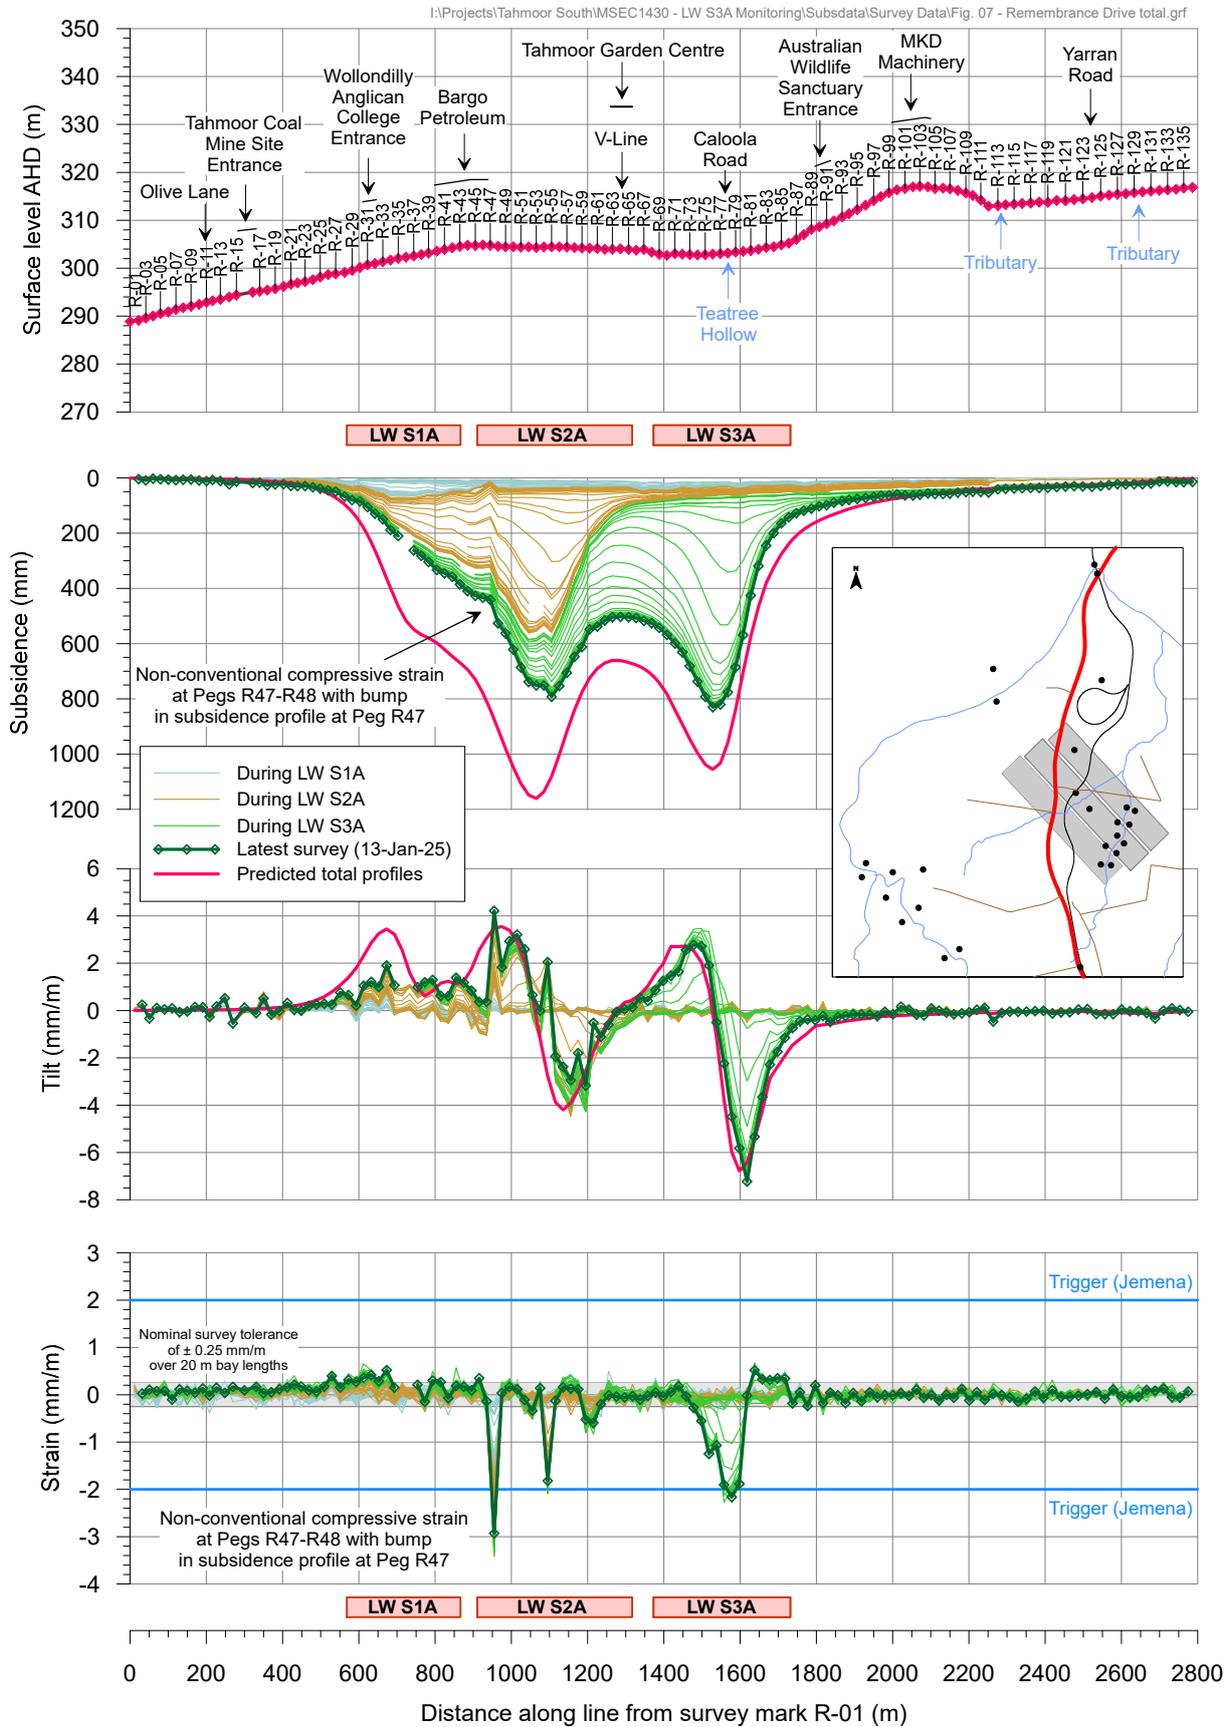
Fig. 2.6 Observed subsidence along Remembrance Drive during the mining of LW S1A-S3A

Extensive monitoring has been undertaken by Tahmoor Coal during the mining of LWs S1A to S3A. Observed incremental subsidence due to the extraction of LWs S1A to S3A has correlated reasonably well with predictions, as shown in Fig. 2.1 to Fig. 2.6.
