SIMEC Mining:

**Tahmoor North Western Domain
Longwalls West 3 and West 4**

Management Plan for potential impacts to Sydney Water Potable Water Infrastructure

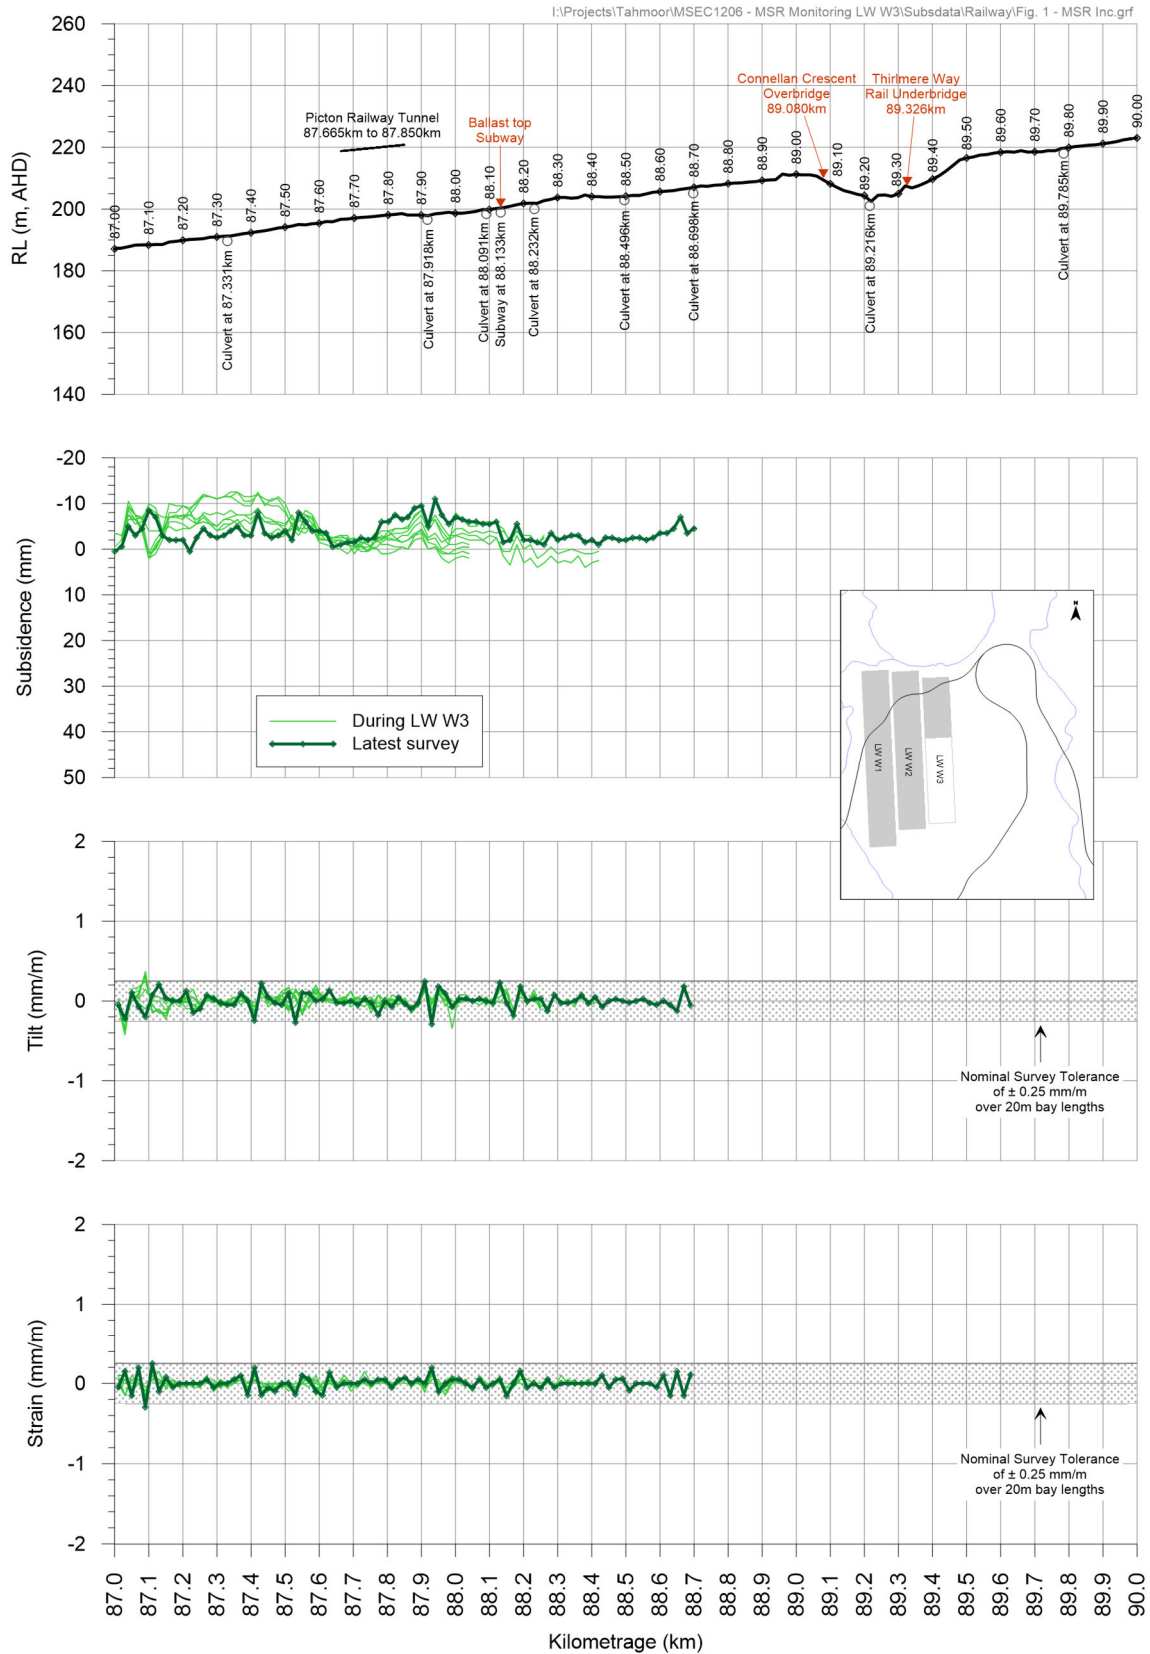
Fig. 3.16 Observed incremental subsidence, tilt and strain along the Main Southern Railway during the mining of LW W3 as at 29 November 2021, at length of extraction of 629 metres

Extensive monitoring is also being conducted along the Main Southern Railway, including continuously operating rail stress gauges stationed every 120 metres along the track, weekly surveys of track geometry along the track at spacings and daily visual inspections. No adverse changes have been observed to date during the mining of LW W3.

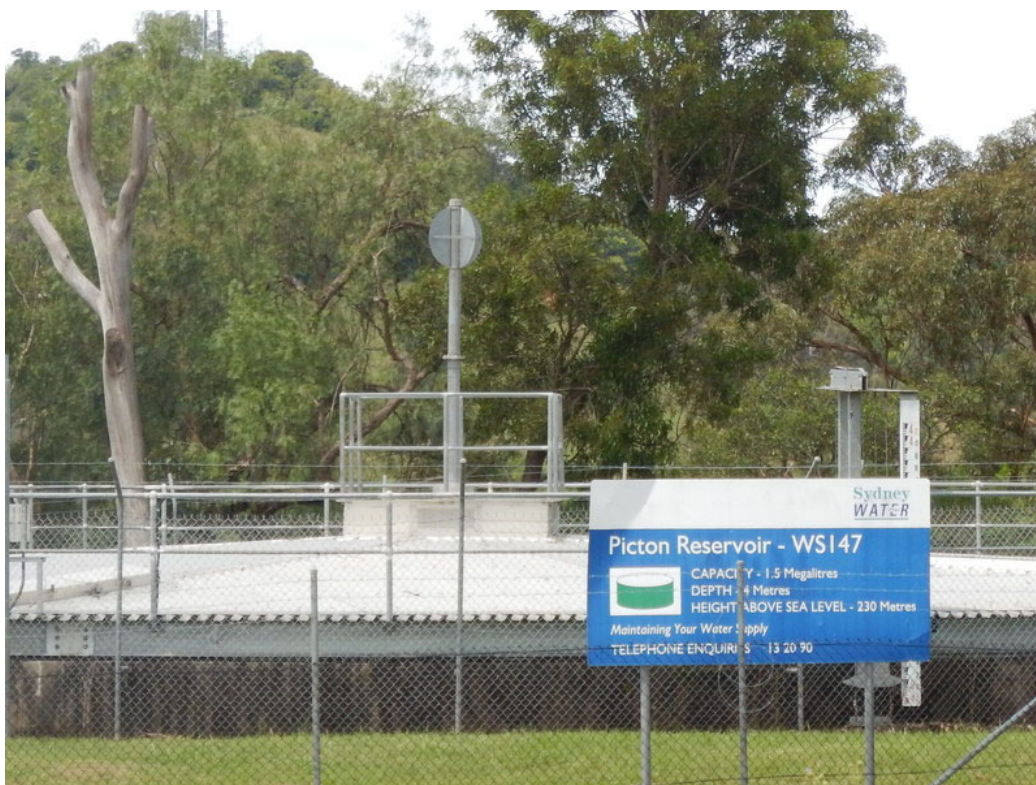
Fig. 3.25 Picton Reservoir

The 1.5 ML reservoir consists of an approximately 22 metre diameter circular concrete slab with masonry walls that are 4 metres deep. The Reservoir supplies approximately 2000 customers within the Picton township.

The Reservoir is predicted to experience less than 20 mm subsidence given the large offset distances from LW W3-W4. The potential for impacts on the Reservoir do not result from absolute far-field horizontal movements, but rather from differential horizontal movements. While the Reservoir is located within the Nepean Fault Complex, the likelihood that it will experience adverse mining-induced movements is very low given its offset distances from LW W3-W4 and relatively small footprint size.
