Myrtle Creek

Corrective Management Action Plan

March 2020 | Newsletter # 10

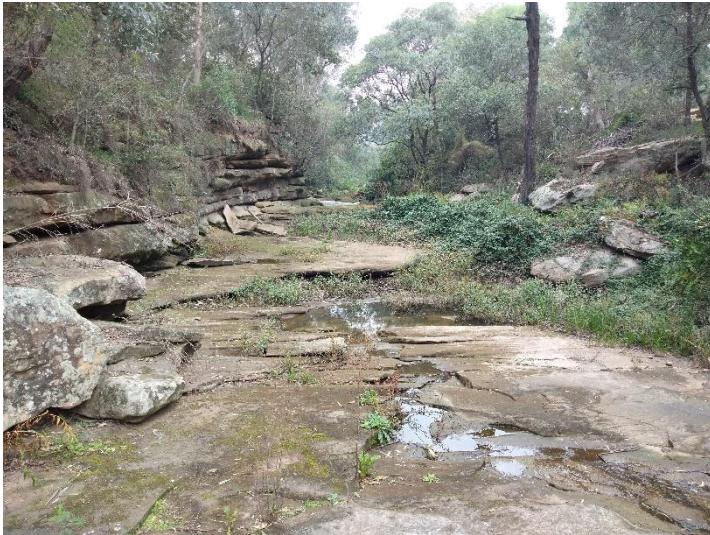
Pool 23 – May 2019

Remediation of the controlling rock bar at Pool 23 was completed in early February 2020. The works consisted of drilling cored holes to 16 meters below the creek height for geotechnical testing to identify the location and size of fracturing. Fractures were then filled using an approved polyurethane material. Polyurethane has been used successfully for creek rehabilitation in Sydney Catchment Authority areas as it has minimal ecotoxicological effects and has proven highly effective.

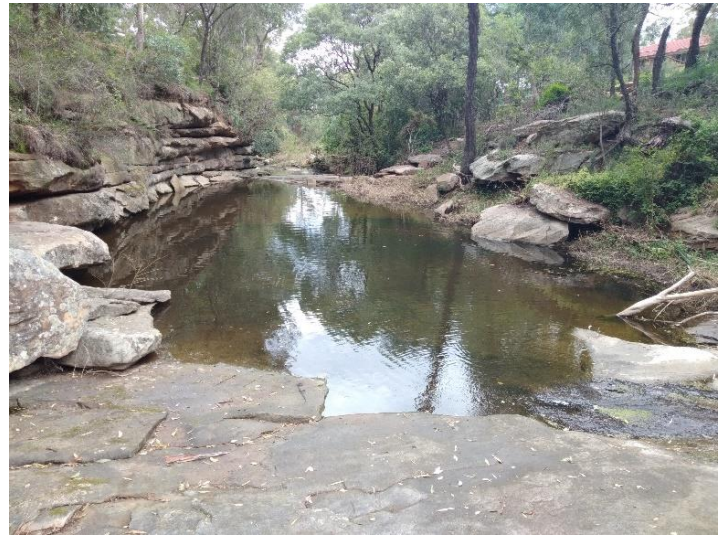
Initial results so far have been encouraging. Since works have completed, the pool has filled and overflowed (see photos overleaf).

Pool 23 – March 2020

With rehabilitation of Pool 23 completed, the pool is now being monitored. Pool levels are being monitored to determine the rate at which the pools recedes compared to its pre-mining rate, factoring in rainfall and evaporation.
