Myrtle Creek

Corrective Management Action Plan

October 2020 | Newsletter # 13

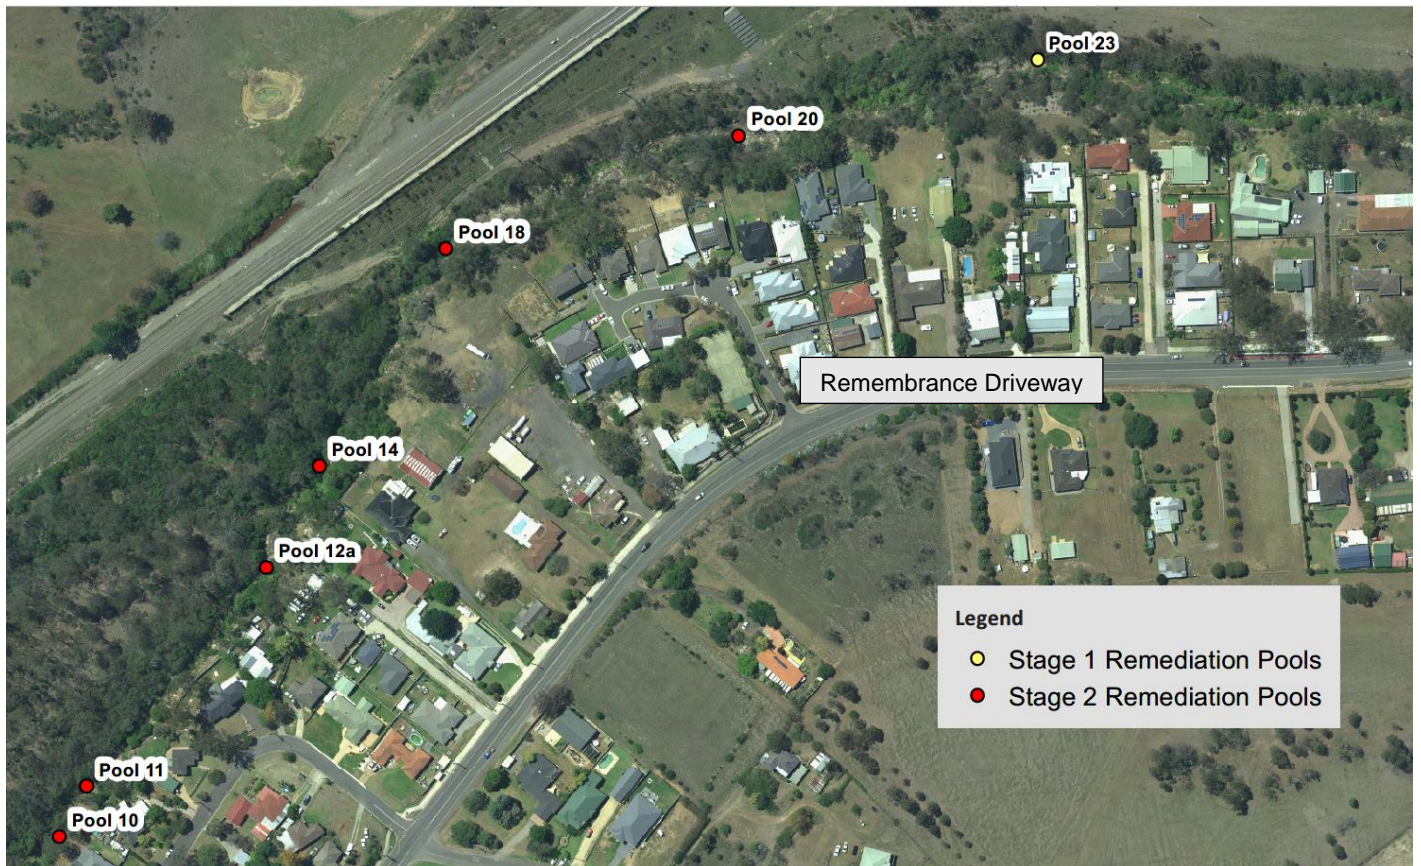
Myrtle Creek CMAP Stage 2 proposed remediation sites

Myrtle Creek CMAP Stage 2 was submitted to the NSW Resources Regulator in May 2020. It involves investigation drilling and remediation of a further six pools along Myrtle Creek (see overleaf). The entire project is expected to return pool holding capacity to selected pools and increase surface flow along Myrtle Creek.

Investigation drilling at Pools 10, 11, 12a, 14, 18 and 20 will commence in early November (see overleaf). This will involve drilling two boreholes in the creek and conducting geotechnical testing to determine the fracture network. Works will be conducted from 8:00am to 5:00pm and will be completed within five weeks.
