Myrtle Creek

Corrective Management Action Plan

September 2021 | Newsletter #17

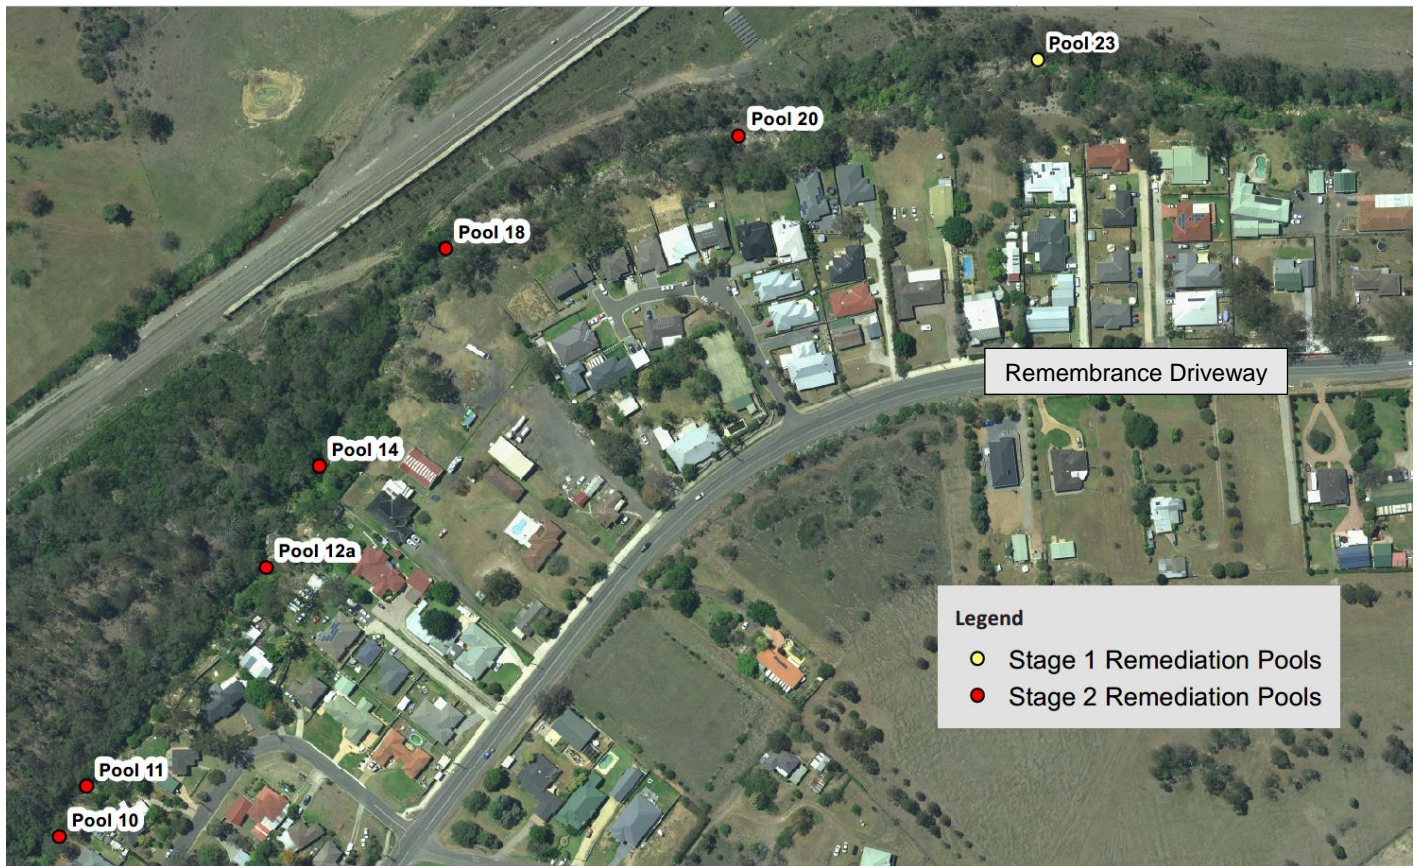
Myrtle Creek CMAP Stage 2 Remediation Sites

To address this, Tahmoor Coal prepared a Myrtle Creek Corrective Action Management Plan (**Myrtle Creek CMAP**) that outlines proposed rehabilitation works, including pool mapping, photogrammetry and surveying, characterisation and pool rehabilitation works. The approved schedule includes the remediation of Pools 23, 20, 14, 12a, 11 and 10 at Myrtle Creek.
