# Myrtle Creek

## Corrective Management Action Plan

March 2022 | Newsletter #19

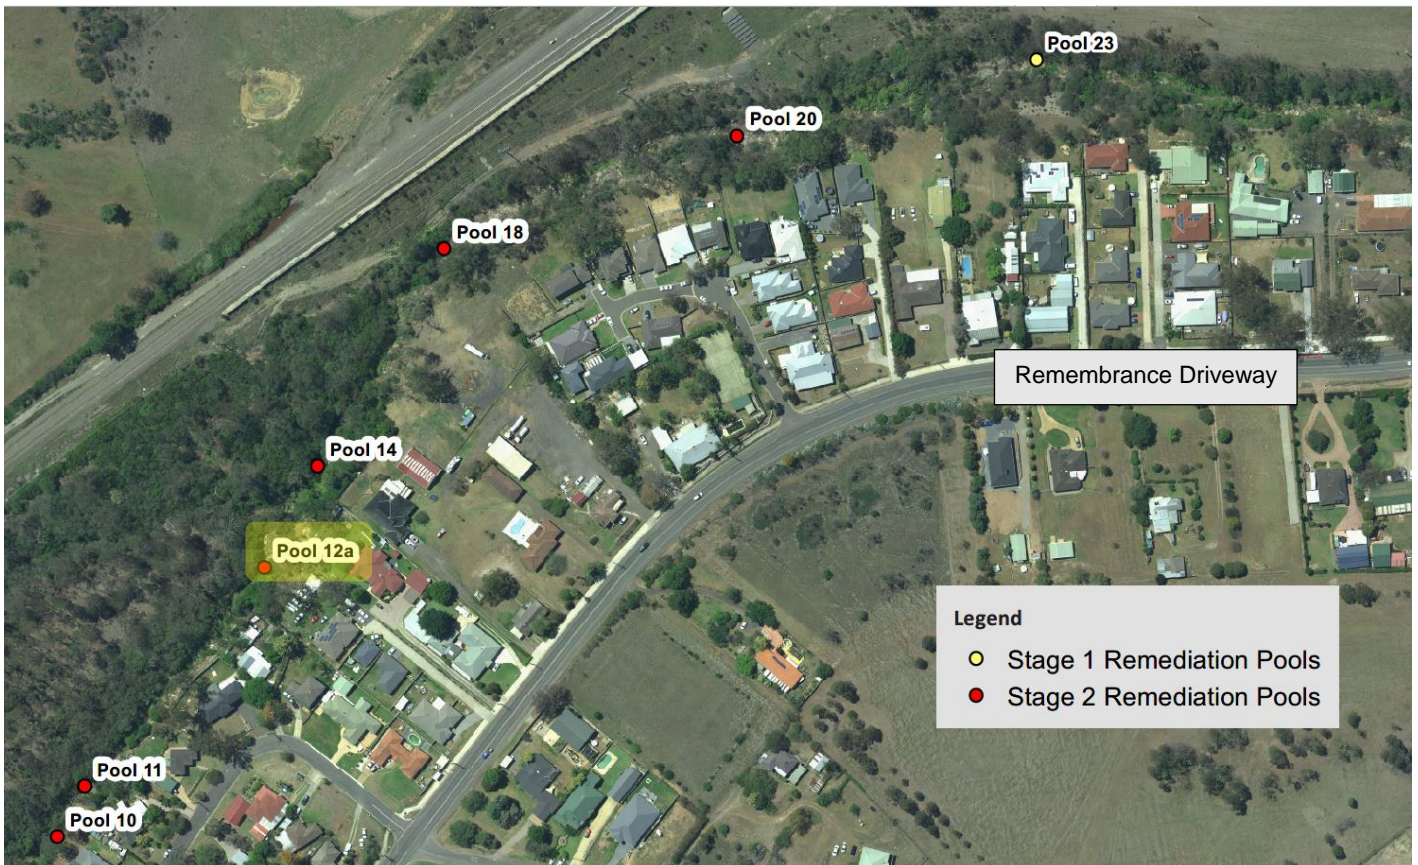
## Myrtle Creek CMAP Remediation Sites

To address this, Tahmoor Coal prepared a Myrtle Creek Corrective Action Management Plan (**Myrtle Creek CMAP**) that outlines proposed rehabilitation works, including pool mapping, surveying, characterisation and rehabilitation works. The approved schedule includes the remediation of Pools 23, 20, 14, 12a, 11 and 10 at Myrtle Creek.
