Tahmoor Coal Pty Ltd

**2023 ANNUAL REVIEW AND ANNUAL
ENVIRONMENTAL MANAGEMENT
REPORT**

March 2024

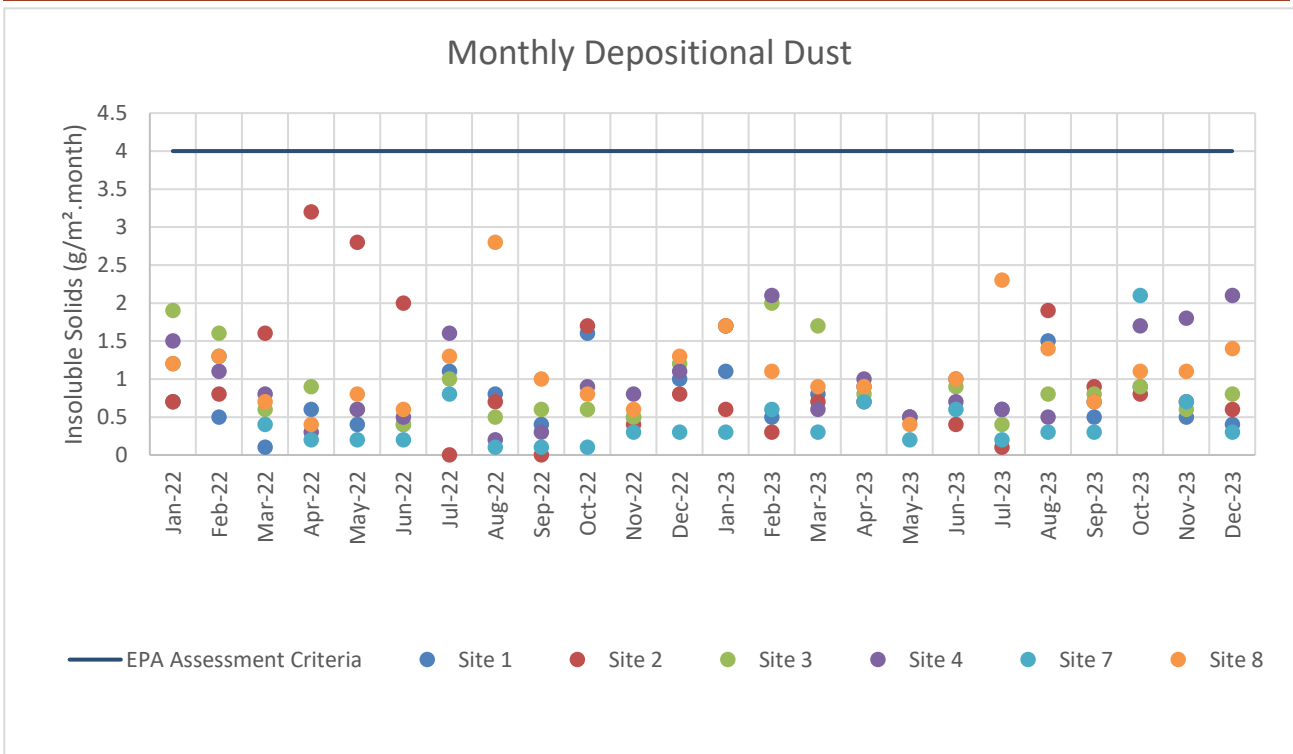
Figure 4: Comparison in pit-top Depositional Dust monitoring between the current monitoring period and previous reporting period.

Figure 4 illustrates all sites are in accordance with Tahmoor Coal’s Environmental Protection Licence (EPL) and within the annual average of 4 g/m²/month as allowed by consent SSD 8445. In general, all Depositional Dust monitoring site levels fluctuated on average between 0.5 to 1.7g/m²/month with an annual average for all sites of 1.0 g/m²/month for 2023. **Figure 5** illustrates the historical annual average of each site over the past 14 years.

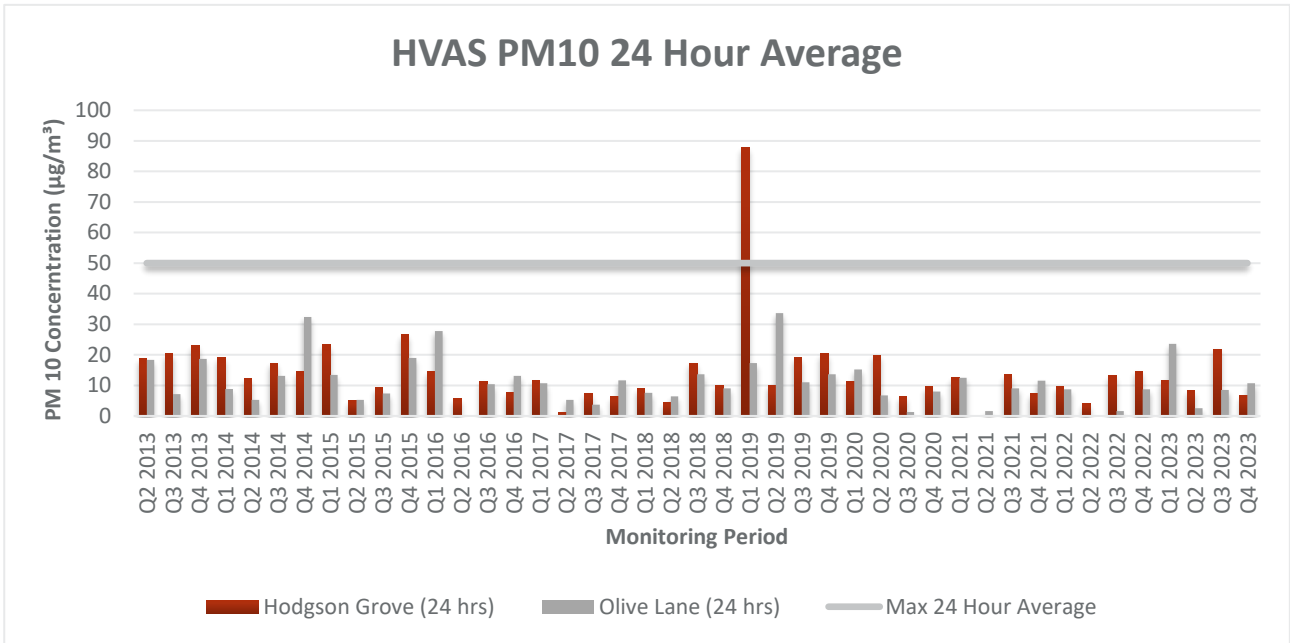
Figure 6 Air Quality monitoring results for PM10 from 24hr High Volume dust monitors located at Olive Lane and Hodgson Grove.

Figure 6 and **Figure 7** demonstrate the results of the particulate matter (PM₁₀) monitoring at Charlies Point Road and quarterly High Volume (Hi Vol) dust monitoring at Olive Lane and Hodgson Grove in Tahmoor. PM₁₀ particles have a diameter of 10 micrometers or smaller and are found in dust and smoke as a common air pollutant. These monitoring sites have been established since August 2013, with a continuous TEOM (Tapered Element Oscillating Microbalance) dust monitor located at Tahmoor Coal’s Charlies Point Road property.

During 2023, Hi vol results have remained low and well below our 24 hour maximum average level of 50 µg/m³ (as shown in **Figure 6**).

As shown in **Figure 7**, bushfires and hazard reduction burns impacted on the air quality significantly during November and December 2019 causing a steep increase in the PM₁₀ annual average. However, during 2020 levels considerably declined and returned to baseline levels during 2021. During 2023, PM₁₀ results from our continuous TEOM dust monitor at Charlies Point Road have remained below development conditions (SSD 8445) maximum annual average of 25 µg/m³. An increase of hazard reduction burns undertaken in the region were noted during this reporting period which could have influenced this year’s average result shown in **Figure 6**.

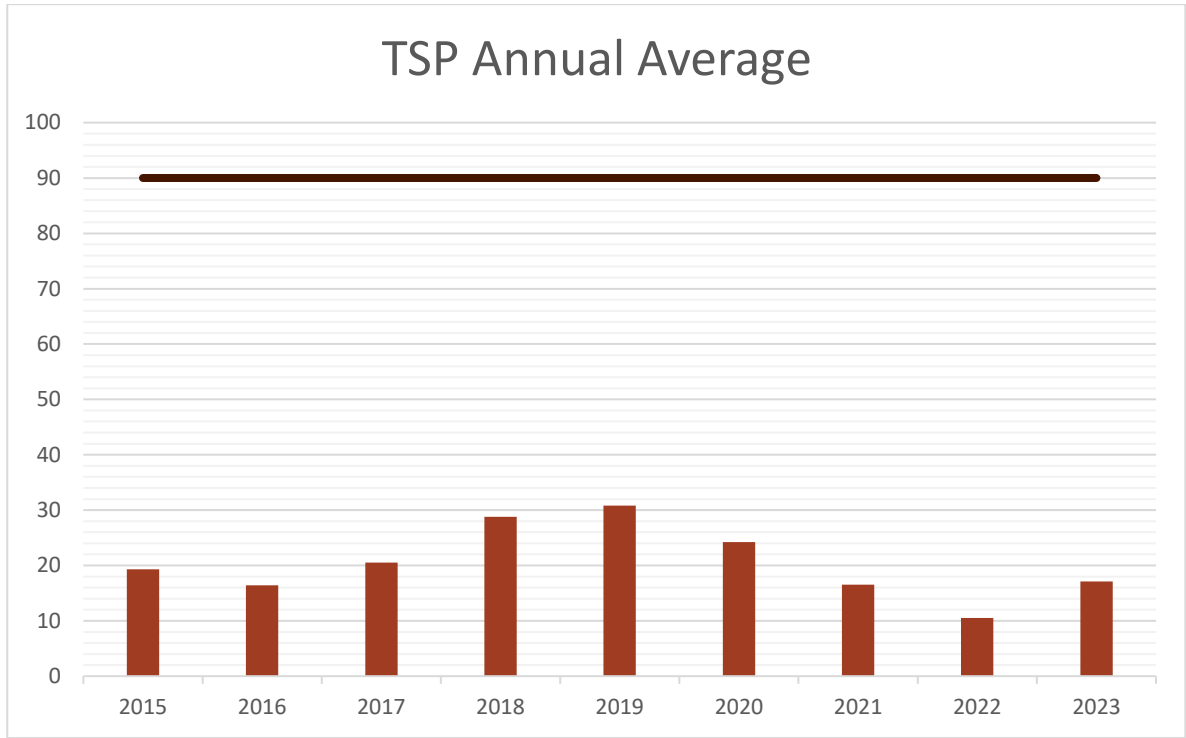
Figure 8 Total Suspended Particulates Annual Average

Total suspended particulate (TSP) refers to the totality of small solid matter released, documented and/or otherwise observed in the atmosphere. TSP is sampled every 6 days by a third-party contractor and sent to a laboratory for analysis. The TSP gauge is located on a mine owned property south of the REA with the TEOM monitoring station. The below data in **Table 10-2** was captured for the reporting period and recorded an average annual concentration of **17.10 µg/m³**, this has increased from the previous reporting period average of 10.49 µg/m³ for 2022 but is within previous baseline results (refer to **Figure 8**) (and within the 90 µg/m³ annual average as stated in Condition 37, DA 67/98).

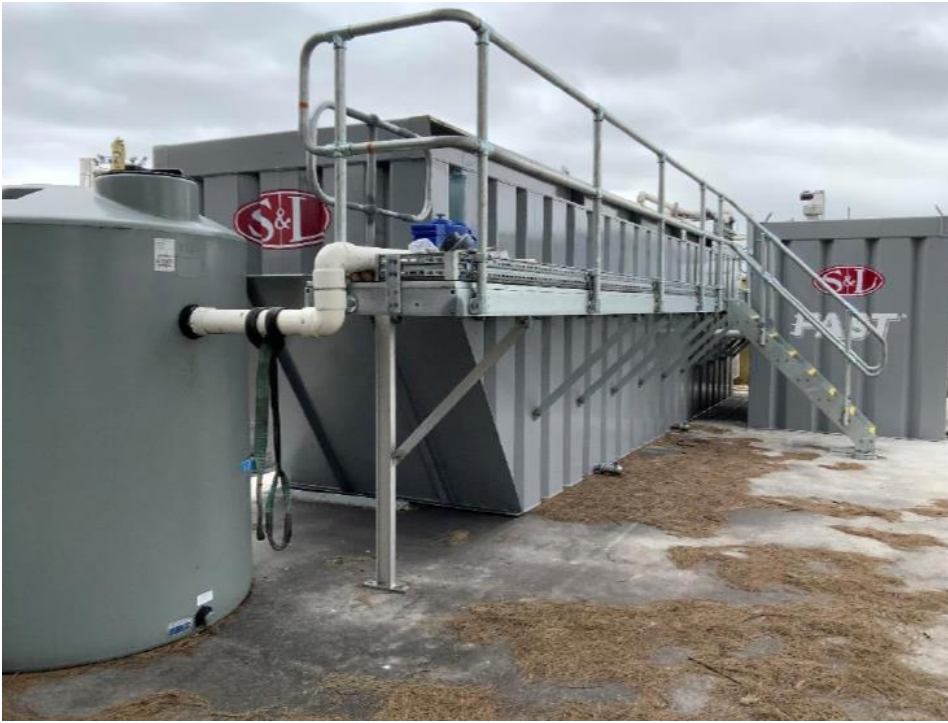
Figure 10: Smith & Loveless Sewage Treatment Plant (STP) onsite

Tahmoor Coal operates a *Smith & Loveless* Sewage Treatment Plant (STP) onsite, illustrated in **Figure 10** below and utilises two (2) maturation treatment ponds to treat its effluent waters. Water Quality samples have continued to be taken to further understand the water quality and potential improvements potentially affecting the new Water Treatment Plant. During the reporting period both maturation ponds were cleaned/dredged out, this had an immediate improvement on E-coli and Enterococci levels, recording a dramatic decrease to previous baseline levels.

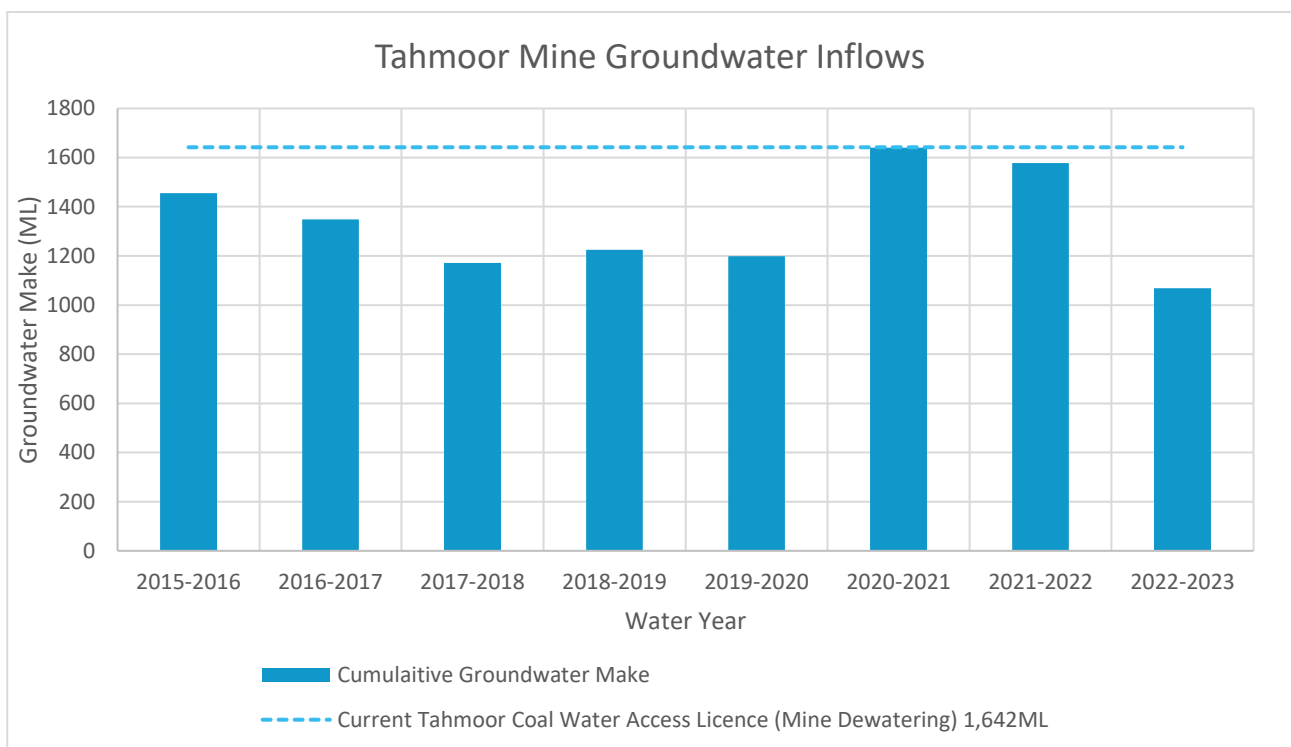
Figure 34 Calculated Groundwater Inflow Annual Volume (Water Year/Financial Year).

An independent contractor completed an analysis of water make for Tahmoor Mine. As of 30 June 2023, the cumulative groundwater make for water year 2022/23 was 1,068 ML, which is within the groundwater entitlement of 1,642 ML/y (refer to **Table 15-1** and **Figure 34**). As of 31 December 2023, the cumulative groundwater make between July to December 2023 was 673 ML, which is within the annual groundwater entitlement. **Table 15-1** provides a summary of groundwater outflow from 2015 to 2023 and is illustrated in **Figure 34**.

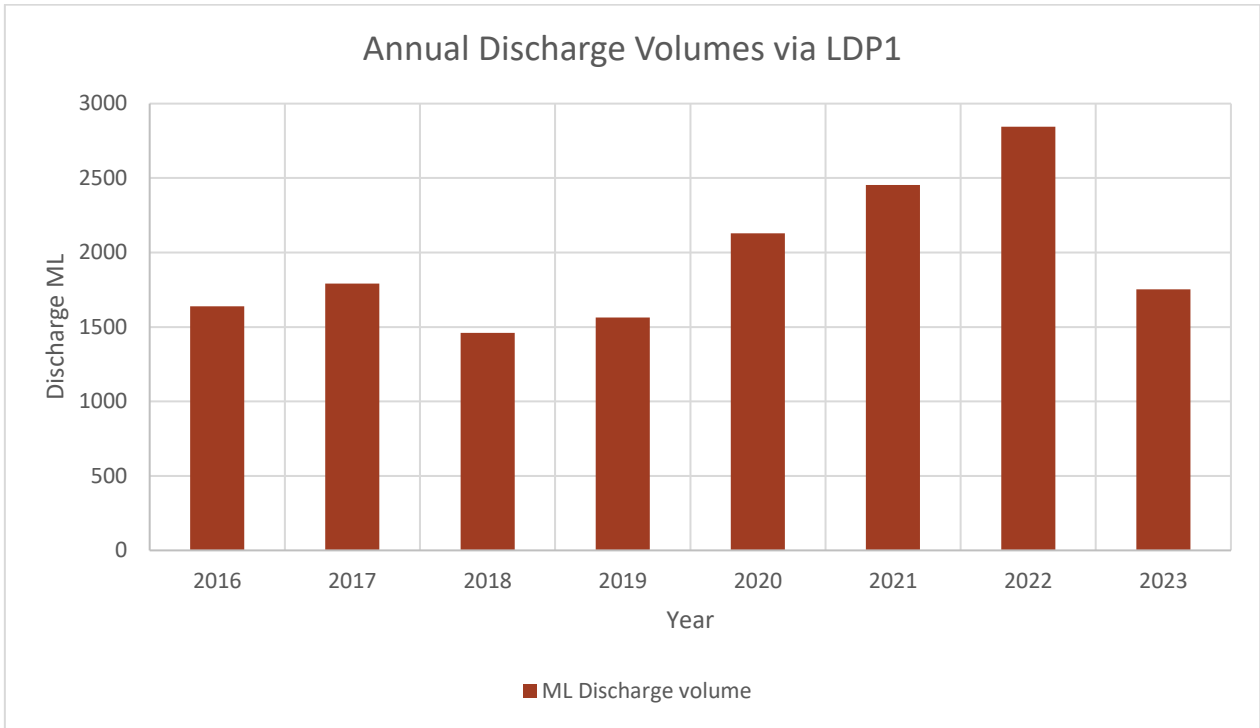
Figure 35 Volume (ML) of Discharge from LDP1 for the past 8 years.

On average Tahmoor Mine discharged 4,800 kL/day, with a total of 1,752,121 kL or approximately 1,752 ML discharged during the reporting period. This is shown in **Table 15-4**, **Figure 35** and **Figure 36**. The peak shown in **Figure 36** on 29th April 2023 was as a result of high rainfall event and corresponds to the peak in **Figure 37** for the total daily rainfall recorded at the Stockpile Weather Station. This is in accordance with EPL 1389 (more than 10 mm rainfall in 24 hrs, recorded from the Stockpile Weather Station).
