BIODIVERSITY MANAGEMENT PLAN – TAHMOOR SOUTH DOMAIN – LONGWALLS SOUTH 1A – SOUTH 6A

Tahmoor Coal Pty Ltd

Doc # TAH-HSEC-00363

Document Title: Tahmoor South Domain
Longwalls South 1A – South 6A
Biodiversity Management Plan

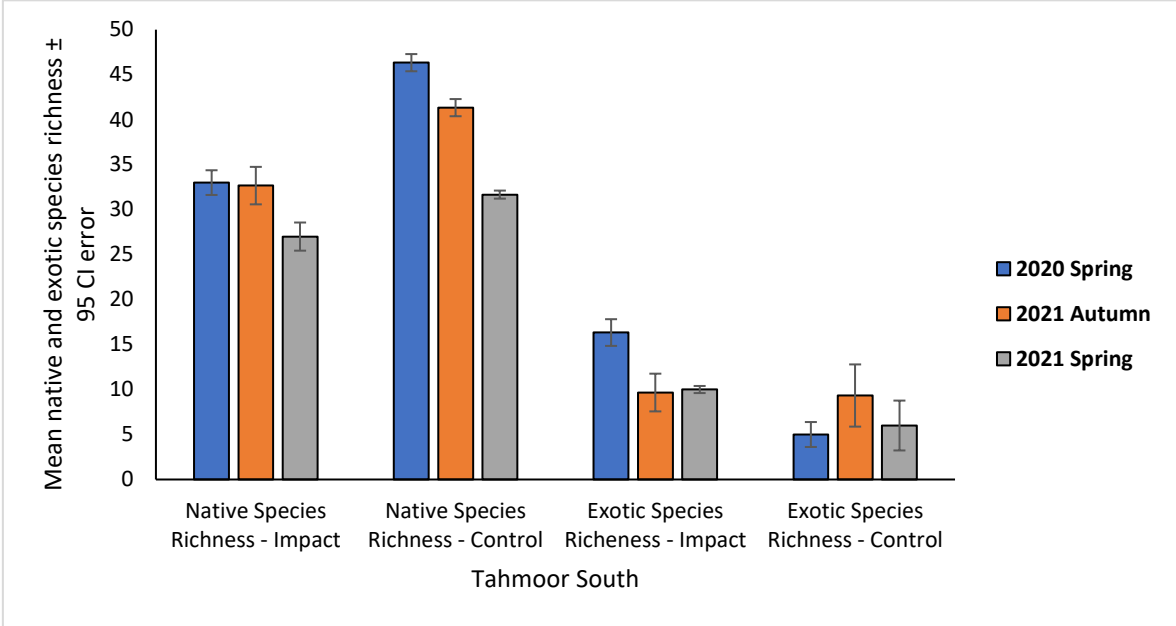
Figure 3 Mean native and exotic species richness at impact and control sites in Spring 2020, Autumn 2021 and Spring 2021

Natural seasonal variation is observed at each site; however diversity of native species has been found to be generally decreasing as a result of competition from *Acacia spp.*, refer to **Figure 3** and **Figure 4**.

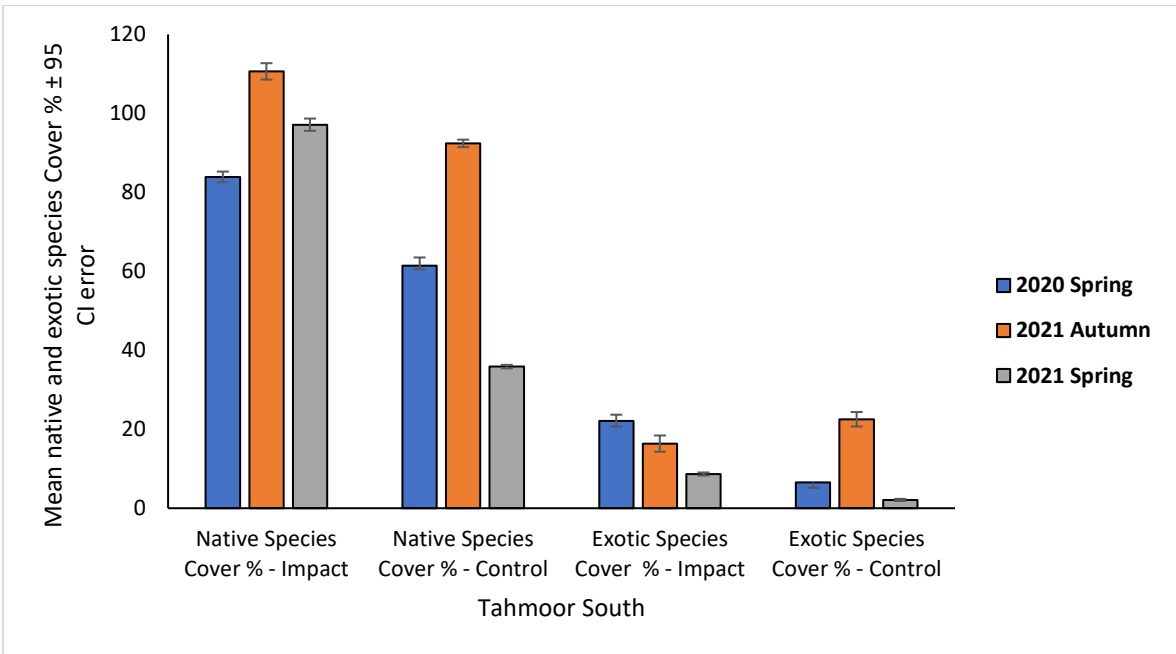
Figure 4 Mean native and exotic species cover percentage at impact and control sites in Spring 2020, Autumn 2021 and Spring 2021
