Report on
Geotechnical Assessment
Longwalls S1A to S6A, Bargo

Prepared for
Tahmoor Coal Pty Ltd

Project 210597.00
December 2022

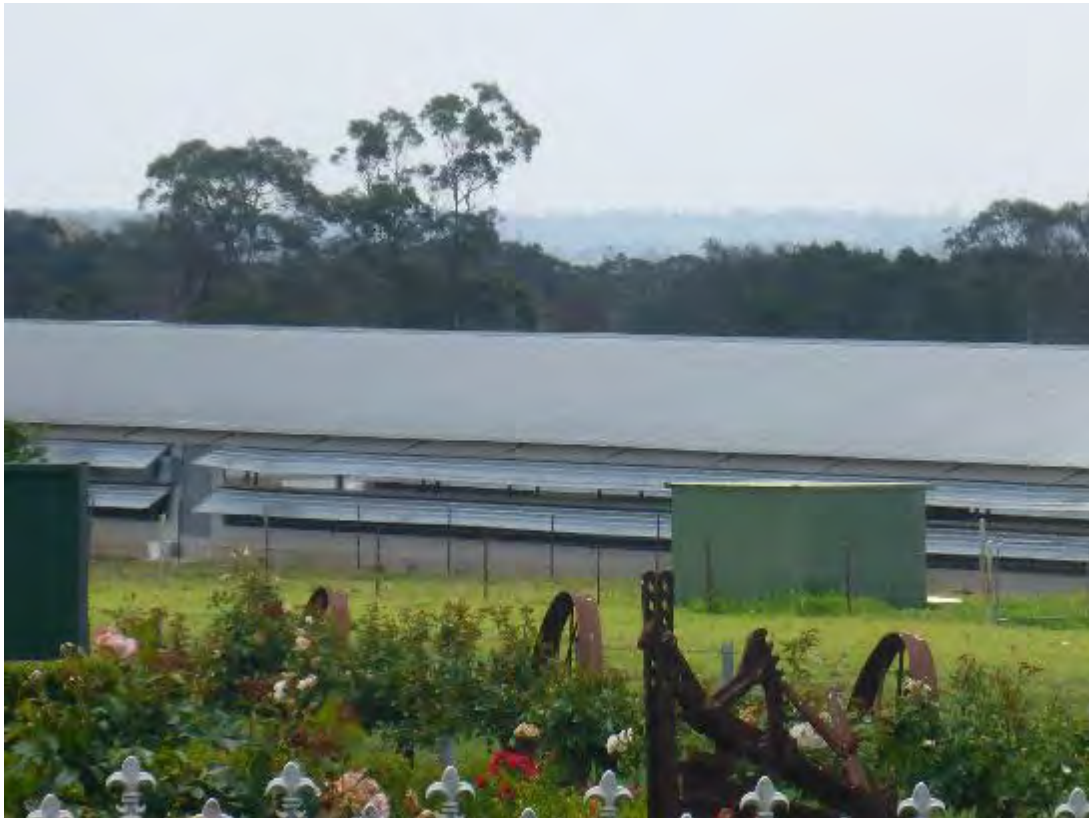
Plate 1 Poultry sheds at Site 55

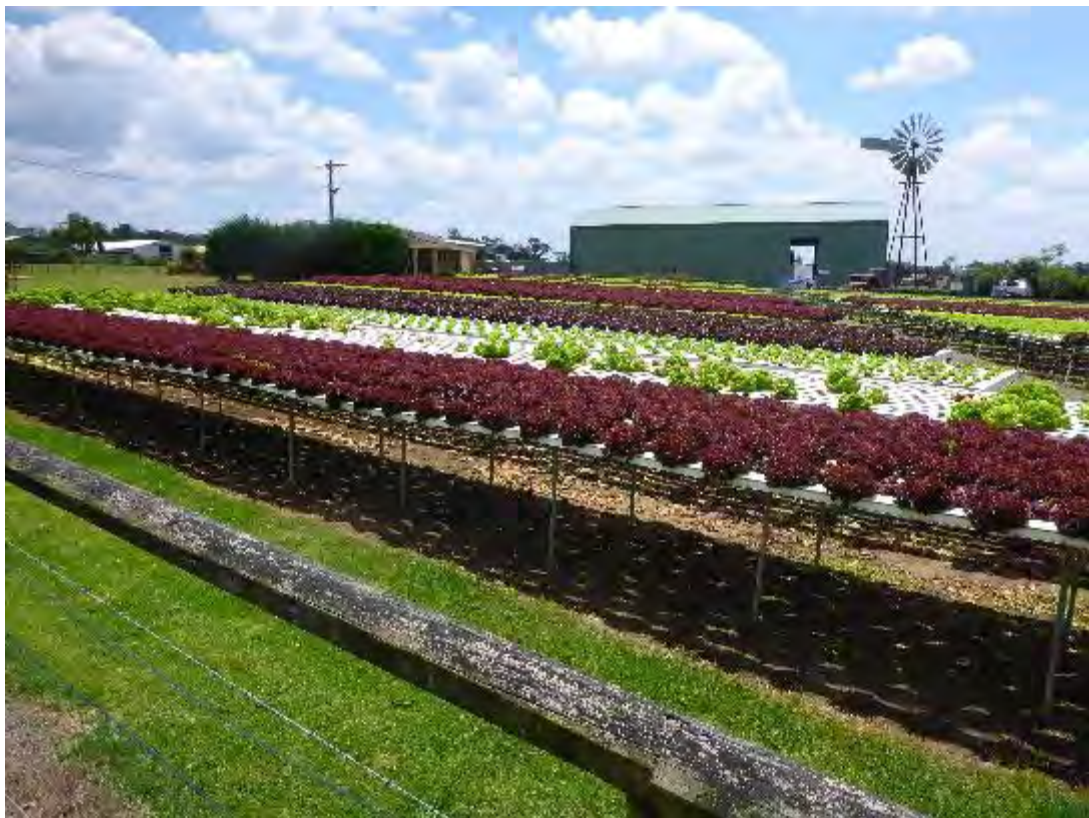
Plate 2 Hydroponic Lettuce at Site 54

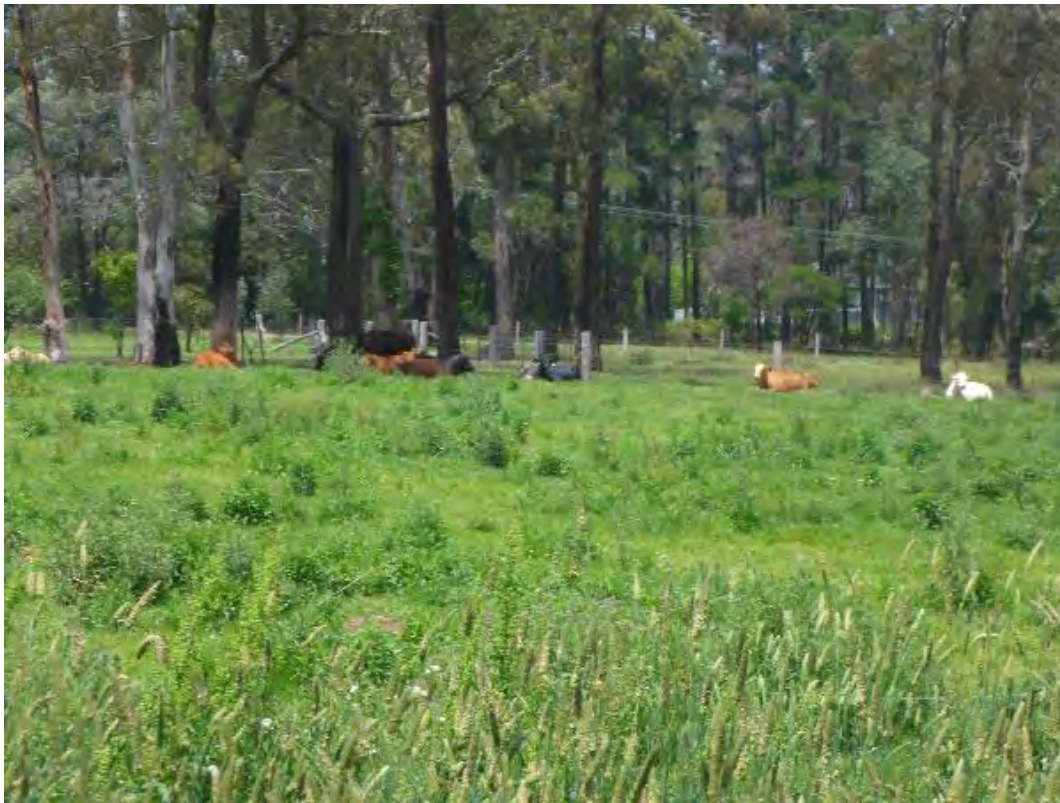
Site 50 – Cattle grazing

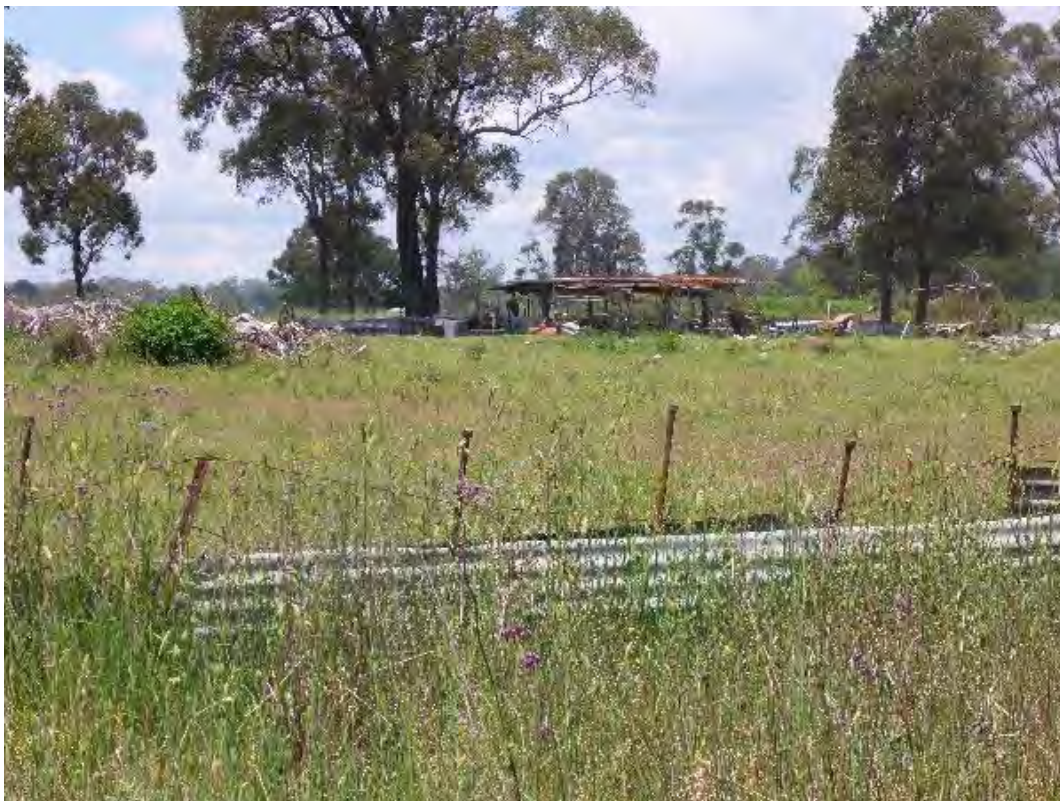
Site 51 – Cattle feedlot 2013, disused cattle feedlot 2017

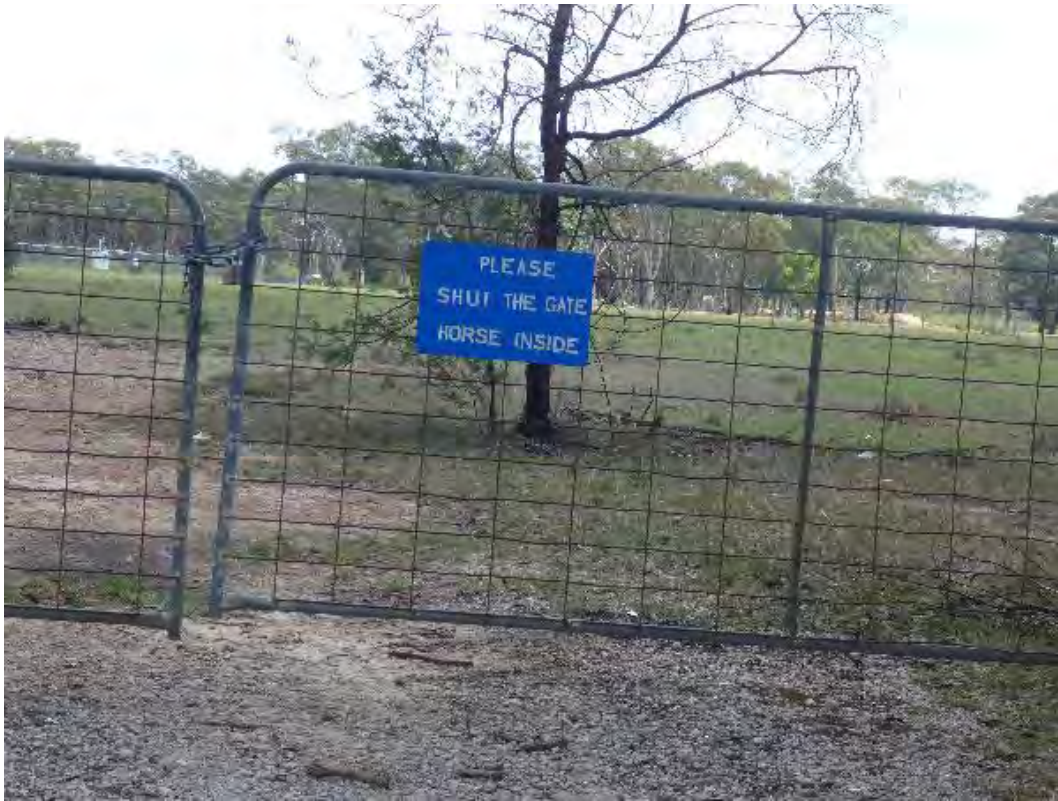
Site 52 – Pleasure horses

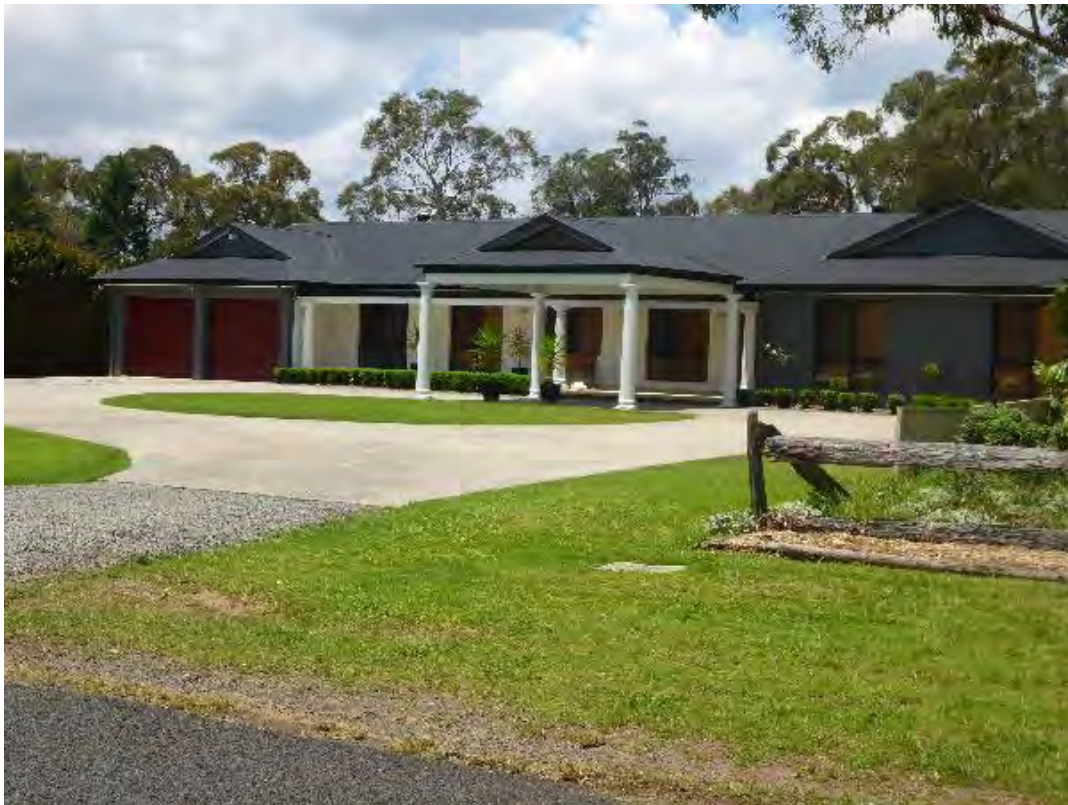
Site 53 – Rural residential

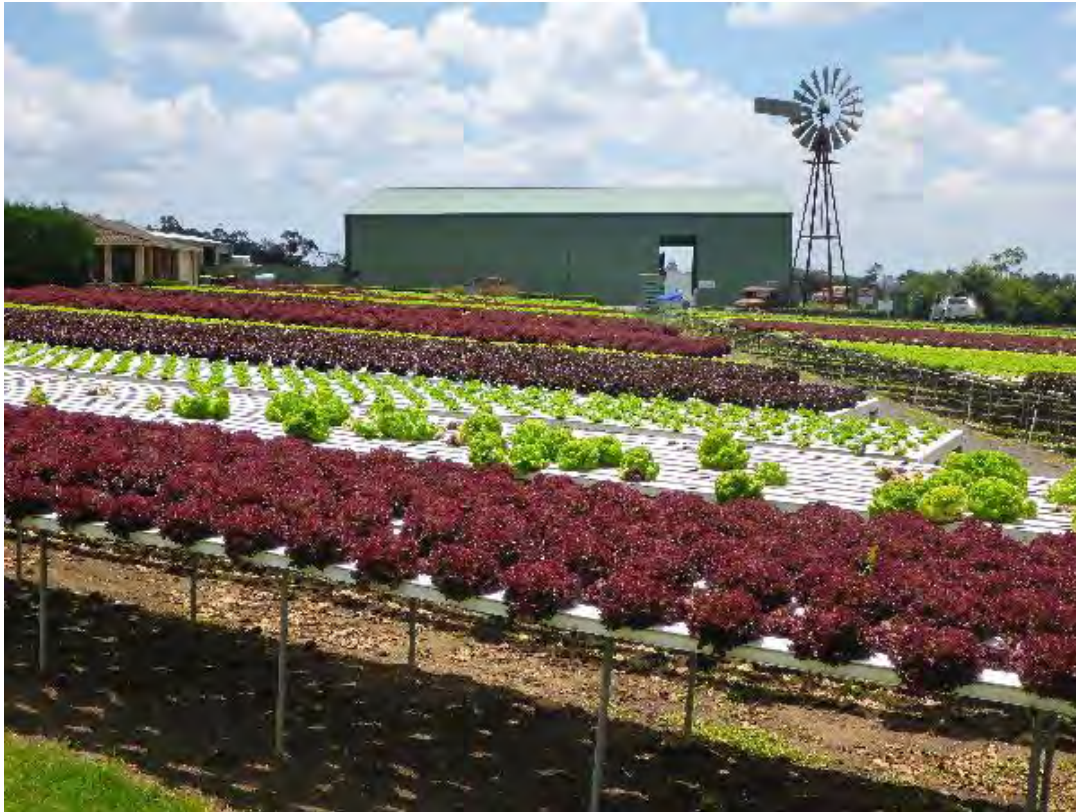
Site 54 – Hydroponic lettuce and poultry sheds

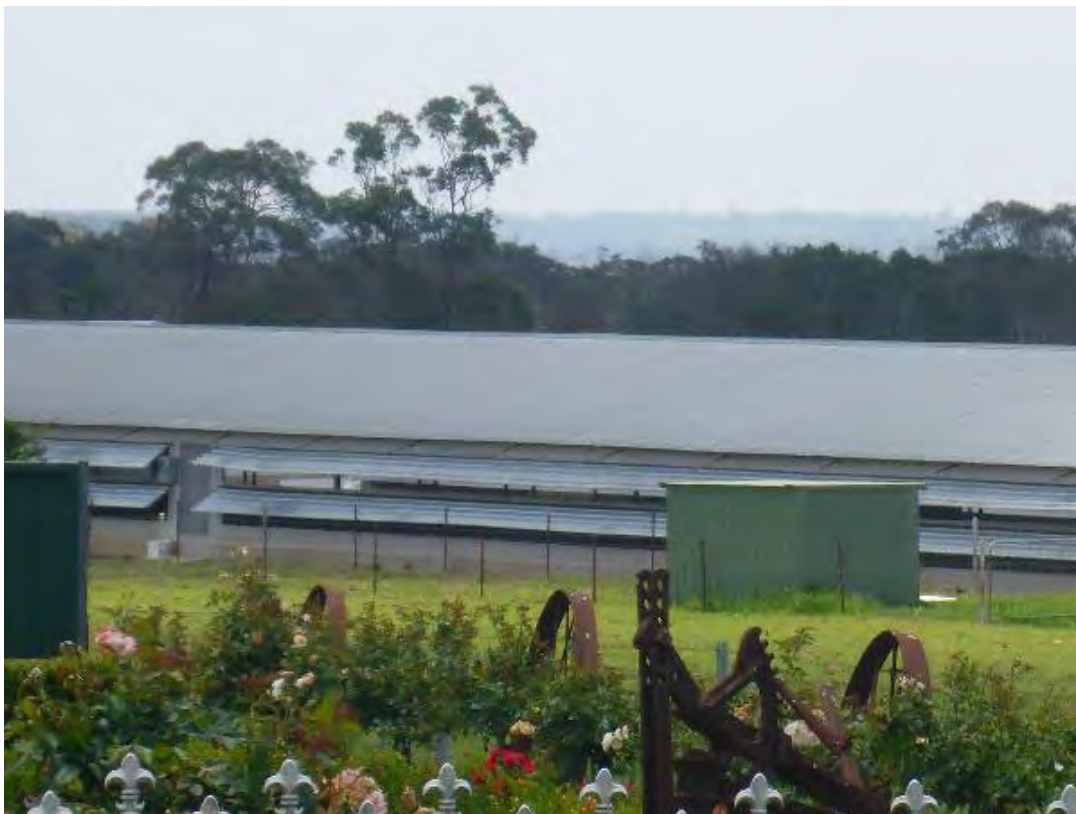
Site 55 – Poultry sheds

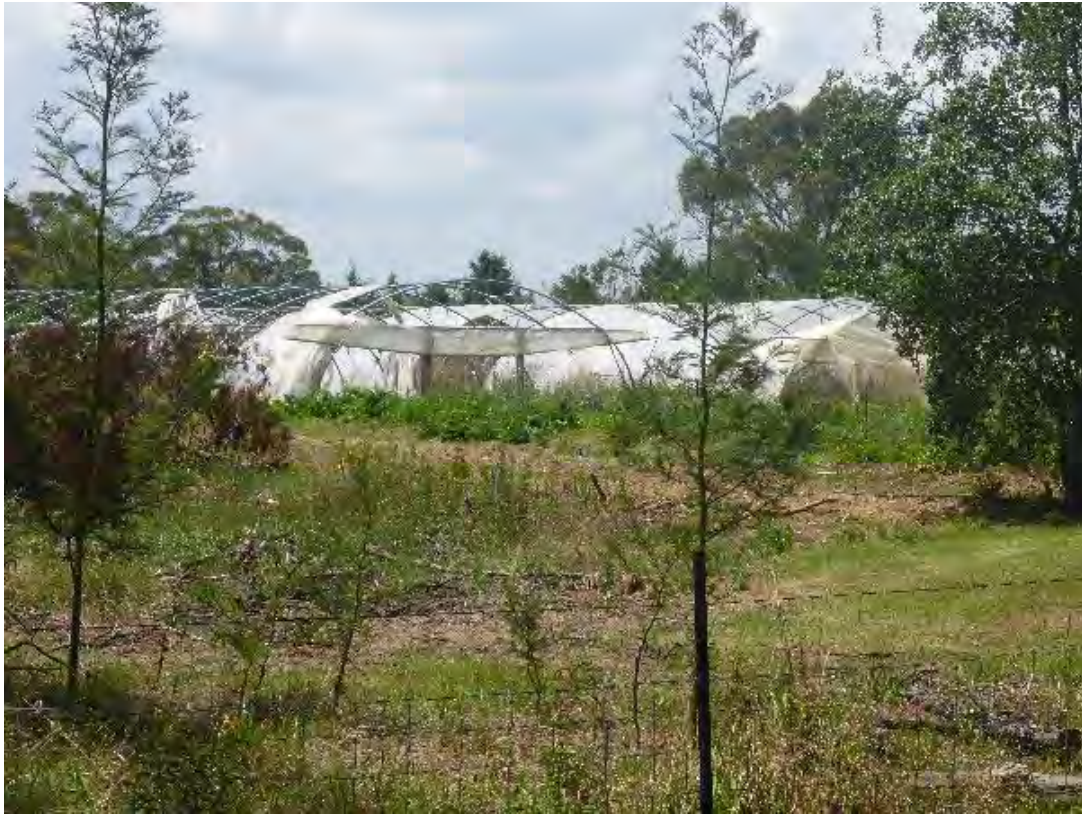
Site 56 – Cut flower greenhouse 2013, disused cut flower greenhouses 2017

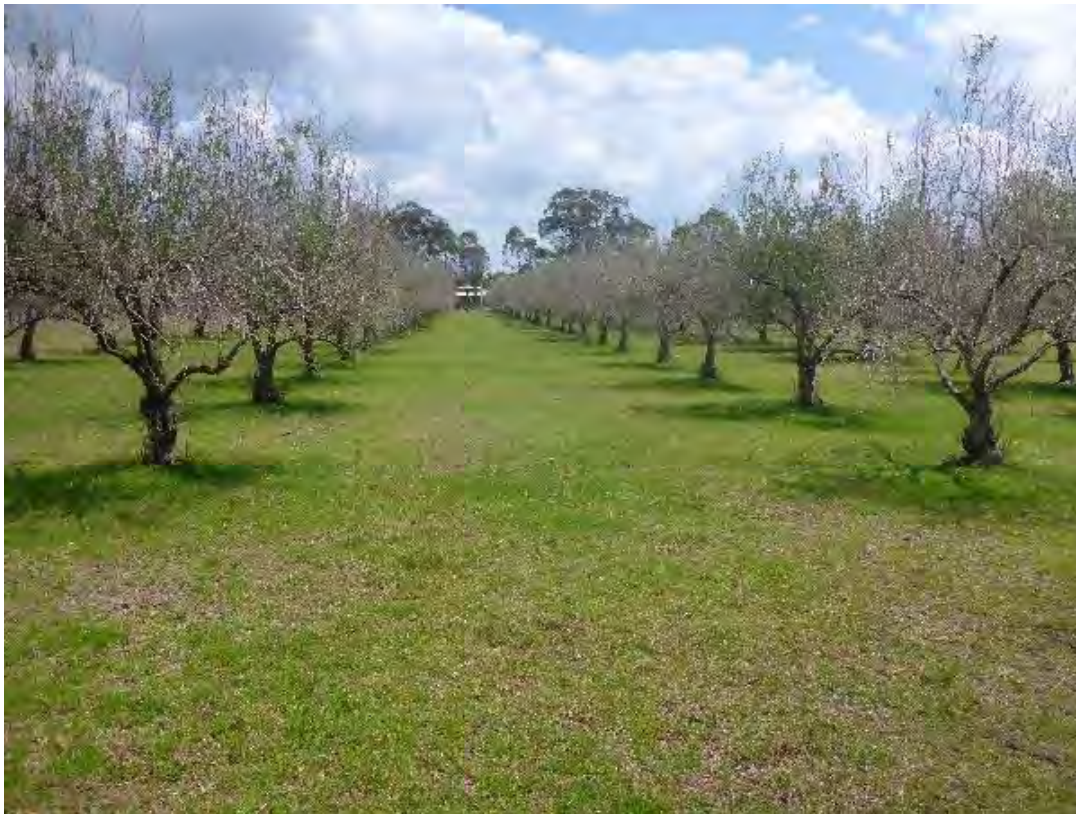
Site 58 – Olives & sheep grazing

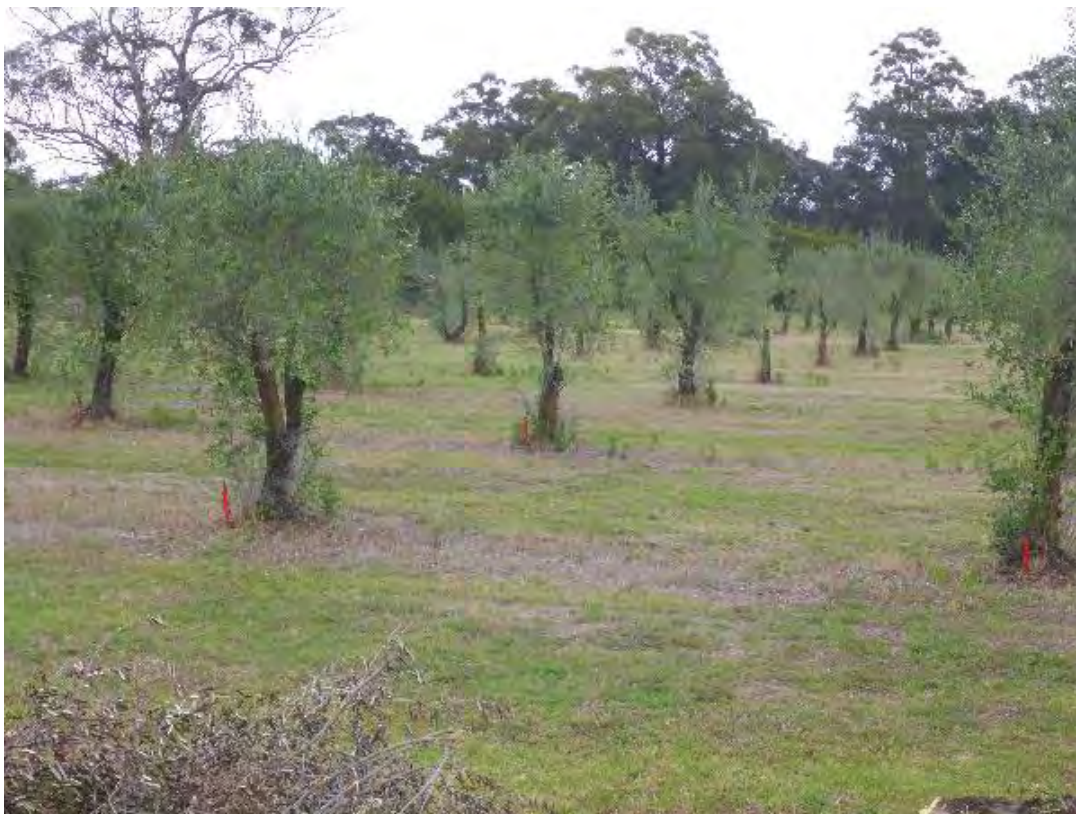
Site 59 – Irrigated olives & alpaca stud

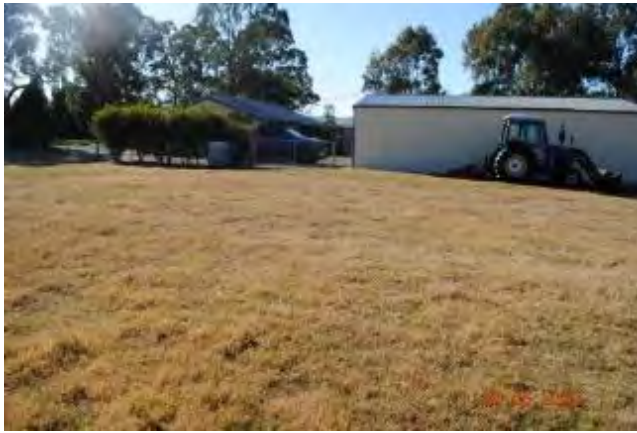
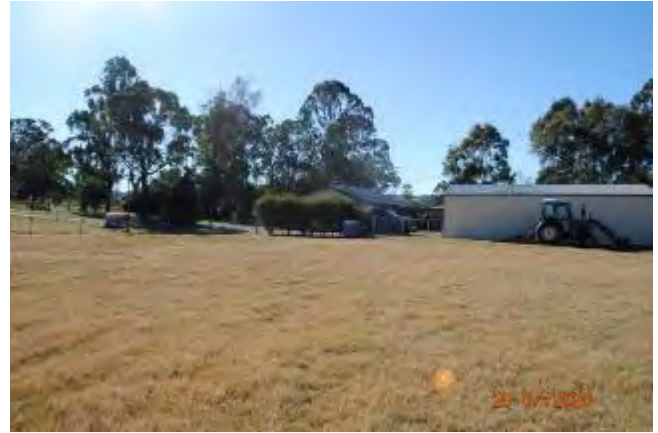
Property Owner east towards sheds (left: June 20; right: current)

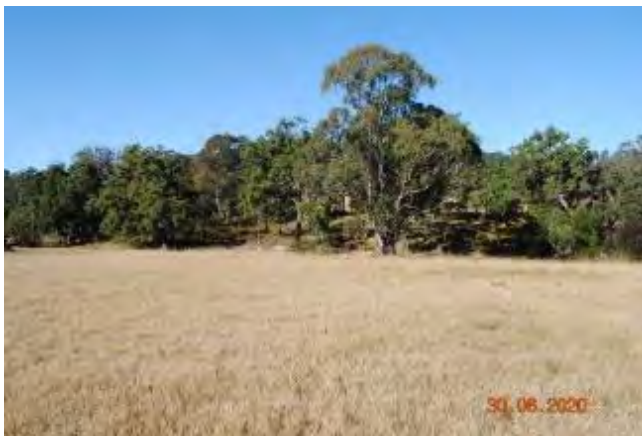
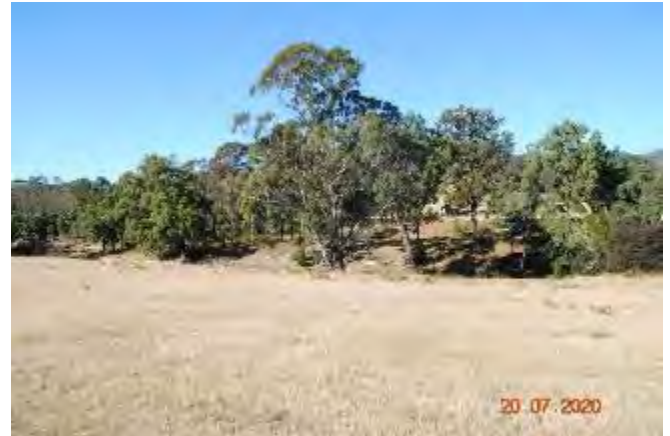
Property Owner south towards Stonequarry Creek (left: June 20; right: current)
