Tahmoor Coal Pty Ltd

SIX MONTHLY SUBSIDENCE IMPACT REPORT

Tahmoor South Domain Longwalls South 1A – South 6A

1 January 2023 – 30 June 2023

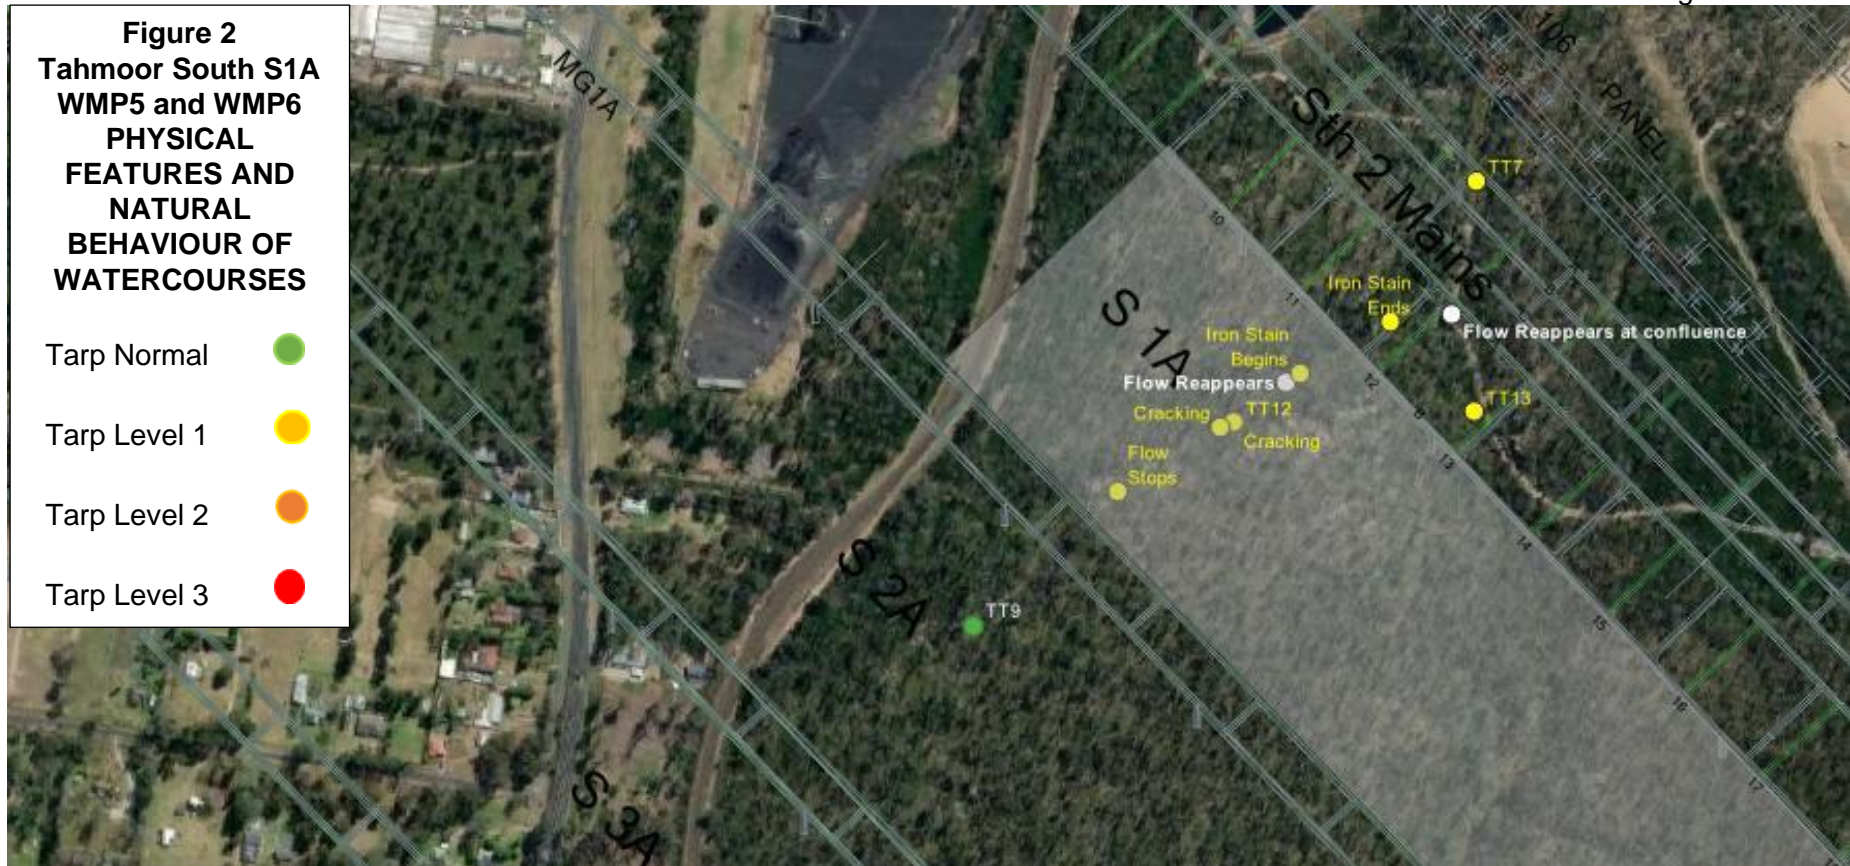
Visual inspections within the Longwall S1A active subsidence area at site TT7 on 1 March 2023 as shown in **Figure 2**, identified that the hydraulic control on the downstream end of the pool was 980 mm Wide with water not flowing over the hydraulic control. No fractures, no gas discharge and the water level is inconsistent with the recent rainfall totals.

At site TT7, there was an observed impact to pool water level. No overland connected flow, iron staining, gas release or turbidity had changed as compared with baseline conditions conducted in September 2022. TT7 was therefore within TARP Level 1.

Visual inspections within the Longwall S1A active subsidence area at site TT12 on 1 March 2023 as shown in **Figure 2**, identified that pool was dry. There was fracturing both upstream and downstream of the pool. As the pool was dry there was no gas discharge noted. The water level is inconsistent with the upstream pool at TT9 with flow stopping approximately 100 metres upstream of TT12.

At site TT12, there was an observed impact to pool water level, TT12 was therefore within TARP Level 1.

Visual inspections within the Longwall S1A active subsidence area at site TT13 on 15 March 2023 as shown in **Figure 2**, identified that the hydraulic control on the downstream end of the pool was 850mm wide and the pool being dry. There were no new changes or fractures and no gas discharge. However, the water level was not consistent with the recent rainfall totals.

At site TT13, there was a change in pool water level that was not seen in the baseline conditions of September 2022 or later. There was evidence of rain ponding above TT13, but water did not flow again until the Teatree Hollow tributary met the Teatree Hollow stream. TT13 was therefore within TARP Level 1.

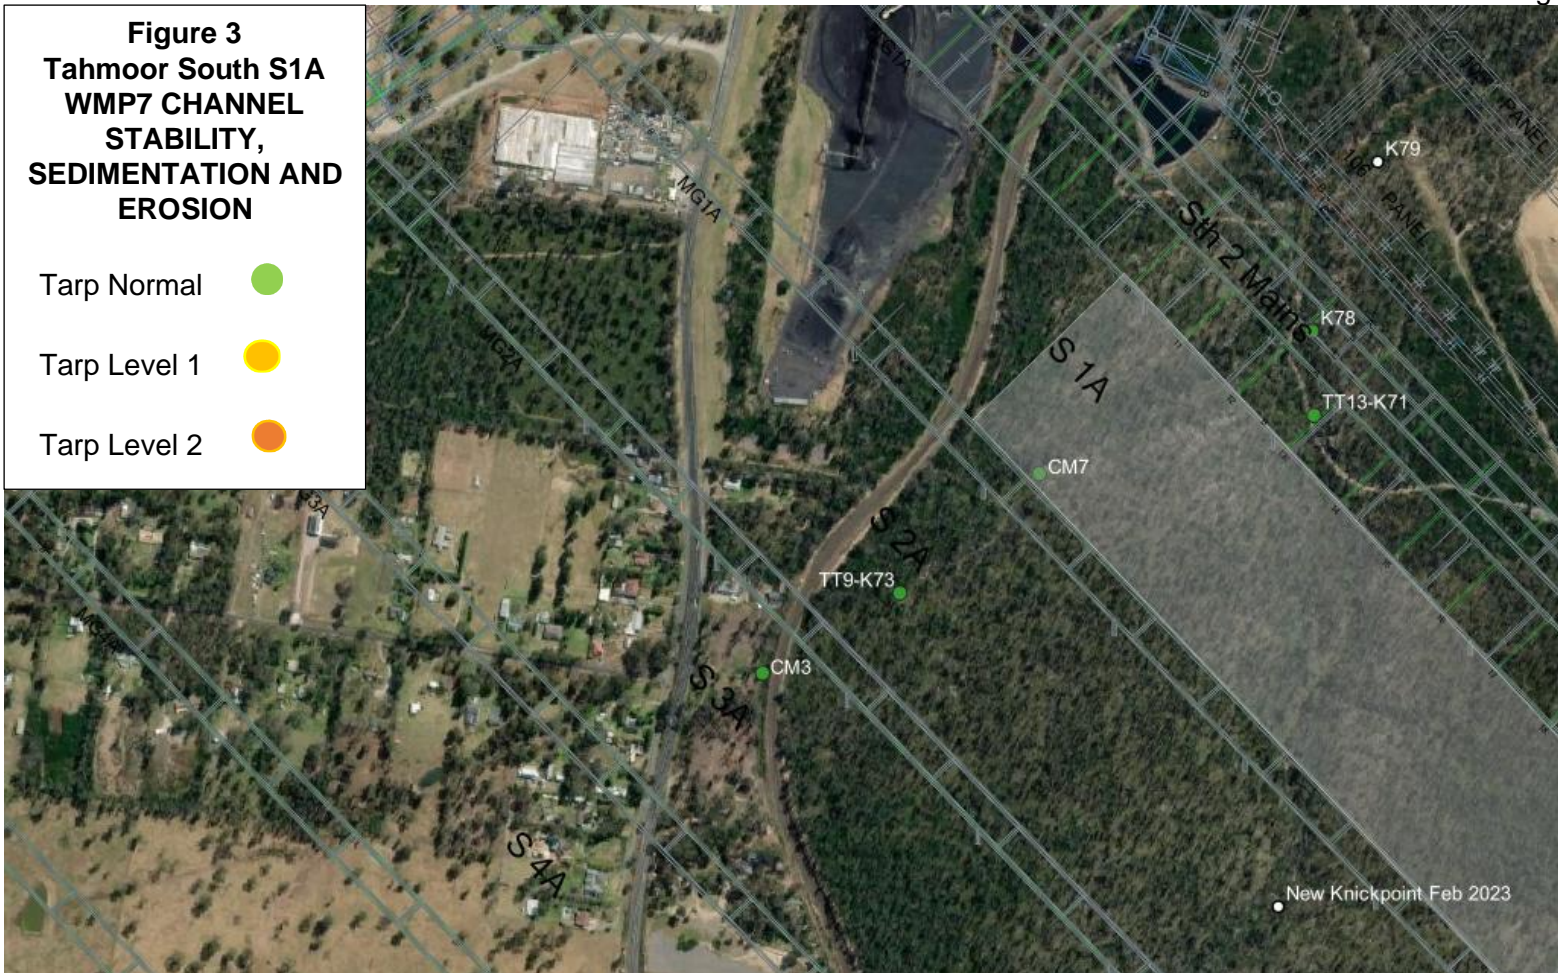
Visual inspections within the Longwall S1A active subsidence area at site CM3 on 15 March 2023 as shown in **Figure 3**, identified that the hydraulic control on the downstream end of the pool was 280mm wide with 25 mm of water flowing over the hydraulic control. No shearing or cracking was identified. No additional iron seeps were noted beyond what was identified the baseline survey. No gas discharge was detected.

At site CM3, there was no evidence of further development of soft knickpoints as compared with baseline conditions conducted in October 2022. CM3 was therefore within TARP Level Normal Condition.

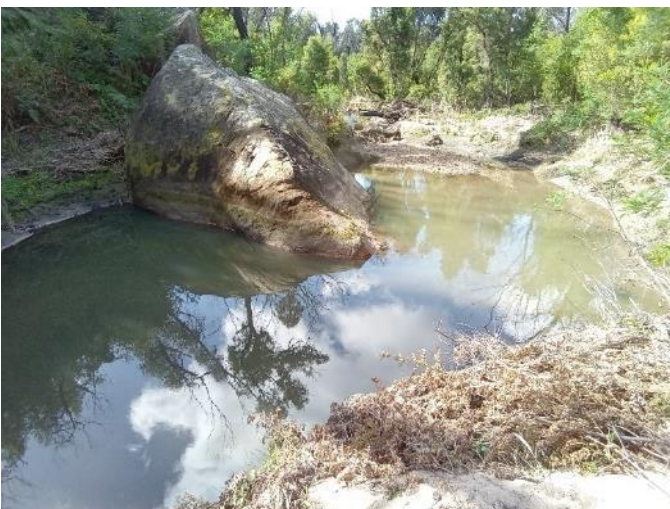
Additional 08/02/2022

Additional Iron Staining 28/06/2023

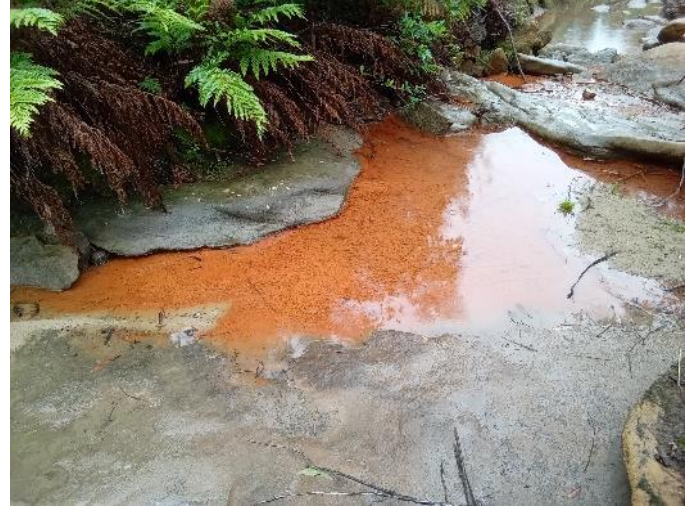
Additional Iron Staining 12/04/2023

Additional Iron Staining 28/06/2023

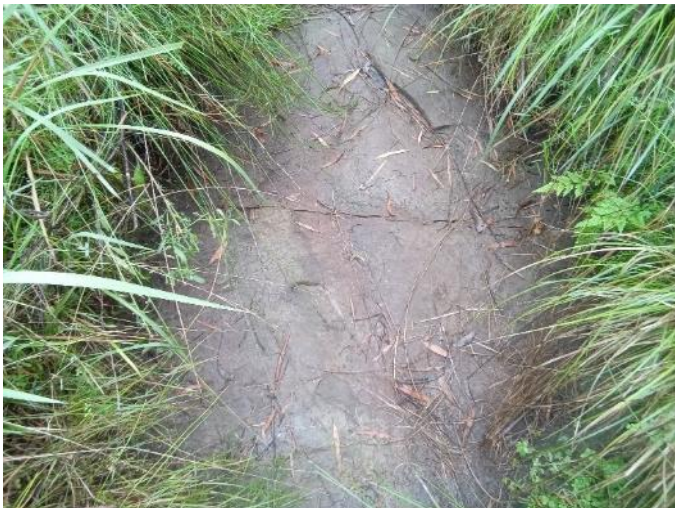
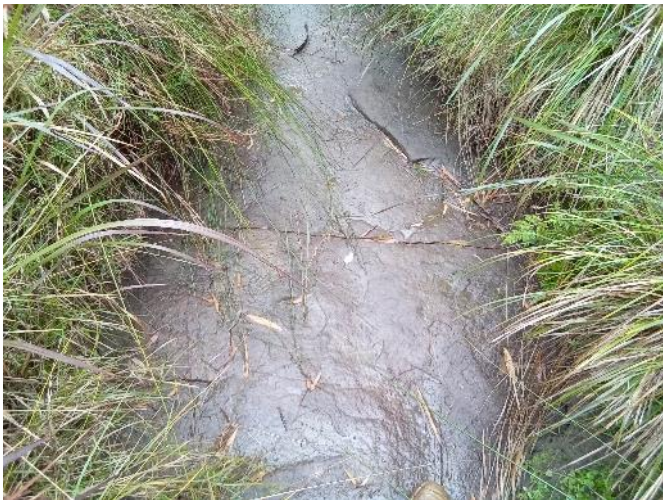
Teatree Hollow – TT12 Upstream Cracking

During the inspection, it was observed that the iron staining identified in the 1 March 2023 survey was still evident approximately 50 meters downstream of TT12. The number of cracks in the area has remained steady at 26. During this inspection, it was observed that the length and width of the cracks have increased.

Crack 15 29/03/2023

Crack 15 28/06/2023

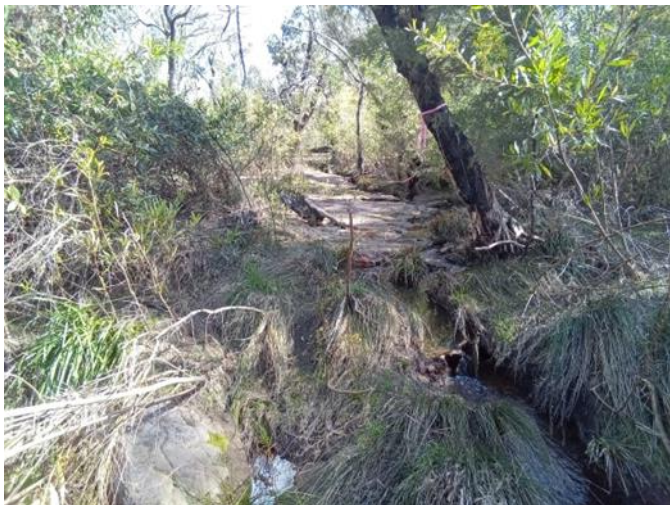
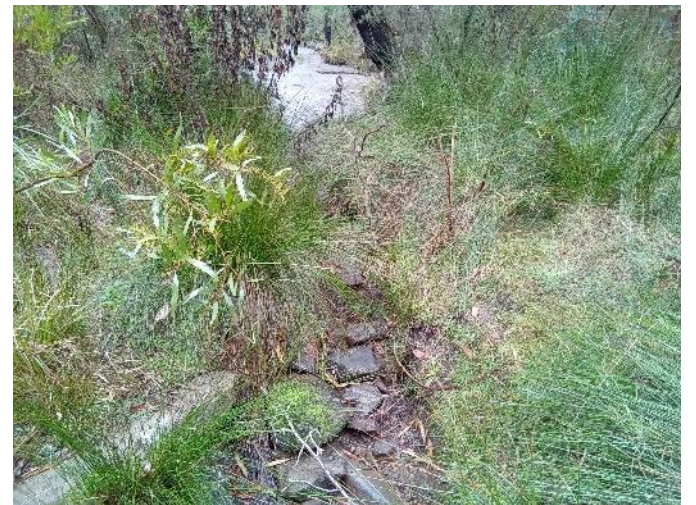
Downstream Knick point 10/08/2022

Downstream Knick point 28/06/2023

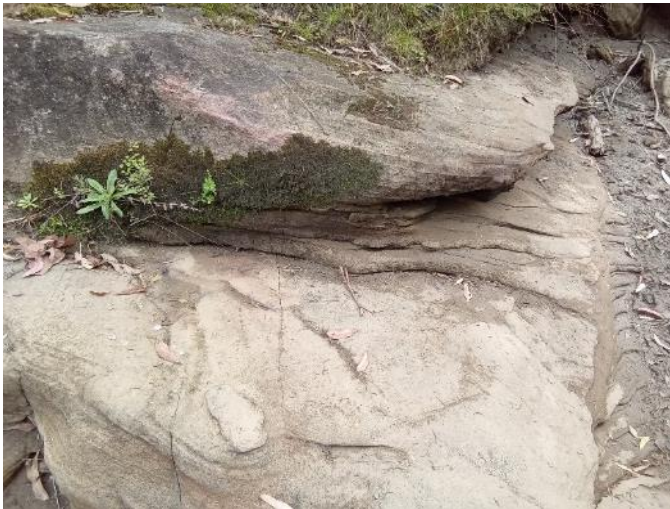
Crack 1 01/03/2023

Based on the consecutive observation of the lengthening and widening of the previous cracks over a three-month period, and the confirmation that these changes are related to mining effects, the area is currently assessed as being within TARP Level 3.

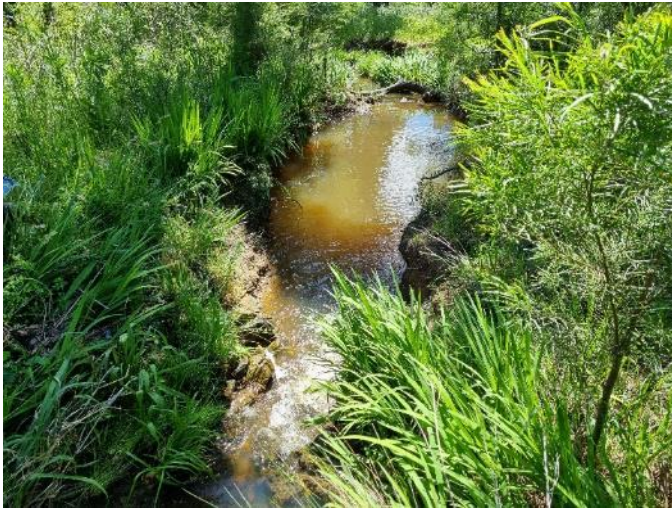
Upstream 27/10/2022

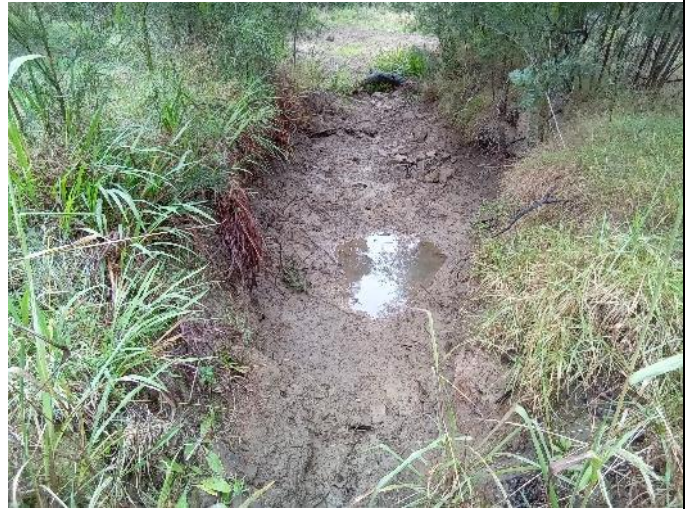
Upstream 28/06/2023

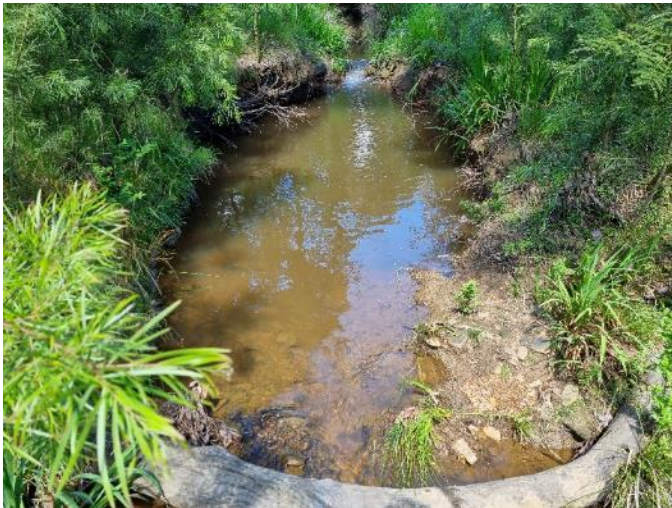
Downstream 27/10/2022

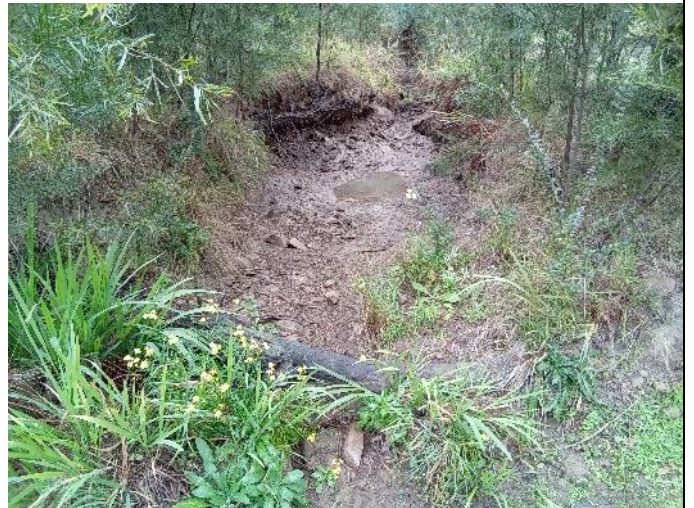
Downstream 28/06/2023

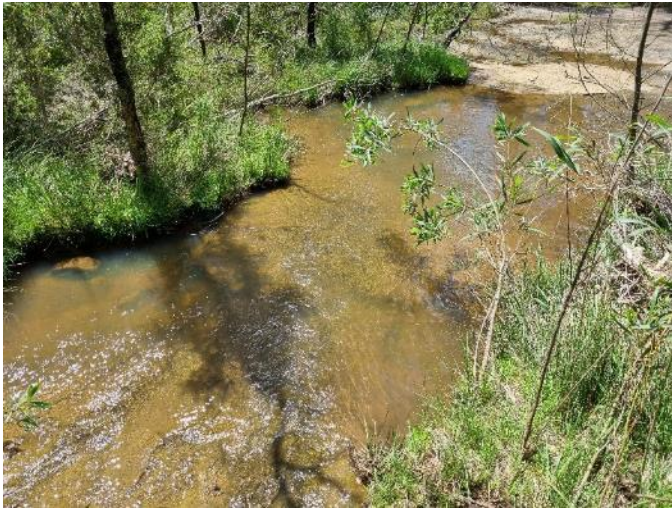
Pool 1 Up 27/10/2022

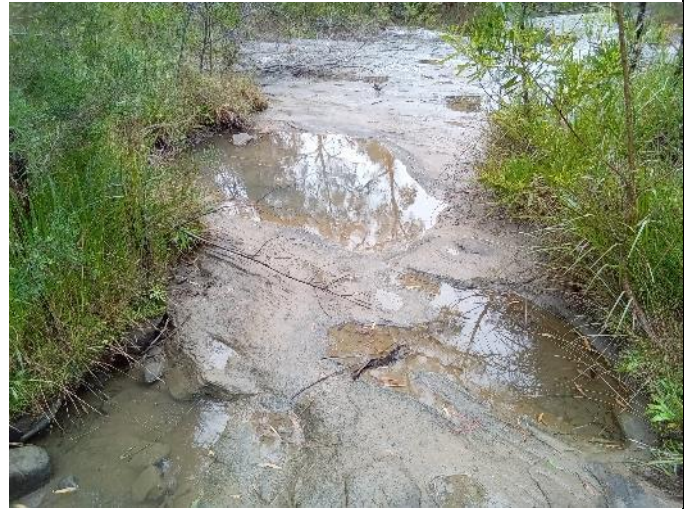
Depression 1 Up 28/06/2023

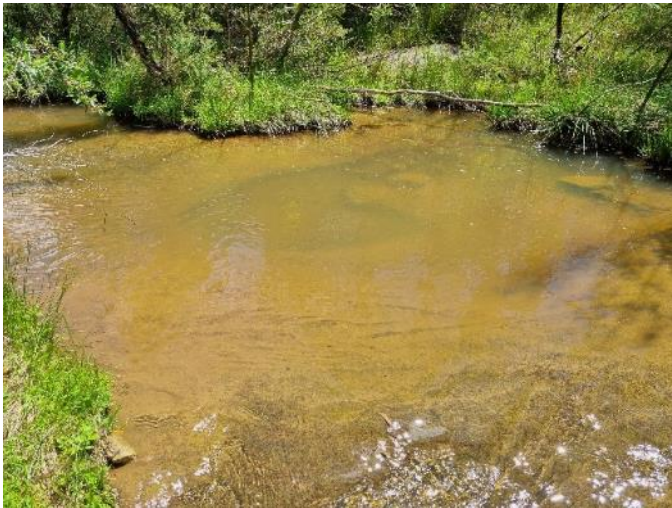
Depression 1 Down 27/10/2022

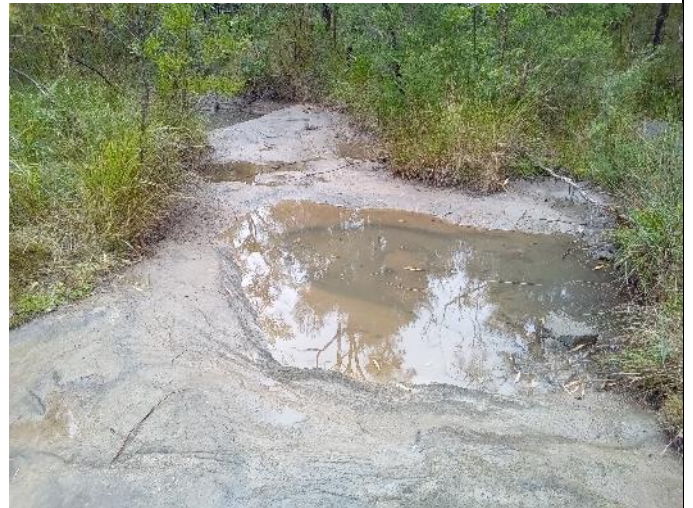
Depression 1 Down 28/06/2023

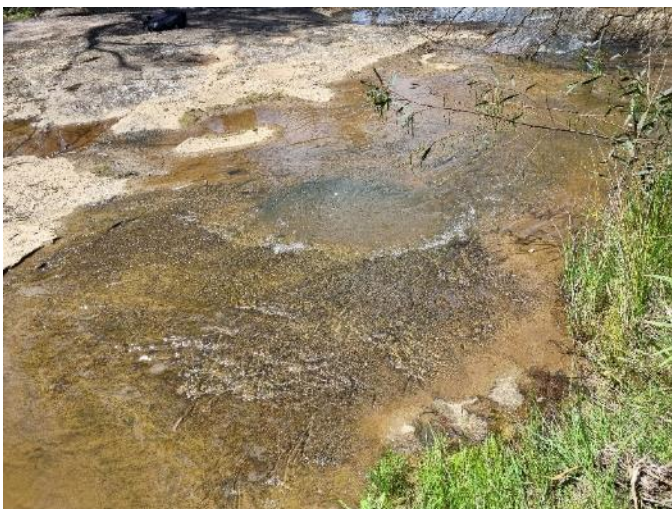
Depression 2 Up 27/10/2022

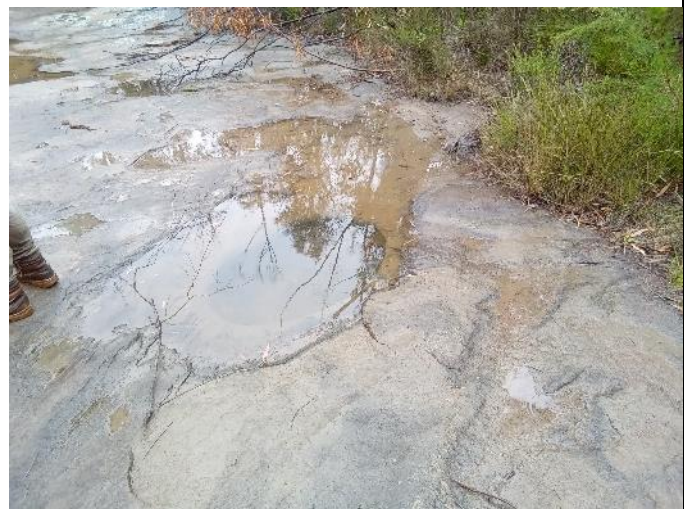
Depression 2 Up 28/06/2023

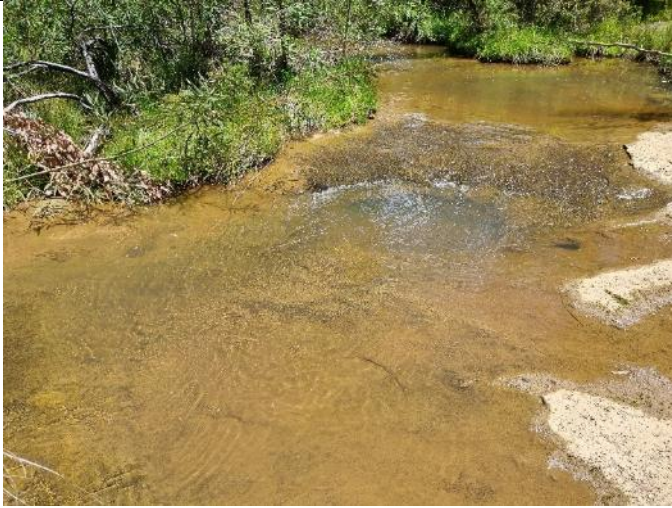
Depression 2 Down 27/10/2022

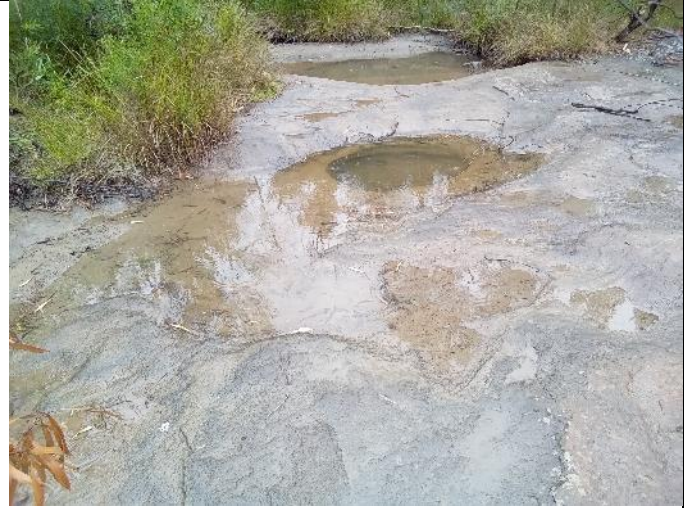
Depression 2 Down 28/06/2023

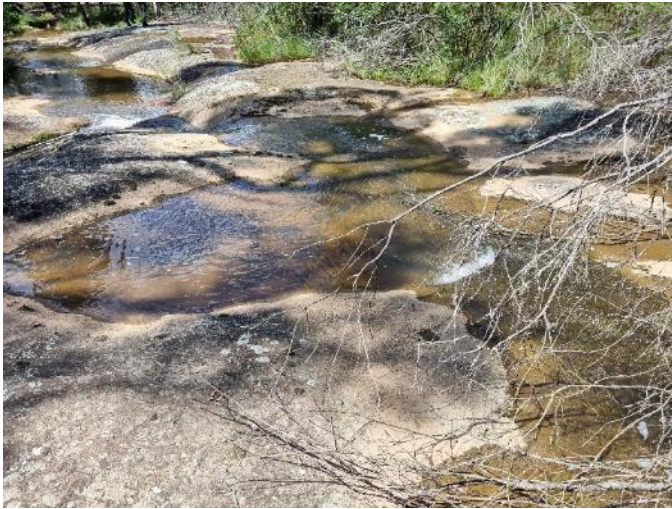
Depression 3 Up 27/10/2022

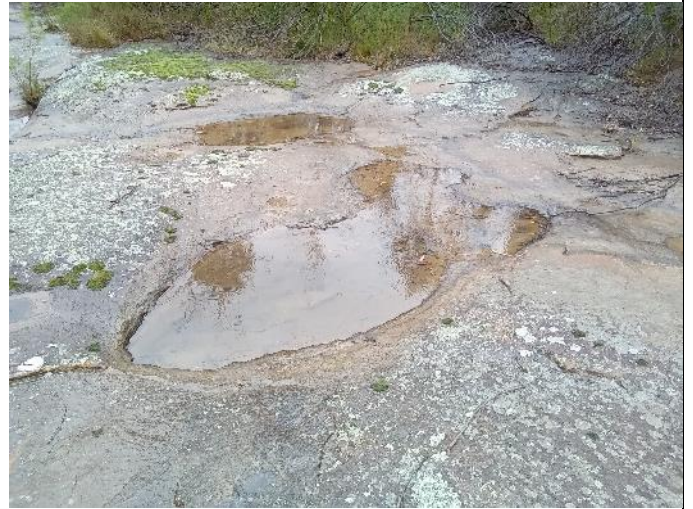
Depression 3 Up 28/06/2023

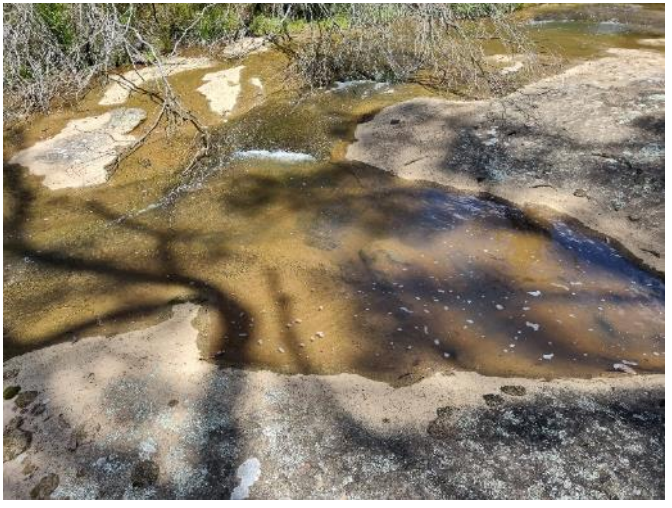
Depression 3 Down 27/10/2022

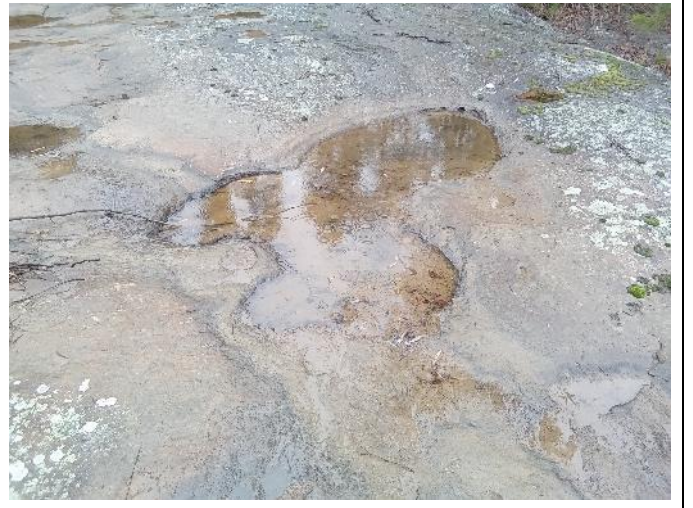
Depression 3 Down 28/06/2023

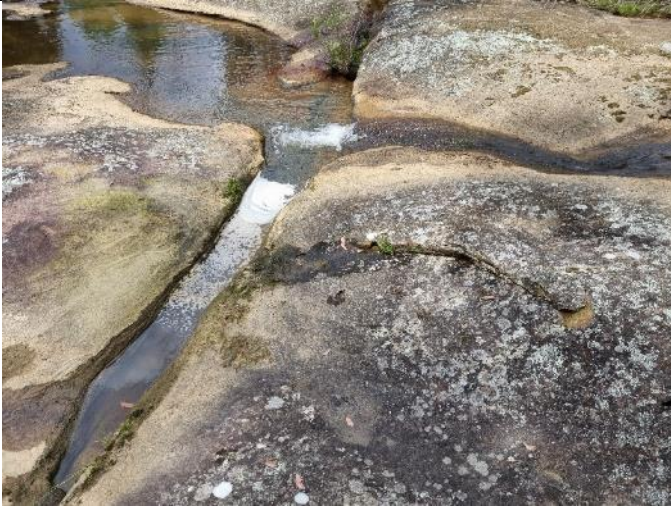
Depression 4 Up 27/10/2022

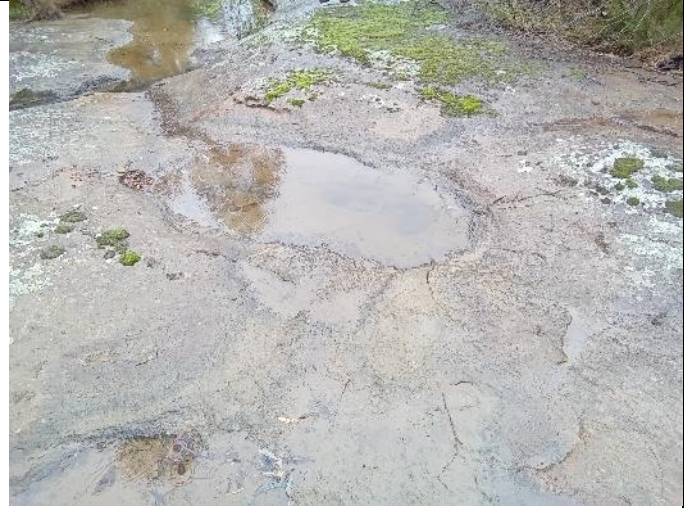
Depression 4 Up 28/06/2023

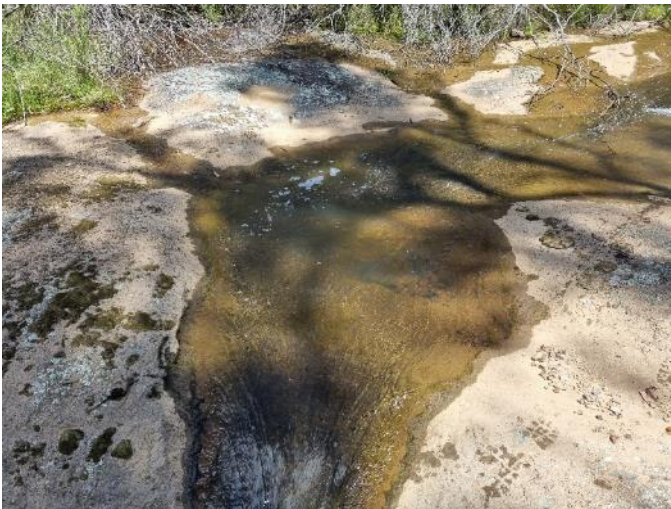
Depression 4 Down 27/10/2022

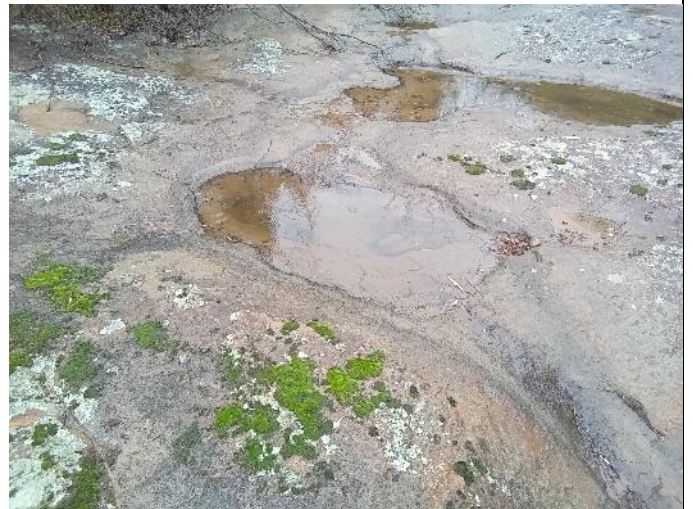
Depression 4 Down 28/06/2023

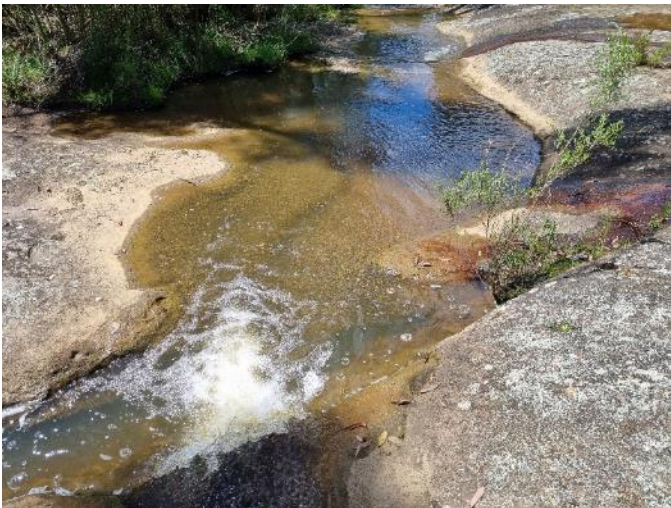
Depression 5 Up 27/10/2022

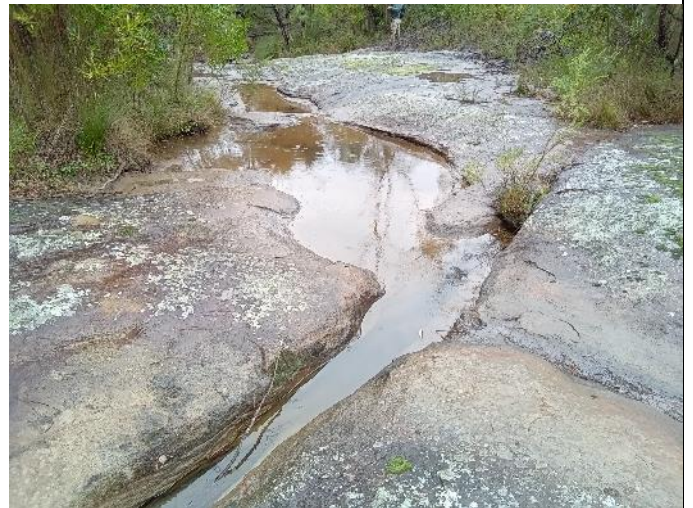
Depression 5 Up 28/06/2023

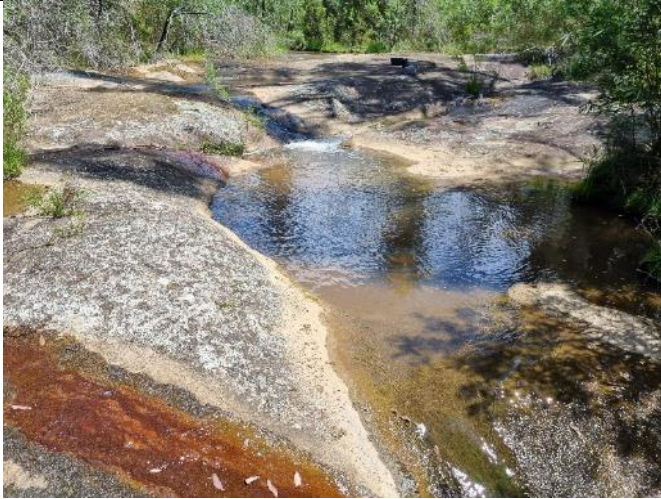
Depression 5 Down 27/10/2022

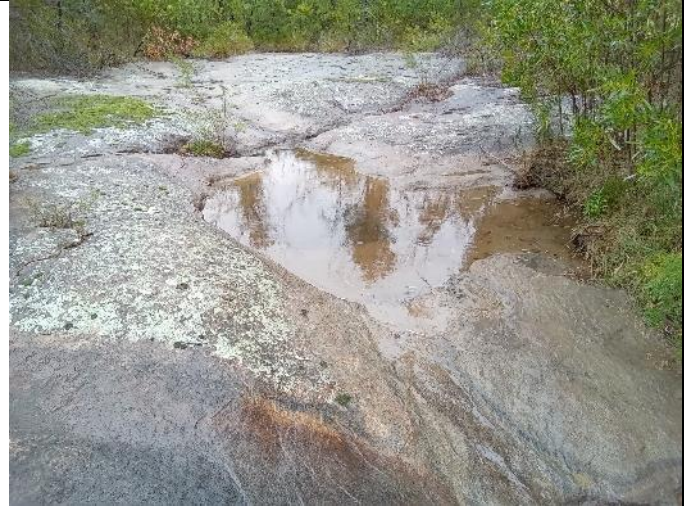
Depression 5 Down 28/06/2023

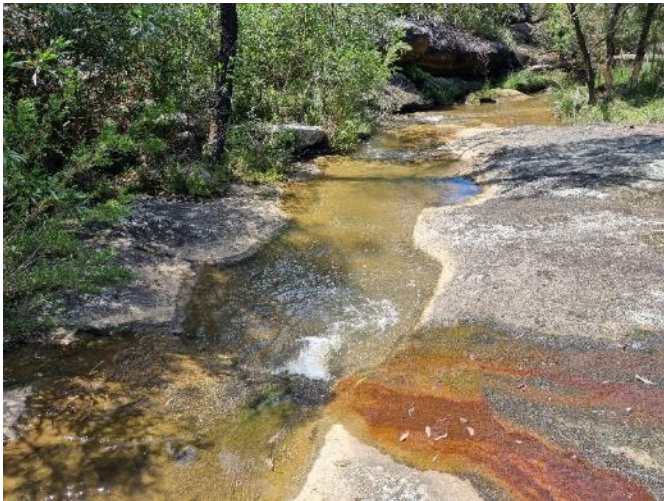
Depression 6 Up 27/10/2022

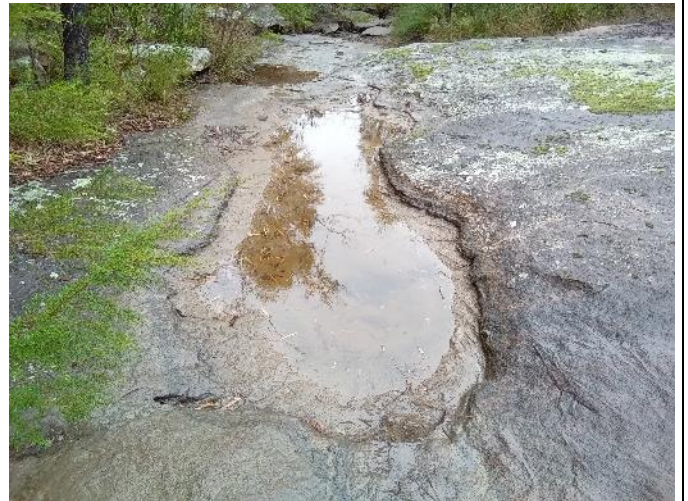
Depression 6 Up 28/06/2023

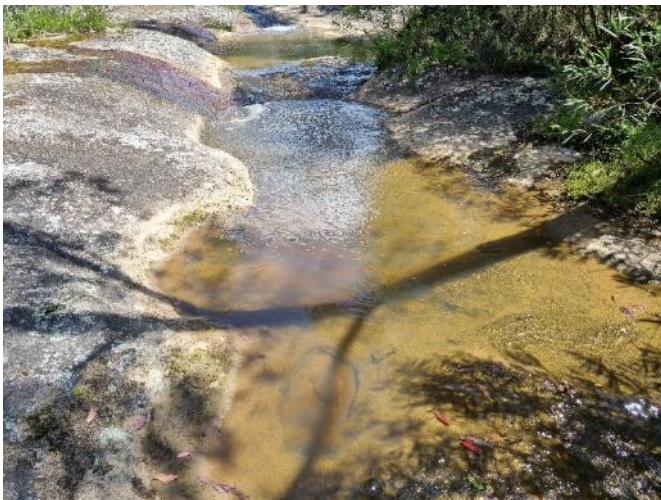
Depression 6 Down 19/10/2022

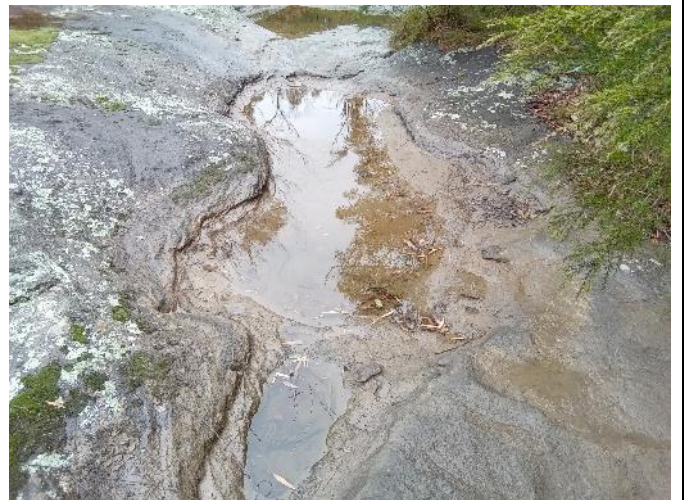
Depression 6 Down 28/06/2023

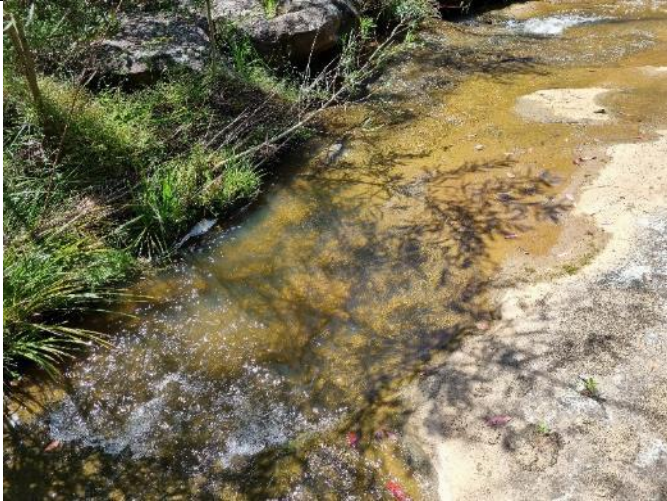
Depression 7 Up 19/10/2022

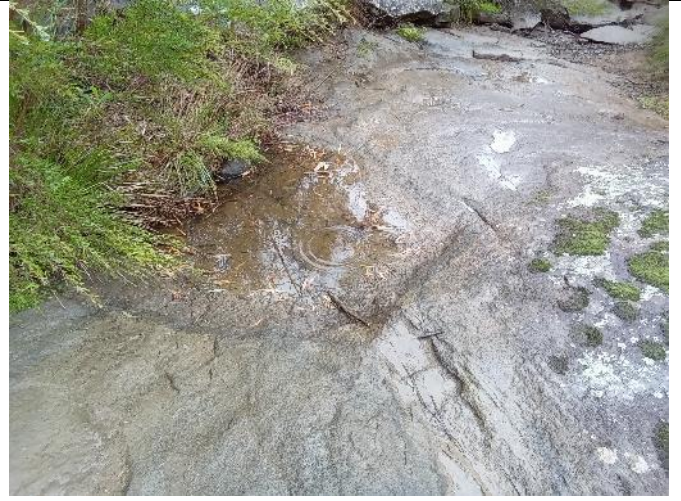
Depression 7 Up 28/06/2023

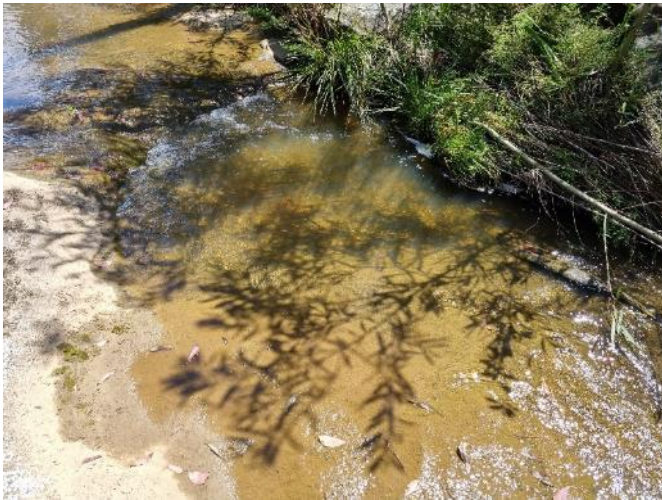
Depression 7 Down 19/10/2022

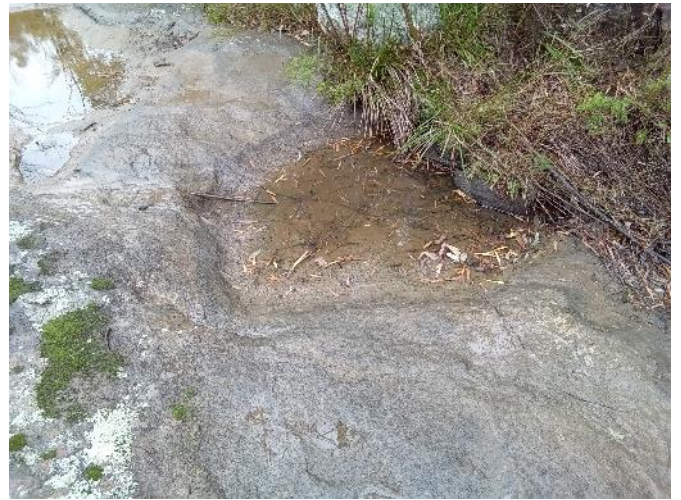
Depression 7 Down 28/06/2023

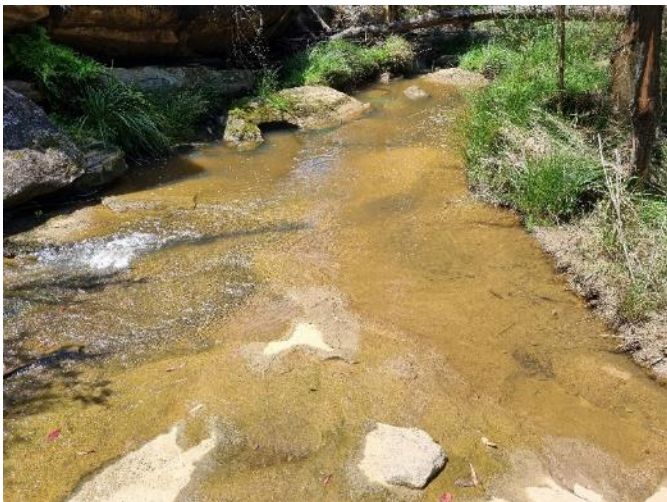
Depression 8 Up 27/10/2022

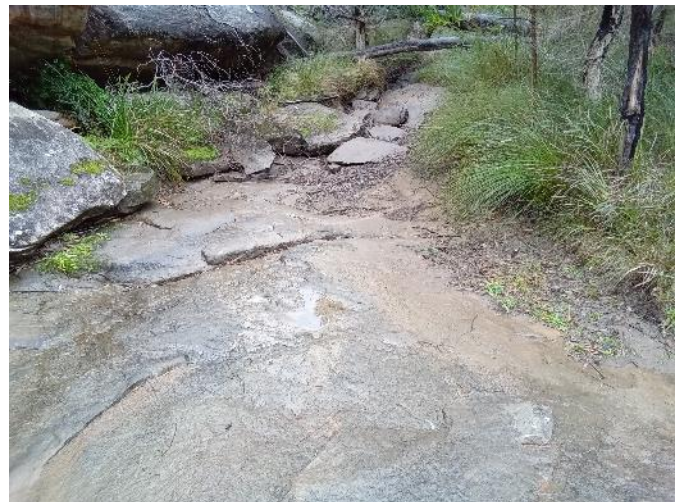
Depression 8 Up 28/06/2023

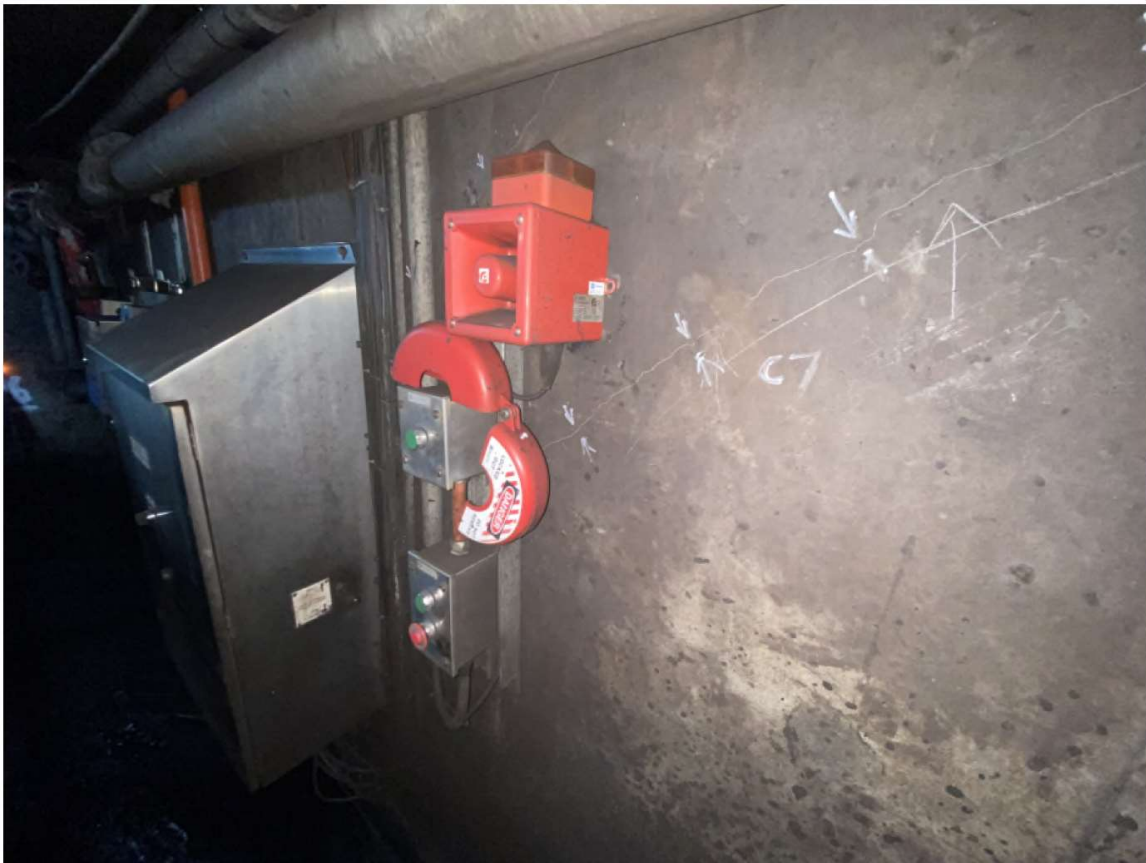
Plate 4.6 Location of C7 (David Talbert, 27 June 2023)

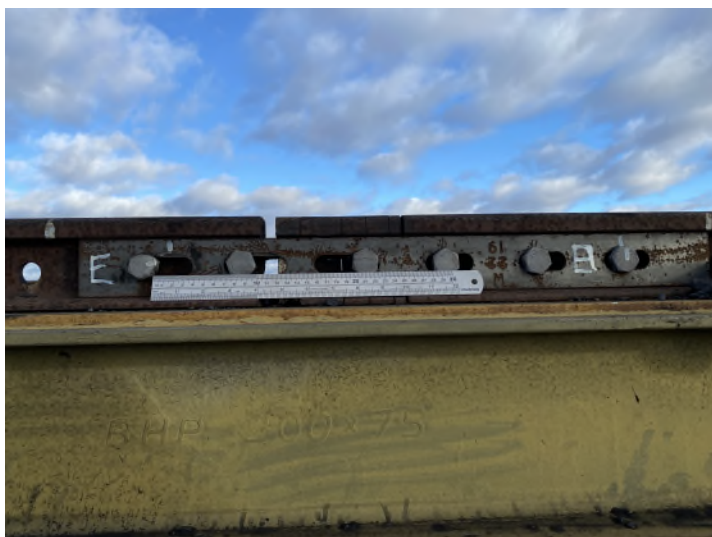
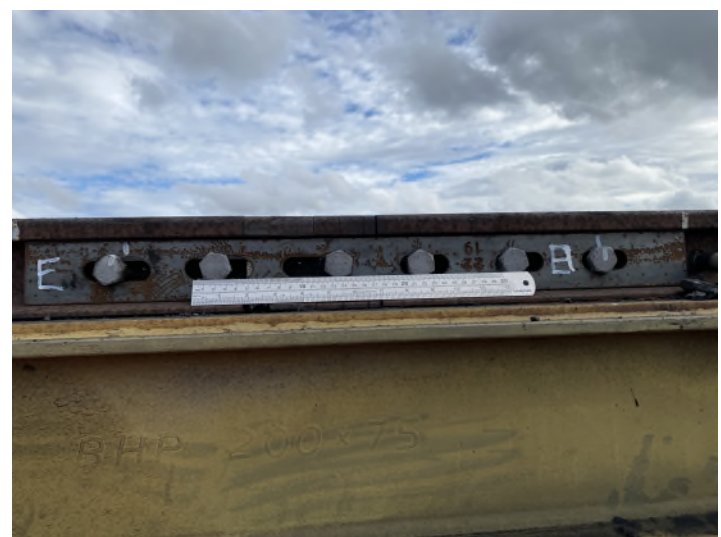
Rail joint gap has **closed significantly**. 20mm spacer has been removed.

Figure 1: 5C slide joint east showing closure of gap (29/05 vs 06/06)

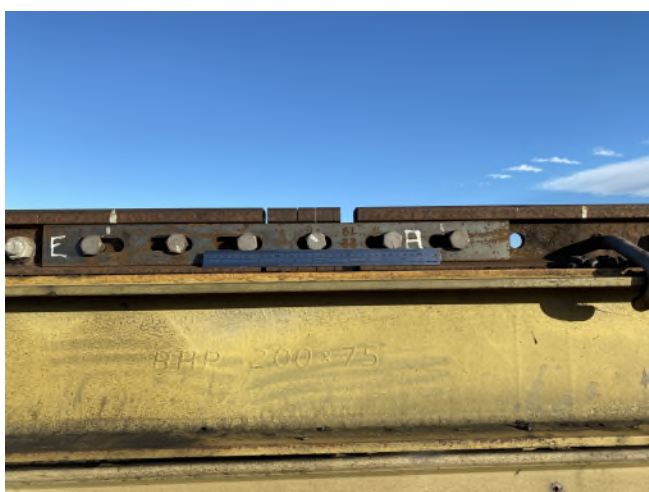
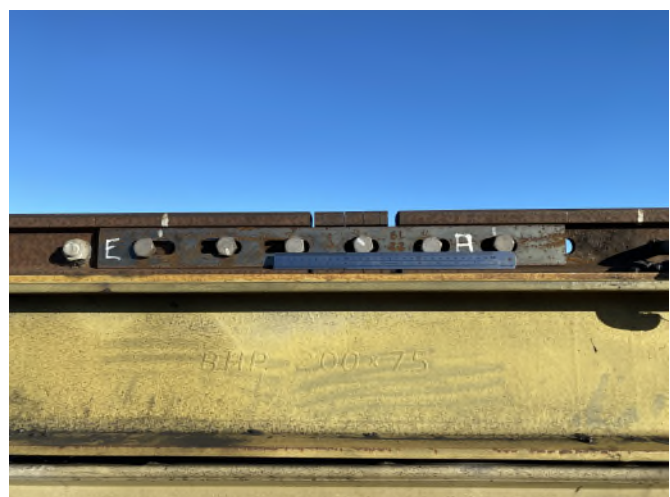
Rail joint gap has **closed a further 5-7mm**. Measurements indicate the west has closed 2mm more than the east.

Figure 1 and 2: 5C slide joint east showing variation 13/06 to 27/06.

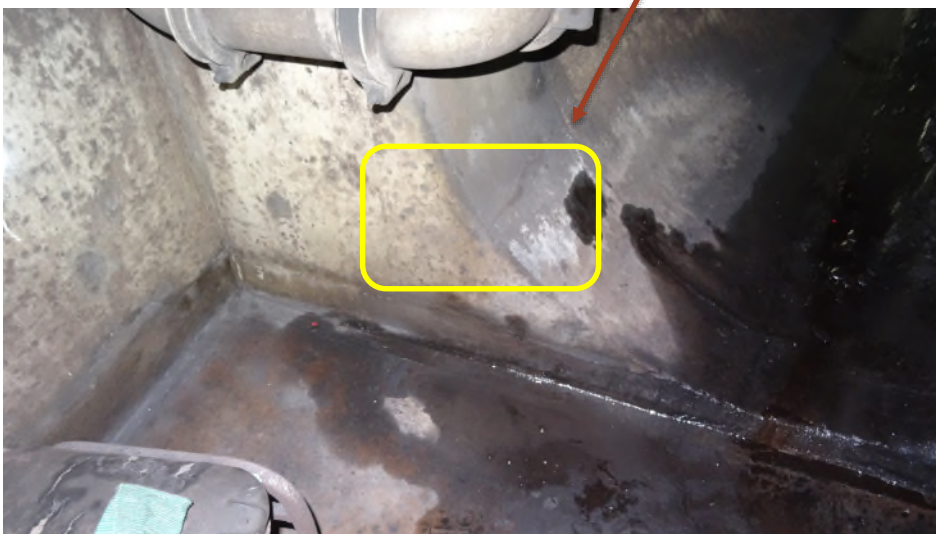
Photo Report: Cracking 6C Tunnel 29/05/23

On 29 May 2023, during extraction of LW S1A, two cracks were observed by the structural engineer at the Tahmoor Mine site within the 6C tunnel and vent shaft interface (Plate 4.1 – Plate 4.2). The site continued to be monitored with weekly inspections and on 6 June, four additional cracks were observed (Plate 4.3 - Plate 4.5). An additional crack was detected on 27 June 2023 (Plate 4.6). The site continues to be monitored with weekly inspections.

It is considered that the hairline cracks (<1 mm) in the concrete within tunnel 6C are minor and, if required, could be repaired in a manner that preserves the heritage value of the mine. The Tahmoor Mine Site is a working site and minor impacts such as hairline cracks are unlikely to affect its heritage values. As the heritage values of the item is not expected to be significantly impacted, this therefore is not considered to be a reportable trigger exceedance under the TARP.

1. The site should continue to be monitored and the data reviewed as per the Tahmoor Mine Site Management Plan.
2. At the conclusion of mining of LW S1A – S6A, the cracks within Tunnel 6C should be assessed by a suitably qualified heritage advisor to determine whether remediation is required.
