Report on  
Geotechnical Assessment  
Longwalls S1A to S6A, Bargo

Prepared for  
Tahmoor Coal Pty Ltd

Project 210597.00  
June 2024

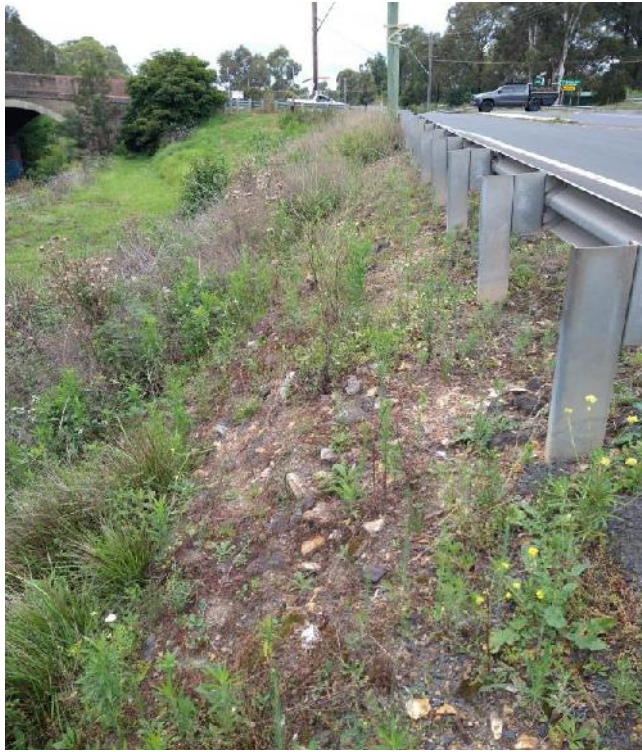
Feature ID/s	Address/Site	Date Inspected	Site Observations
RE1	Remembrance Drive intersection with Wellers Road	23/12/2021	<ul style="list-style-type: none"> <li>– The soil exposed in the embankment comprises clay and gravel fill (refer Photo 1) including shale, carbonaceous siltstone and sandstone.</li> <li>– There is rutting, crocodile cracking, shoving and bleeding in the Remembrance Drive wearing course and a number of patches in both lanes (refer Photo 3). Table drains are located on both sides of the Remembrance Drive roadway to the north of the intersection with Wellers Road.</li> <li>– The surface of the road embankment batter on the eastern side of Remembrance Drive, approximately 130 m to the north of the intersection has an irregular surface.</li> <li>– No signs of deep-seated movement in the pavement.</li> <li>– A high-pressure gas pipeline is located along the eastern side of the embankment.</li> </ul>

Photo 1: View looking south towards the Wellers Road overpass bridge, along the crest of the downstream face for the RE1 road embankment.

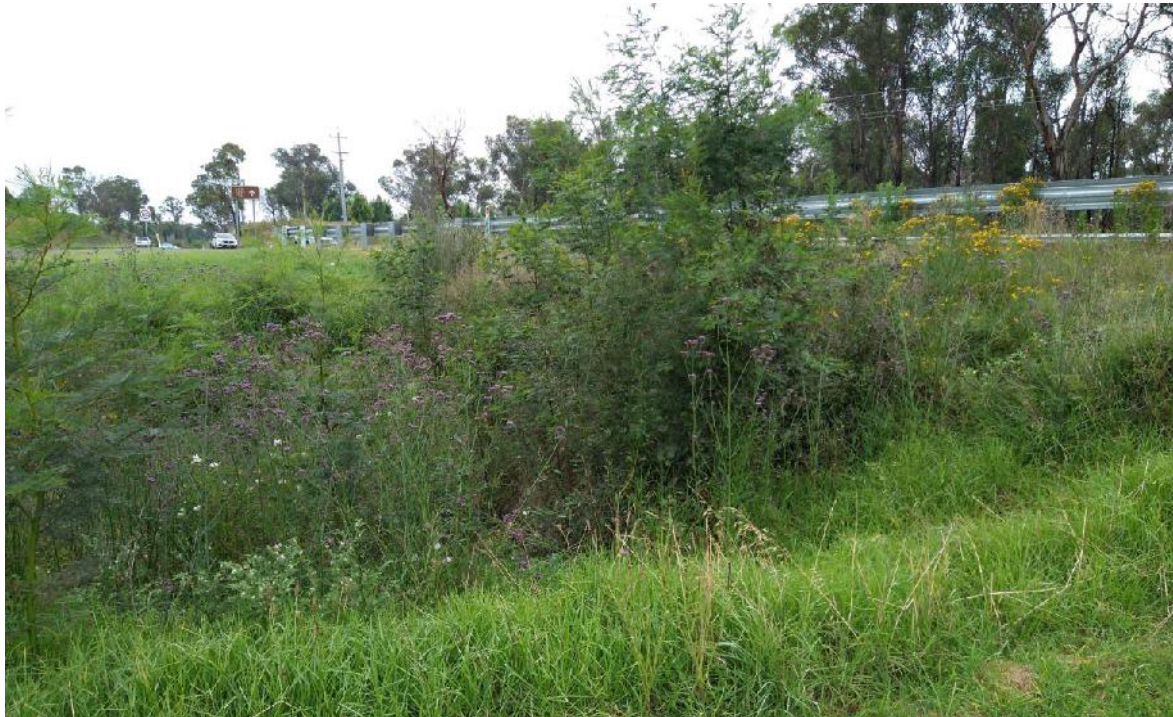
Photo 7: View looking towards the upstream culvert for RE3.

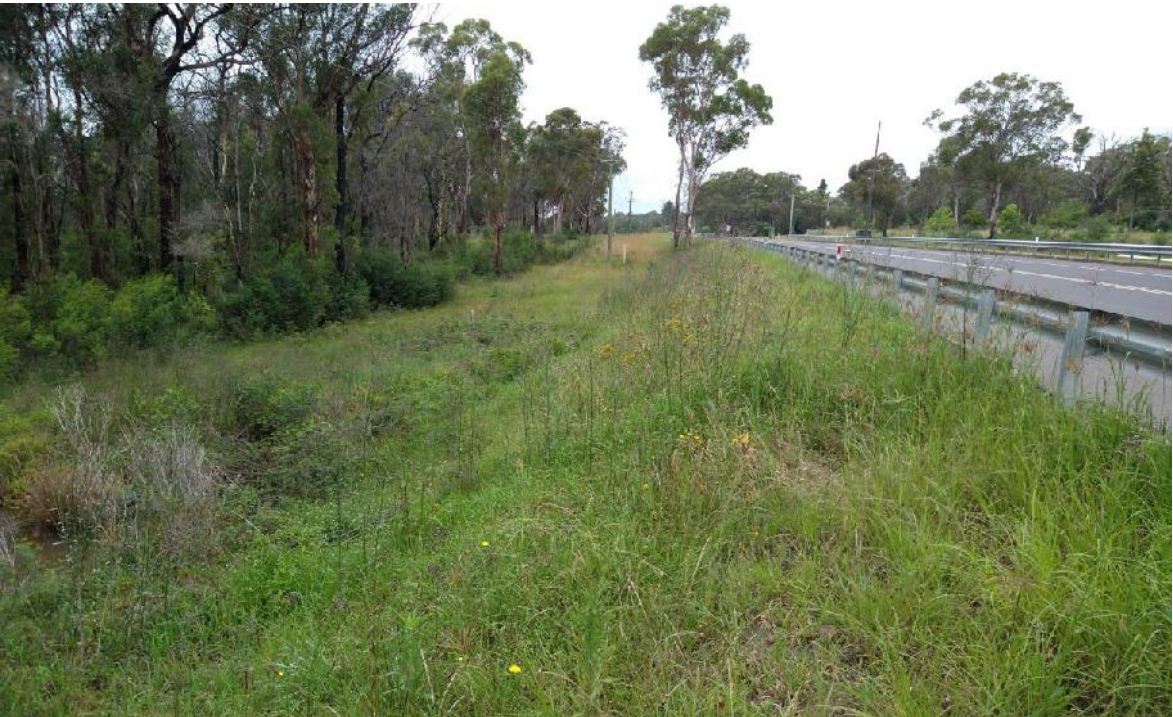
Photo 8: View looking south along the downstream face crest for RE3.

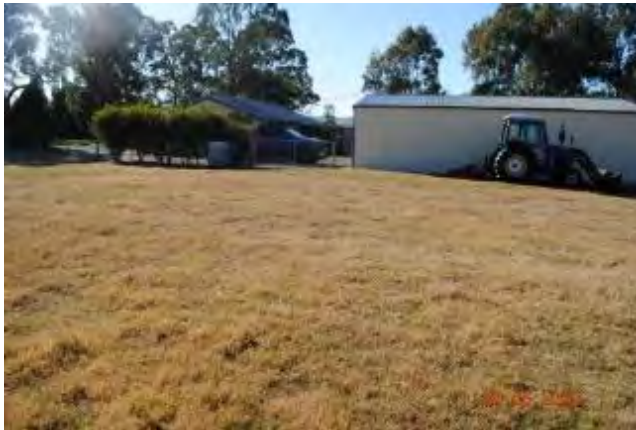
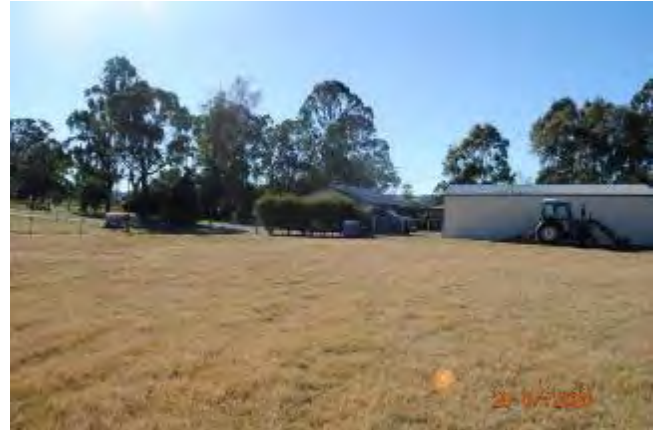
Property Owner east towards sheds (left: June 20; right: current)

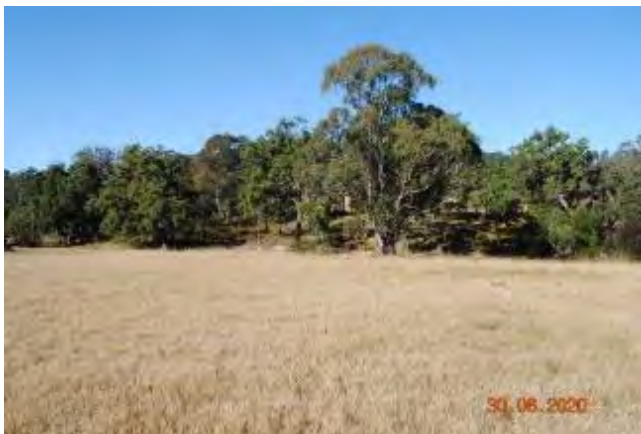
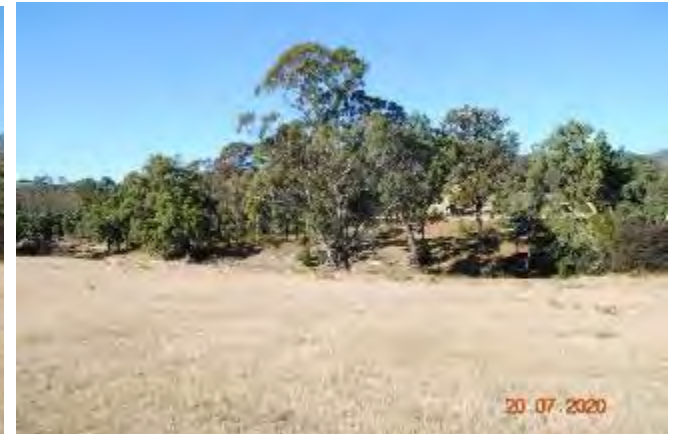
Property Owner south towards Stonequarry Creek (left: June 20; right: current)

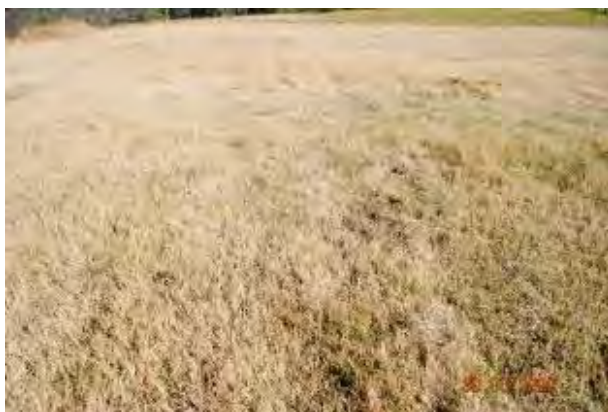
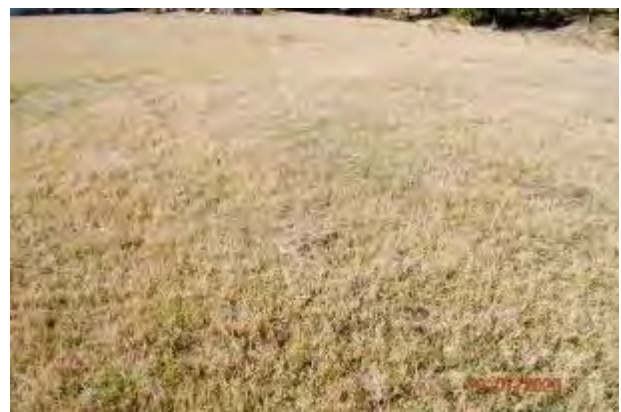
Property Owner ground surface (left: June 20, right: current)
