SIMEC Mining – Tahmoor Coal

Management Plan for extraction of Tahmoor South LW S4A-S7A adjacent to Wellers Road Overbridge

Revision A

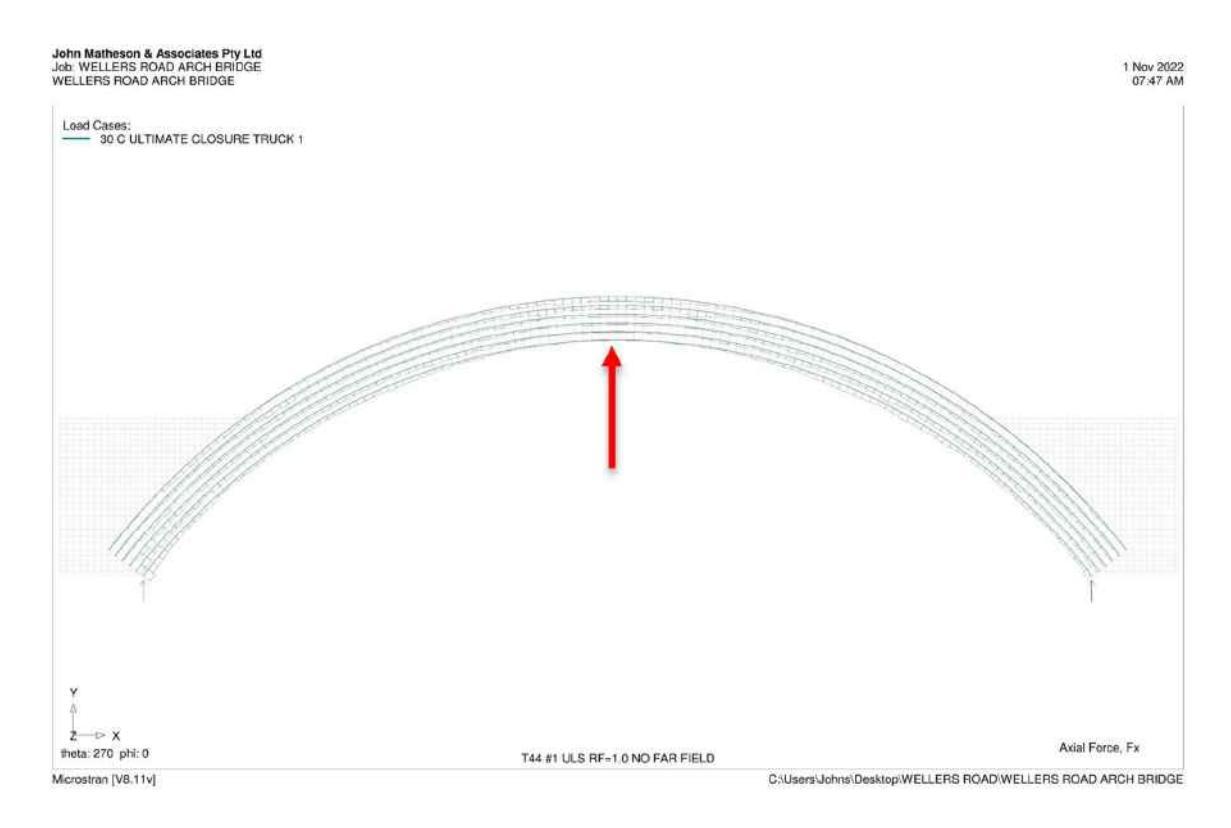
Figure 9 The intrados is very close to decompression around midspan under T44 loading #1 centred at ¼ span.

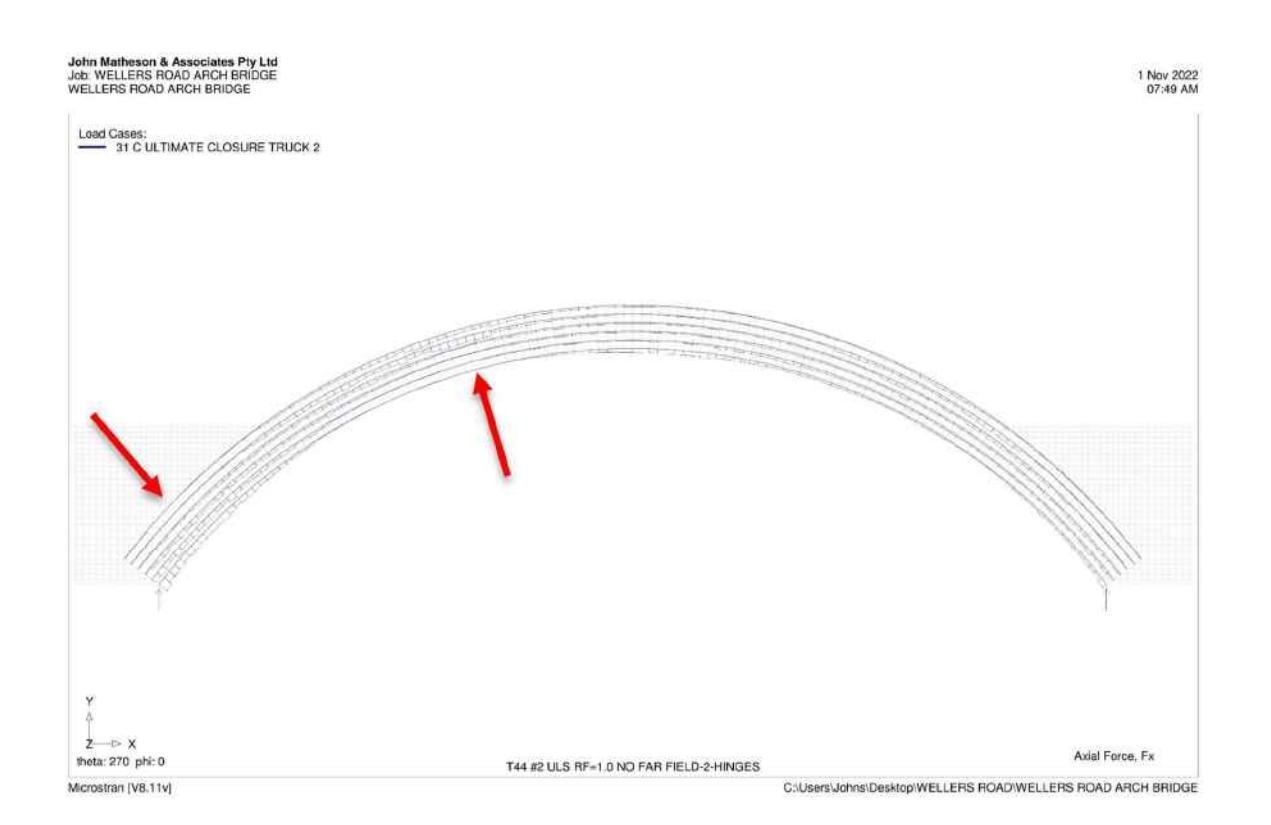
The simulation predicts a maximum compressive stress of around 8.6MPa in the concrete arch at ULS with a rating factor of RF=1.0, see **Figure 11**. The analysis predicts that two hinges could develop at ULS, indicated by the red arrows, see **Figure 10**.

Figure 10 The numerical model predicts that two (2) hinges will develop for T44 #2 truck load (centred at ½ span) at ULS with a rating factor RF=1, red arrows indicate the hinge locations.

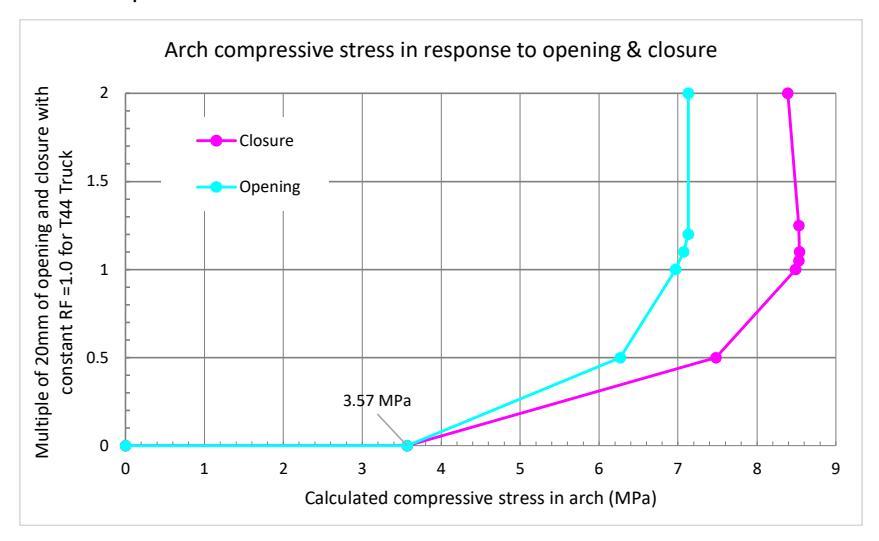
Under existing conditions with no valley opening or closure, a compressive stress of around 3.6MPa was calculated for a T44 truck assuming a rating factor of RF=1.0, which is much less than the characteristic compressive strength of the concrete (Thirlmere Way) of 8.2MPa and 8.85MPa, respectively, at the 0.1% and 0.2% exceedance probabilities. Therefore, the actual rating factor for this bridge is considerably higher than RF=1.0. For valley opening and closure displacement, a baseline value of 20mm was assumed. The bridge was then assessed for factored amounts of the assumed baseline valley opening and closure displacements, holding the rating factor for the T44 truck load constant at RF=1.0. Valley closure has the greatest impact on the development of compressive stress in the arch, with compressive stress more than doubling from 3.6MPa to 7.4MPa at 10mm of closure, see **Figure 11**. Compressive stress appears to asymptote reaching a maximum value of 8.6MPa, after a 3rd hinge develops, see the Magenta trace in **Figure 11**. It is noted with the development of a third hinge, that the arch has become statically determinate and is generally unaffected by differential settlement, temperature change or horizontal strain. However, it is recommended that opening or closure displacement should not exceed 25mm.

Figure 11 Variation in compressive stress calculated in the arch with increasing opening and closure movement.

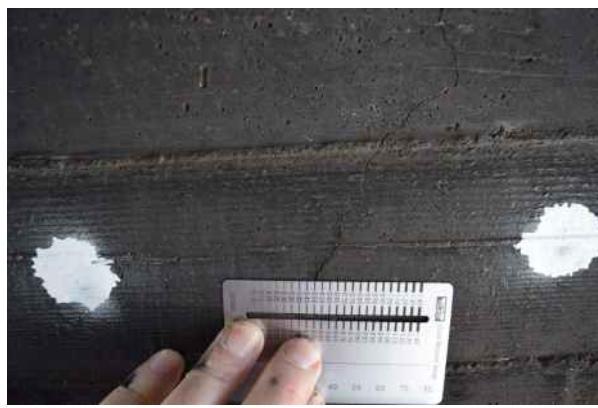
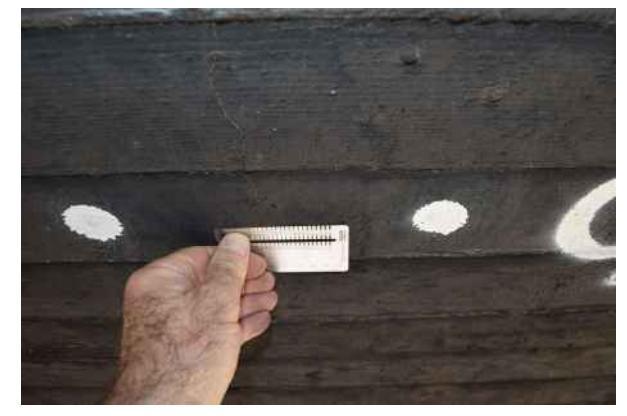
Figure 17: DSC_2871 Crack 2, gauge G2 upside
 Figure 18: DSC_2872 Crack 3, gauge G3 upside

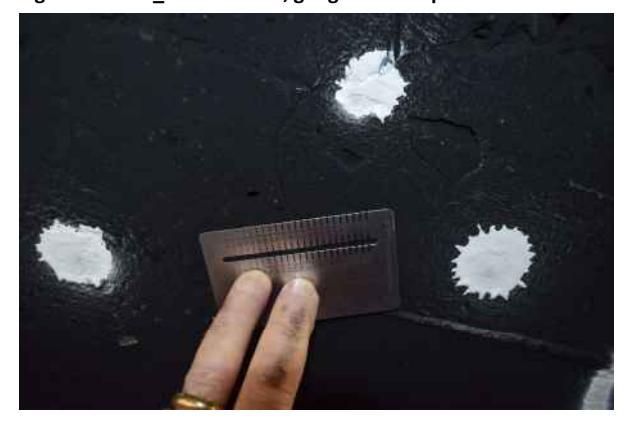
Figure 22: DSC_2876 Crack 5, gauge G5 midspan

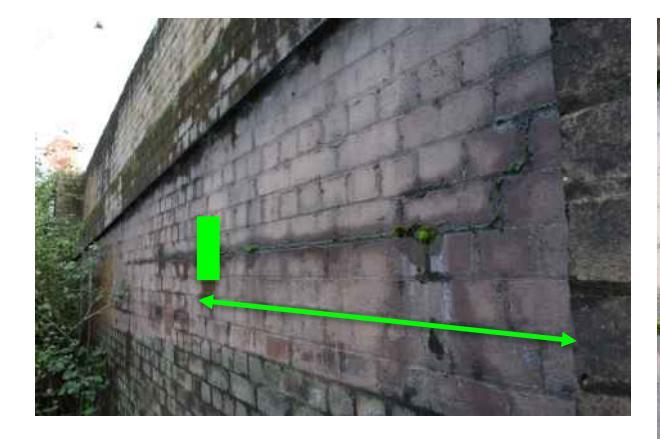
Figure 31: DSC_2854 Install gauge G1 2000mm from buttress

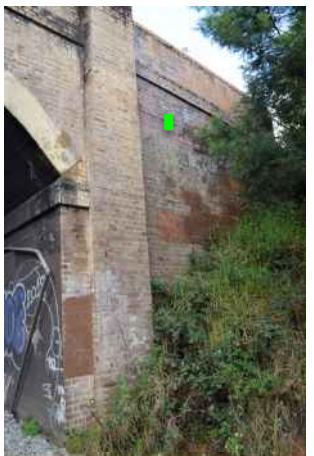
Figure 39: DSC_2845 Gauge G1 on upside see Figure 33

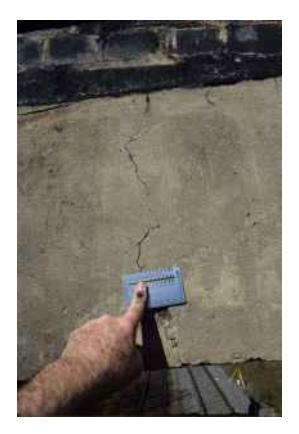
Figure 43: DSC_2885 The transverse crack extends up the side face of the arch to the top

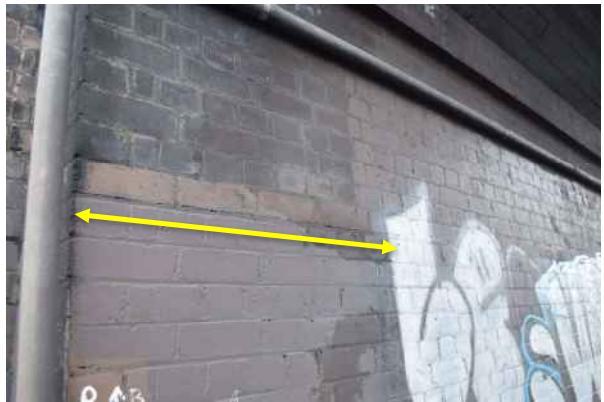
Figure 56: DSC_2840 Bed joint crack vanishes \approx 1100mm from corner

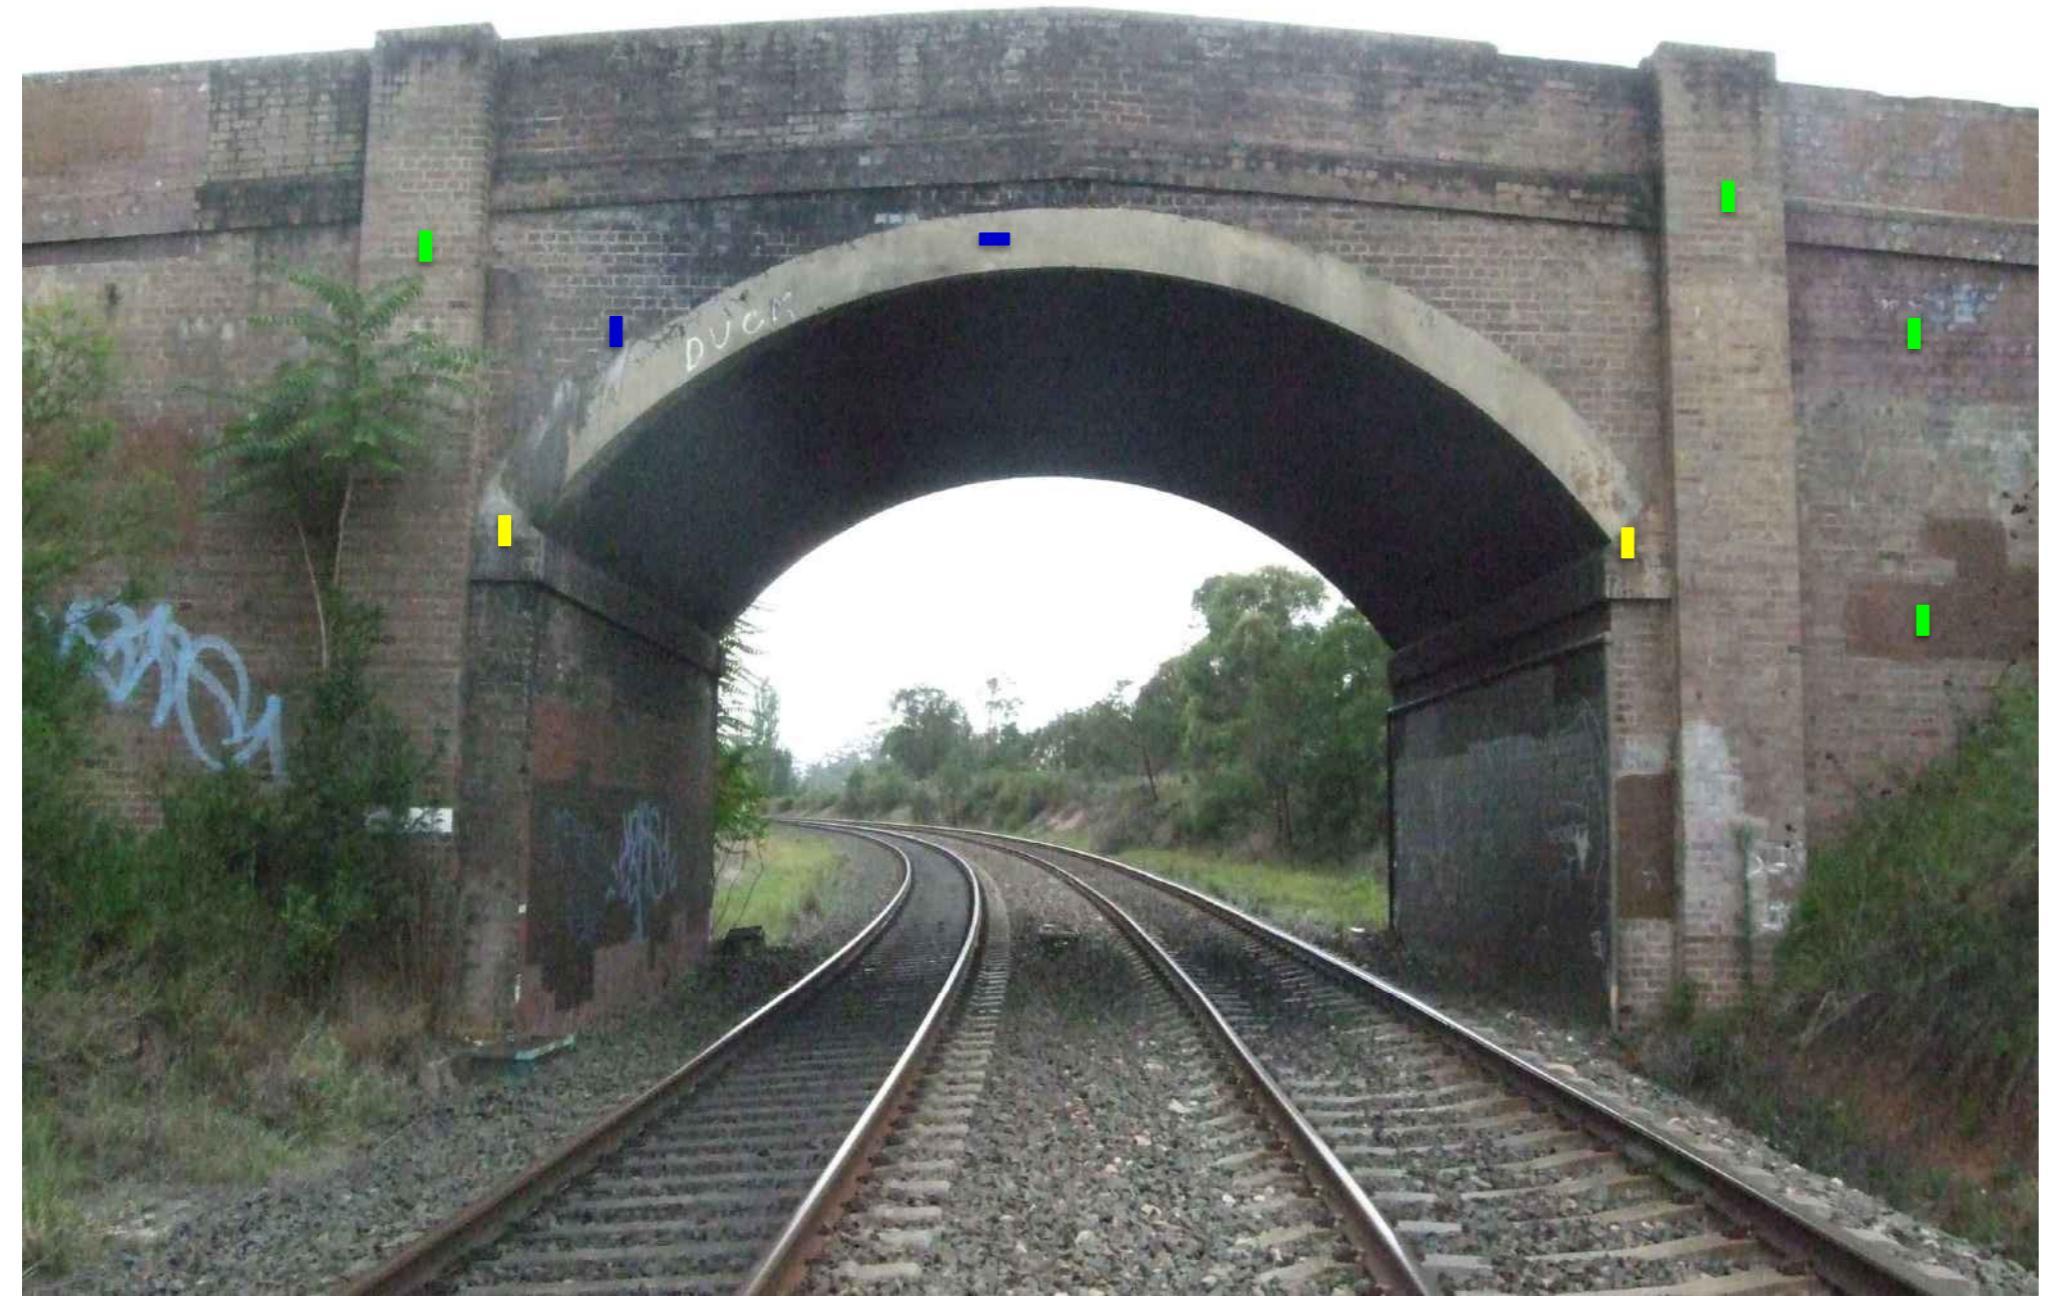
The spandrel walls and concrete arch have developed pre-existing cracking, caused by lateral earth pressure acting against the spandrel walls, transient live load, and seasonal temperature change. Notwithstanding the observed cracking, the structure is in serviceable condition. However, since far field movement is possible at the site of this bridge, JMA recommends that the RMG should install crack gauges and tell-tale marks across cracks or bed joints where an increase in crack width or movement is possible, see **Figure 4** & **Figures 60-62**.

Figure 61 Sydney spandrel wall elevation showing location of 4# Type 1 (lime-green) & 2# Type 2 (dark blue) crack gauges and 2# tell-tale marks, yellow.

- iii. Instal crack gauges over cracks as shown in **Figure 4 & Figures 60-62**. Install tell-tale marks at the spring points at the four corners of the arch, see **Figures 61 & 62**.

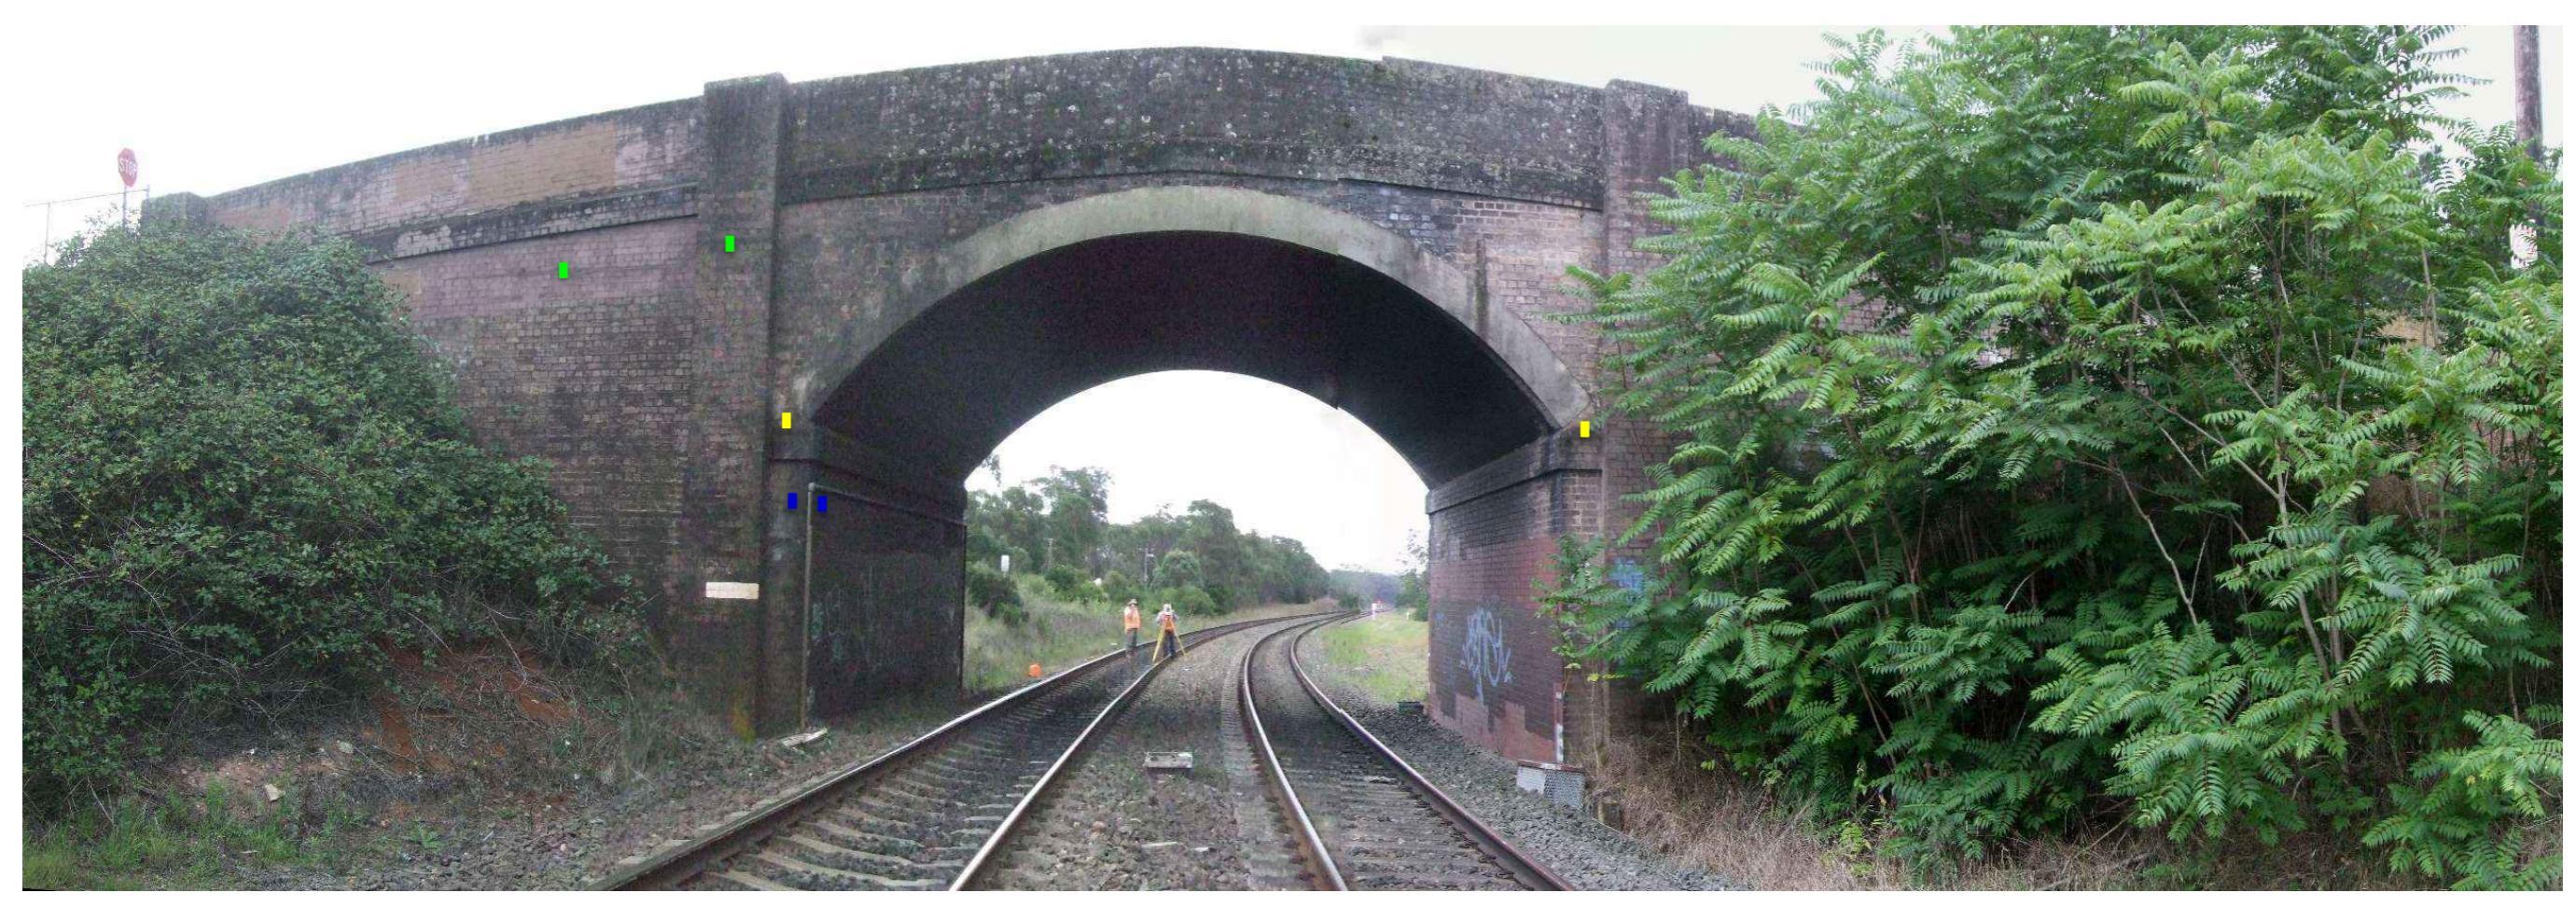
Figure 62 Country spandrel wall elevation showing location of 2# Type 1 (lime-green) & 2# Type 2 (dark blue) crack gauges and 2# tell-tale marks, yellow.

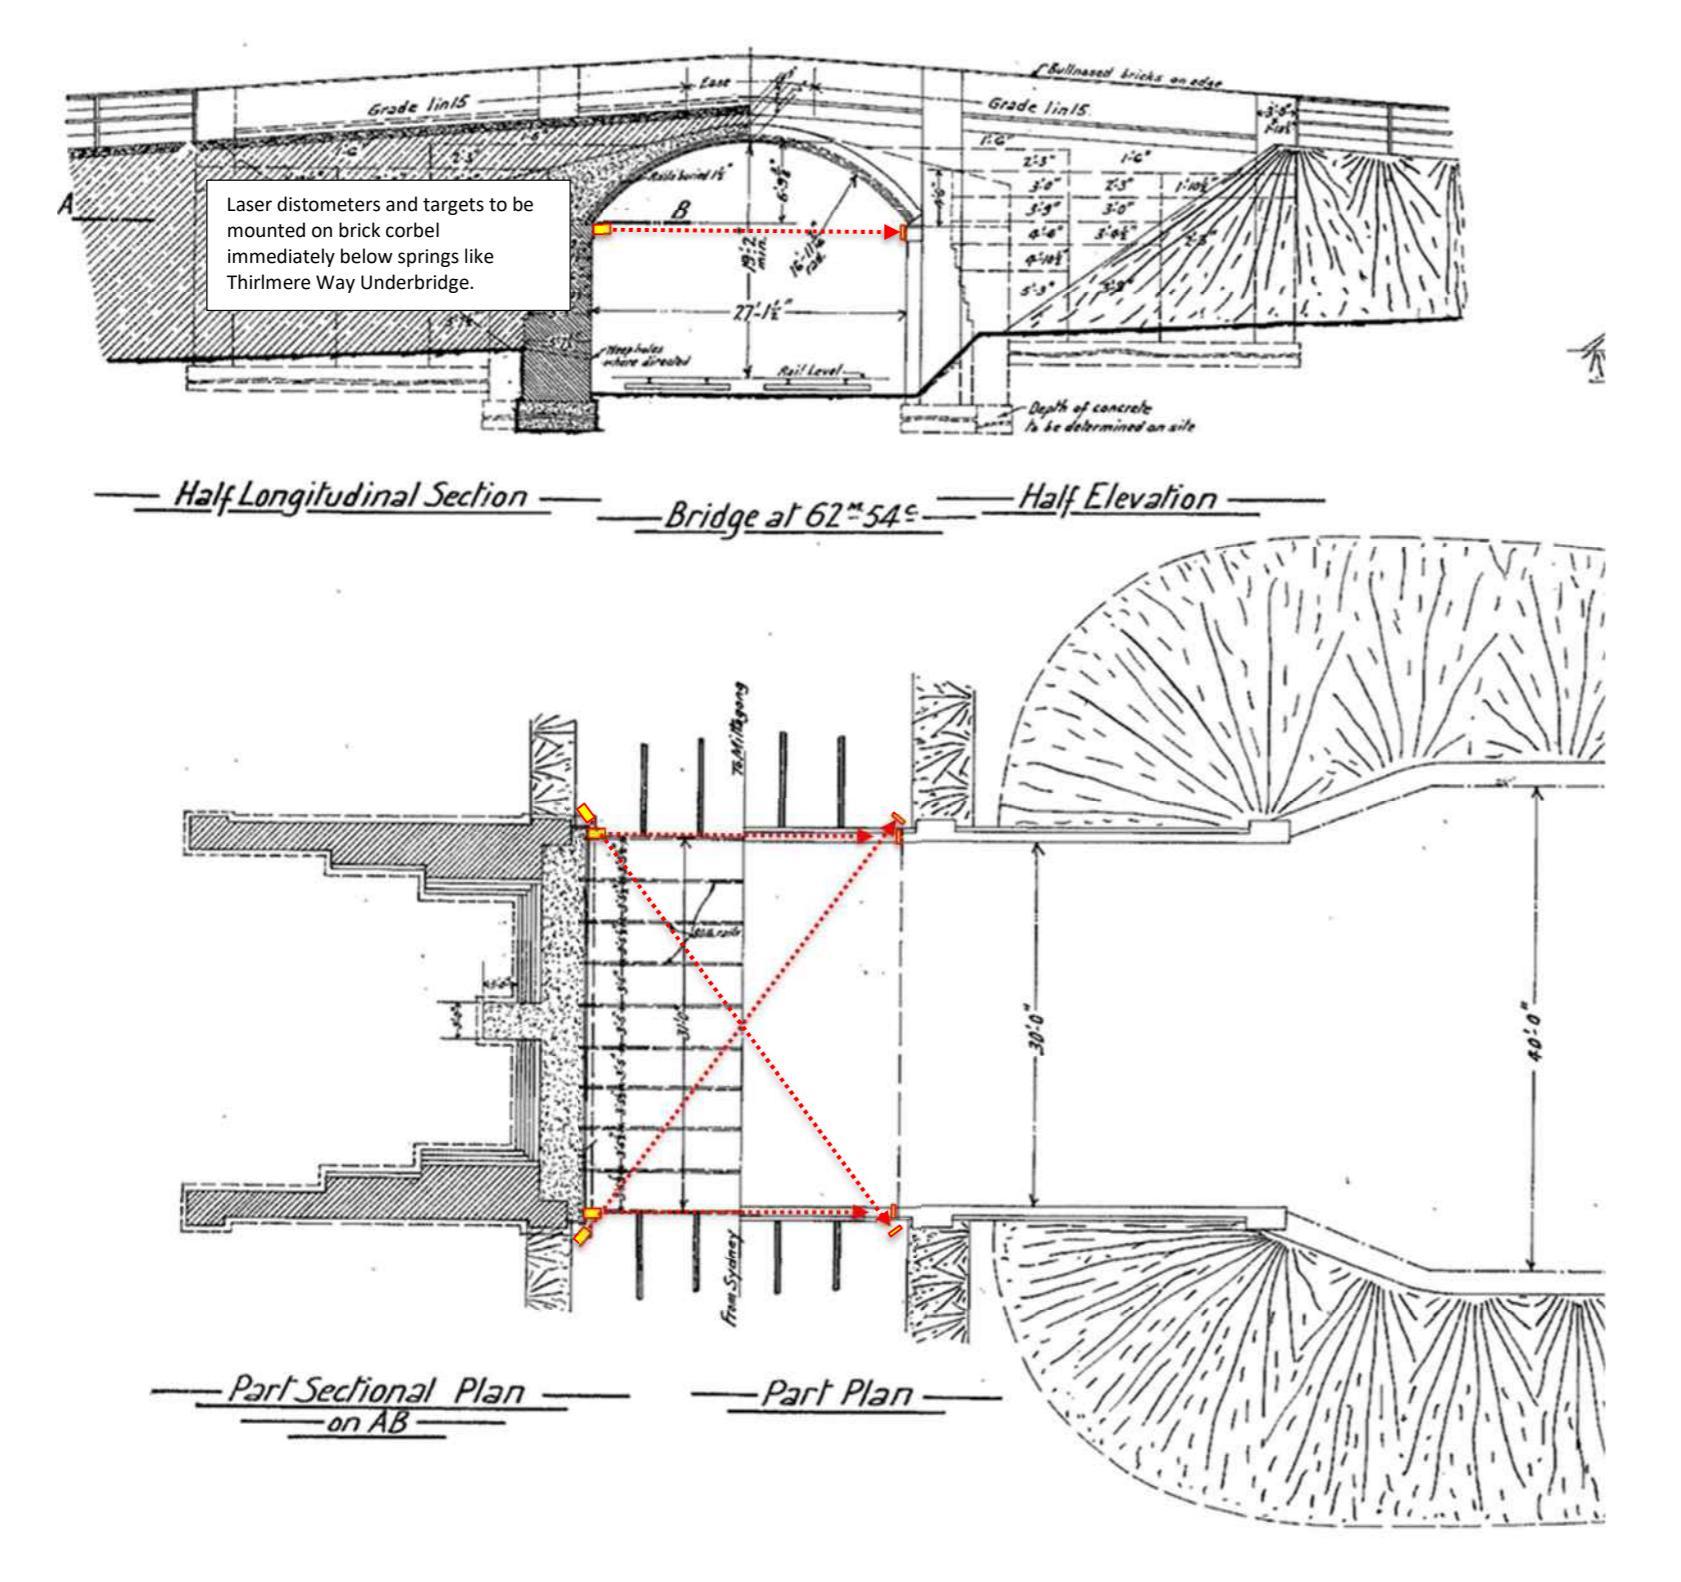
Figure 63 Proposed schematic layout of laser distometers and targets to be fastened to the face of the brick corbel immediately below the spring point. Telltales to be painted on concrete and brickwork at spring to monitor movement between arch and abutment.

As a control, it is recommended that a 5mm early warning trigger should be adopted as an intermediate monitoring review point to determine the likelihood of far-field movements or damage could exceed predictions. If it appears likely that the 5mm trigger will be exceeded or if structure damage exceeds expectations, then the Rail Management Group (RMG) should consider whether additional response measures are required. JMA has recommended that crack gauges should be installed on the parapet and spandrel walls, abutment wall and arch intrados cracks to monitor for the impact of far field movement during LW S1A-S7A, see **Figure 4 & Figures 60-62** and **Figures 61 & 62**. Furthermore, JMA has recommended that laser distometers should be installed to monitor abutment opening, closure and transverse displacement, see **Figure 63**.

- ii. Instal laser distometers and targets to the vertical surface of the brick corbel immediately beneath the arch spring points to measure the perpendicular distance between the abutment walls at the country and Sydney ends of the up- and down-side abutment walls and the diagonal distance between the abutment walls, see Figure 63 for the diagrammatic layout of distometers and targets. The laser distometers and targets, and the baseline distances and ambient temperature should be measured on site before the end of longwall panel LW S2A.

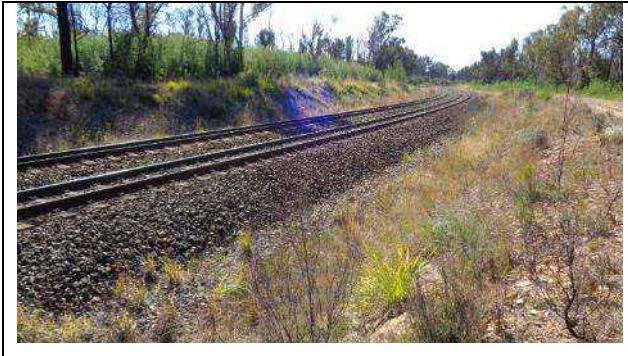
98.600km cutting view to city

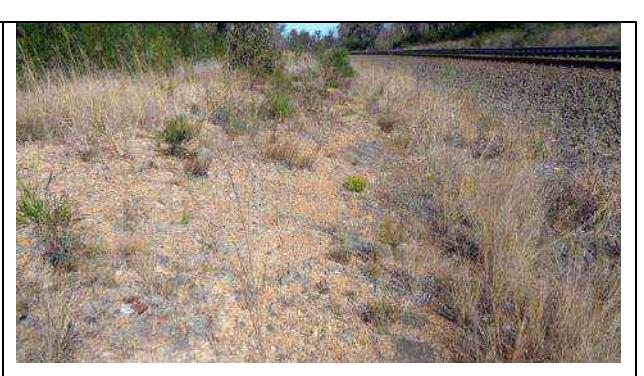
98.600km sandstone rock in batter and cess

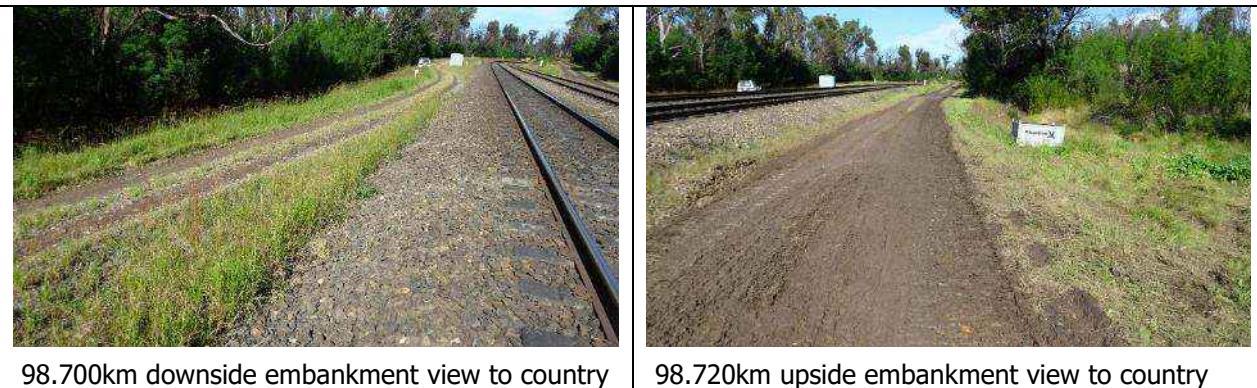
98.700km downside embankment view to country

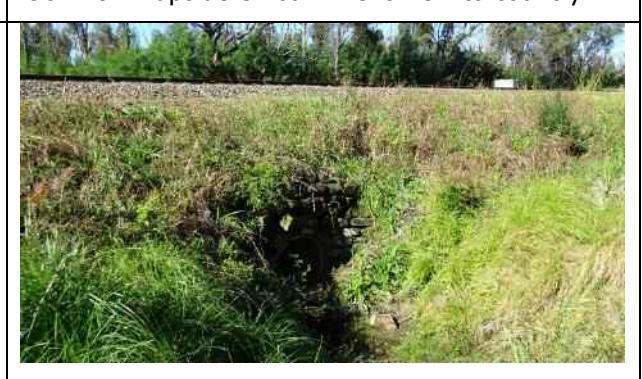
The culvert (listed as 98.739km) comprises a 0.9m diameter brick arch culvert with 0.9m diameter reinforced concrete pipe extensions on both the upside and downside beneath the access road. Survey indicates the upside invert level is 289.14m AHD and the downside 287.57m AHD with a length of 28.7m. Dilapidation assessment of the culvert has been undertaken by Robinson Rail.

98.739km upside culvert (upstream)

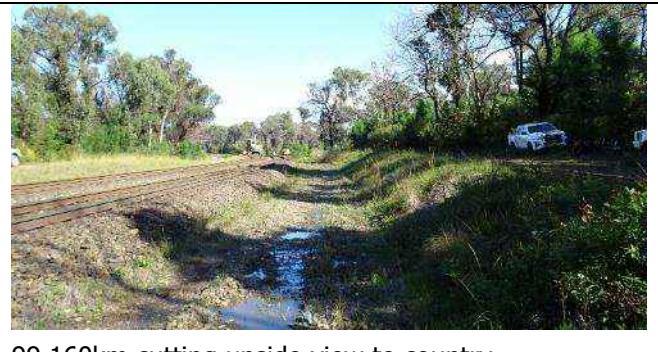
99.160km cutting upside view to country

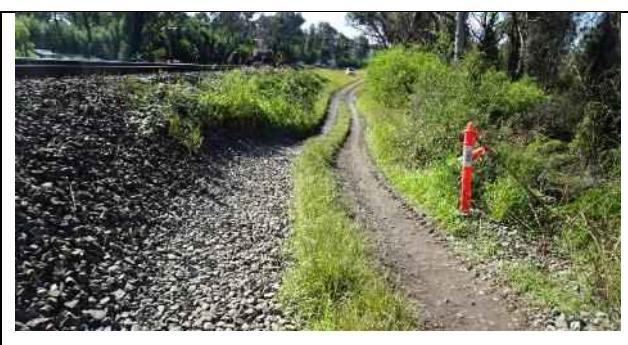
99.320km upside embankment toe view to country

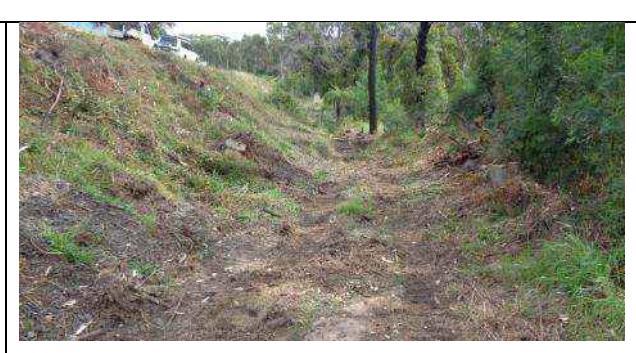
99.340km downside embankment view to city

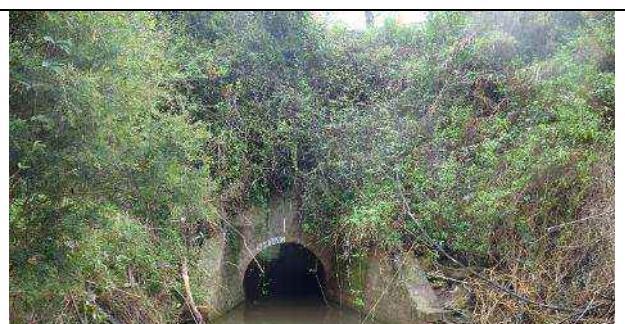
- No evidence of current or past embankment instability observed apart from the past washout failure of the downside culvert extension at 99.338km.
- Requirement for remedial works to reinstate the downside culvert extension and batter slopes.

99.338km downside 1.5m diameter original culvert 99.

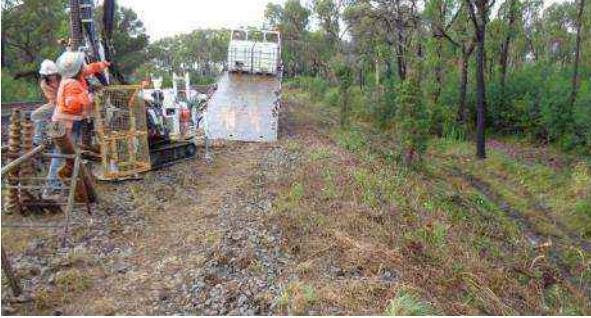
99.390km upside embankment crest view to country (borehole 5)

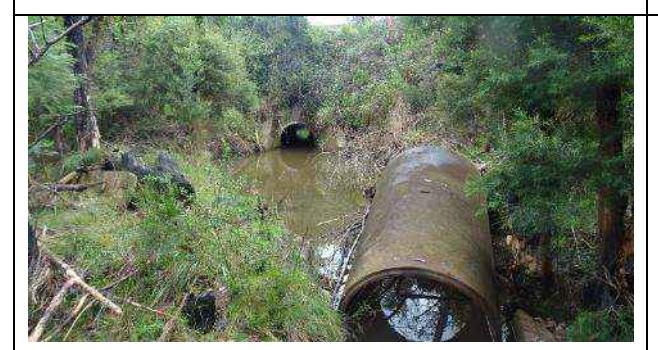
headwall with very steep batter slope above

99.338km downside culvert with 1.2m diameter RCP extension from washout located downstream

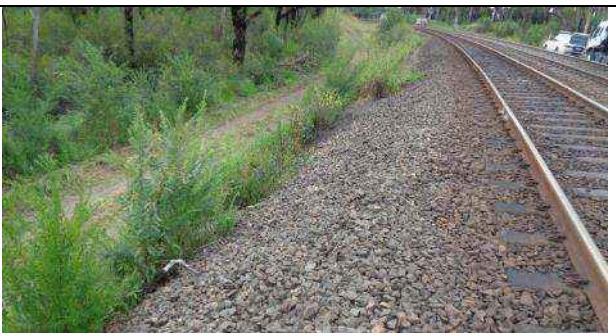
99.395km downside view to country

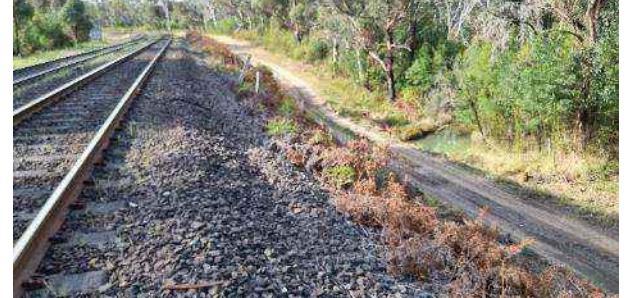
100.150km downside embankment view to city

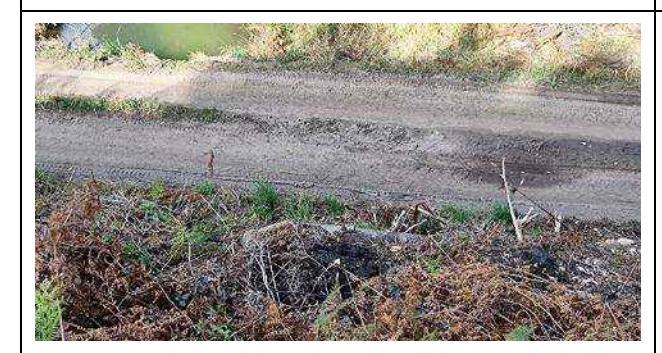
- No evidence of current or past embankment instability observed.
- No evidence of culvert piping erosion observed apart from gap between downside pipe extension and headwall.
- No requirement for any remedial works identified apart from sealing of the downside gap between the culvert headwall and pipe extension.

100.127km downside original BAC headwall with pipe extension at shallow depth below access road

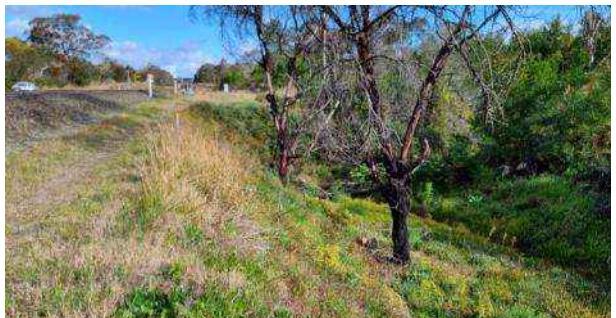
100.080km upside embankment view to country

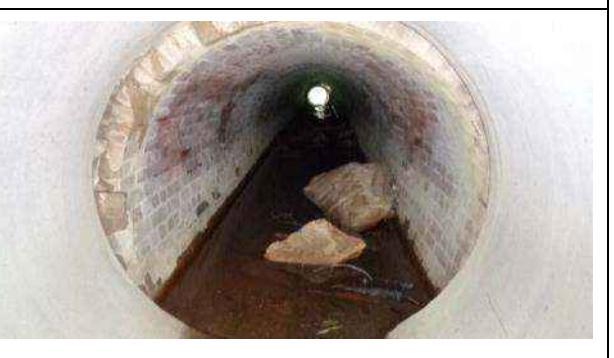
100.147km upside 1.5m diameter brick arch culvert and pipe extension

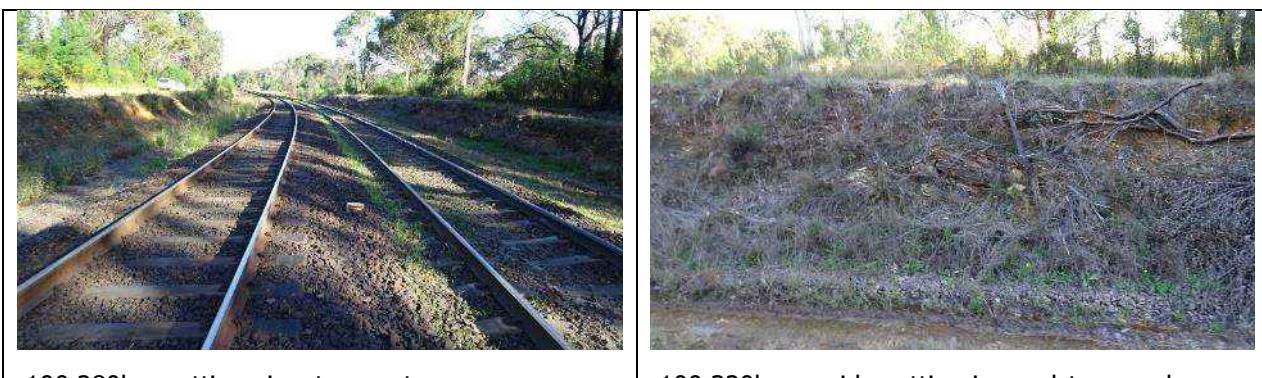
100.280km cutting view to country

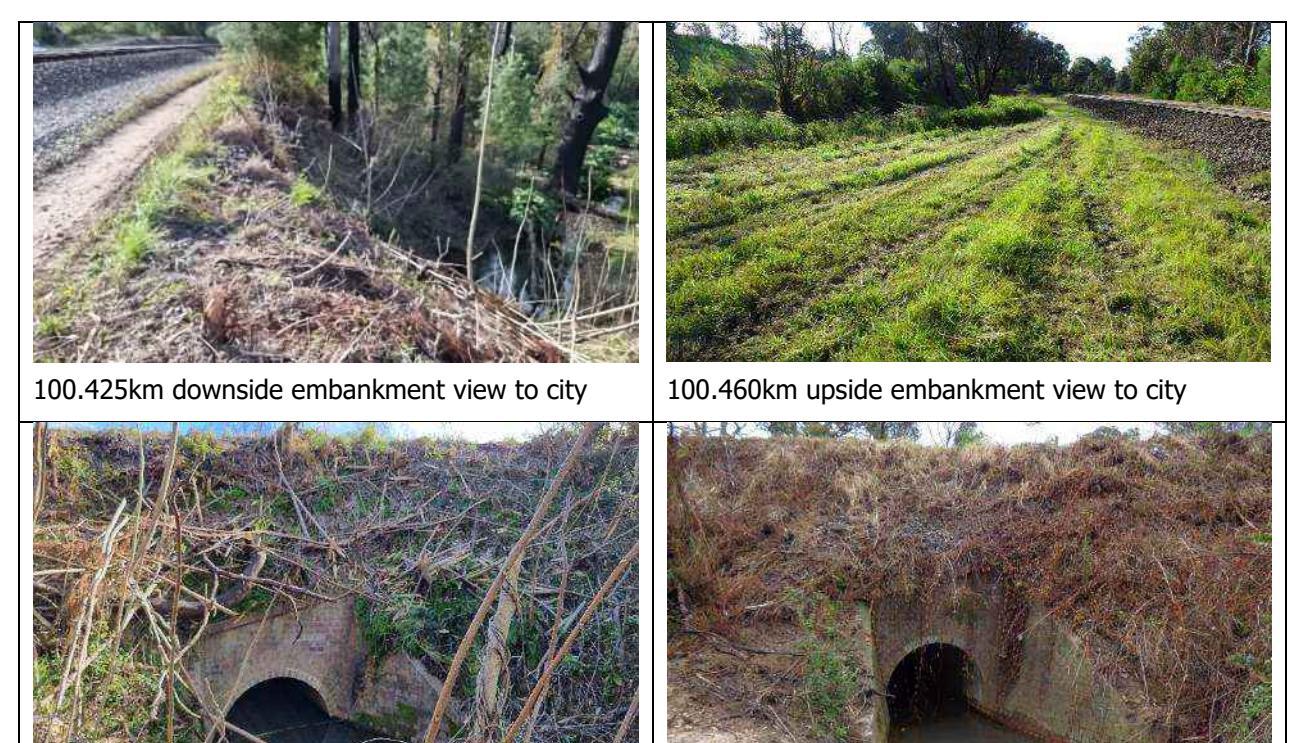
100.430km upside culvert (upstream)

98.422km downside culvert (downstream)

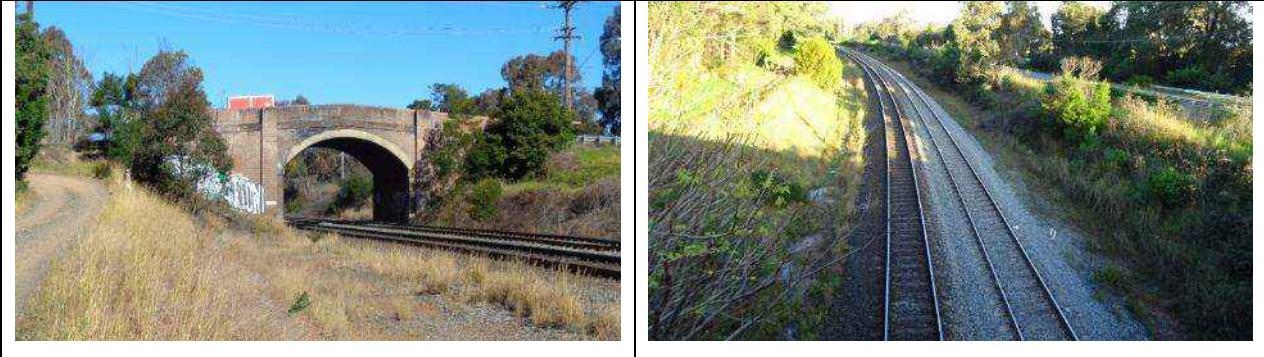
Brief geotechnical assessment of the cutting at 101.162km did not note any evidence of current or past cutting instability or fault structures.

101.162km Wellers Road overbridge view from city

101.180km cutting view to country

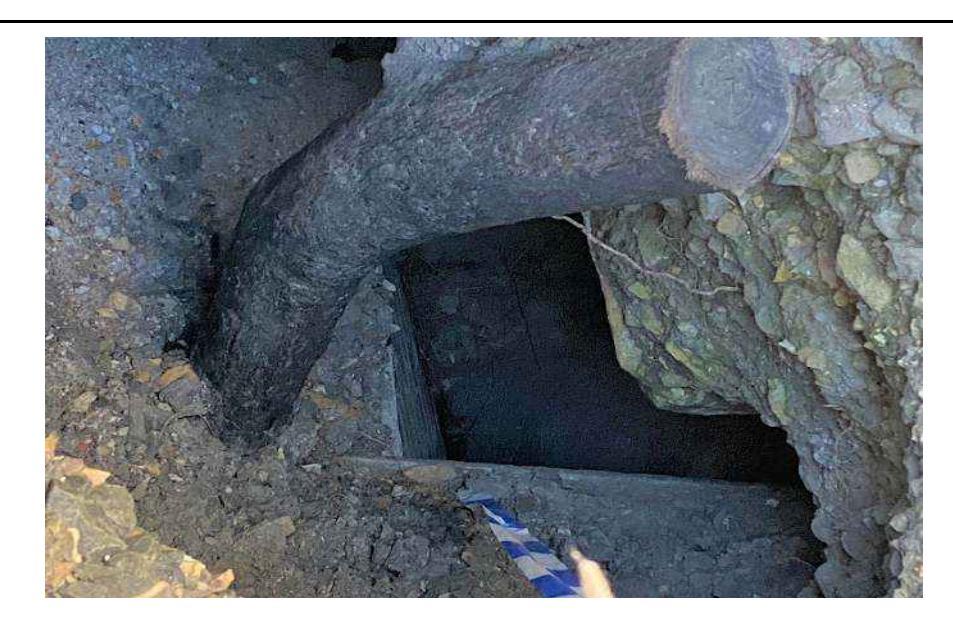
The existing piping hole in the downside has widened from approximately 1m diameter in August 2021 to 2.3m diameter on 28 March 2022 where the hole was observed choked off at 2m depth. A cover of 3.8m over the open RCP extension was previously observed. Details are shown on attached Drawing 99.035.

Sinkhole 1m diameter August 2021. Sinkhole now 2.3m diameter

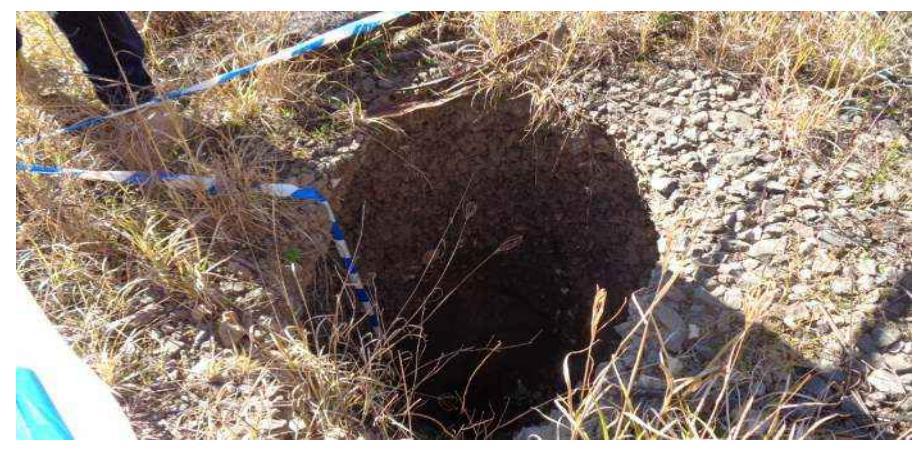
- 99.035km where there is a piping hole / void in the downside access associated with a broken roof section in the 0.9m diameter reinforced concrete pipe (RCP) culvert extension resulting in wash in and collapse of the 3.8m deep fill cover to the surface.
- 99.384km where a narrow downside access road and very steep fill batter slope occurs above the original 1.5m diameter brick arch culvert outlet and wingwalls. The original 1.2m diameter RCP culvert pipe extension and overlying fill at this location has previously failed presumably under a peak flow / food event resulting in a very steep fill batter / scarp below the access road.

Collapsed culvert extension roof August 2021. Note tree growing in fill.

- 2 Expose open pipe section and joint between 0.9m dia RCP and original brick headwall. The scope of rectification by concrete patching, grouting, headwall dowel installation (or combination of) or pipe section replacement will only become apparent once the joint and extent of RCP damage is exposed. The treatment methodology adopted to ensure a tight permanent seal is maintained between the pipe extension and original brick headwall.

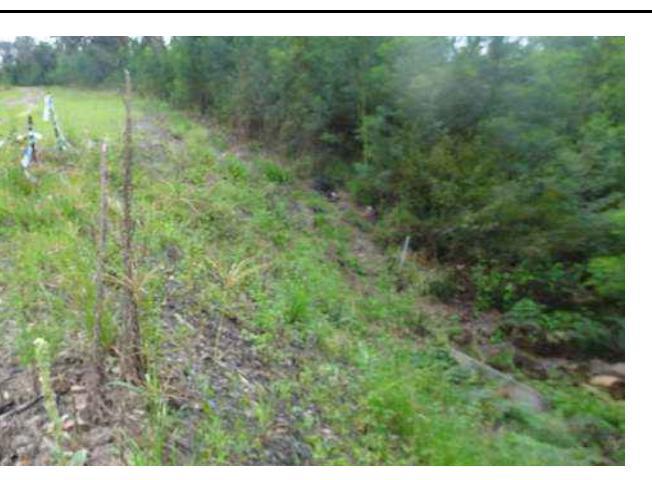
The piping hole is about 4m from the ballast toe and as such is not currently constraining access. The key issue is that further collapse of the hole may potentially result in culvert blockage during a rainfall event resulting in potential impoundment of water along the upside embankment. As such rectification is recommended.

Bunded off sinkhole at crest of fill embankment 4m from ballast toe 28 march 2022

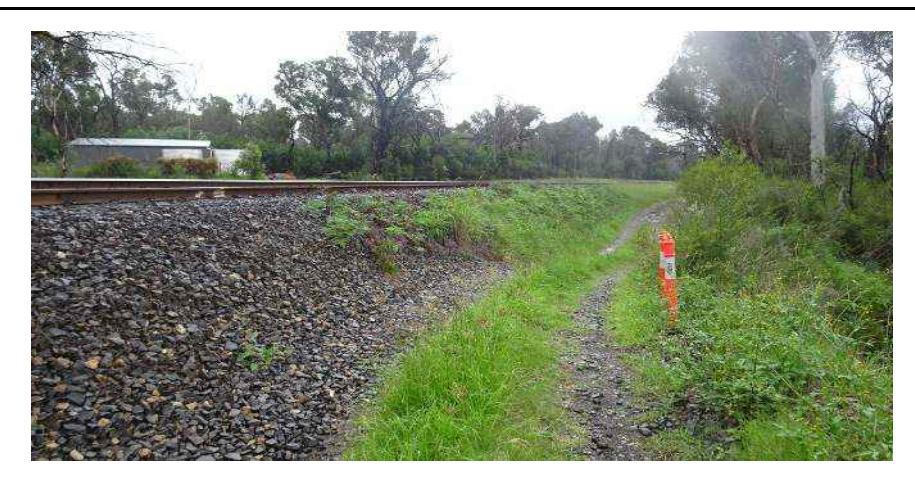
The failure has resulted in a narrow (3.3m) access road between the ballast toe and embankment crest with a very steep fill embankment slope / slip scarp up to estimated 45 degrees down to the culvert headwall. This steep bank is expected to have marginal stability based on the steep profile for the fill materials. Potential loading from construction plant during the Tahmoor South Project establishment works would increase the risk of slump type instability along the roadway. It is noted that evidence of recent batter instability can be noted in the dense vegetation on the city side of the culvert, possibly associated with the March 2022 rainfall event.

In its present state the steep bank and narrow roadway presents a risk to the project in terms of potential loss of downside access and potential for vehicle drive off over the steep bank. As such remedial works are recommended with options presented on Drawing 99.384 comprising:

Narrow (3.3m) access between ballast toe and steep bank 28/03/2022

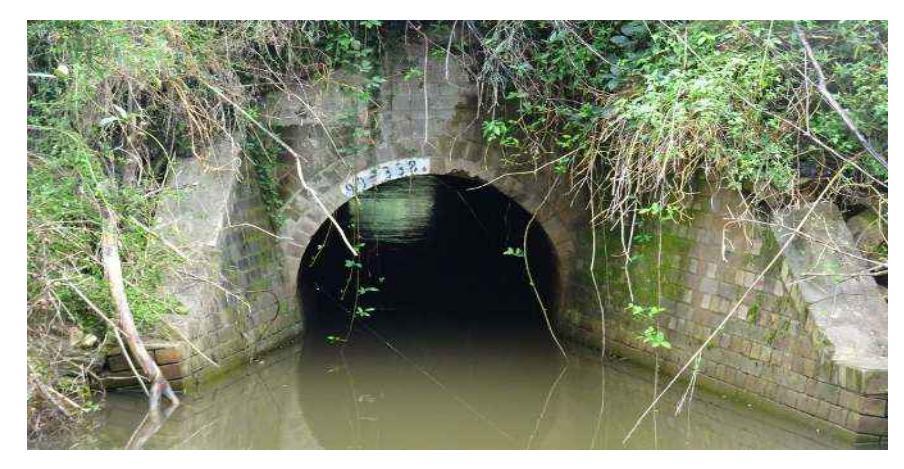
At some stage it is appears that flood damage has occurred with blow out of the RCP culvert extension pipes and slumping of the batter slope above the original headwall. The underlying reason for the failure at this location appears to be the undersized 1.2m diameter RCP extension joined to the 1.5m diameter brick arch culvert and the skewed alignment of the culvert and tight configuration of the brick wingwalls that is likely to have precluded a tight fit between the pipe extension and headwall.

1.5m dia brick arch culvert outlet with tight join between wingwalls and culvert restricting ability to tightly join / seal extension pipe against headwall.

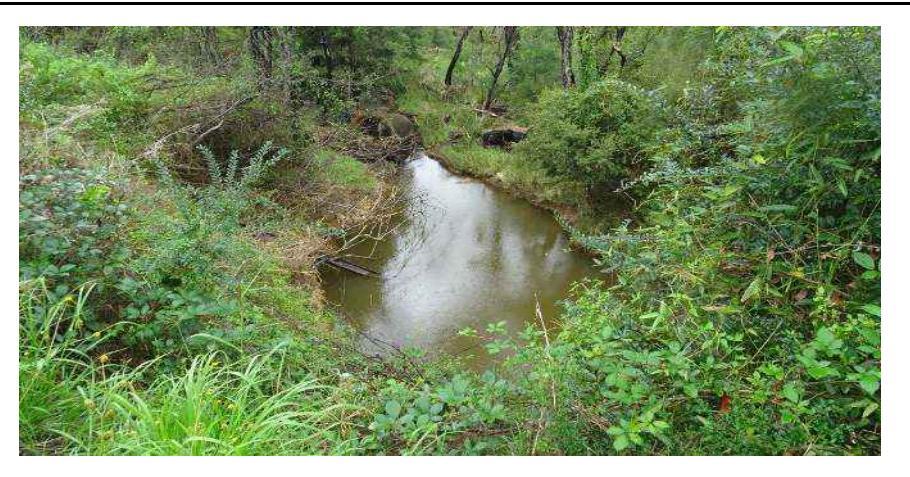
Very steep bank down to ponding water where original batter slope was before washout 28/3/2022
