SIMEC Mining – Tahmoor Coal

Management Plan for extraction of Tahmoor South LW S4A-S7A adjacent to Wellers Road Overbridge

Revision A

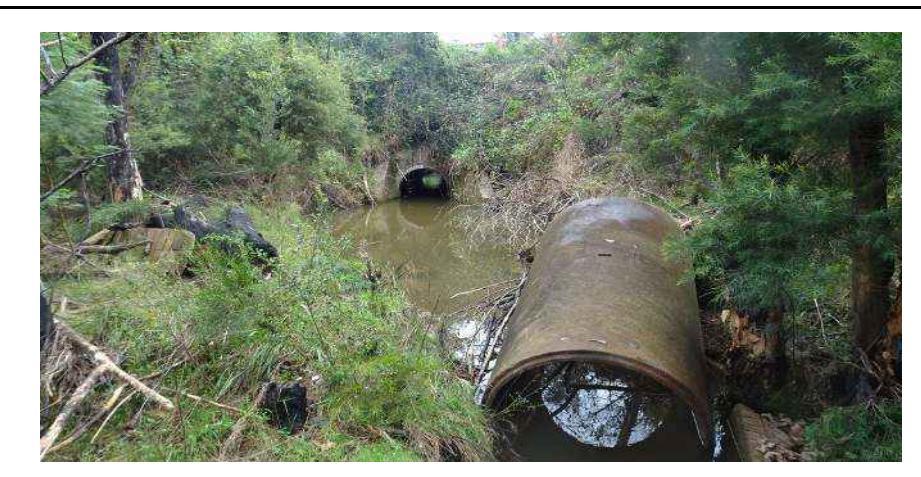
Washed out 1.8m diameter and 2.45m long RCP extension 20m downstream, presumably others further down 28/3/2022

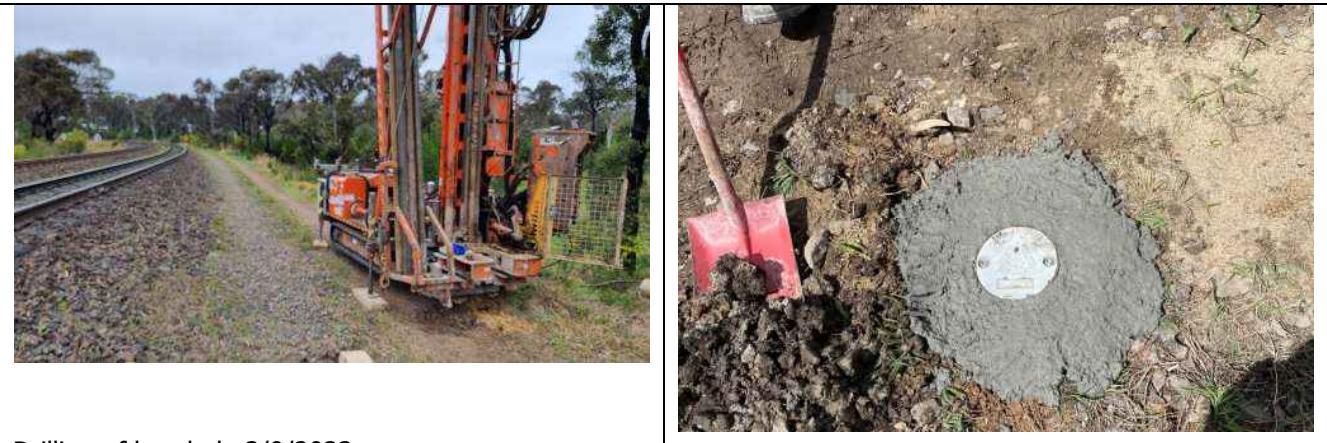
Drilling of borehole 3/9/2022

Completion of inclinometer grouting 28/9/2022.
